MINERALS PROGRAM INSPECTION REPORT
PHONE: (303) 866-3567

MINE NAME: Lindsey Pit	MINE/PROSPECTING ID#: M-2013-015	MINERAL: Gravel	COUNTY: Phillips
INSPECTION TYPE: Monitoring	INSPECTOR(S): Brock F. Bowles	INSP. DATE: August 29, 2019	INSP. TIME: 13:00
OPERATOR: Mike L. Koellner dba L&L Ready Mix	OPERATOR REPRESENTATIVE: Laurine Koellner	TYPE OF OPERATION: 110c - Construction Limited Impact	
REASON FOR INSPECTION: Normal I&E Program	BOND CALCULATION TYPE: Complete Bond	BOND AMOUNT: \$30,137.39	
DATE OF COMPLAINT: NA	POST INSP. CONTACTS: None	JOINT INSP. AGENCY: None	
WEATHER: Clear	INSPECTOR'S SIGNATURE:

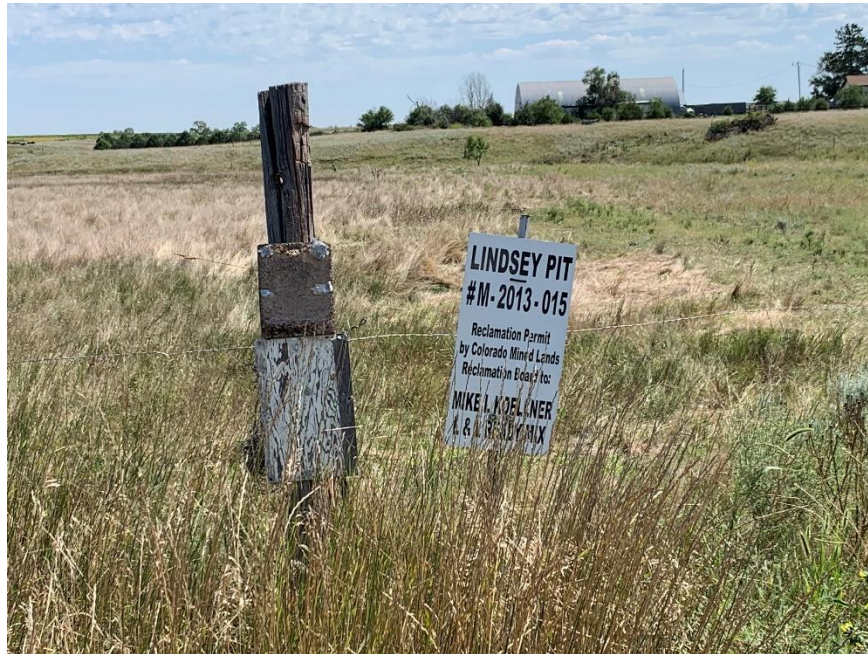
Mine entrance sign from County Road 7 facing east

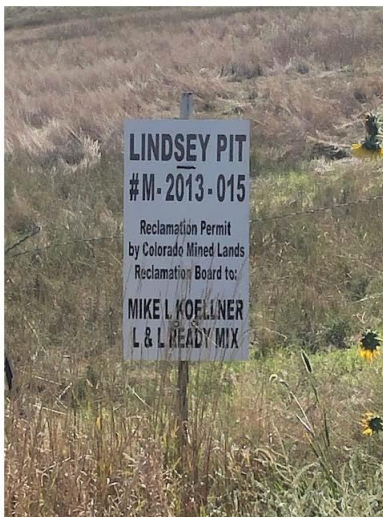
Lindsey Pit Sign

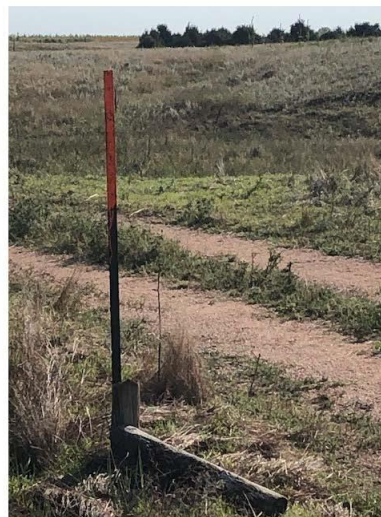
The permit identification sign was in place at the mine entrance and legible. All but one permit boundary markers were in place. The operator submitted photos on September 5, 2019 documenting that the missing permit boundary marker has been replaced. No mining activity was being conducted and no equipment was on site.

T-Post that replaces broken wooden post

Photo submitted by Operator to verify boundary marker t-post was installed.

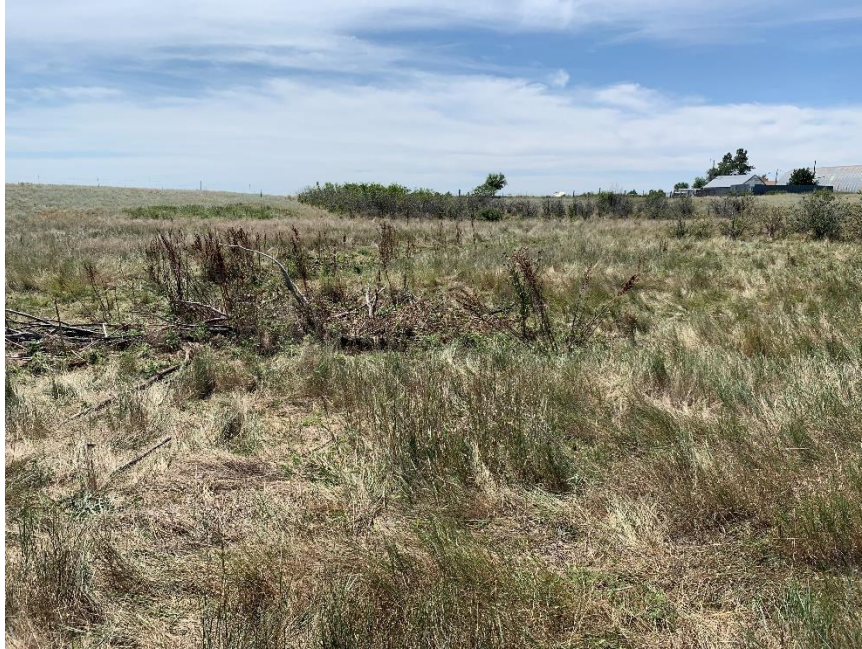
There are a couple a dense patches of Canada thistle within the permit area that need to be treated. Canada thistle is a CO Dept. of Ag B-List species that needs to be controlled.

Canada thistle patch on east side of tree belt.

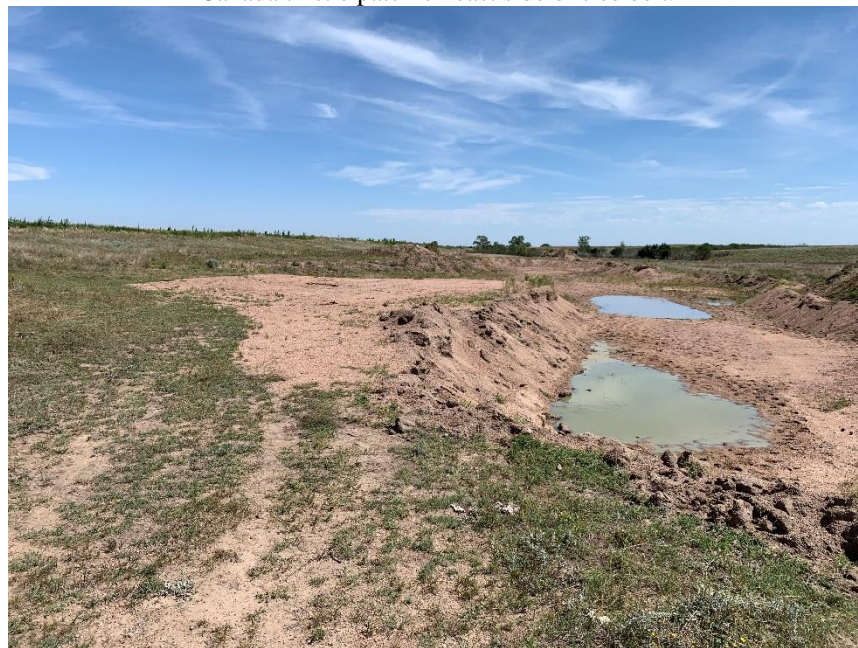
Gravel was being mined from the east end of the permit area. The pit was approximately 6 feet deep. The average expected depth of gravel reported in the permit is about 7 feet. Some standing water was in the bottom of the pit area. This is most likely due to the large recent rain events.

Pit area on east side of permit
