MINERALS PROGRAM INSPECTION REPORT
PHONE: (303) 866-3567

MINE NAME: J-Rude Site	MINE/PROSPECTING ID#: M-1989-009	MINERAL: Sand and clay (general)	COUNTY: Prowers
INSPECTION TYPE: Monitoring	INSPECTOR(S): Amy Eschberger	INSP. DATE: September 12, 2019	INSP. TIME: 08:45
OPERATOR: J-Rude Inc	OPERATOR REPRESENTATIVE: Rudy Torres	TYPE OF OPERATION: 110c - Construction Limited Impact	
REASON FOR INSPECTION: Normal I&E Program	BOND CALCULATION TYPE: Partial Bond	BOND AMOUNT: \$800.00	
DATE OF COMPLAINT: NA	POST INSP. CONTACTS: None	JOINT INSP. AGENCY: None	
WEATHER: Clear	INSPECTOR'S SIGNATURE:

M-1989-009 / J-Rude Site / J-Rude Inc (110c)

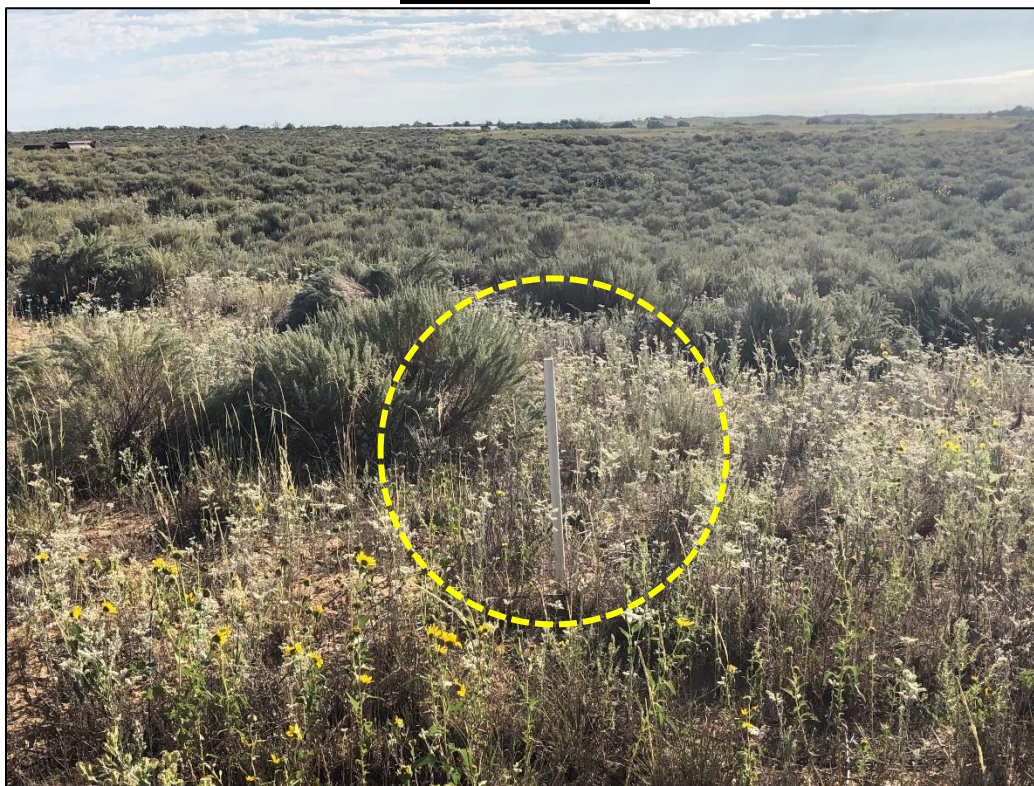
Photo 1. View looking north showing PVC pipe (circled) marking southeastern corner of 4-acre permit area.

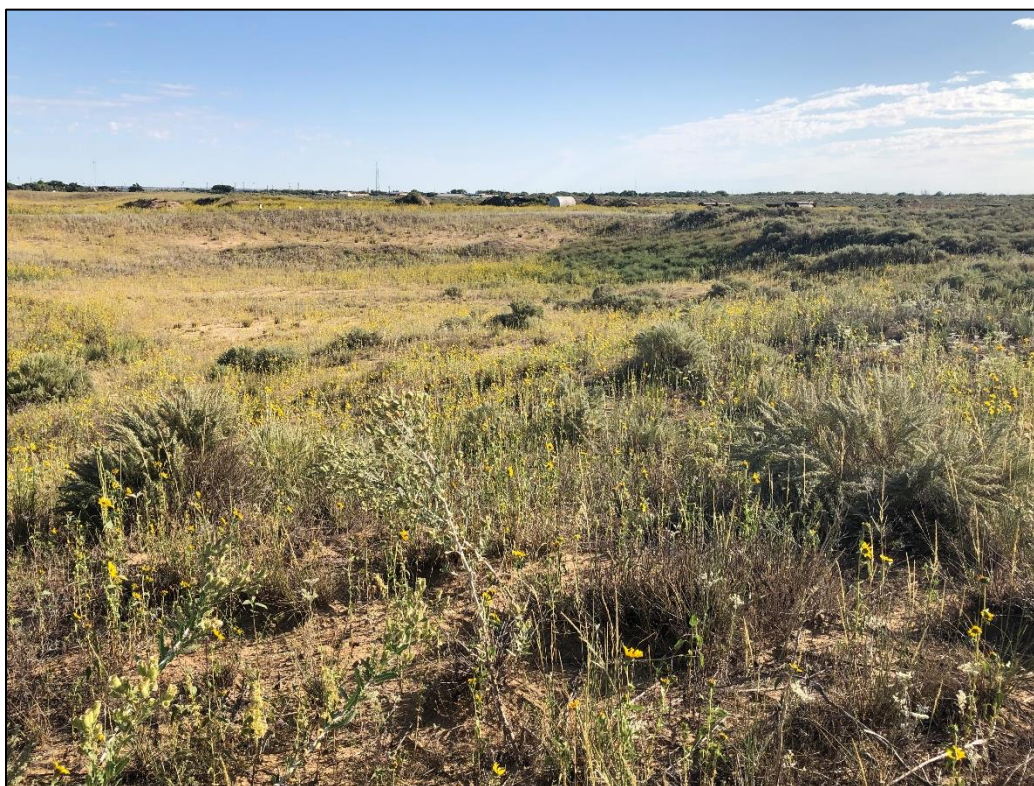
Photo 2. View looking north across reclaimed pit located in eastern half of permit area.

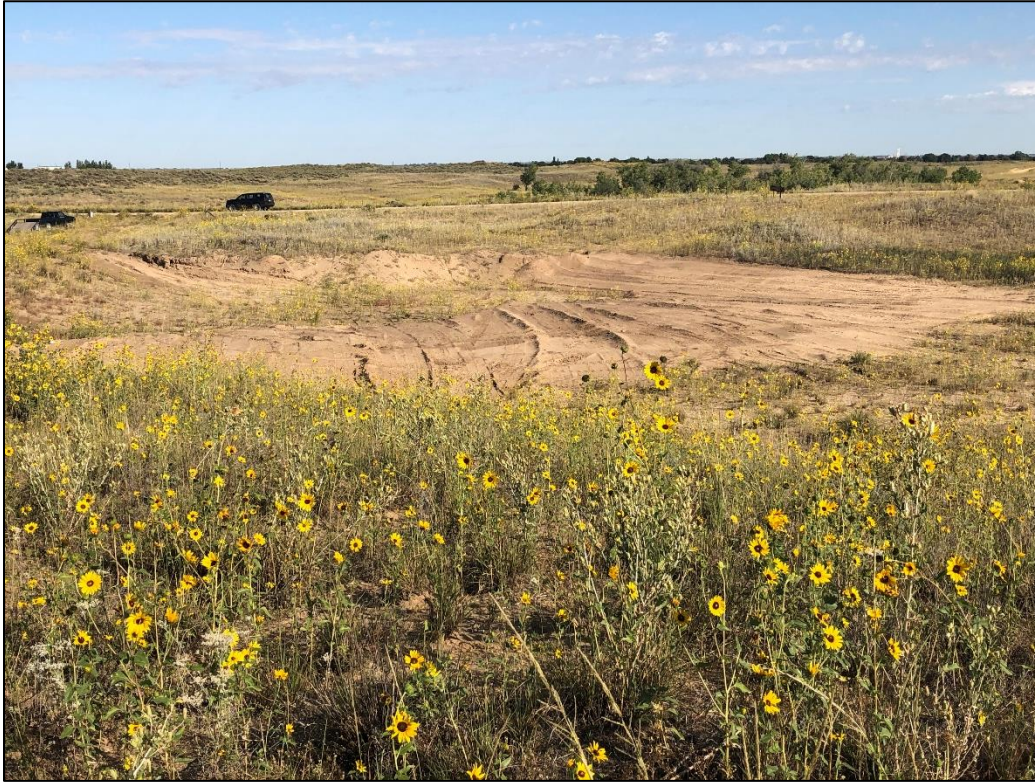
Photo 3. View looking north across recent disturbance near center of permit area. Note this area is mostly bare in vegetative cover and includes no pit walls.

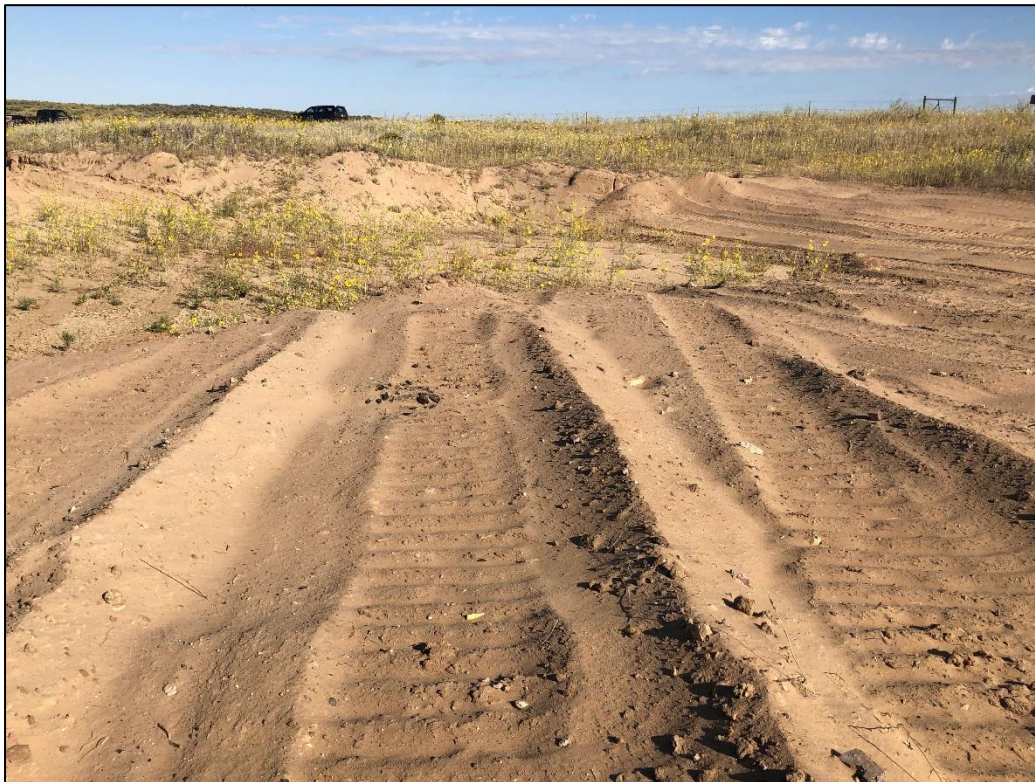
Photo 4. Closer view of recent disturbance near center of permit area shown in Photo 3 (looking north).

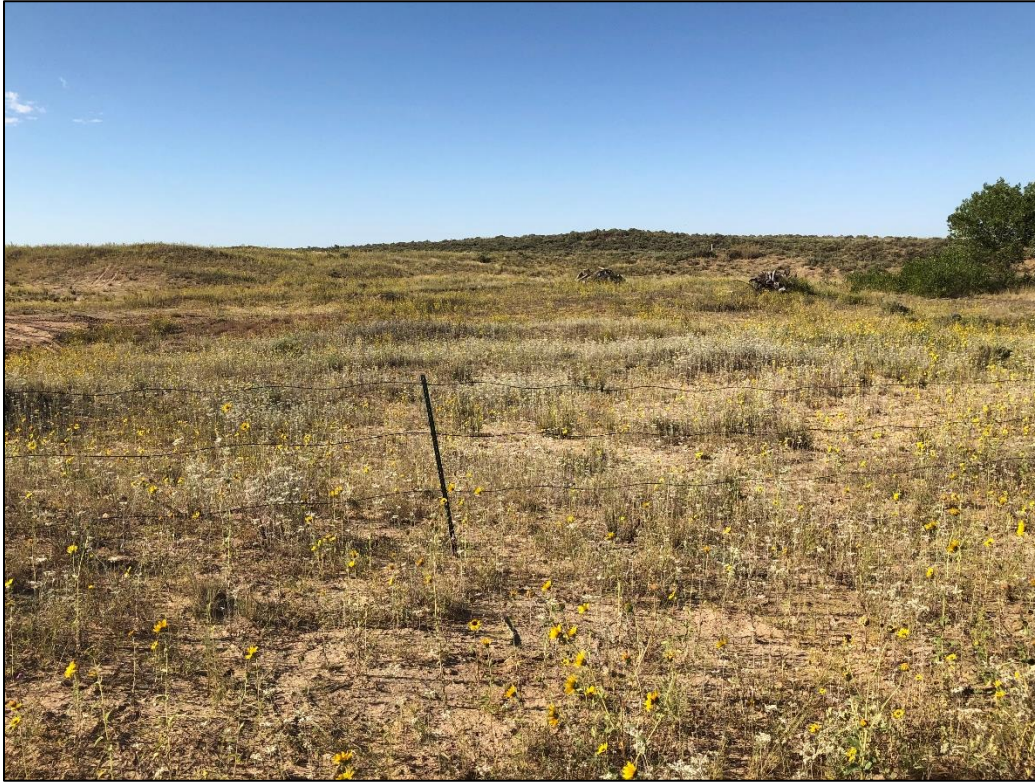
Photo 5. View looking south from Co Rd Ff across western half of 4-acre permit area.

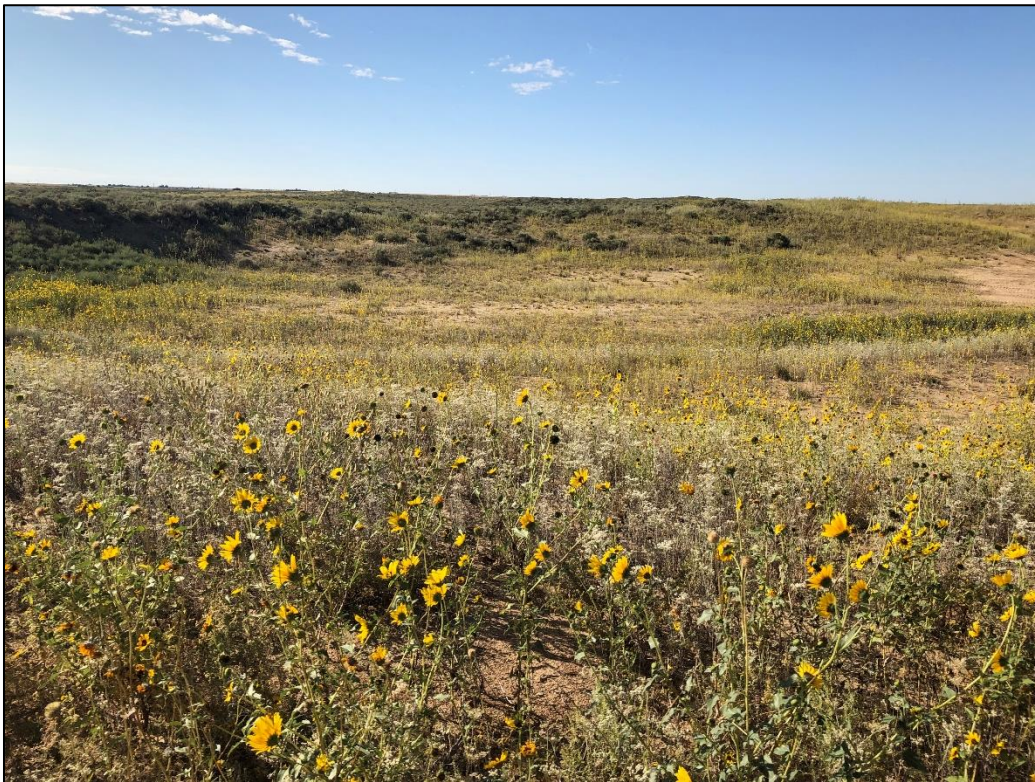
At the time of the inspection, the weather was clear, warm, and dry. A permit sign was posted at each of the two entrances to the site off Co Rd Ff. The corners of the remaining 4-acre permit boundary were marked with PVC pipes. The site was not active during the inspection. However, according to the operator, the site is used every year in accordance with its intermittent status. The most recent extraction activities occurred near the center of the permit area. The Division estimates this disturbance area to be approximately 0.2 acre in size. This area does not include any pit walls and is mostly bare in vegetative cover. The rest of the disturbed area has good vegetative cover consisting of native grasses, forbs, shrubs, and some annual weeds (e.g., wild sunflowers). The old horseshoe-shaped pit wall present in the eastern part of the permit area daylights mainly to the west and is approximately 8 feet in height. According to the operator, this pit wall was graded flatter after the Division's last inspection of the site in 2015, during which, its slopes were observed to be as steep as 1H:1V. It is difficult to determine the slope gradient of this pit wall now given its dense vegetative cover; however, the slopes appear to be at a stable configuration.

Photo 6. View looking south from Co Rd Ff across eastern half of 4-acre permit area with old horseshoe-shaped pit wall now graded to a stable configuration and well vegetated.
