Attachment 1

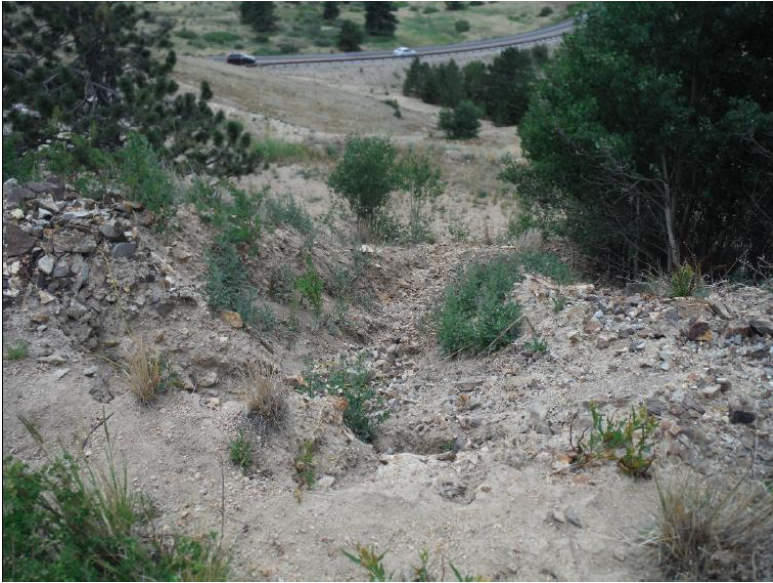
Photo 1.
Erosion Gully 1 as shown in DRMS
Inspection report, looking west. Photo taken
7/12/18.

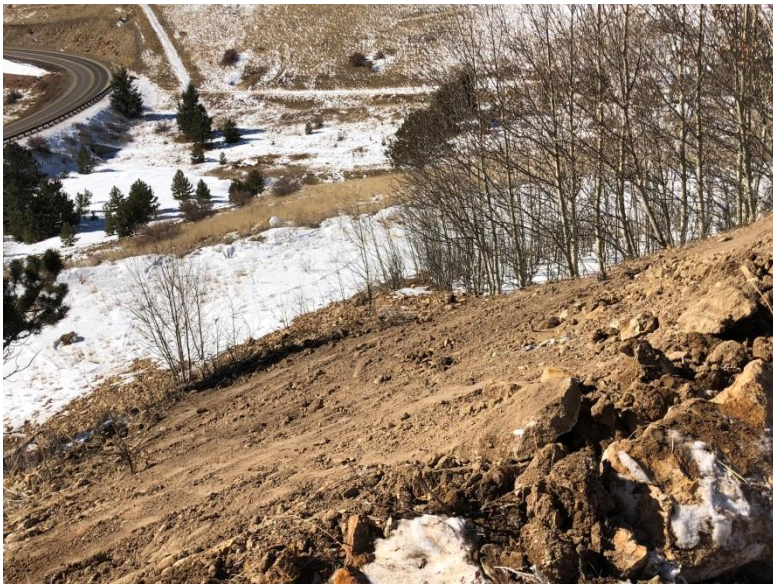
Photo 2.
Erosion Gully 1 after repair, looking west.
Photo taken 11/14/18.

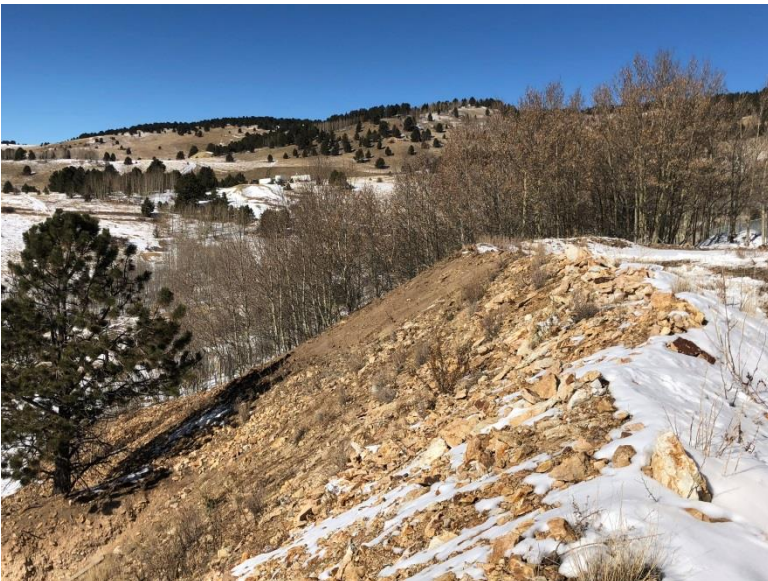
Photo 3.
Erosion Gully 1 and surrounding slope after
repair, looking north. Photo taken 11/14/18.

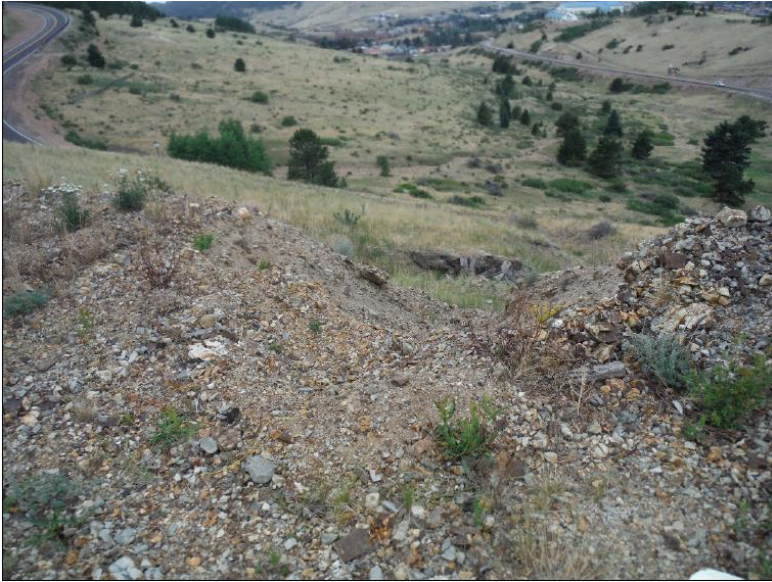
Photo 4.
Erosion Gully 2 as shown in DRMS
Inspection report, looking southwest. Photo
taken 7/12/18.

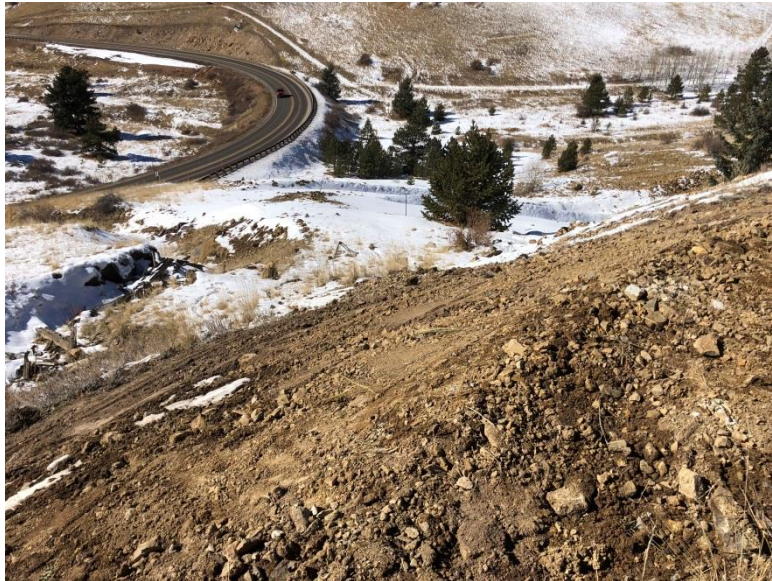
Photo 5.
Erosion Gully 2 after repair, looking
northwest. Photo taken 11/14/18.

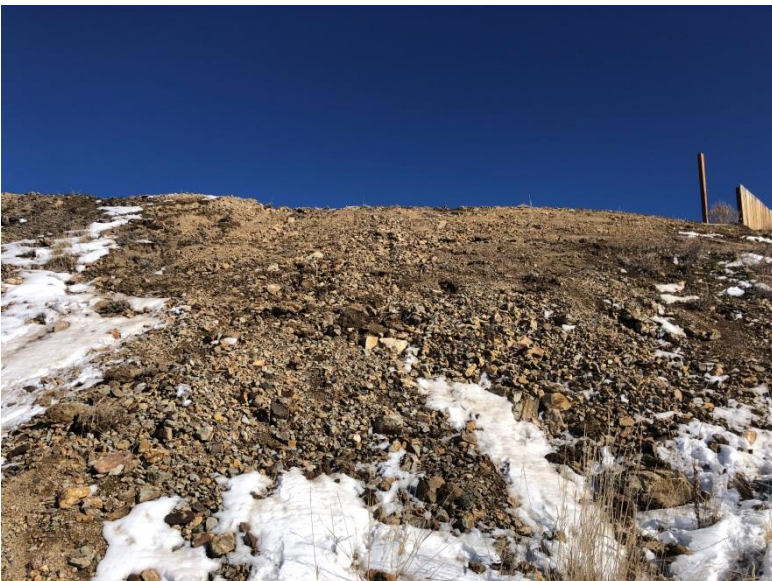
Photo 6.
Erosion Gully 2 and surrounding slope after
repair, looking east from bottom of slope. Photo
taken 11/14/18.

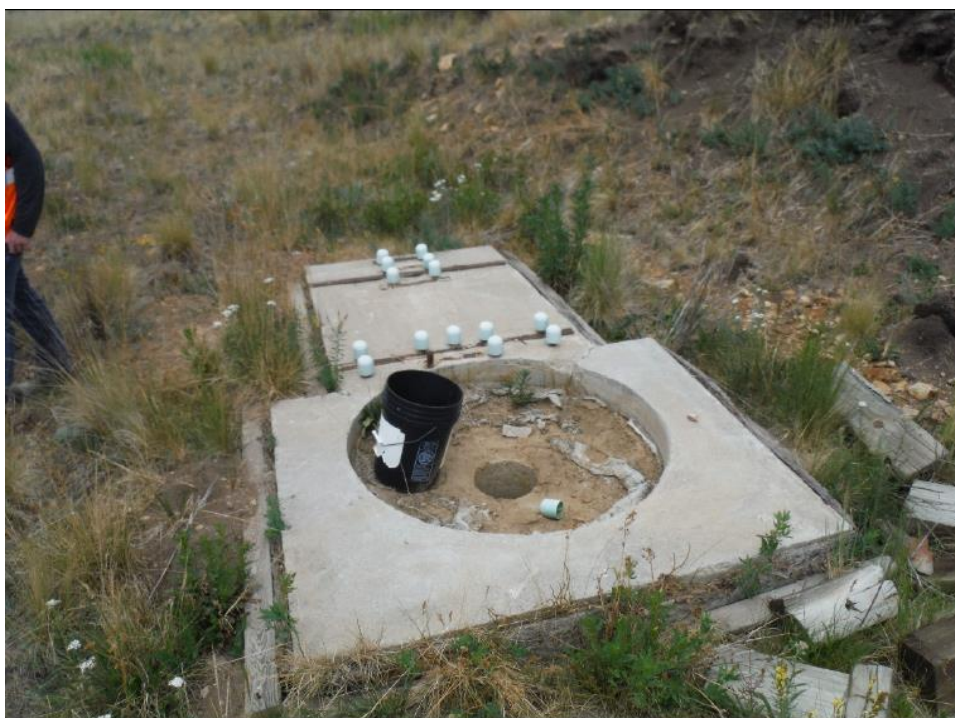
Photo 7.
Open Borehole 1 as shown in
DRMS Inspection report, looking
northwest. Photo taken 7/12/18.

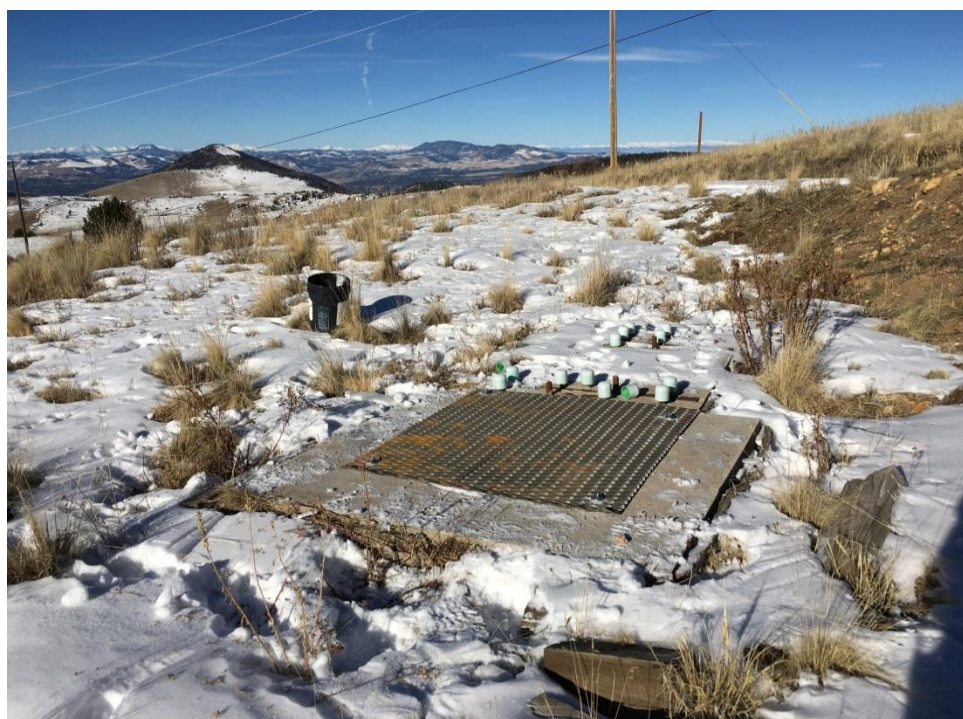
Photo 8.
Open Borehole 1 after safeguard
installed, looking west. Photo
taken 11/19/18.

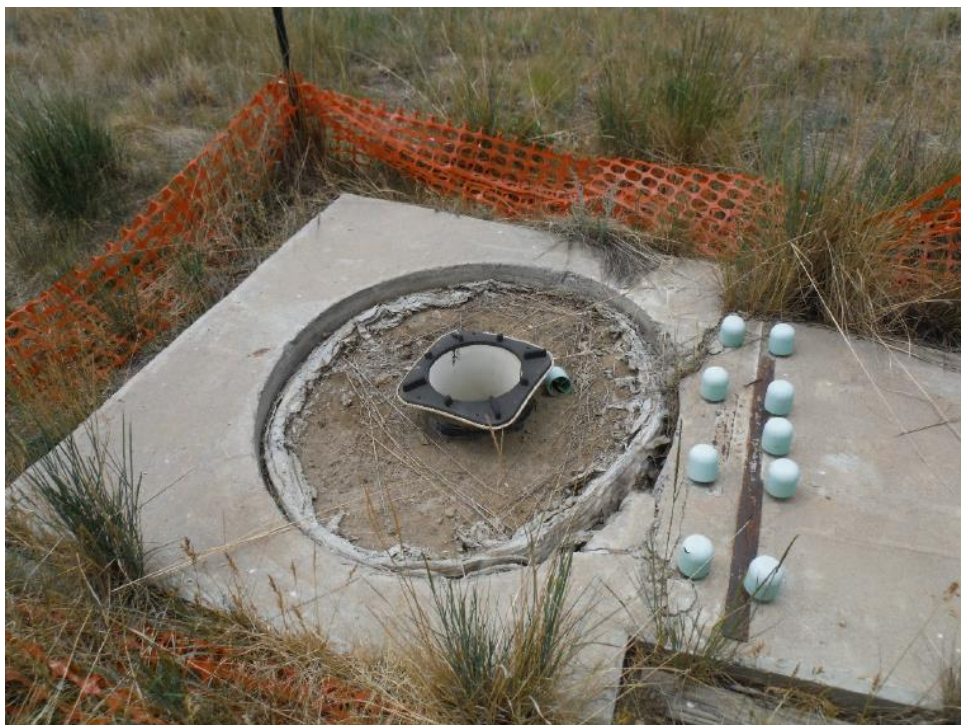
Photo 9.
Open Borehole 2 as shown in
DRMS Inspection report, looking
west. Photo taken 7/12/18.

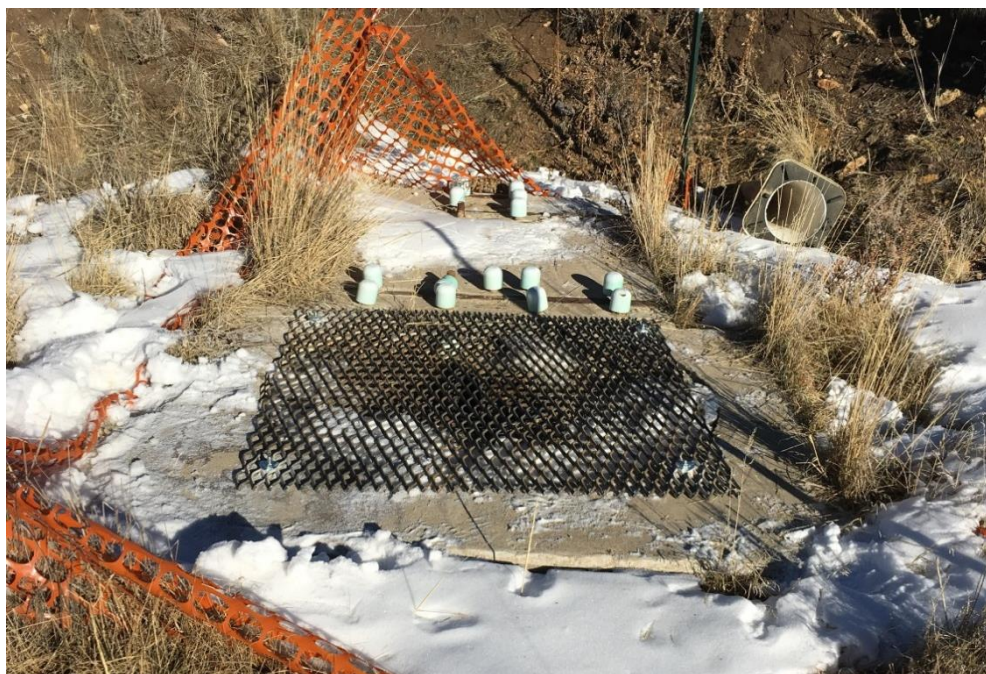
Photo 10.
Open Borehole 2 after safeguard
installed, looking north. Photo
taken 11/19/18.

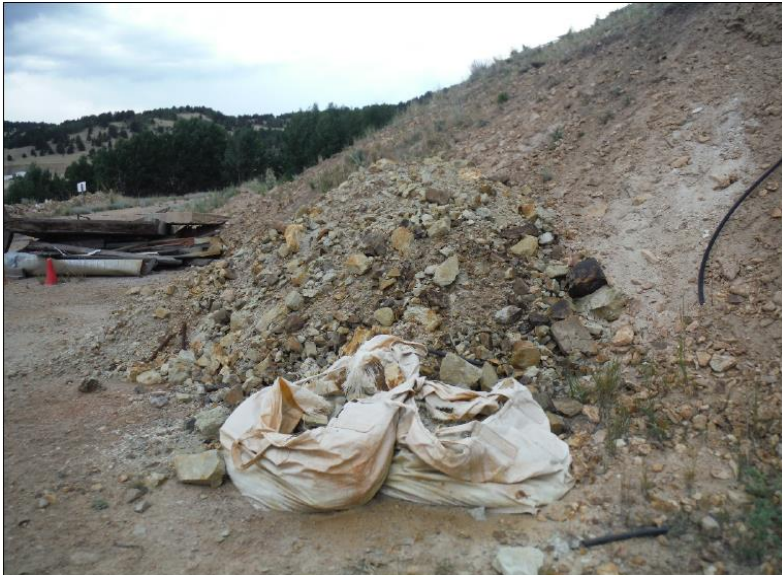
Photo 11. (Above)
Stockpile as shown in DRMS Inspection report, looking north.
Photo taken 7/12/18.

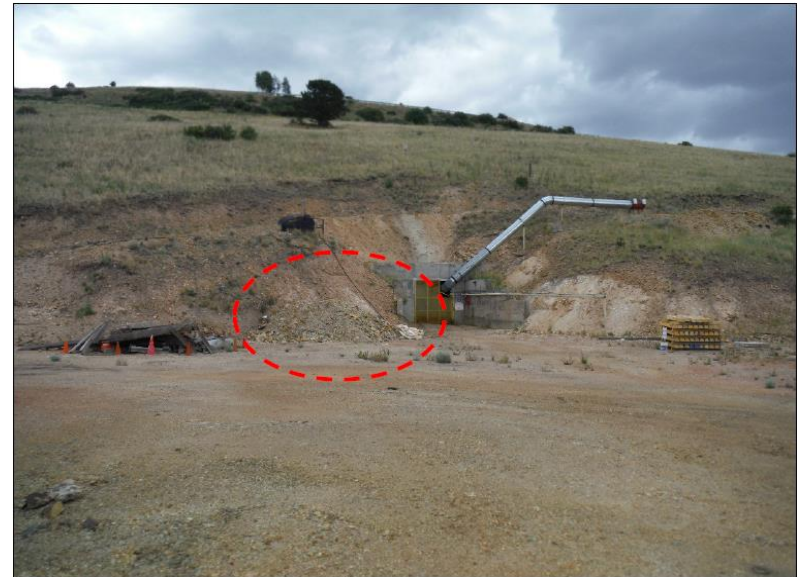
Photo 12. (Above)
Stockpile (circled in red) as shown in DRMS Inspection report, looking east. Photo taken 7/12/18.

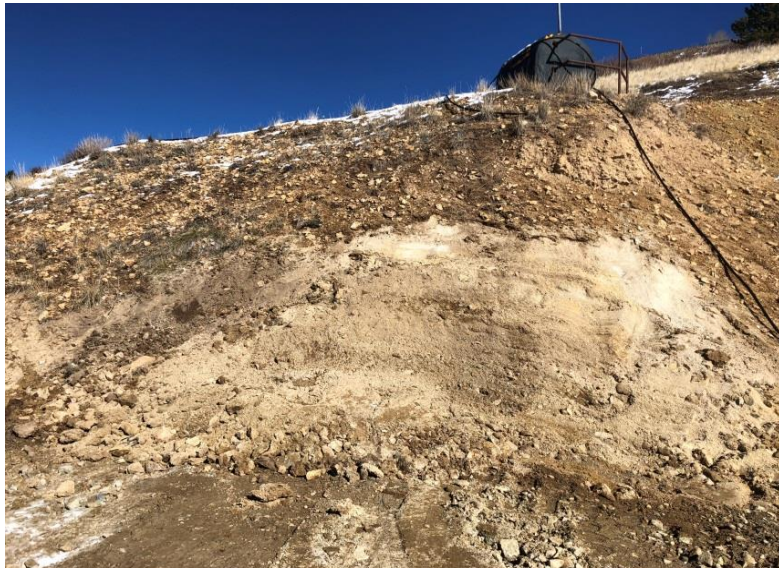
Photo 13.
Removed stockpile area, looking east. Photo taken 11/14/18.

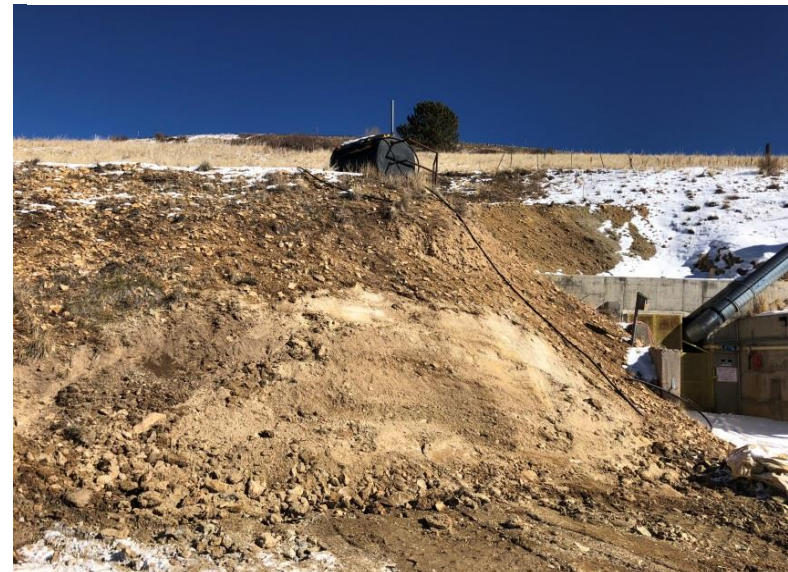
Photo 14.
Removed stockpile area, looking east (Sangre de Cristo Tunnel entrance located to right side of photo). Photo taken 11/14/18.

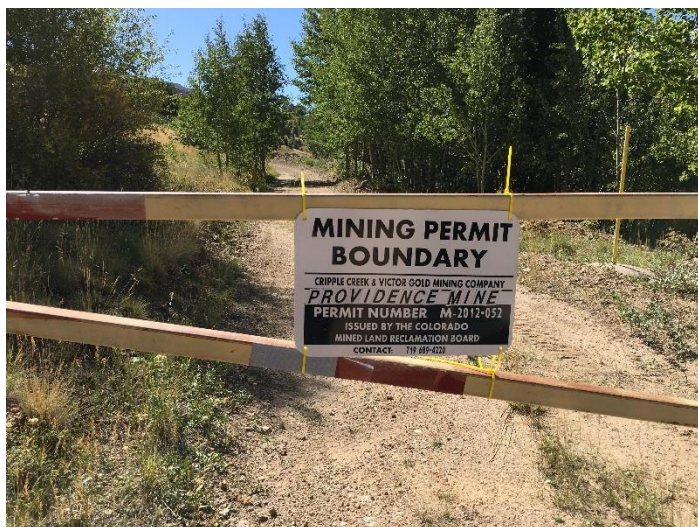
Photo 15.
Updated signage. Photo taken 9/25/19.

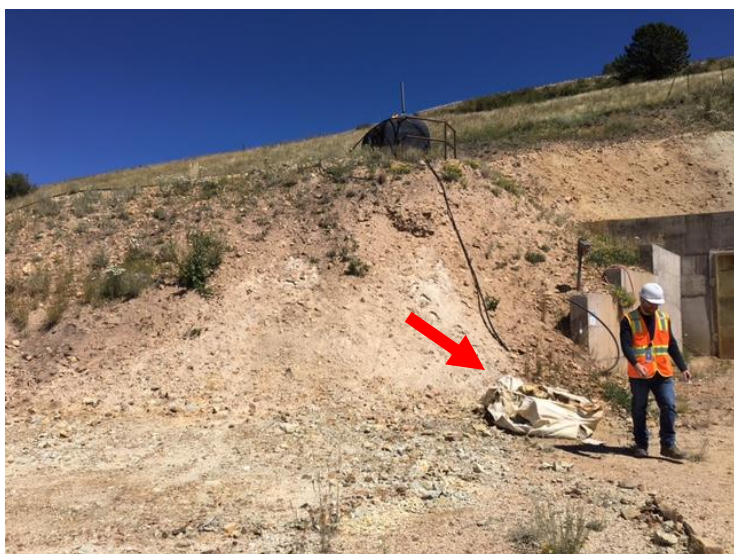
Photo 16.
Waste rock in super-sack. Photo taken 8/28/19.

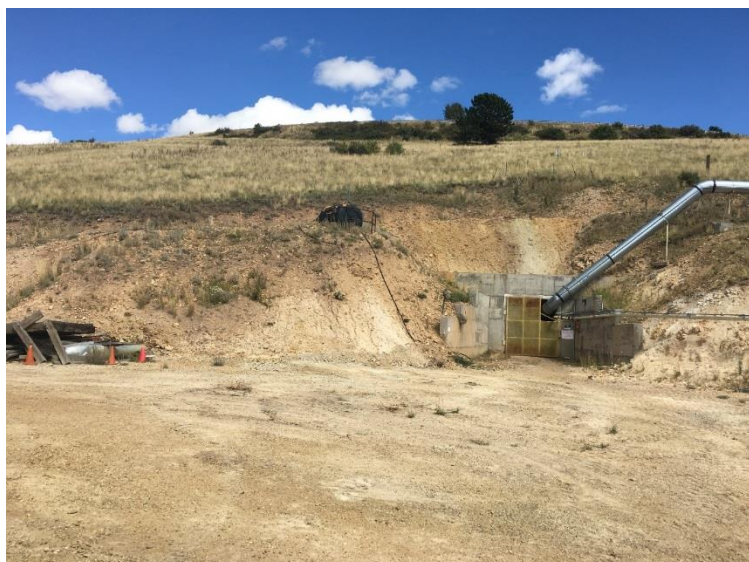
Photo 16.
Waste rock removed. Photo taken 9/17/19.
