MINERALS PROGRAM INSPECTION REPORT
PHONE: (303) 866-3567

MINE NAME: May Day Idaho Mine Complex	MINE/PROSPECTING ID#: M-1981-185	MINERAL: Gold and silver	COUNTY: La Plata
INSPECTION TYPE: Monitoring	INSPECTOR(S): Lucas West, Bill Scott MSHA	INSP. DATE: September 5, 2019	INSP. TIME: 09:58
OPERATOR: Sunrise Mining LLC	OPERATOR REPRESENTATIVE: None	TYPE OF OPERATION: 112d-2 - Designated Mining Operation

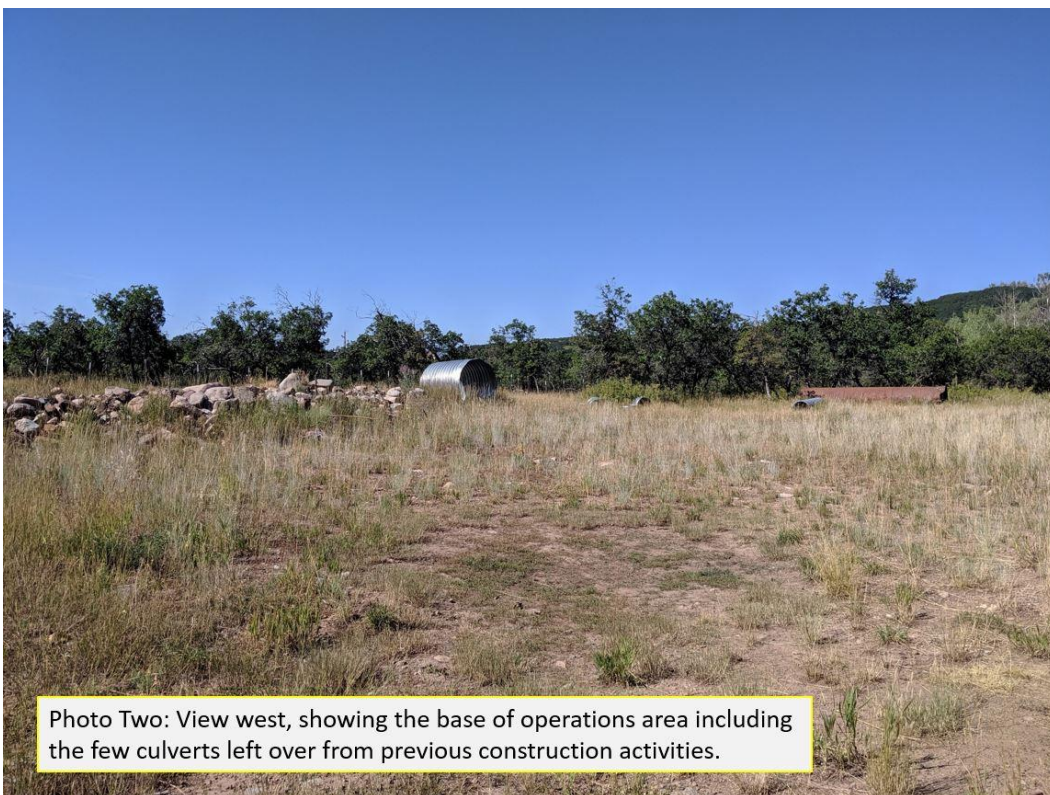
Base of Operations: The Base of Operations area will be the location of the mine offices as well as the lined ore storage pad used to stage ore prior to transport. Construction of these facilities has not begun yet and the area is in the same condition as it was during the previous inspection. A few pieces of leftover materials from construction activities including pieces of culvert and large boulders are located in the area. The area can be seen in Photo Two.

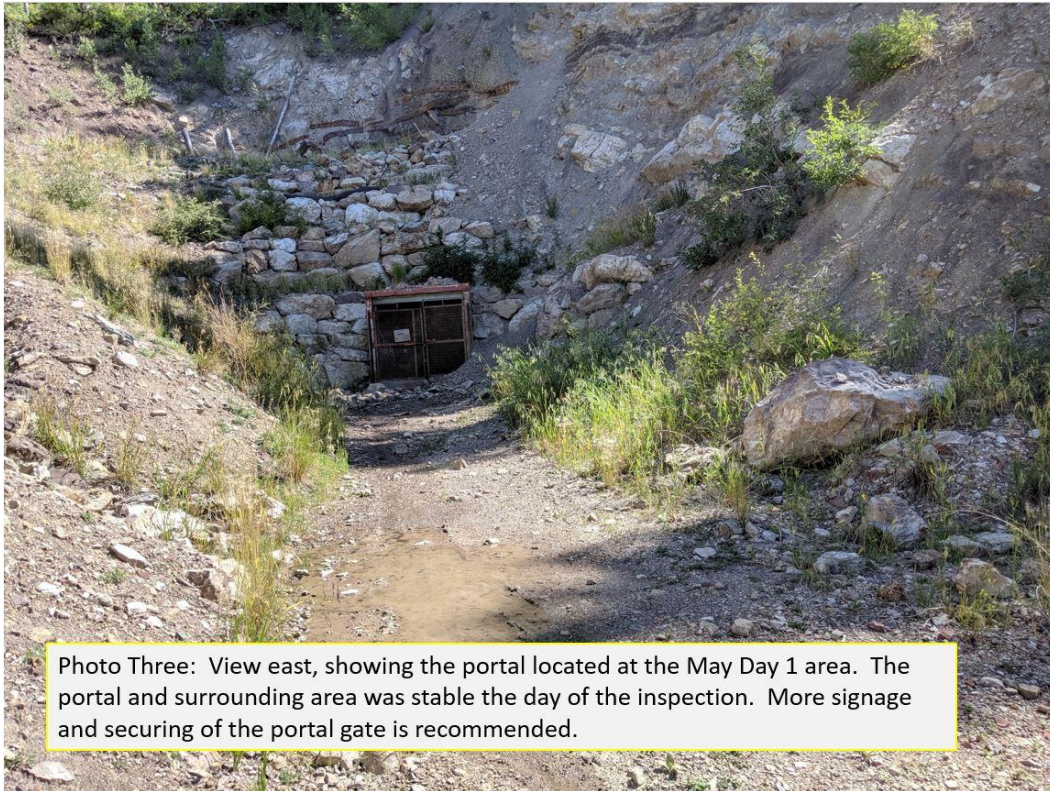
May Day 1 Area: The May Day area is in similar condition from the previous inspections and no significant changes have been made. The portal remains closed with a locked gate, and the surrounding slopes buttressed with the placement of large boulders. The area above the portal has been stabilized with wire mesh and rock bolts. The old mill building was not secure and was inspected at this time. The items in the mill building were in good condition at the time of the inspection. The sealed back of the building was observed and was stable at the time of the inspection. The door to mill building should be repaired and secured to prevent unauthorized entry. Various equipment including an underground loader, several shipping containers and various other mining related debris are still on site. The surface conditions of the area are largely unchanged from the October 2016 Inspection. Bill Scott (MSHA) recommends adding additional "Do Not Enter" signage on the portal gate, as well as additional methods of securing the gate to aid in preventing attempted unauthorized entry. Photos Three, and Four show the conditions of the May Day 1 Area.

Photo Three: View east, showing the portal located at the May Day 1 area. The portal and surrounding area was stable the day of the inspection. More signage and securing of the portal gate is recommended.

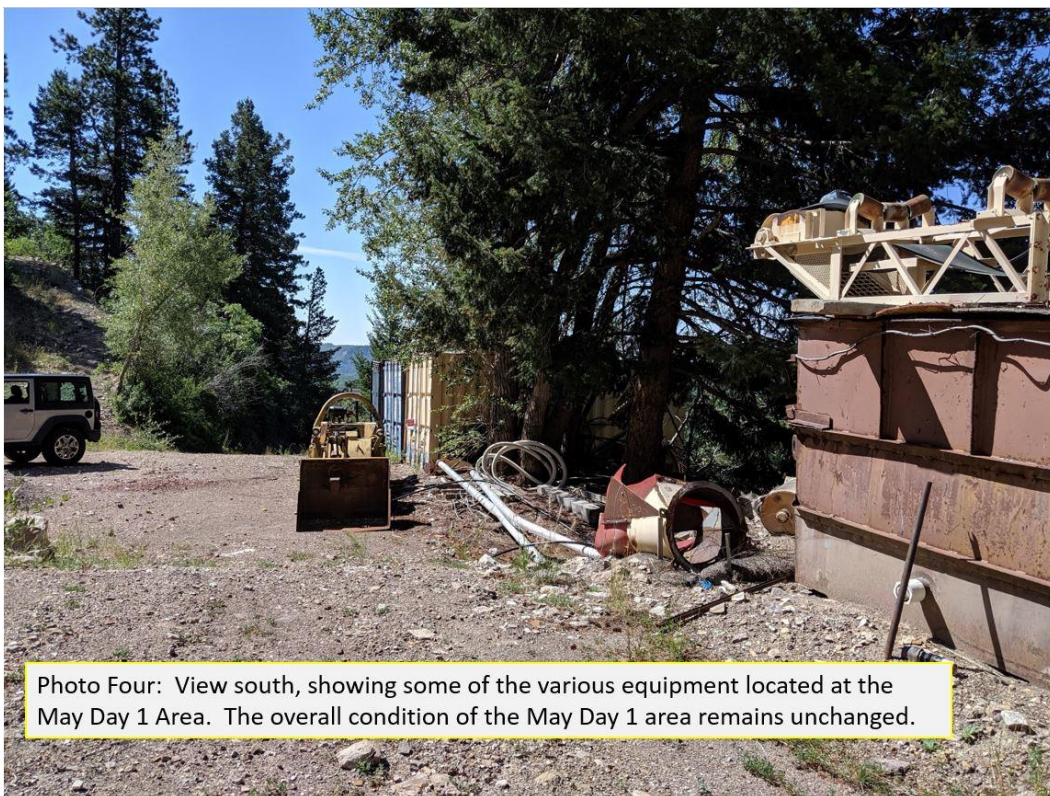
Photo Four: View south, showing some of the various equipment located at the May Day 1 Area. The overall condition of the May Day 1 area remains unchanged.

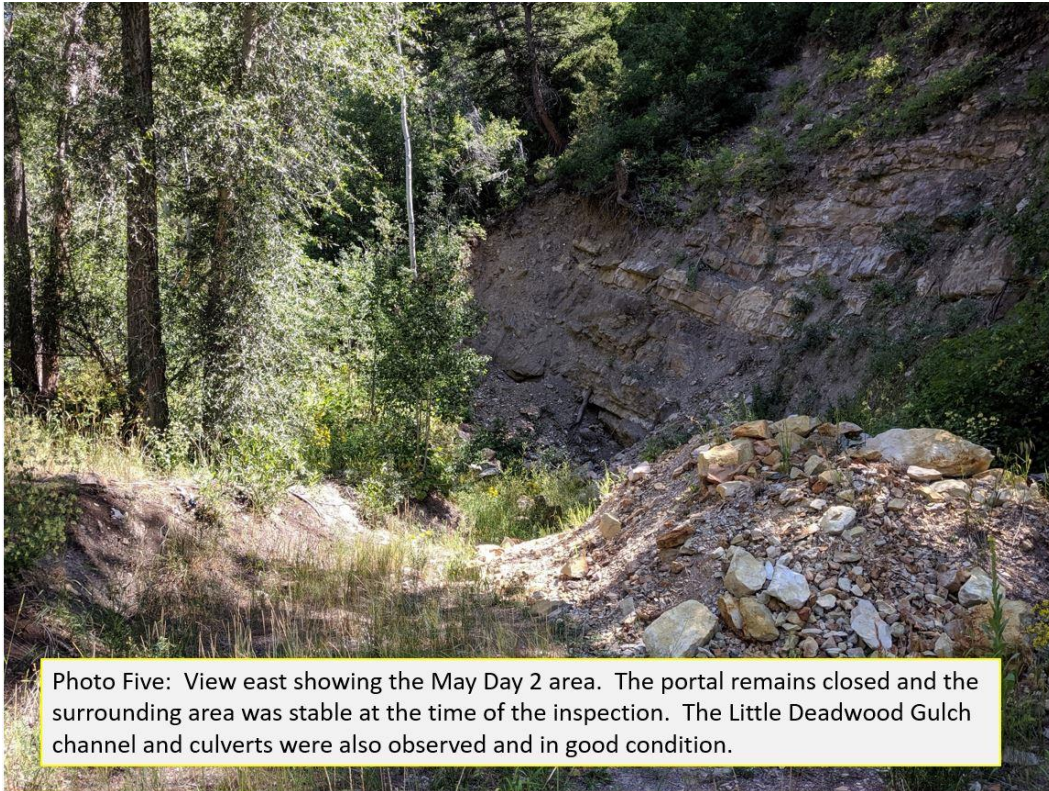
May Day 2 Area: The three culverts, and associated structures that were constructed as part of the restoration of Little Deadwood Gulch were functioning as designed at the time of the inspection and are in good condition as seen in Photo Four. The outfall of the culverts has been armored to prevent down cutting of the channel immediately downstream of the culverts. Within the channel immediately upstream of the culverts, two water bars have been installed to help dissipate the energy as the stream flow approaches the crossing. The minor erosion of the channel that was noted during the previous inspection has been monitored and addressed. No further erosion in this area was noted. The portal at the May Day 2 Area remains closed. A small waste rock pile was located adjacent to the closure, and was present during the previous inspection. The pile appears to be stable and in good condition. The May Day 2 Area can be seen in Photo Five.

Photo Five: View east showing the May Day 2 area. The portal remains closed and the surrounding area was stable at the time of the inspection. The Little Deadwood Gulch channel and culverts were also observed and in good condition.

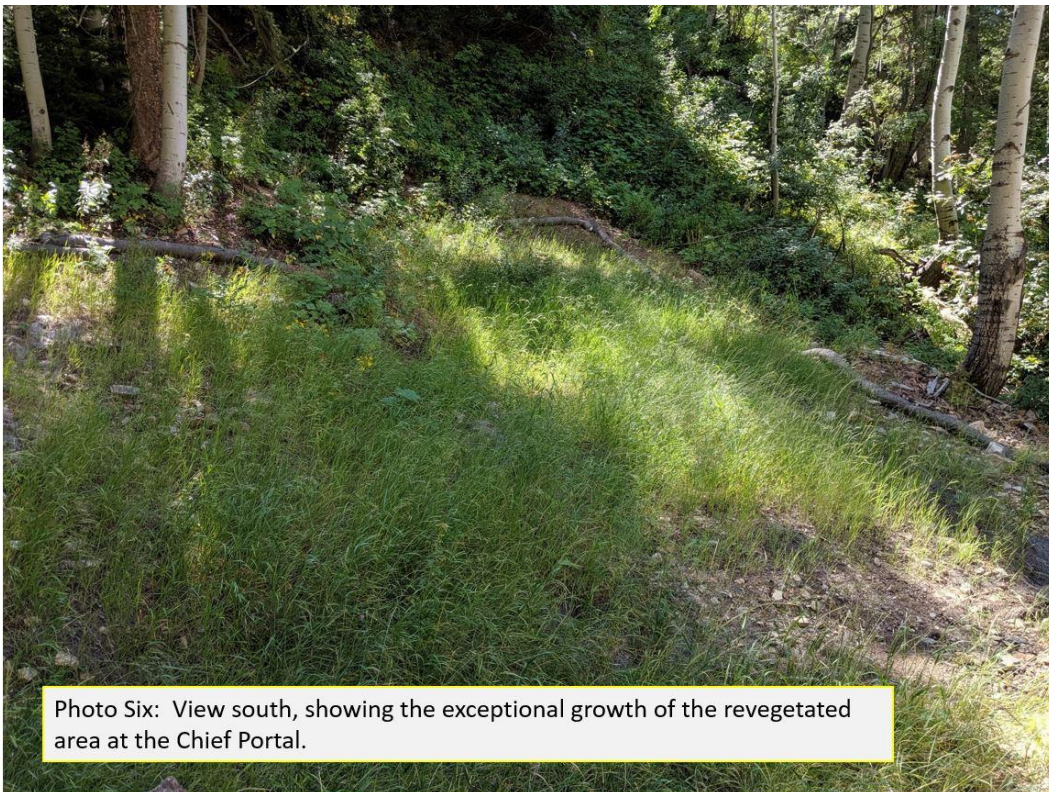
Photo Six: View south, showing the exceptional growth of the revegetated area at the Chief Portal.

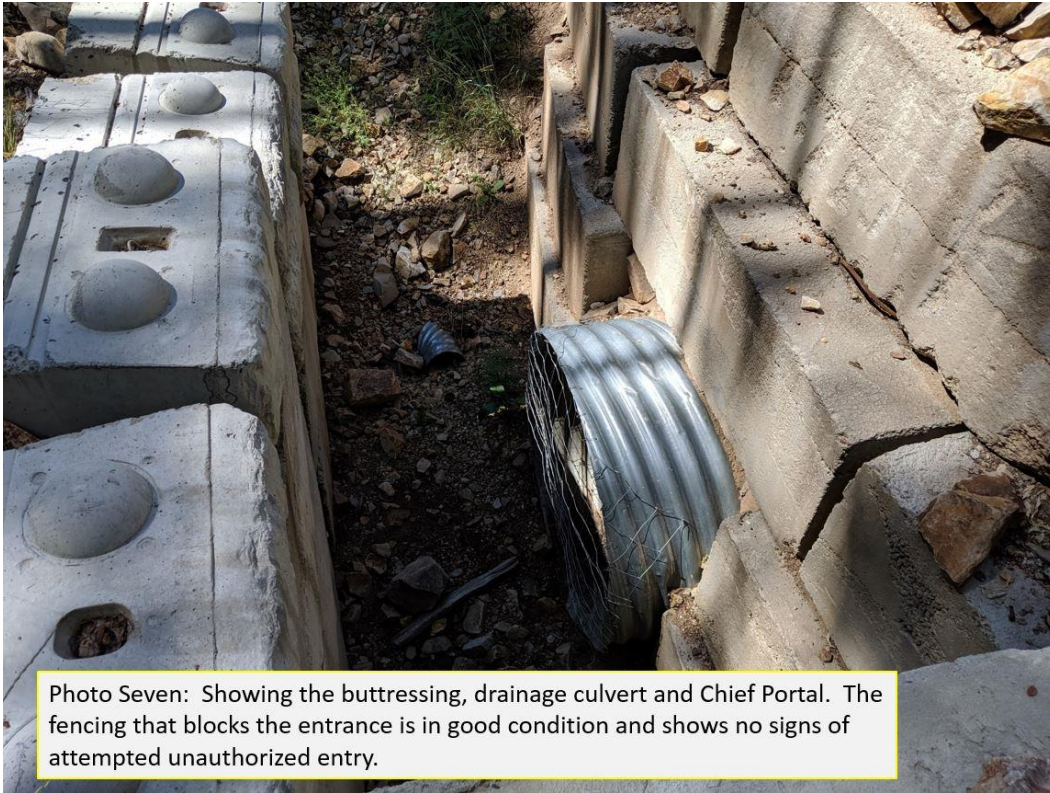
Chief Portal Area: The restoration activities at the Chief Portal Area were completed and inspected in the fall of 2016 and remains in good condition. The Chief Portal is designed to function as a secondary escape way and underground access point. All backfilled areas appear to be stable and in good condition, no evidence of settling, slumping or subsidence was observed. Areas where the vegetation matting was installed are well vegetated and stable. Photo Six shows an examples of the vegetative cover in the area. The secondary escape / emergency access has been further buttressed with the restoration of Little Deadwood Gulch. Photo Seven shows the buttressing and secondary escape way. A secondary drain has been installed to allow any water generated from the portal to be conveyed into Little Deadwood Gulch. The portal is temporarily secured by wire fencing and prior to operations will need to be upgraded to an MSHA compliant safety gate.

Photo Seven: Showing the buttressing, drainage culvert and Chief Portal. The fencing that blocks the entrance is in good condition and shows no signs of attempted unauthorized entry.
