**MINERALS PROGRAM INSPECTION REPORT**  
**PHONE: (303) 866-3567**

| <b>MINE NAME:</b><br>Fort Lyon - State Pit No. 1 | <b>MINE/PROSPECTING ID#:</b><br>M-2001-097 | <b>MINERAL:</b><br>Limestone (general) | <b>COUNTY:</b><br>Bent |
| <b>INSPECTION TYPE:</b><br>Monitoring | <b>INSPECTOR(S):</b><br>Amy Eschberger | <b>INSP. DATE:</b><br>September 11, 2019 | <b>INSP. TIME:</b><br>13:15 |

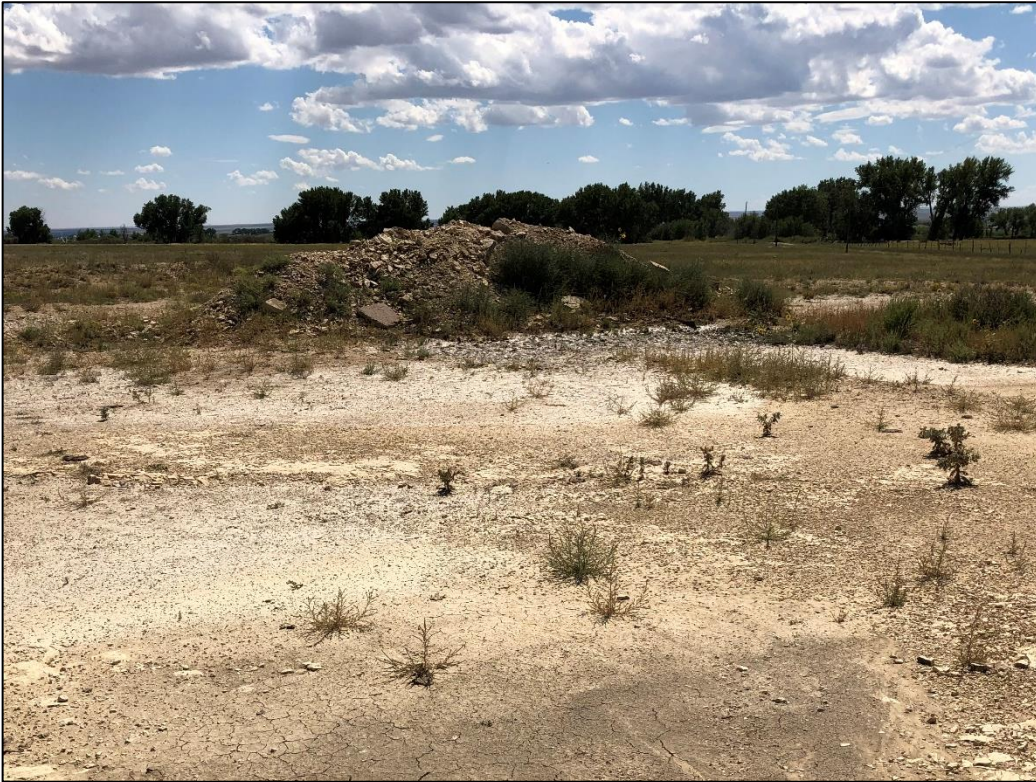
**Photo 1.** View looking south, showing small overburden stockpile stored at southwestern corner of disturbed area.

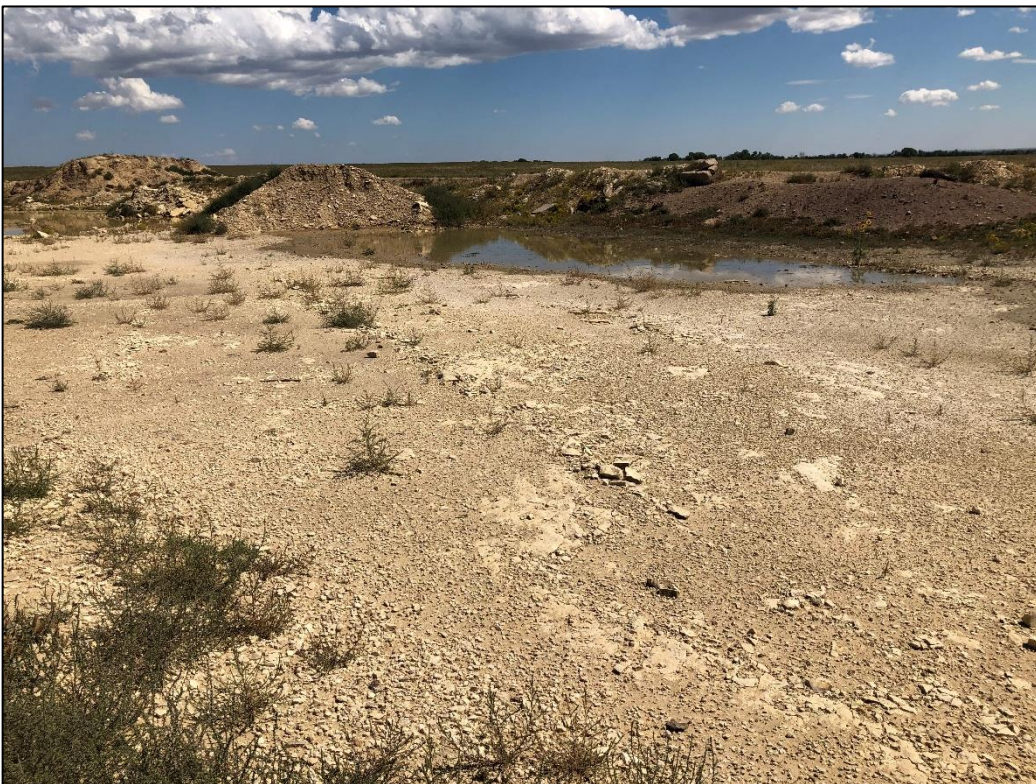
**Photo 2.** View looking southeast across southern portion of pit. Note ponded water present on pit floor (in background).

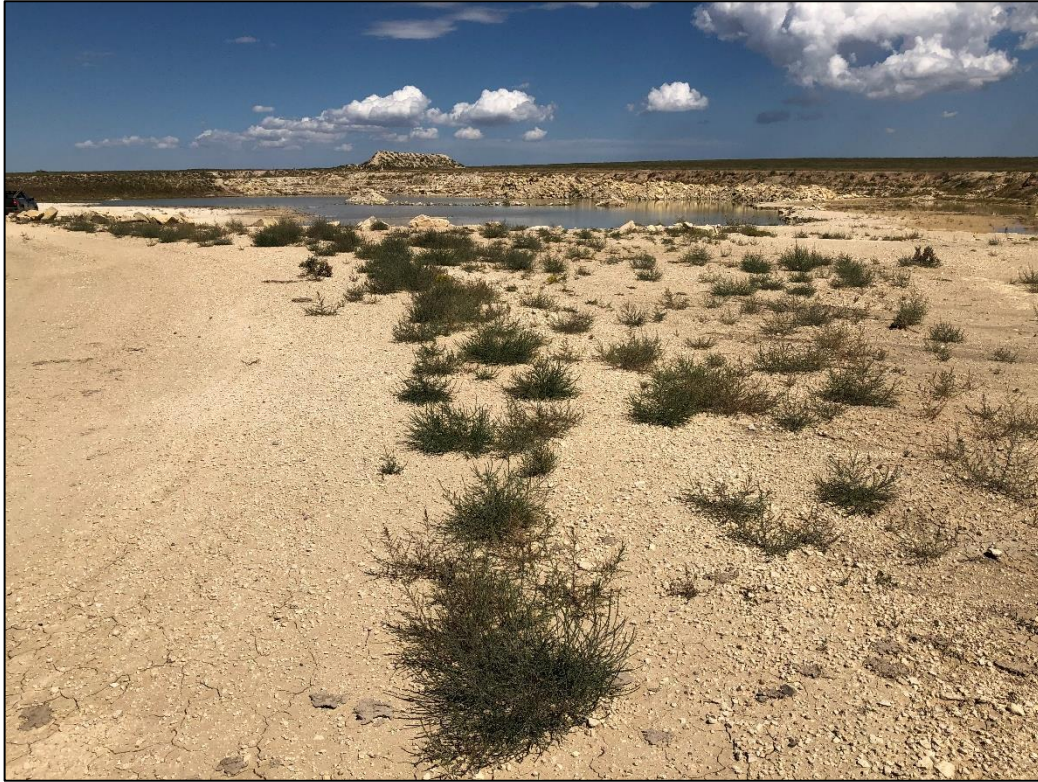
**Photo 3.** View looking east across central portion of pit. Note ponded water present on pit floor (in background).

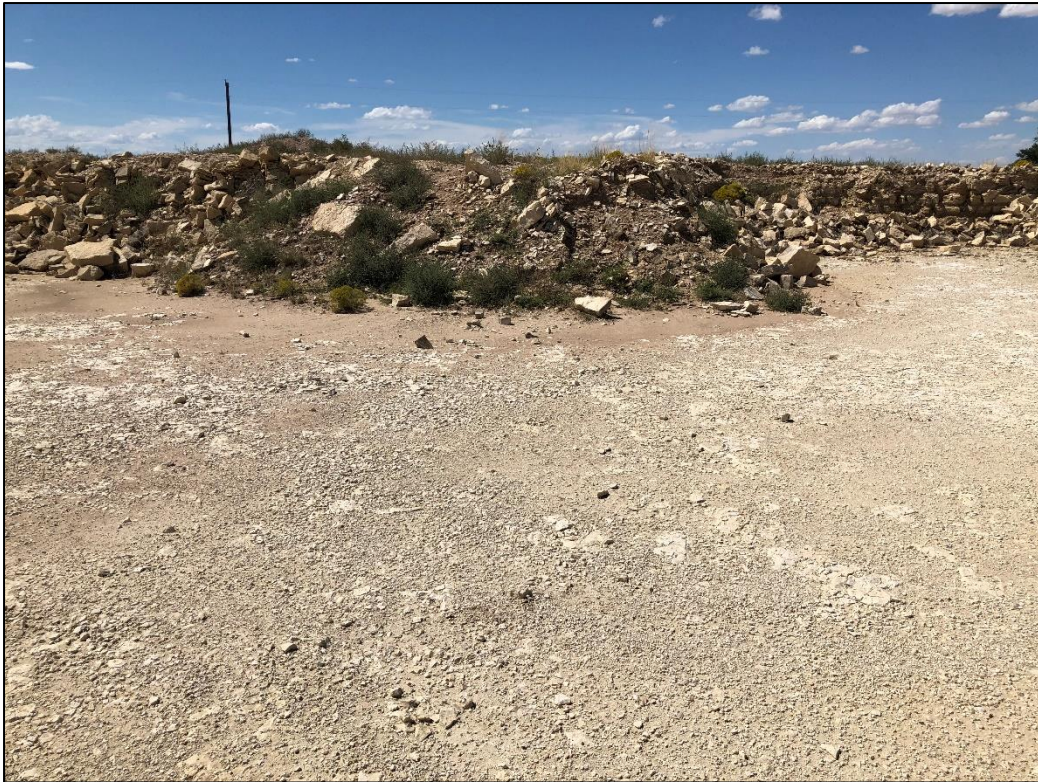
**Photo 4.** View looking west, showing mined material stockpiled at southwestern edge of pit area.

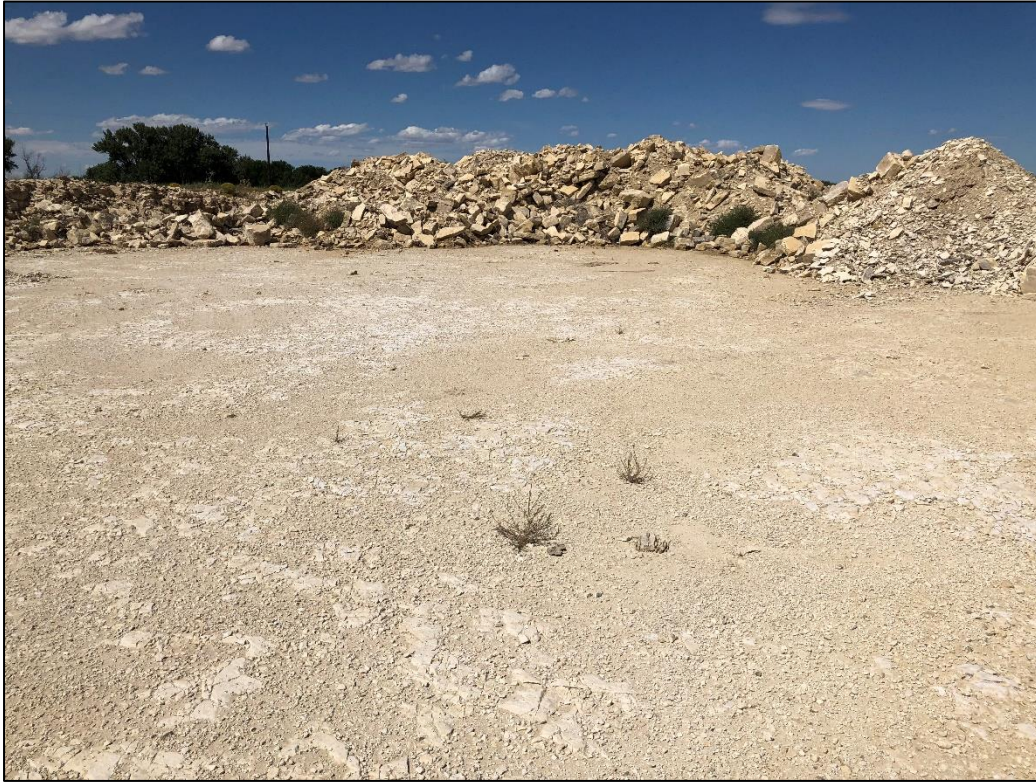
**Photo 5.** View looking west, showing mined material stockpiled at southwestern edge of pit area.

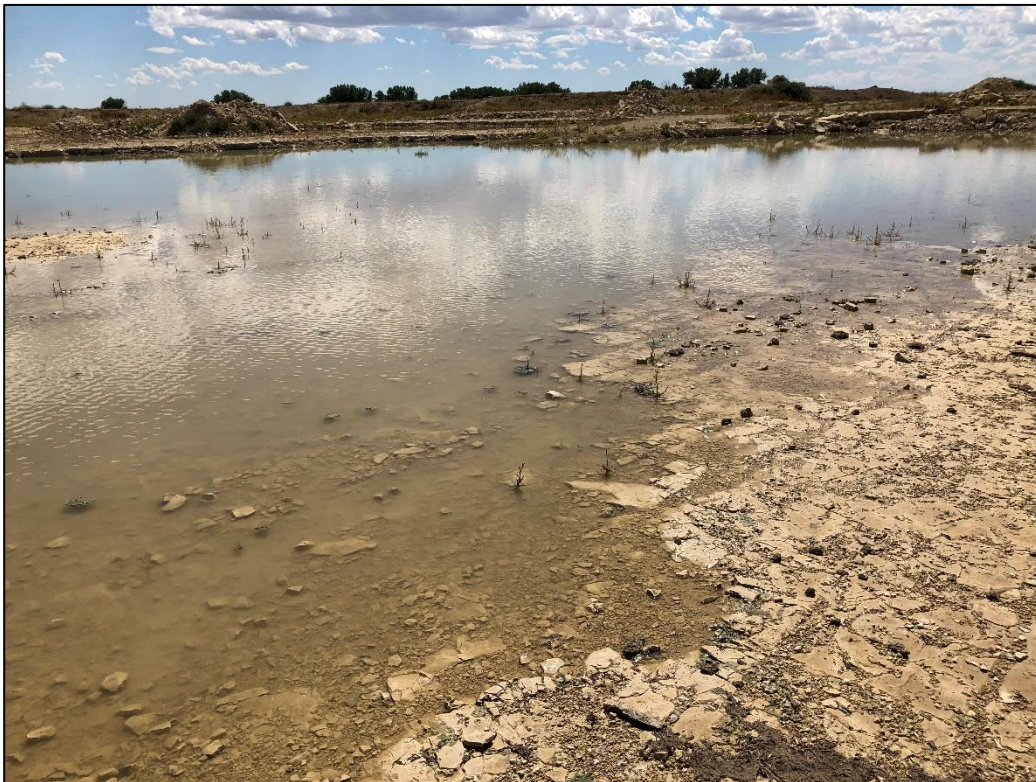
**Photo 6.** View looking southeast across pit. Note shallow ponded water present on pit floor.

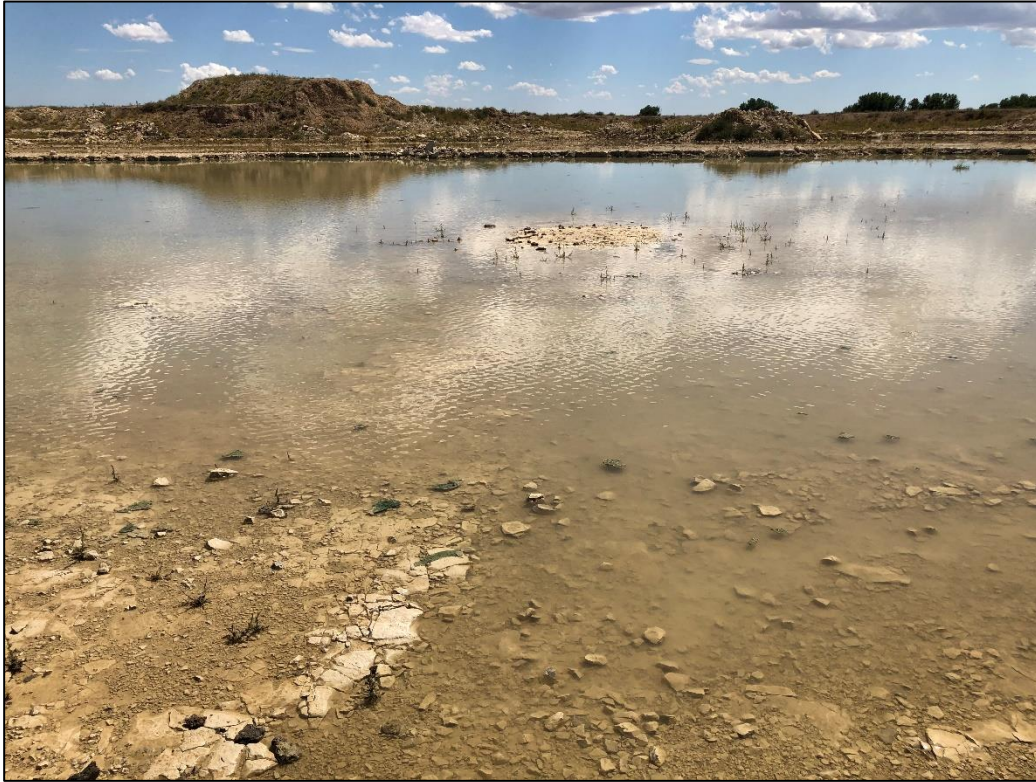
**Photo 7.** View looking east across central portion of pit. Note shallow ponded water present on pit floor. Also note large topsoil stockpile stored above pit wall (in background).

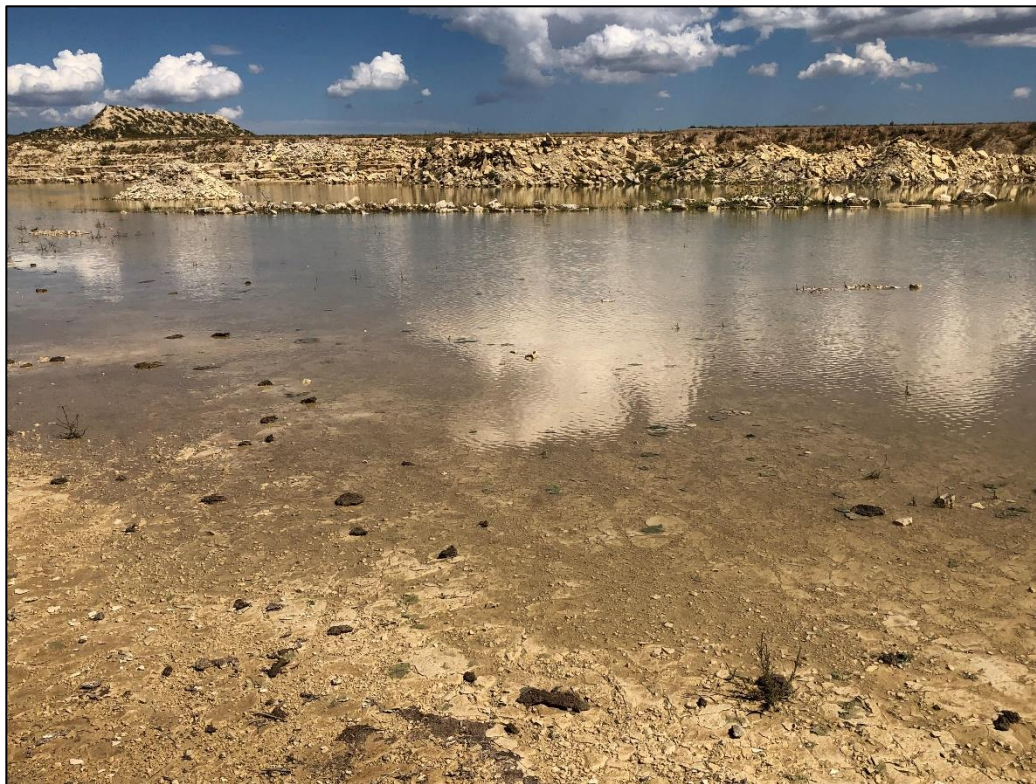
**Photo 8.** View looking northeast across central portion of pit. Note shallow ponded water present on pit floor. Also note material stockpiled on pit floor (in background).

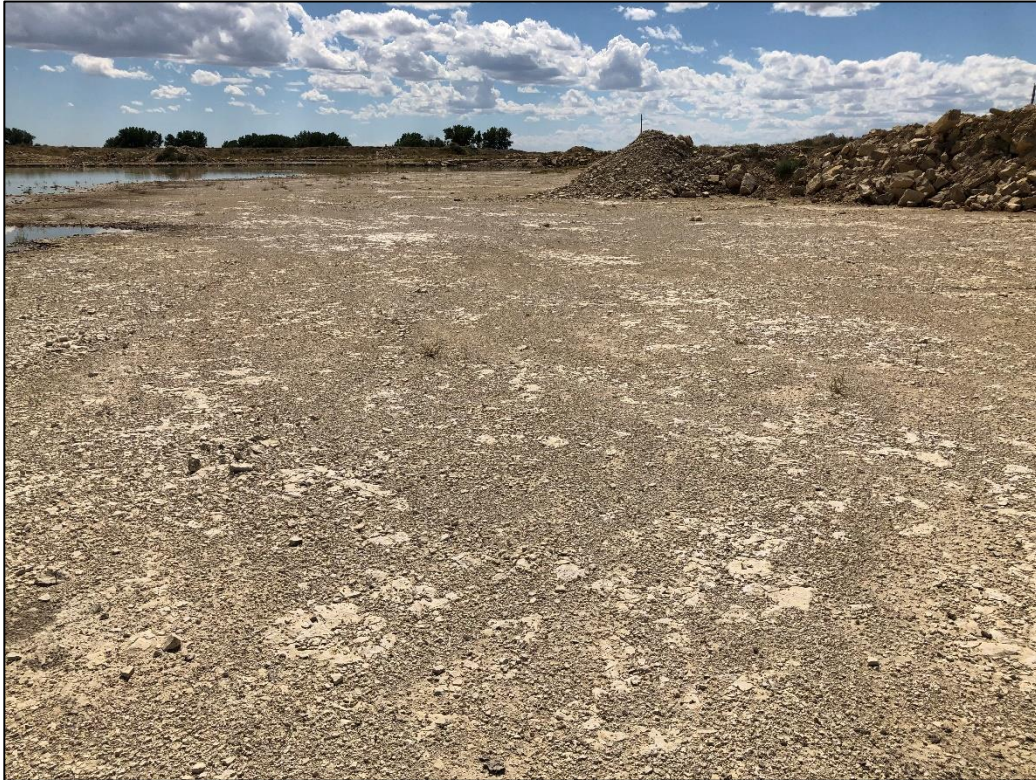
**Photo 9.** View looking south across western portion of pit which was dry during the inspection.

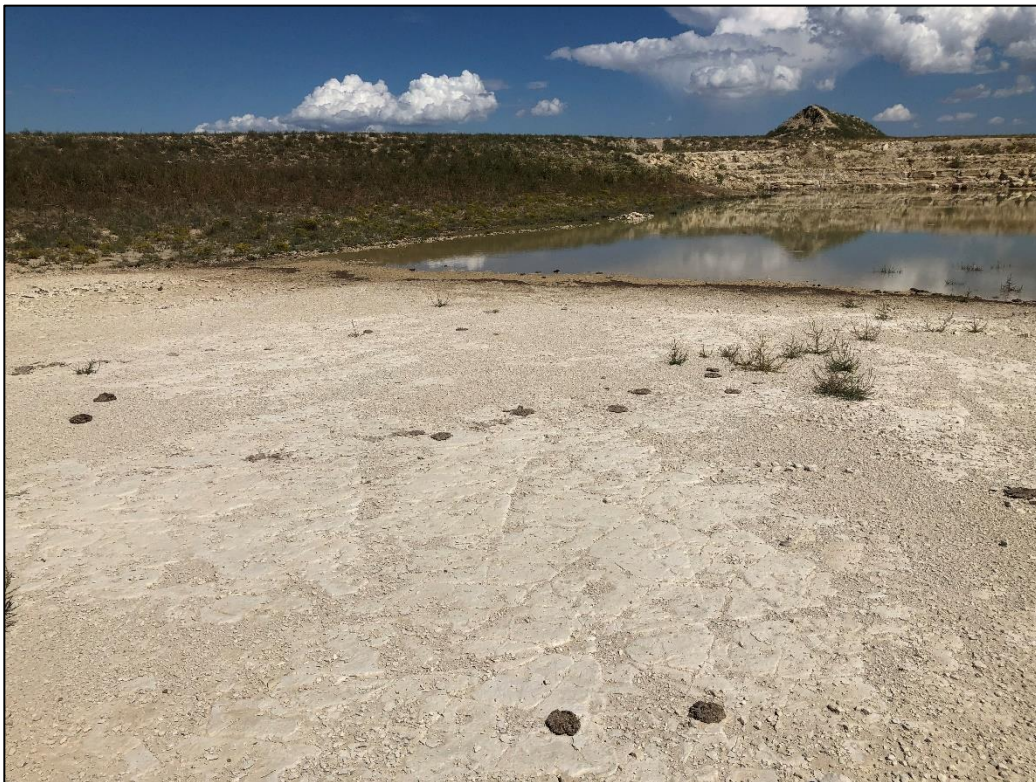
**Photo 10.** View looking northeast across northern portion of pit. Note ponded water present on pit floor (in background).

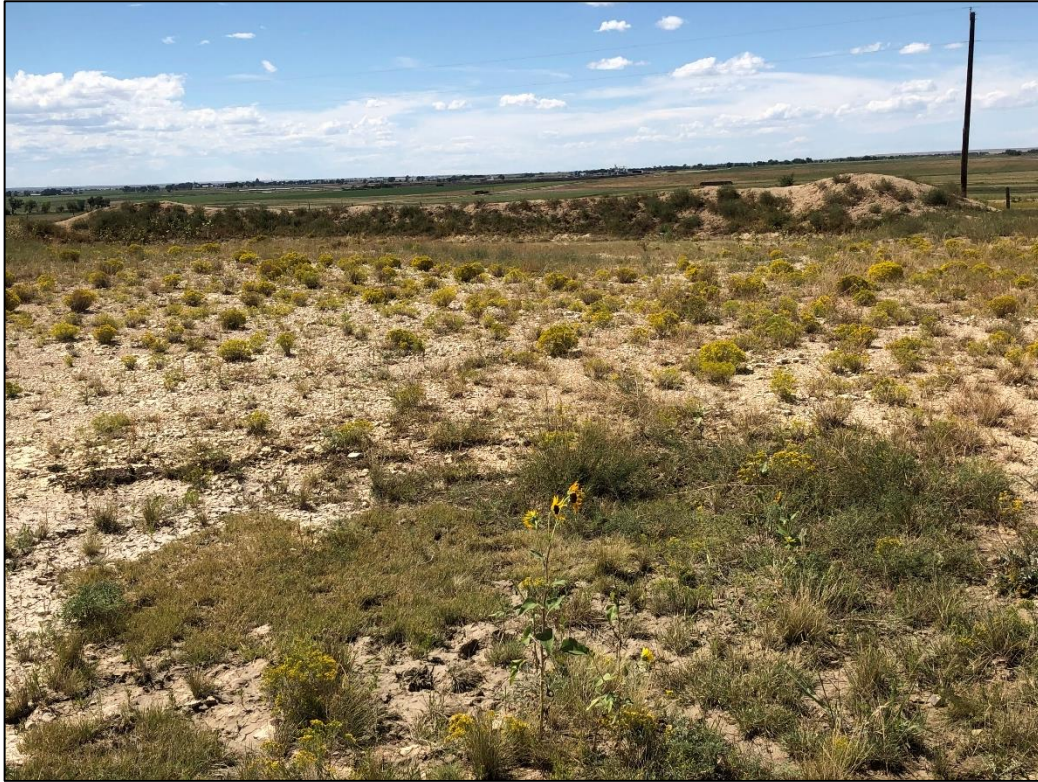
**Photo 11.** View looking west across area at northwestern edge of disturbance which was stripped in preparation for mining. Note topsoil berm stored at western edge of stripped area (in background).

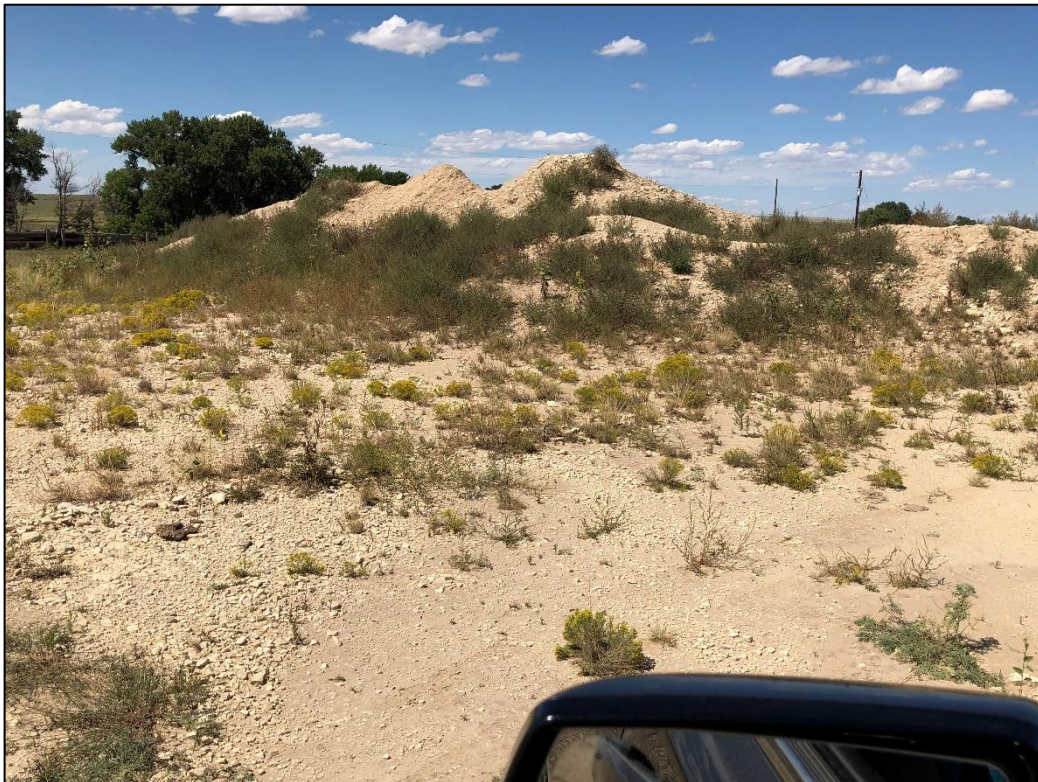
**Photo 12.** View looking west, showing topsoil stockpile stored at northern edge of area stripped in preparation for mining.

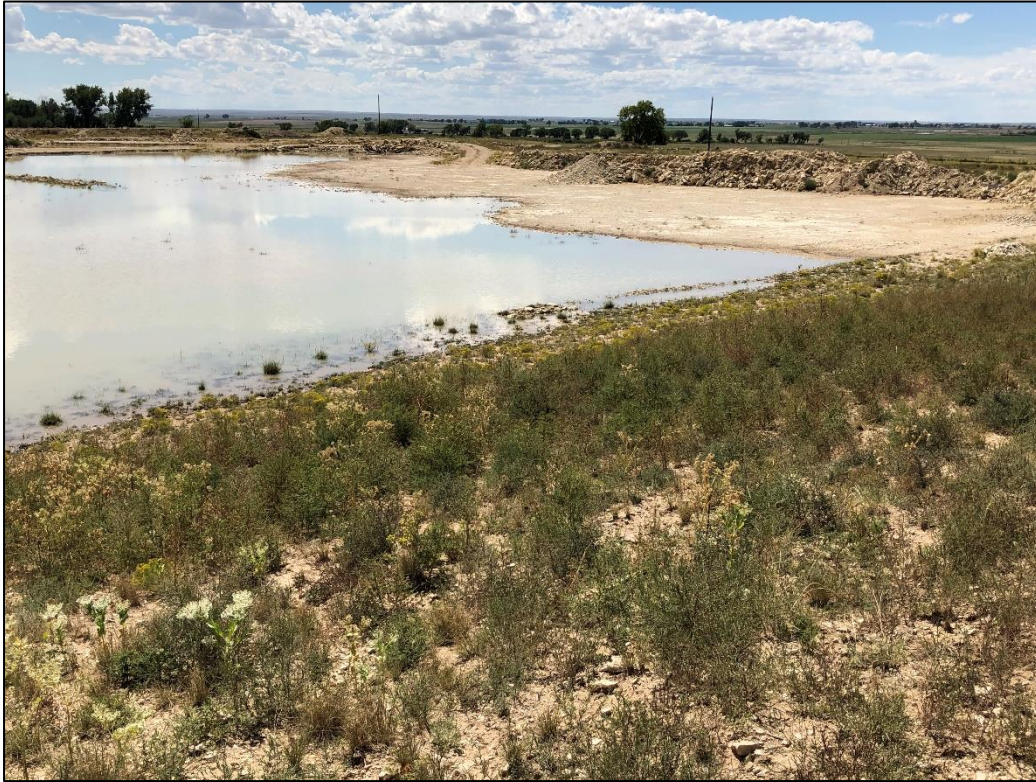
**Photo 13.** View looking southwest across pit from top of northern pit wall. Note ponded water present on pit floor.

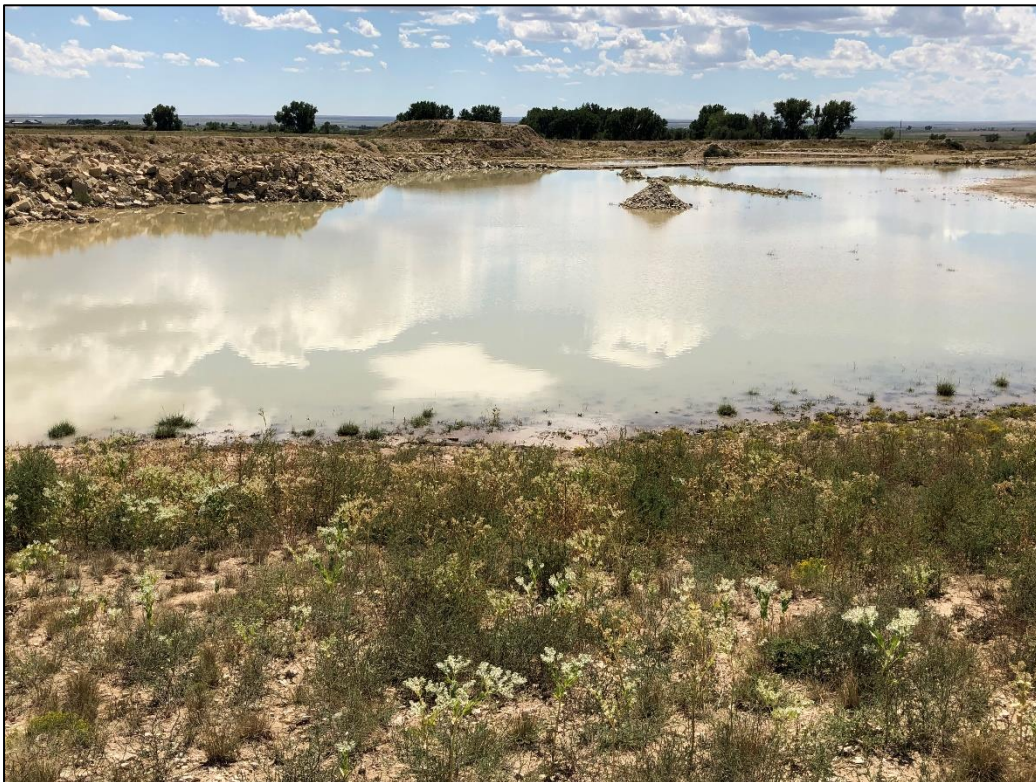
**Photo 14.** View looking south across pit from top of northern pit wall. Note ponded water present on pit floor. Also note material stockpiled on pit floor.

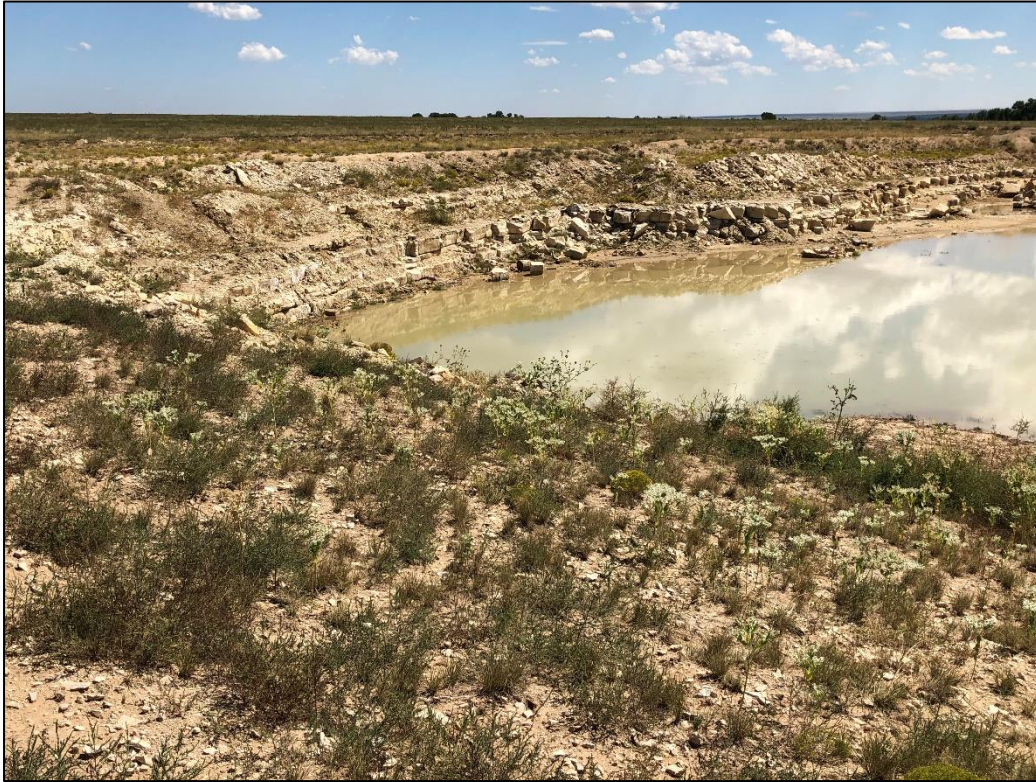
**Photo 15.** View looking southeast across pit from top of northern pit wall. Note ponded water present on pit floor. Also note pit wall approximately 12-15 feet in height with near vertical to 1.5H:1V slopes in this portion of the pit.

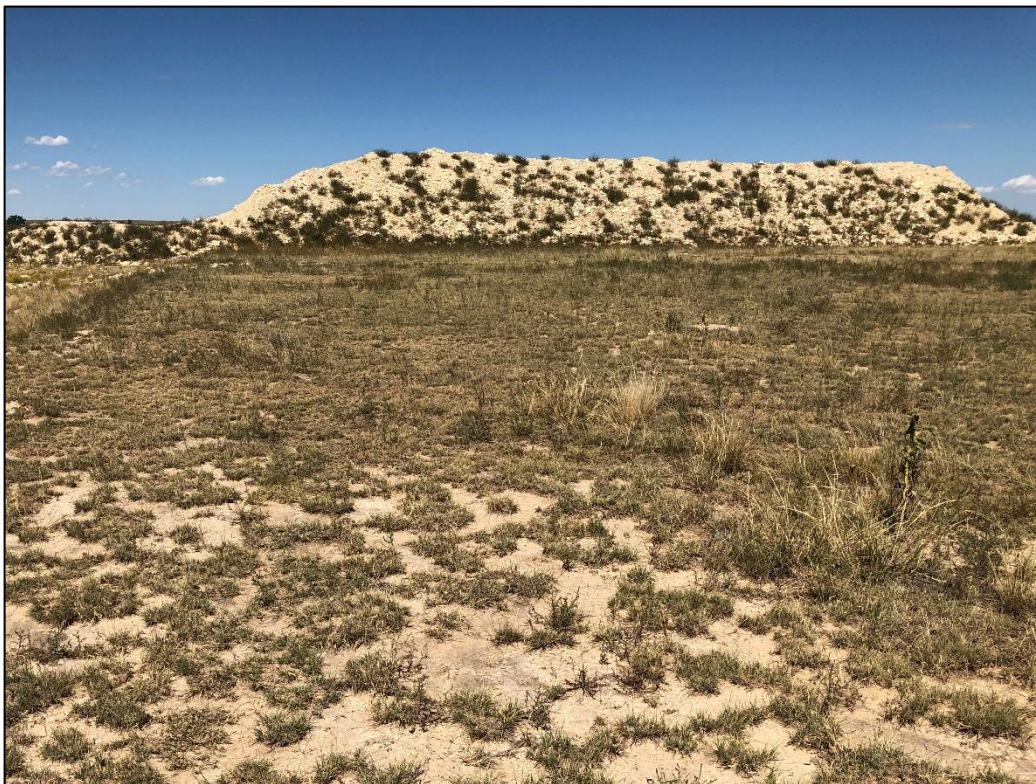
**Photo 16.** View looking north, showing large overburden stockpile stored at northeastern edge of pit, above the pit wall.

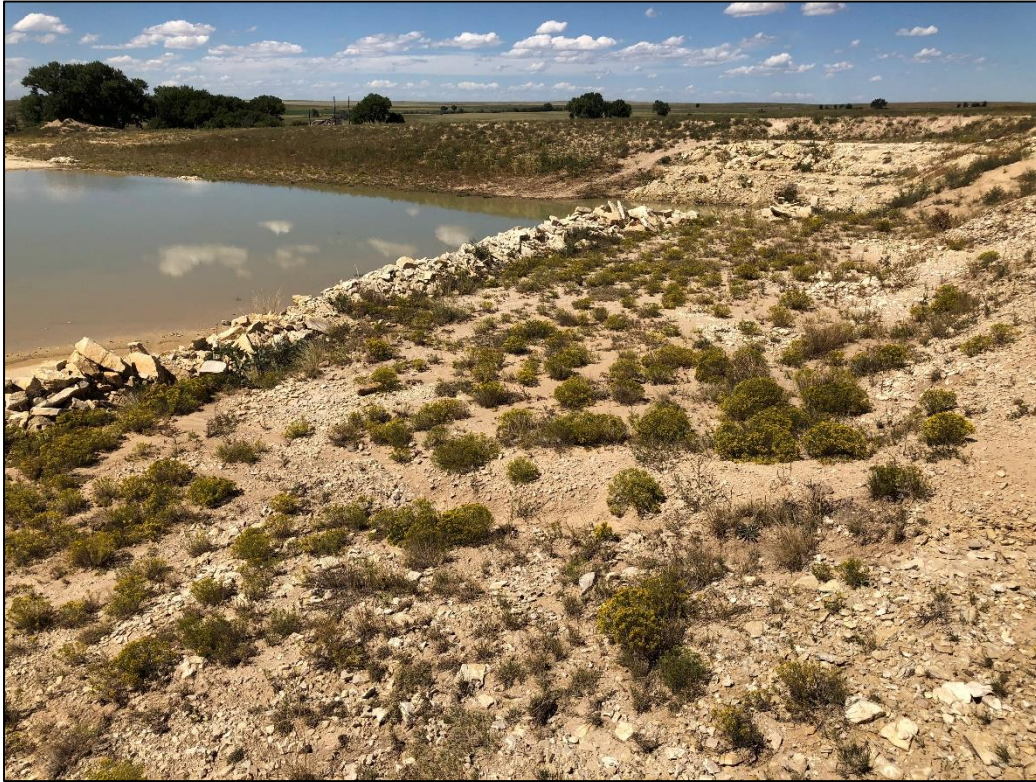
**Photo 17.** View looking northwest across pit from top of eastern pit wall. Note ponded water present on pit floor.

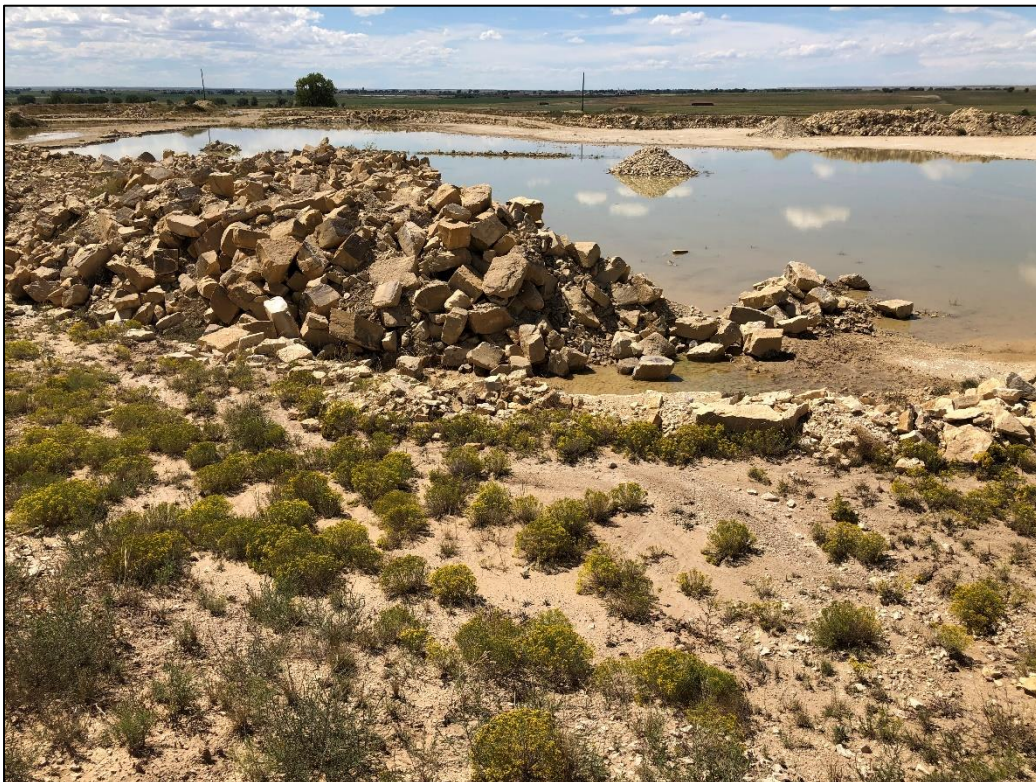
**Photo 18.** View looking southwest across pit from top of eastern pit wall. Note ponded water present on pit floor. Also note material stockpiled on pit floor.

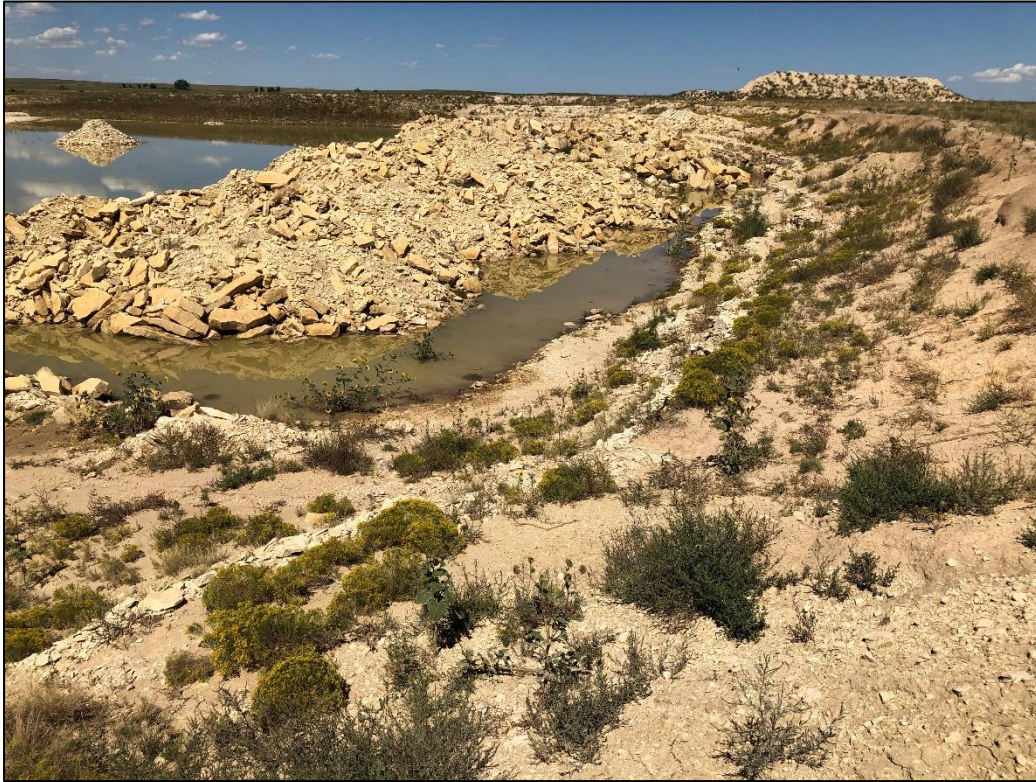
**Photo 19.** View looking north across eastern pit wall. Note material stockpiled on pit floor. Also note large overburden stockpile at northeastern corner of pit (in background).

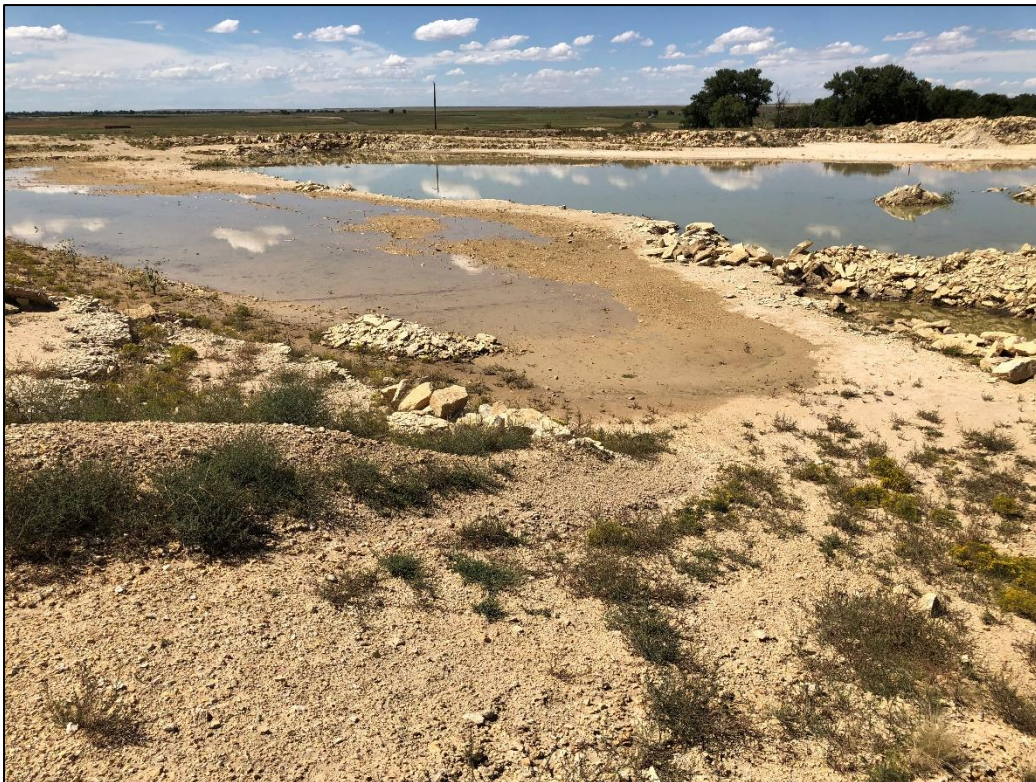
**Photo 20.** View looking west across pit from top of eastern pit wall. Note ponded water present on pit floor. Also note material stockpiled on pit floor.

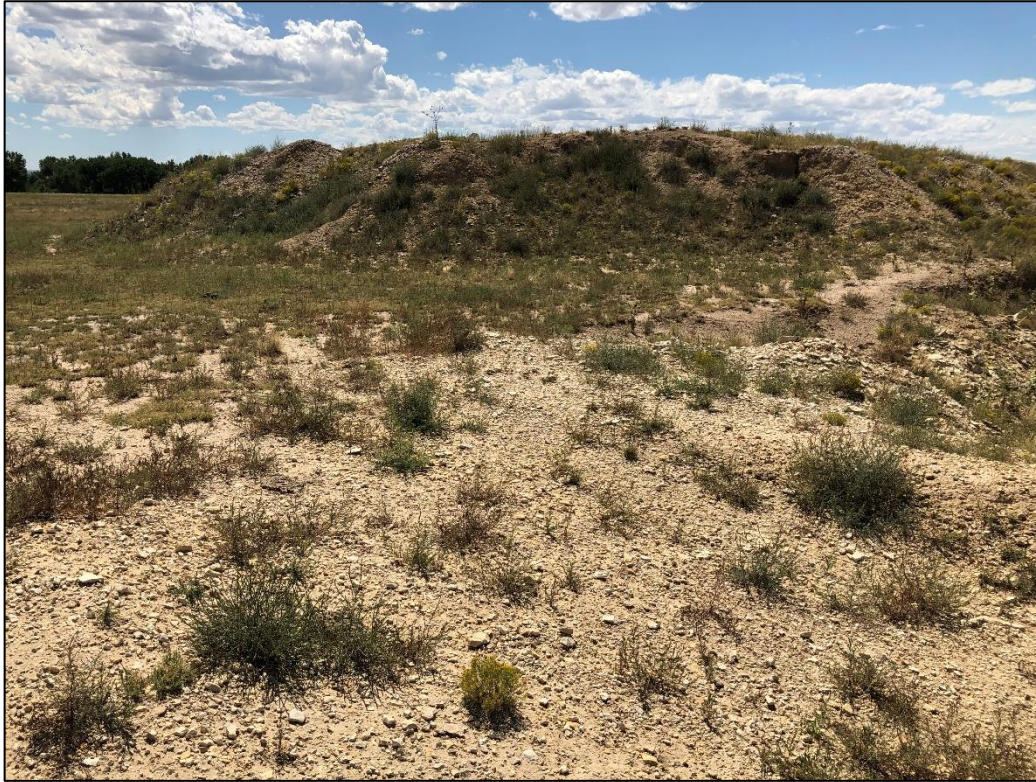
**Photo 21.** View looking south, showing large topsoil stockpile stored at eastern edge of pit, above the pit wall.

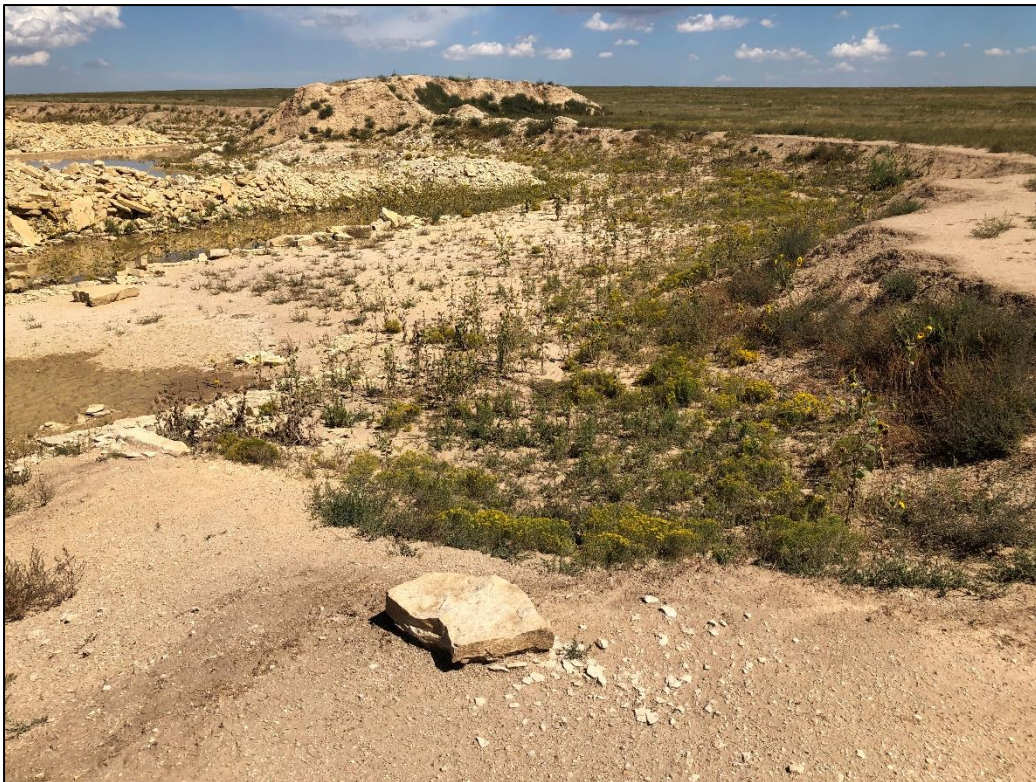
**Photo 22.** View looking east across southern pit wall. Note pit wall approximately 4 feet in height with approximate 1H:1V slopes in this portion of the pit.

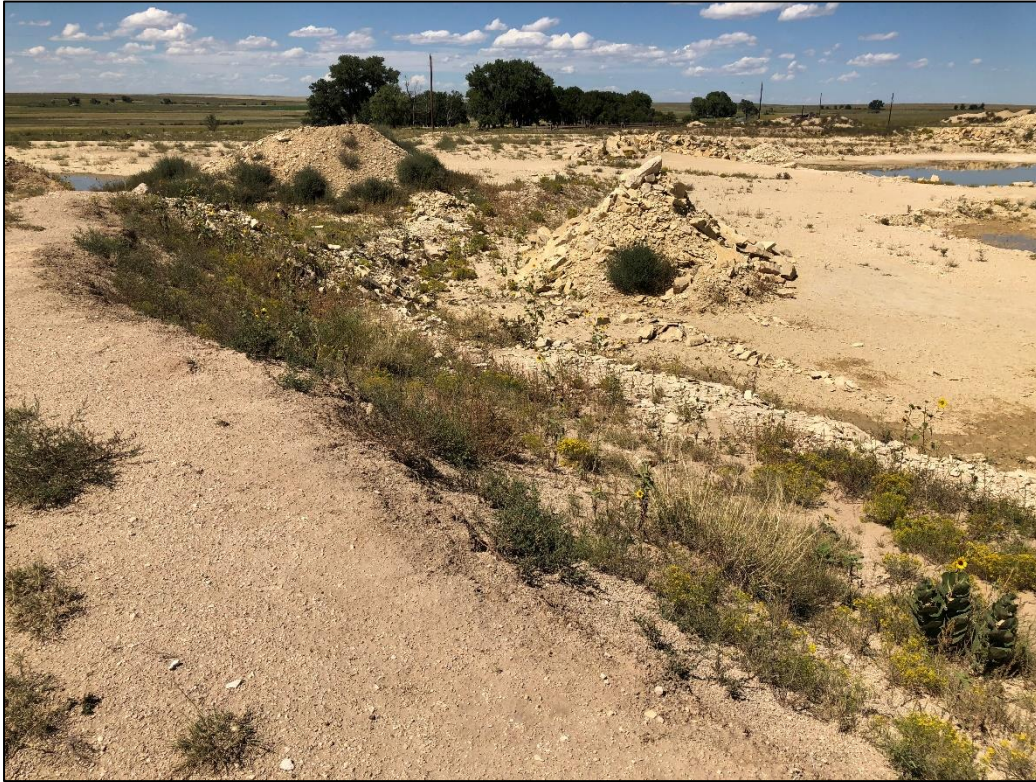
**Photo 23.** View looking west across southern pit wall. Note pit wall approximately 4 feet in height with approximate 1H:1V slopes in this portion of the pit. Also note material stockpiled at southwestern edge of pit.

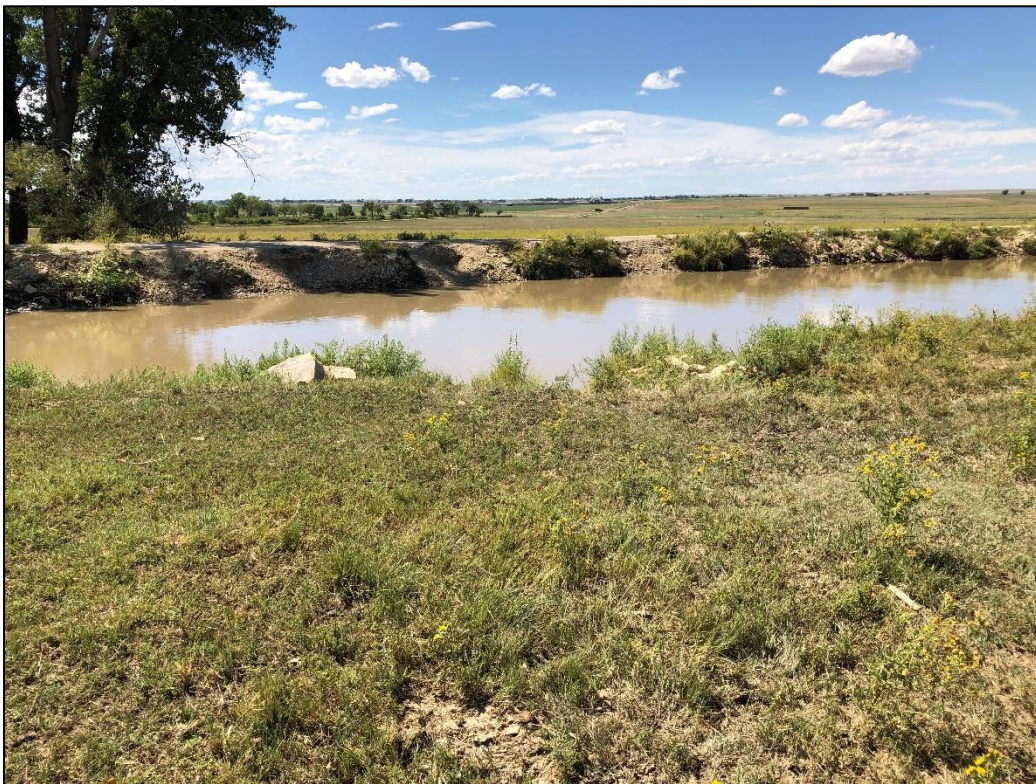
**Photo 24.** View looking west across Fort Lyons Ditch located west of mine site, which is owned and maintained by the operator.
