**MINERALS PROGRAM INSPECTION REPORT**  
**PHONE: (303) 866-3567**

| <b>MINE NAME:</b><br>Fort Lyon - State Pit No. 1 | <b>MINE/PROSPECTING ID#:</b><br>M-2001-097 | <b>MINERAL:</b><br>Limestone (general) | <b>COUNTY:</b><br>Bent |
| <b>INSPECTION TYPE:</b><br>Monitoring | <b>INSPECTOR(S):</b><br>Amy Eschberger | <b>INSP. DATE:</b><br>September 11, 2019 | <b>INSP. TIME:</b><br>13:15 |

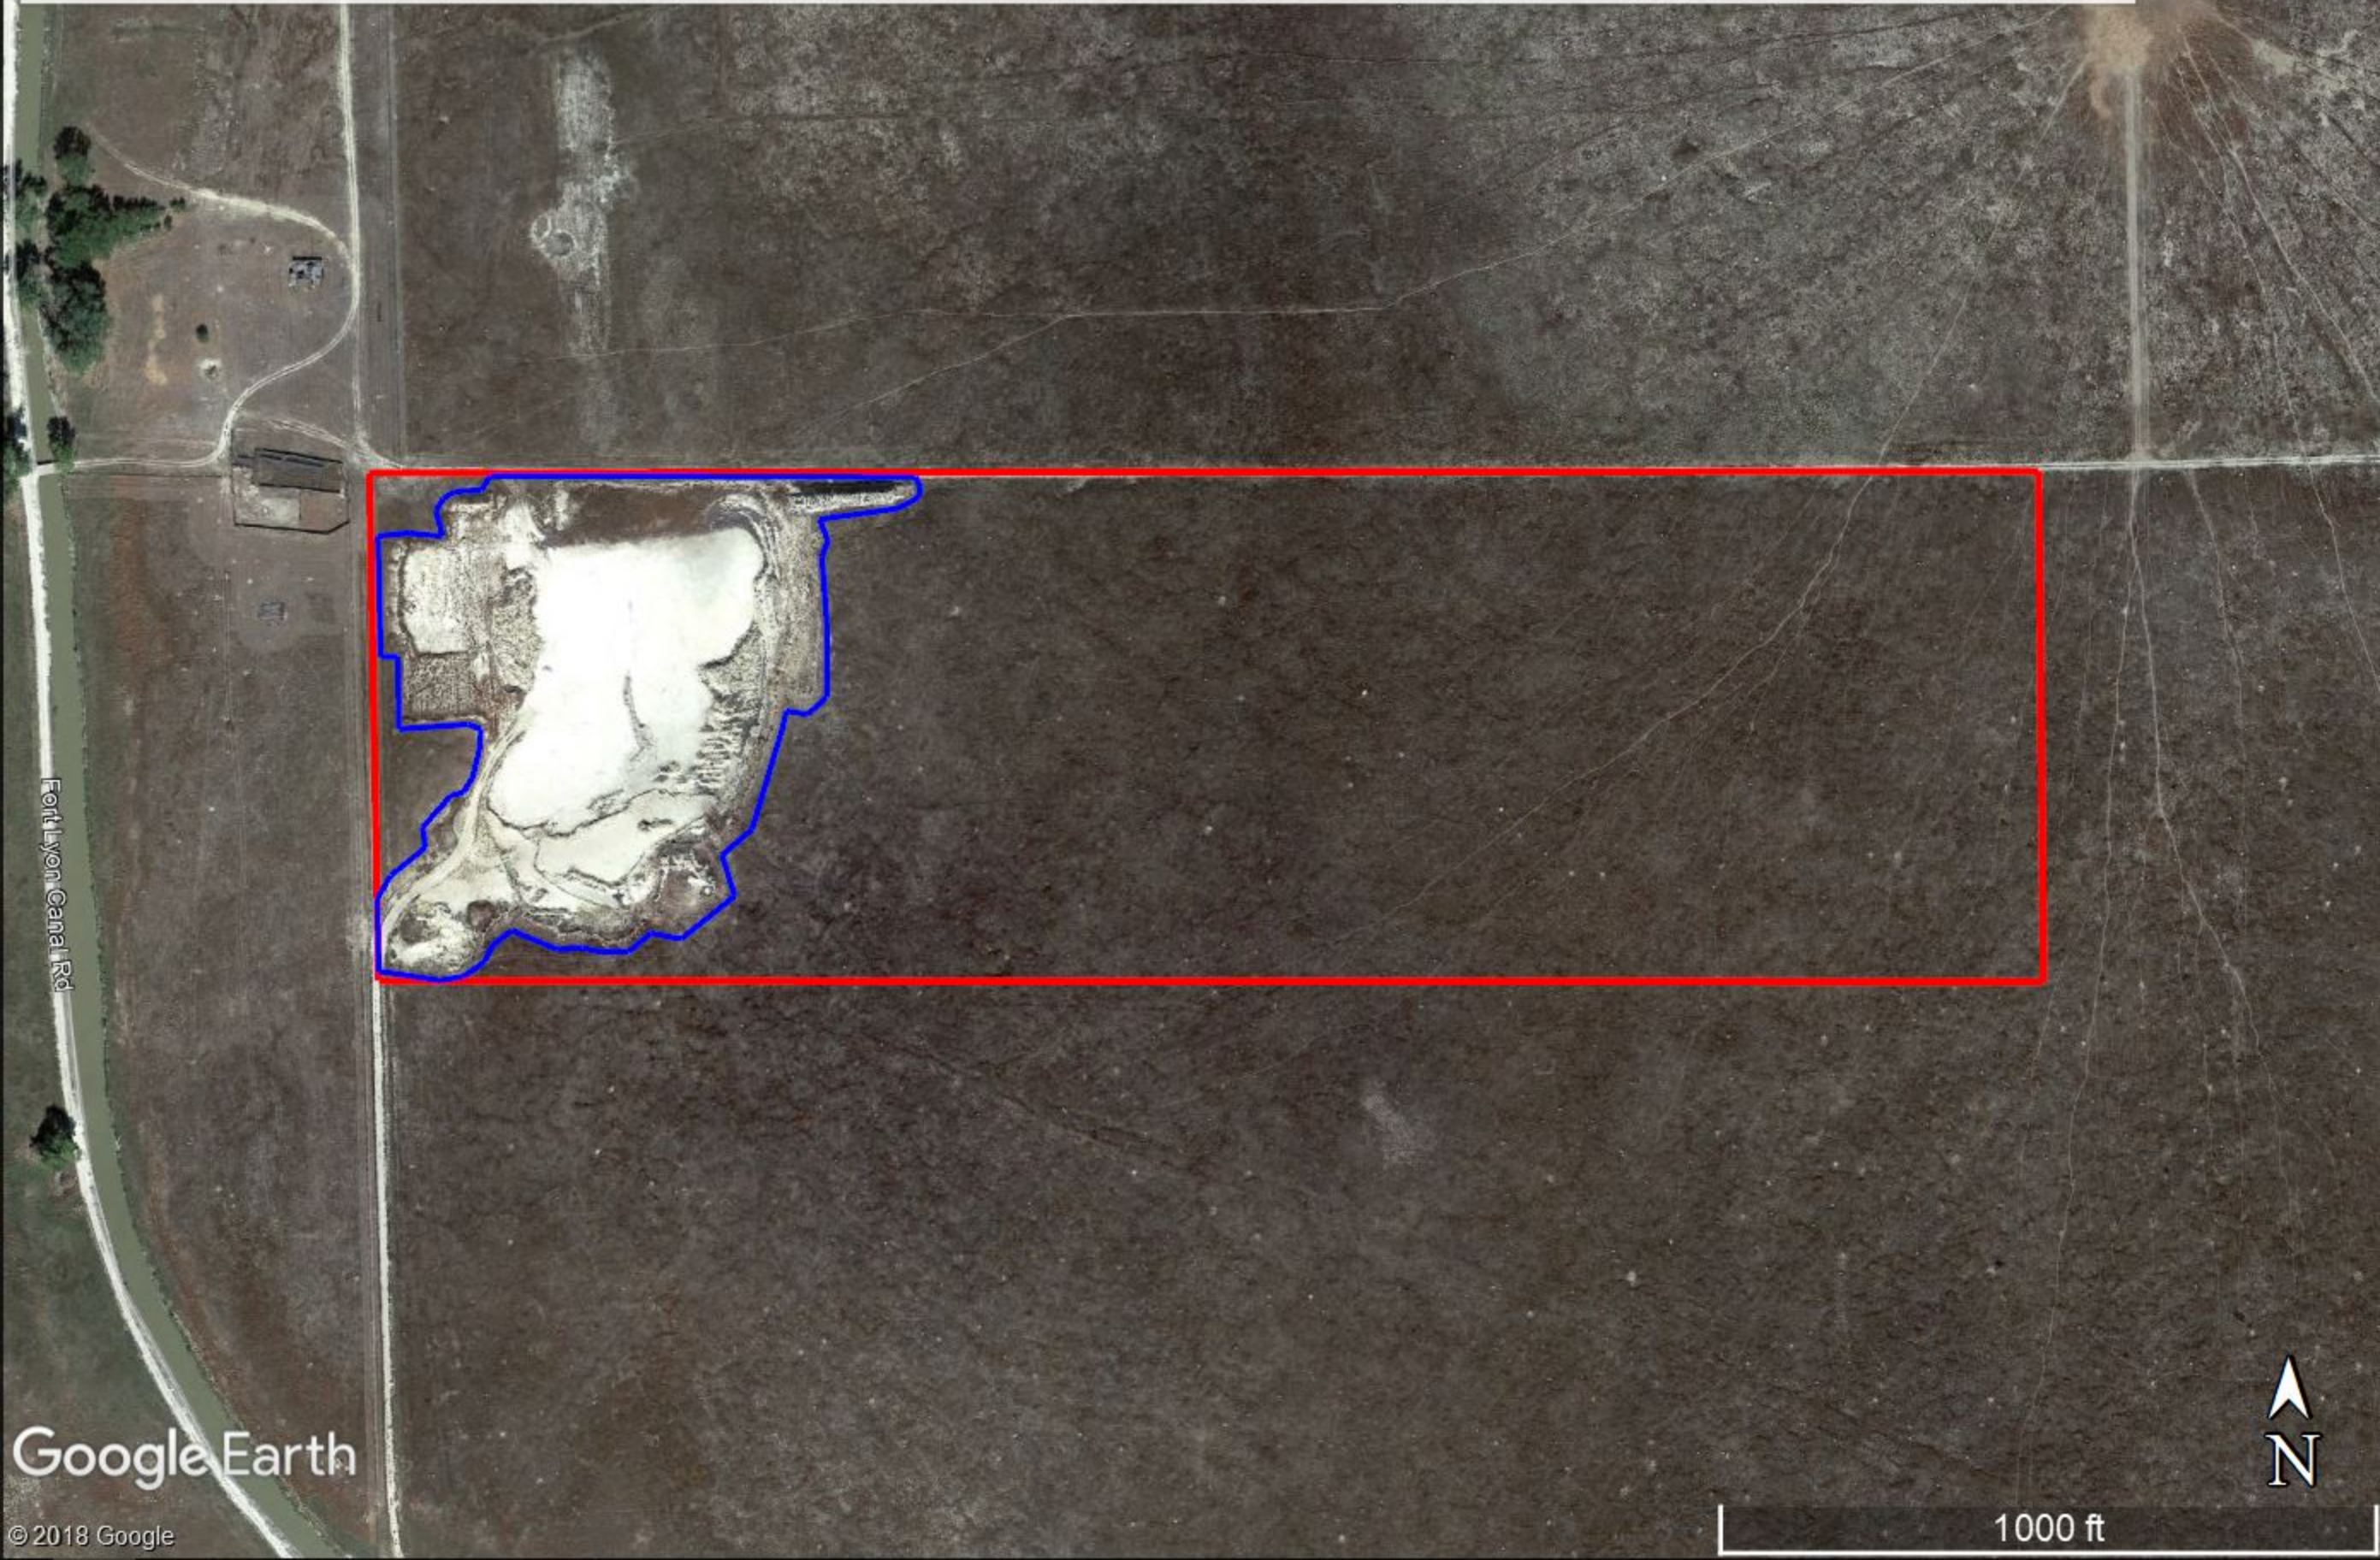
At this time, disturbance at the site is limited to the far western edge of the approved permit area. The Division estimates current disturbance to cover approximately 9.5 acres (see enclosed Google Earth image of site). This disturbance includes an open limestone pit that is approximately 4 feet deep at its southern edge, and approximately 12-15 feet deep at its northern edge. The pit daylights primarily to the west, with slope gradients of near vertical to 1.5H:1V. An approximate 1.5 acre area at the northwestern edge of the pit has been stripped of topsoil in preparation of mining. The salvaged topsoil from this area is bermed along its northern and western edges. Overburden and topsoil salvaged from the main pit area are stockpiled along the eastern and southern perimeters of the pit, above the pit walls. Several stockpiles of mined material are stored on the pit floor and at the southwestern edge of the pit near the access road. The operation appears to be following the approved mining and reclamation plans for the site.

Red Outline = 44.5 acres = Approved Permit Area (location approximated based on permit maps)

Blue Outline = 9.5 acres = Disturbed Area (as of 9/11/2019 inspection)
