MINERALS PROGRAM INSPECTION REPORT
PHONE: (303) 866-3567

MINE NAME: Golden Wonder Mine	MINE/PROSPECTING ID#: M-1978-091-UG	MINERAL: Gold	COUNTY: Hinsdale
INSPECTION TYPE: Monitoring	INSPECTOR(S): Stephanie J. Mitchell	INSP. DATE: June 19, 2019	INSP. TIME: 12:00
OPERATOR: LKA International Inc.	OPERATOR REPRESENTATIVE:	TYPE OF OPERATION: 110d - Designated Limited Impact

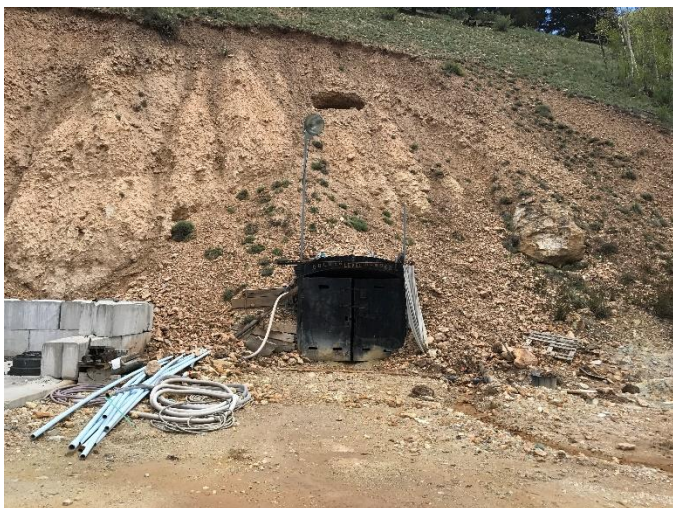
Above the portal at the level 3, there appears to be some subsidence or collapsing. The Operator is encouraged to repair the feature to reduce future collapsing.

Portal with subsidence above

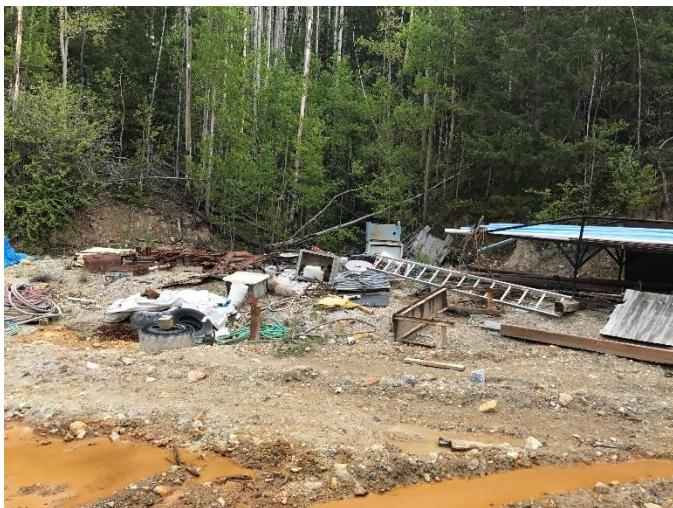
Miscellaneous mining debris / trash was observed along the eastern portion of the mine bench. The materials appeared disorganized and out of place. The conditions observed are not considered problem but poor housekeeping and is noted in this inspection report to be used as a tool to monitor future site conditions.

Unsightly trash

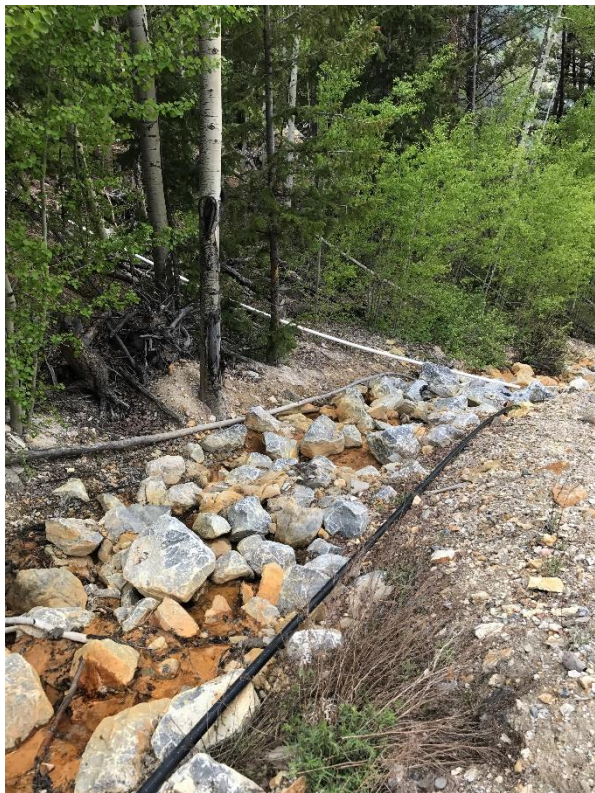
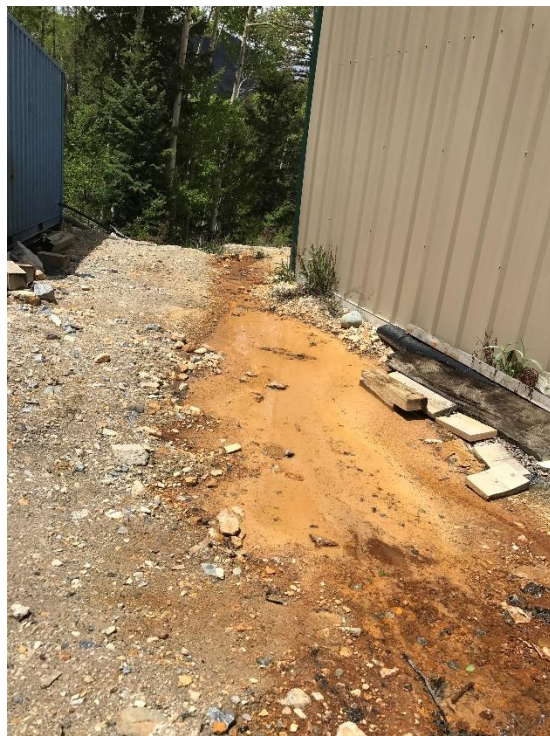
Water running past Office

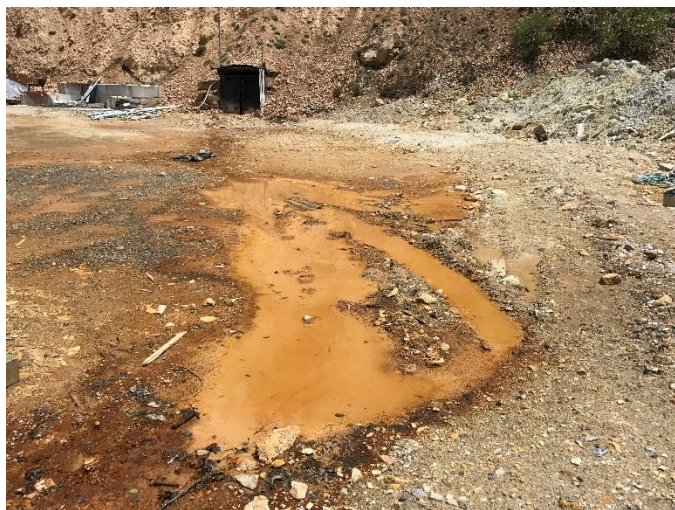
No active mining was observed during the inspection. An orange colored mine water discharge was observed exiting the portal which was observed during prior inspections. The discharge was NOT collecting into the grate that then goes into piping that directed the water into the passive metal slag treatment system. The flow is still estimated to be 0.1 gpm. **This is noted as a problem at the beginning of this inspection report.** The Operator will have 60 days to make repairs to the water treatment system to insure that water is indeed conveying into the piping and provide water sample results to the Division and CDPHE. At this time the water is running across the parking lot as a surface runoff, not entering into the water treatment system, flowing past the shop and into the limestone rip rap channel. Water samples were taken at the portal, near the water treatment system and in the channel. Results of the water sampling included very low pH (2.5 pH), high levels of iron, copper, lead and zinc. All exceeding the limits of CDPHE standards.

AMD surface runoff

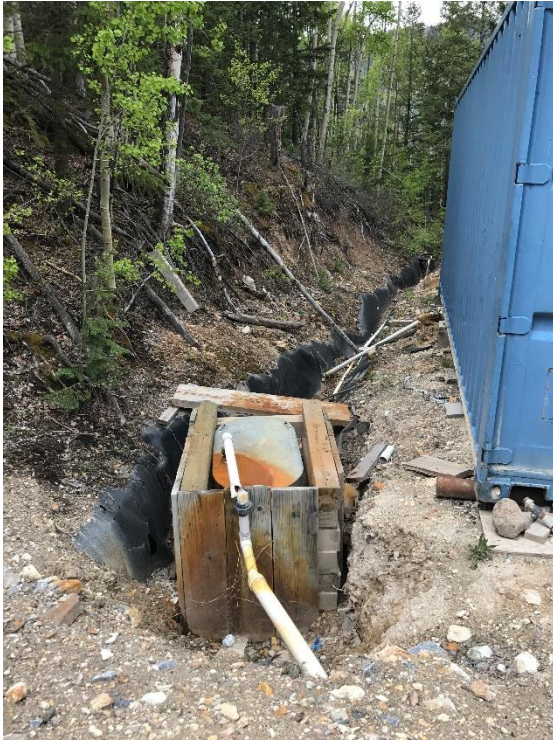
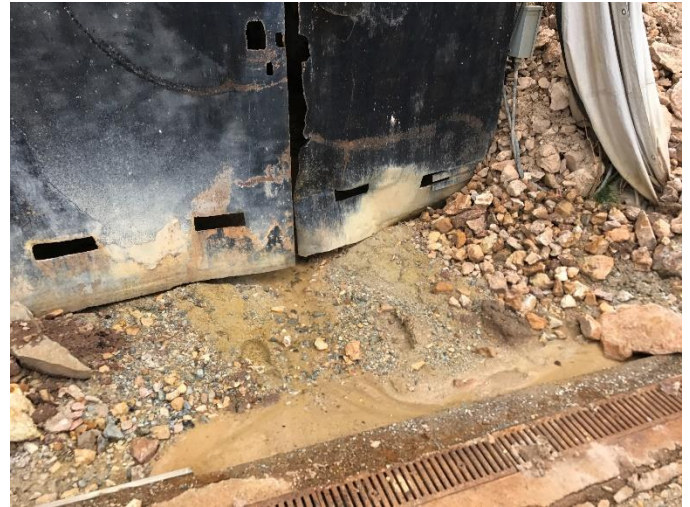
Water not draining into drain

CORRECTIVE ACTIONS: The operator shall install the process water control system as designed and approved in the permit application including lining of any ponds or compaction of embankments as necessary to prevent loss of containment of the process water by the corrective action date.

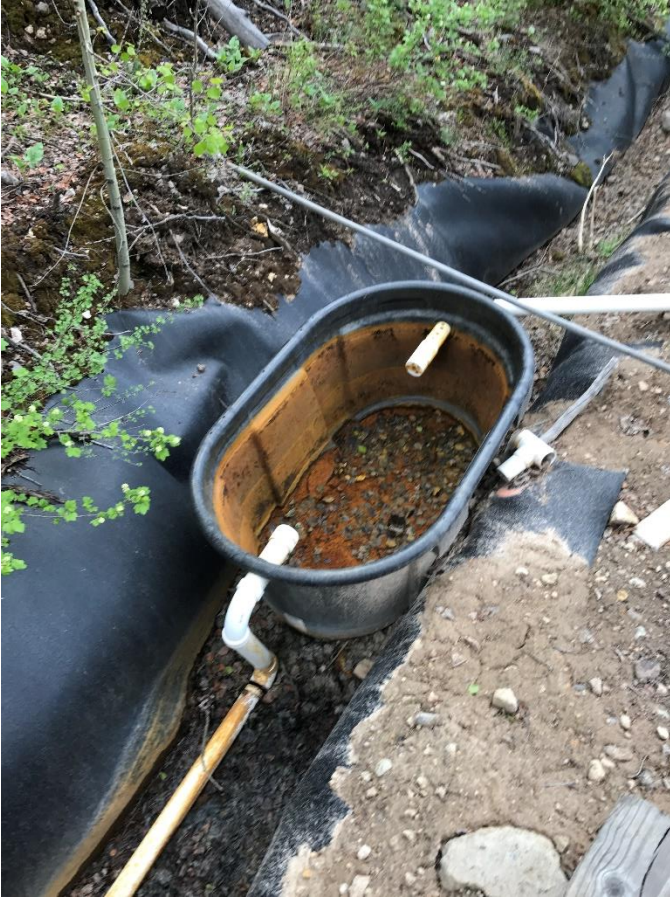
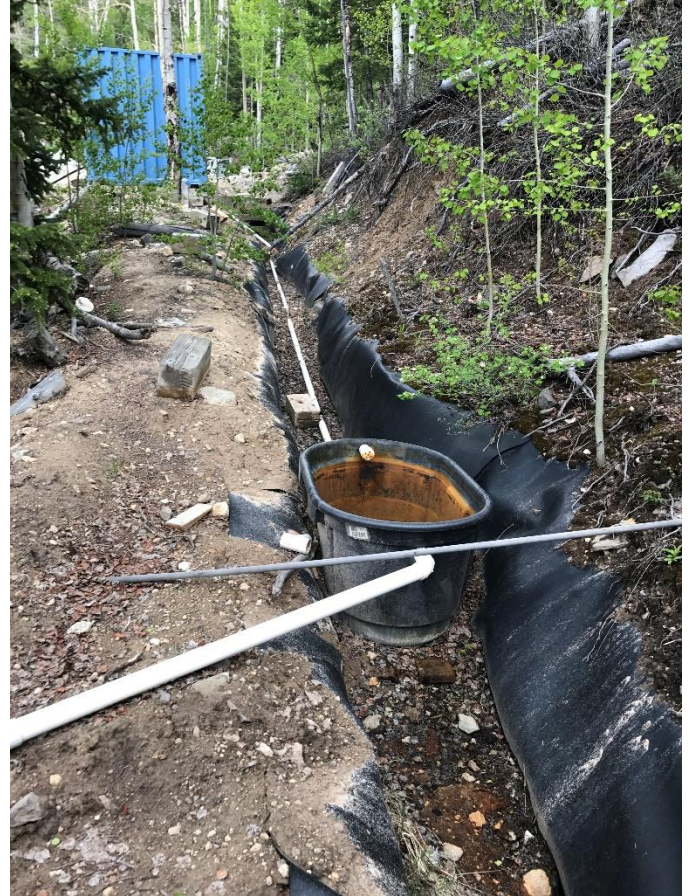
PROBLEM/POSSIBLE VIOLATION: Problem: The operator failed to prevent disturbances to the hydrologic balance through inadequate containment or treatment of processing wastewater, specifically; the operator has not properly installed the approved process water treatment in accordance with the approved application. Furthermore, ponds that have been installed are malfunctioning by allowing leakage and loss of containment of the process water. C.R.S. 34-32.5-116(4)(h) and Rule 6.4.7(2)(c)

Water Treatment System- Water not entering
system (Dry)
