MINERALS PROGRAM INSPECTION REPORT
PHONE: (303) 866-3567

MINE NAME: Ruby Trust Mine	MINE/PROSPECTING ID#: M-1979-181	MINERAL: Gold and silver	COUNTY: Ouray
INSPECTION TYPE: Monitoring	INSPECTOR(S): Lucas J. West	INSP. DATE: September 5, 2019	INSP. TIME: 08:53
OPERATOR: Walker Ruby Mining Company, Inc.	OPERATOR REPRESENTATIVE: None	TYPE OF OPERATION: 110(2) - Hard Rock Limited Impact	
REASON FOR INSPECTION: Normal I&E Program	BOND CALCULATION TYPE: None	BOND AMOUNT: \$18,738.00	
DATE OF COMPLAINT: NA	POST INSP. CONTACTS: None	JOINT INSP. AGENCY: None	
WEATHER: Cloudy	INSPECTOR'S SIGNATURE:

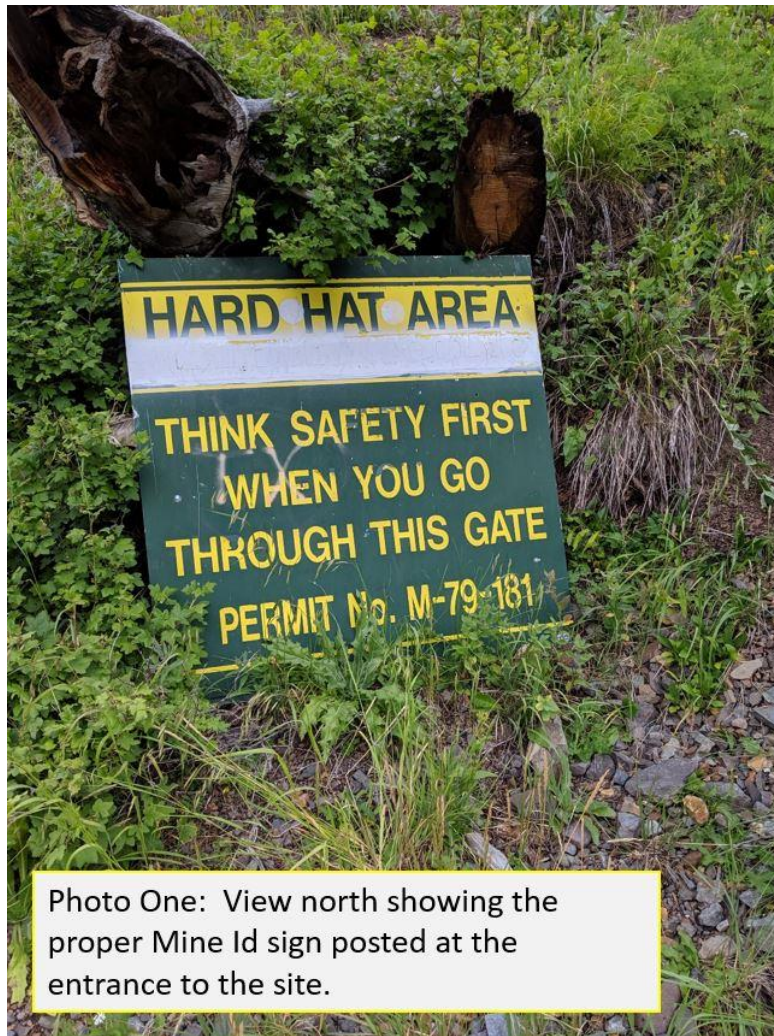
The proper mine identification signage was posted at the entrance to the site and can be seen in Photo One. Mining activities were not occurring at the time of the inspection, however the construction crew from Blackford's construction was on site conducting a major site cleanup. Scrap metal, miscellaneous equipment and debris was being consolidated for removal from the site. Examples of the debris can be seen in Photos Two and Three. Several items of historical debris not related to the current mining operation were removed from Sneffles Creek, adjacent to the mine site. The crew was also conducting repair work to the road and mining area as it had been eroded during the spring runoff.

Photo One: View north showing the proper Mine Id sign posted at the entrance to the site.

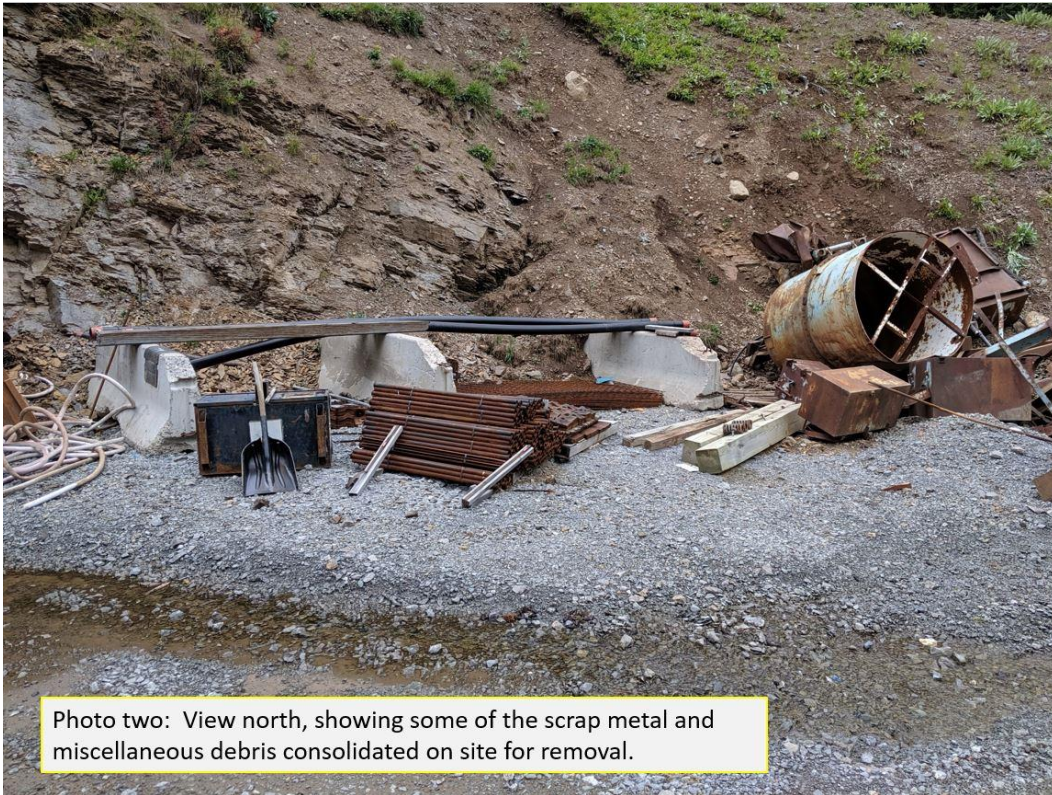
Photo two: View north, showing some of the scrap metal and miscellaneous debris consolidated on site for removal.

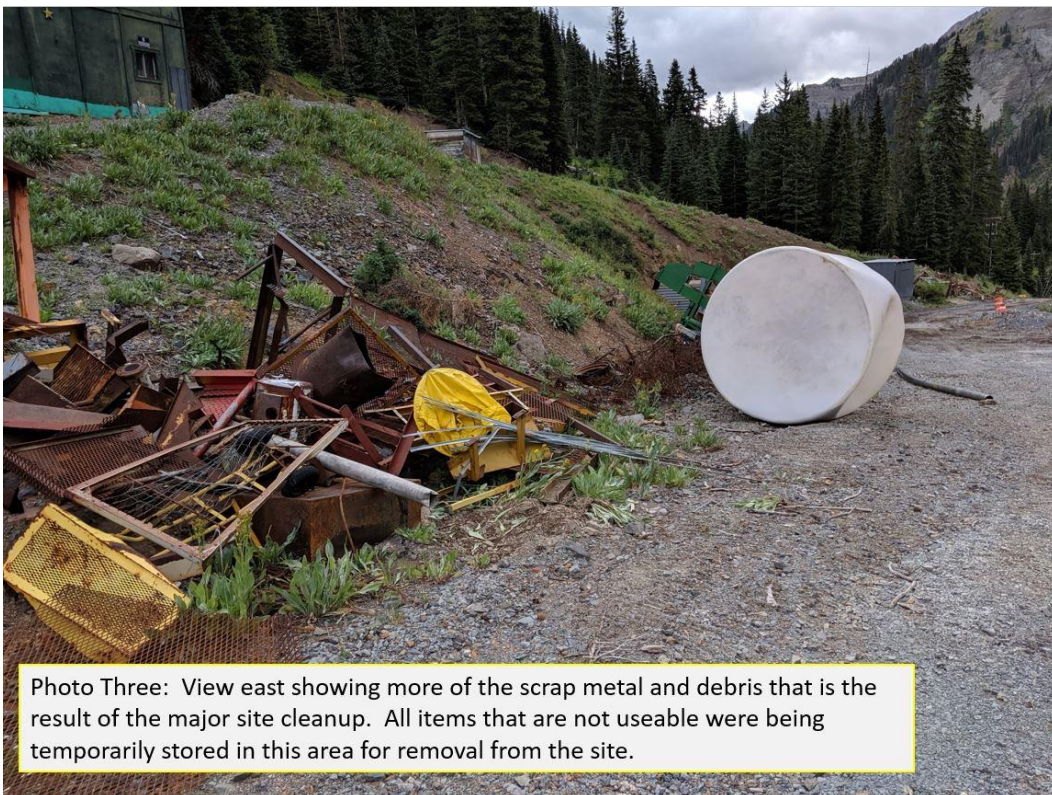
Photo Three: View east showing more of the scrap metal and debris that is the result of the major site cleanup. All items that are not useable were being temporarily stored in this area for removal from the site.

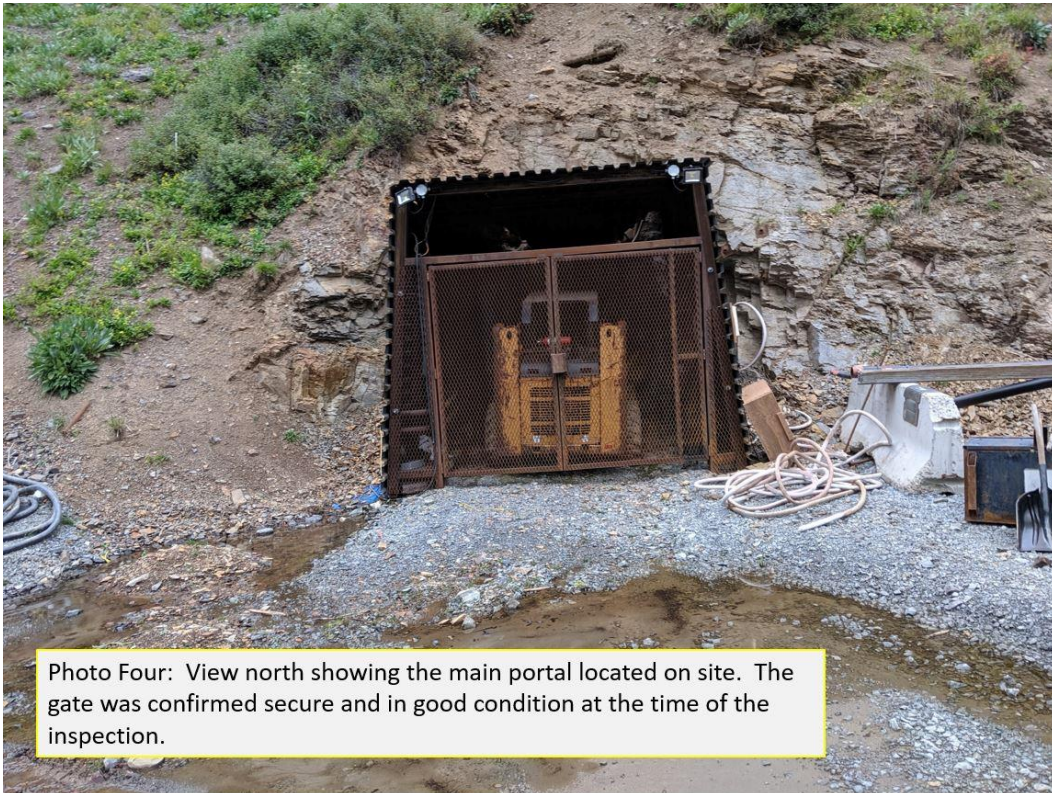
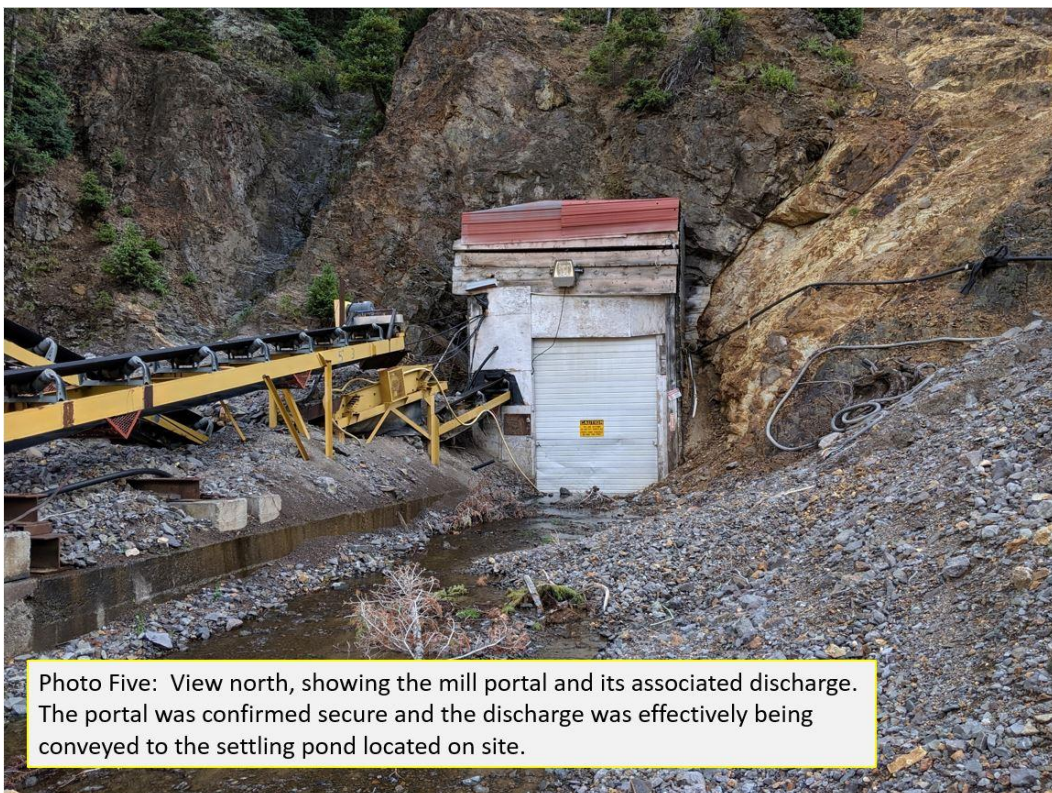
The site contains four separate portals. The main portal was secured with a locking steel grate with a Skid Steer parked immediately inside the closure. The main portal can be seen in Photo Four. The mill portal, was observed and confirmed secure. At the time of the inspection a discharge of approximately 20 gallons per minute was observed coming from the mill portal. The water was being conveyed through a series of ditches that reports to a settling pond which ultimately discharges to Sneffles Creek. The portal and its discharge can be seen in Photo Five. The historic portal located at the west end of the site was observed to be opened which can be seen in Photo Six. On site discussions with the construction crew indicate that in addition to site cleanup they had cleared debris from the portal gate and opened it in preparation for the installation of a new more secure closure. This was the portal that was subject to the internal notification of unauthorized entry which was found to be authorized and not of concern at this time. The lower portal located near the settling pond was also observed and confirmed secure. It can be seen in Photo Seven.

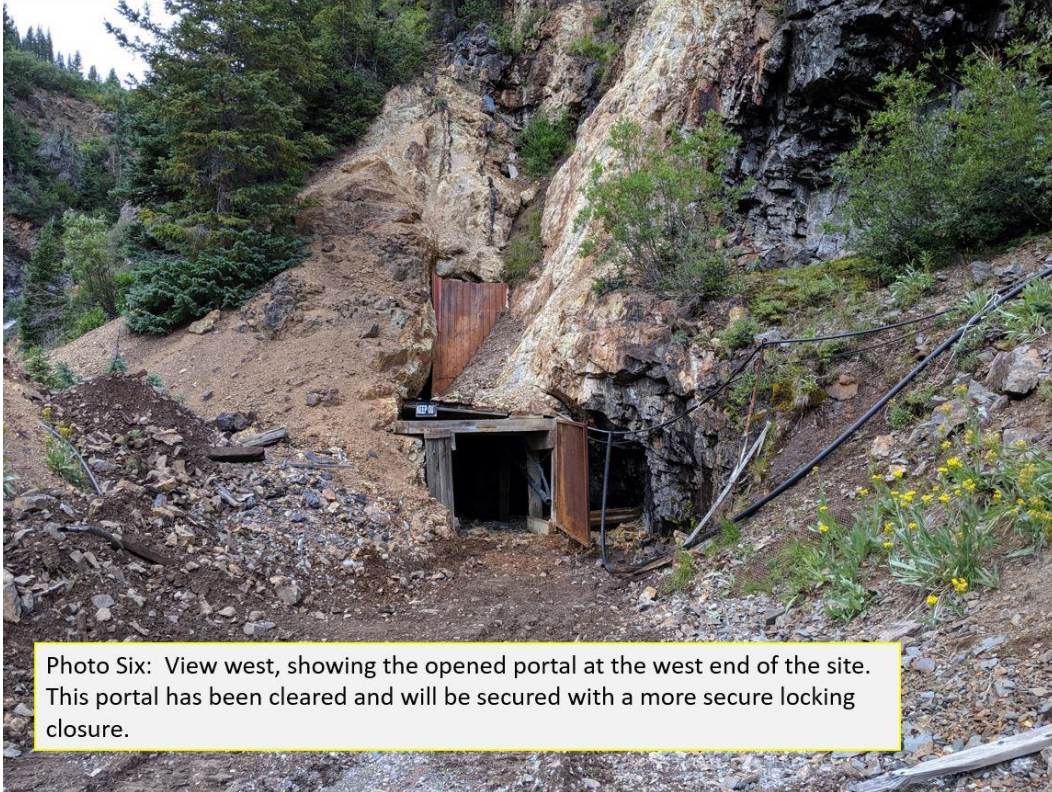
Photo Six: View west, showing the opened portal at the west end of the site. This portal has been cleared and will be secured with a more secure locking closure.

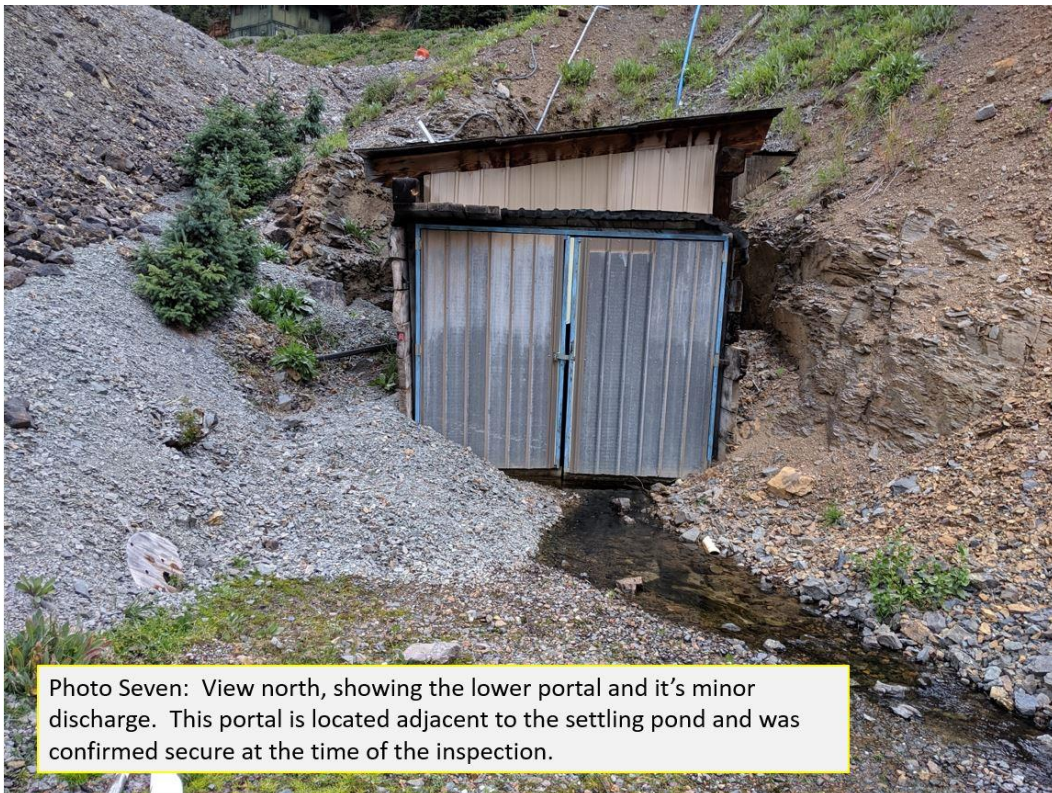
Photo Seven: View north, showing the lower portal and its minor discharge. This portal is located adjacent to the settling pond and was confirmed secure at the time of the inspection.
