MINERALS PROGRAM INSPECTION REPORT
PHONE: (303) 866-3567

MINE NAME: South Asphalt Plant	MINE/PROSPECTING ID#: M-2009-004	MINERAL: Gravel and sand	COUNTY: El Paso
INSPECTION TYPE: Monitoring	INSPECTOR(S): Timothy Cazier	INSP. DATE: July 31, 2019	INSP. TIME: 09:30
OPERATOR: Rocky Mountain Materials and Asphalt, Inc.	OPERATOR REPRESENTATIVE: Dave Bieber	TYPE OF OPERATION: 110c - Construction Limited Impact

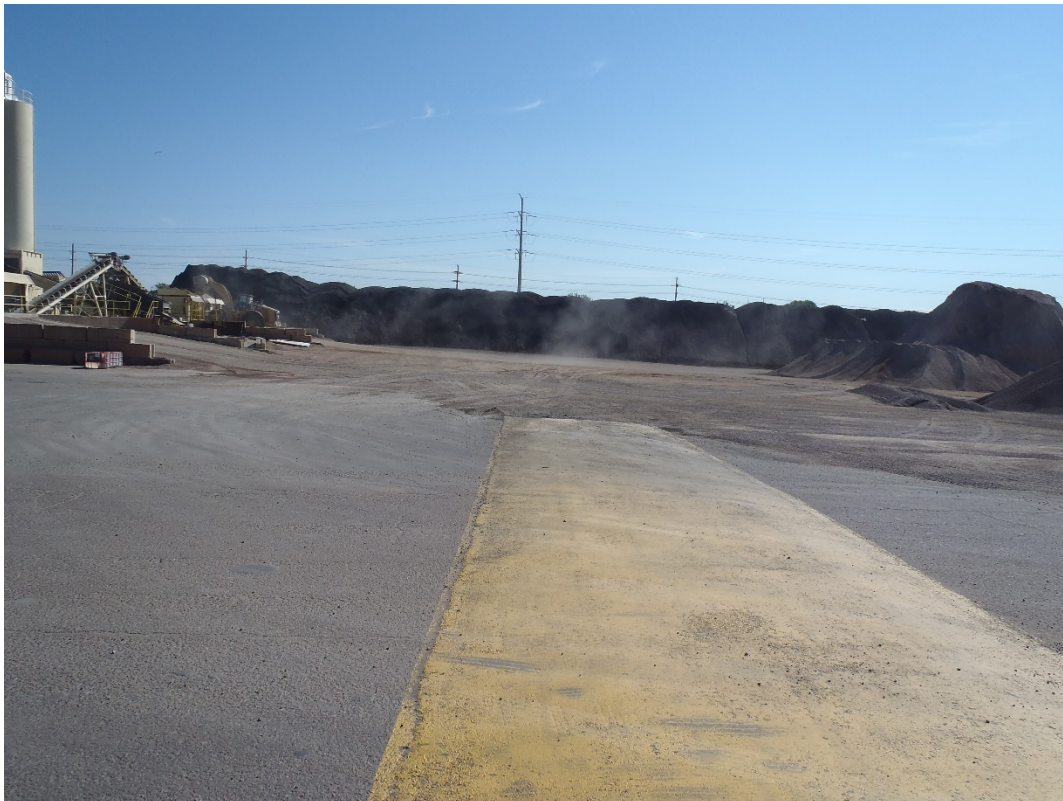
Roads: Other than the stockpile areas, the majority of the surface is paved (see **Photos 1** and **2**), as such it is unlikely that sediment could be tracked offsite.

Support Facilities On-site: A Cat 980 loader was actively moving imported stockpiled material to the adjacent batch plant. (see **Photo 1**).

Photo 1. North end of Permit boundary (approximately an extension of the yellow line in the foreground, looking NE), note loader and stockpiled material.

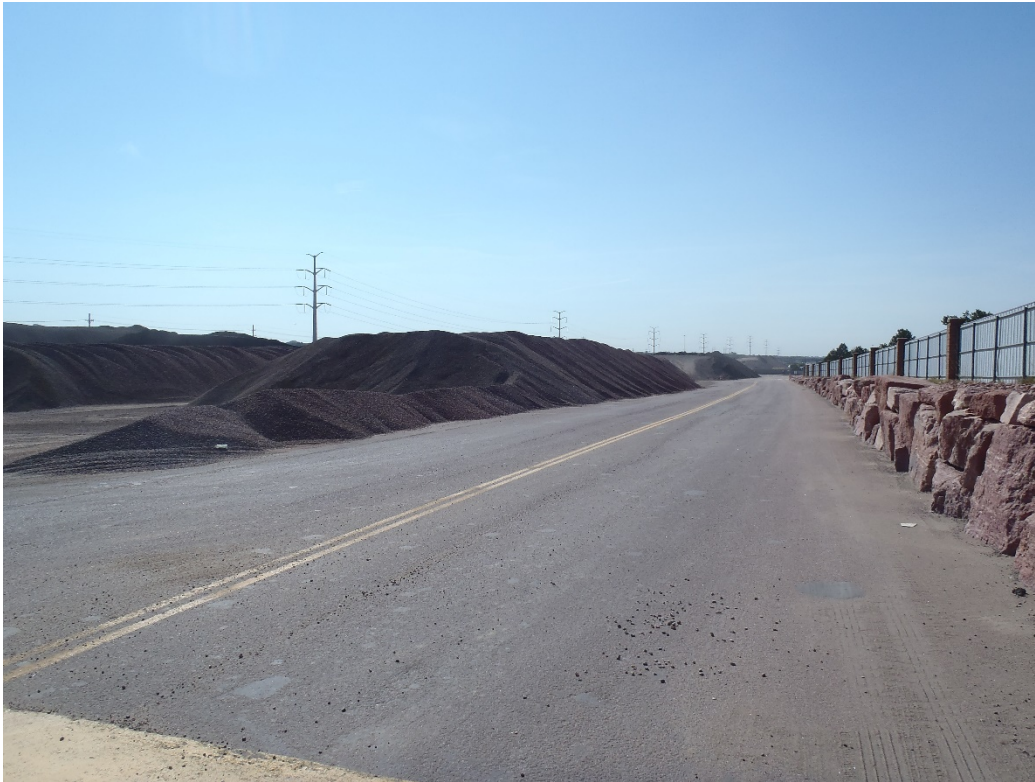
Photo 2. Pavement on west side of permit boundary (looking SE) stockpiled material on permit boundary.

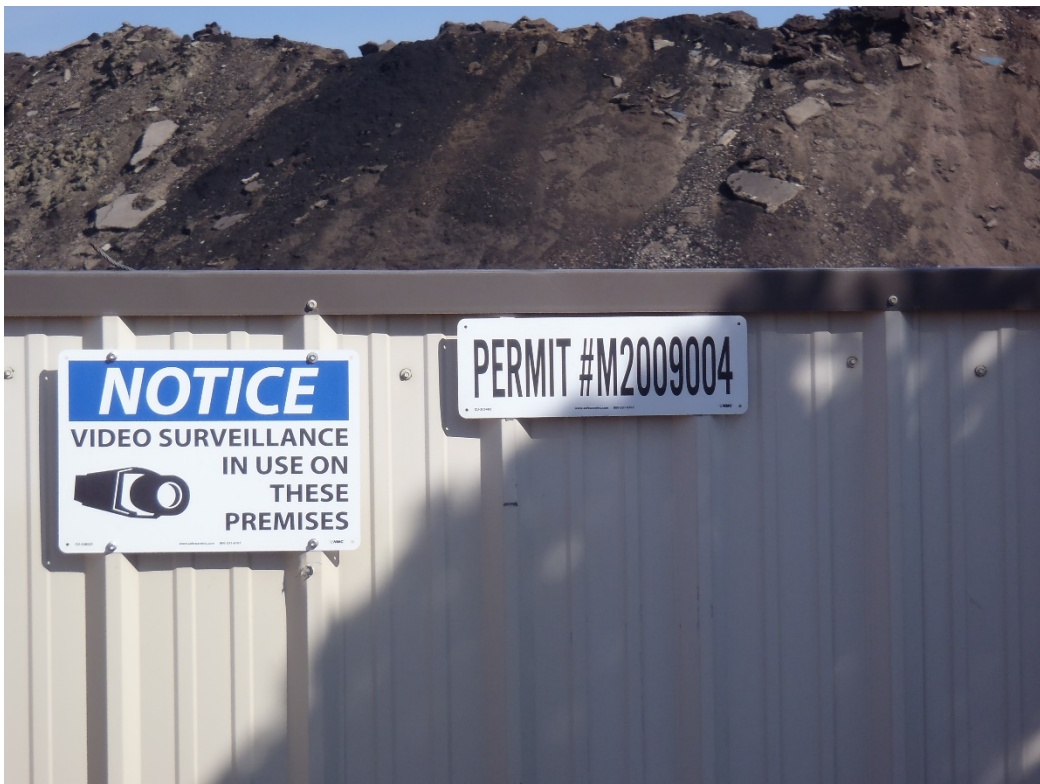
Signs and Markers: The permit sign was properly posted (see **Photo 3**) the north boundary markers missing. Mr. Bieber explained the imported material stockpiles and third party truck traffic at the permit boundary leads to frequently buried and or run over boundary markers. [Prior to resuming mining, some means of marking the permit boundary must be established pursuant to Rule 3.1.12\(2\).](#)

Photo 3. Permit sign (south entrance).

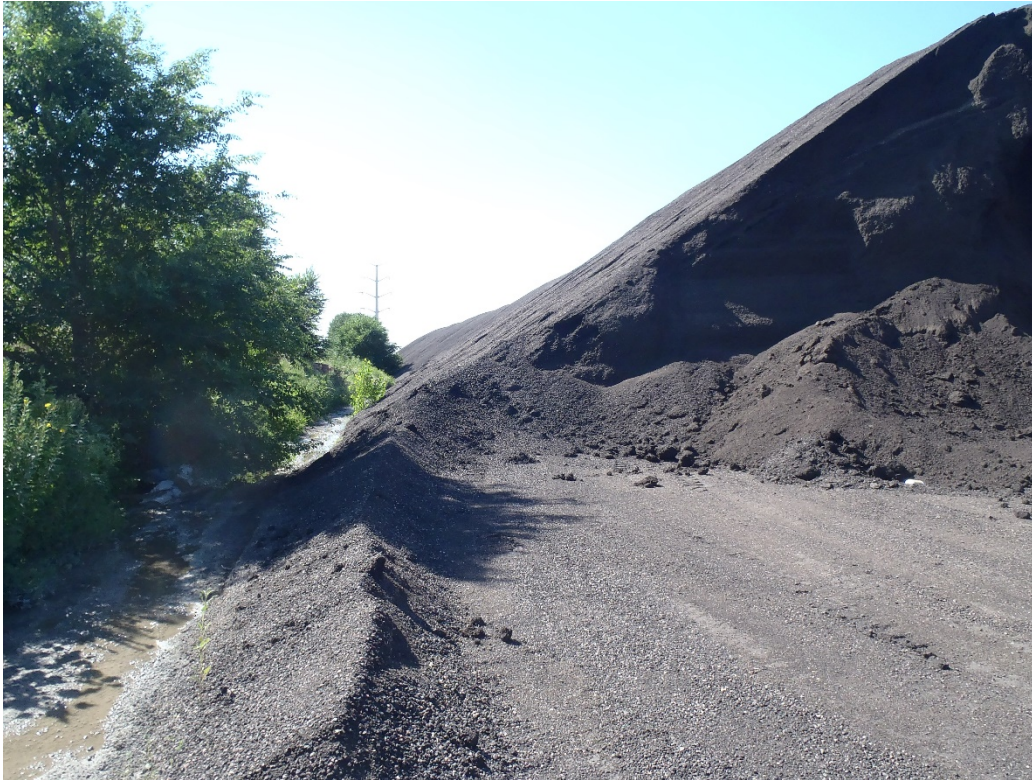
Storm Water MGT Plan: No oil or fuel spills observed. A file review indicates sediment ponds were present prior to the permit being issued as the site was being used for stockpile storage. Stormwater is routed around the area on the east side (see **Photo 4**)

Photo 4. Stormwater diversion on east side (looking SE).
