**MINERALS PROGRAM INSPECTION REPORT**  
**PHONE: (303) 866-3567**

| <b>MINE NAME:</b><br>Dewitt Excavating | <b>MINE/PROSPECTING ID#:</b><br>M-1983-132 | <b>MINERAL:</b><br>Sand | <b>COUNTY:</b><br>Prowers |
| <b>INSPECTION TYPE:</b><br>Monitoring | <b>INSPECTOR(S):</b><br>Amy Eschberger | <b>INSP. DATE:</b><br>September 12, 2019 | <b>INSP. TIME:</b><br>10:00 |

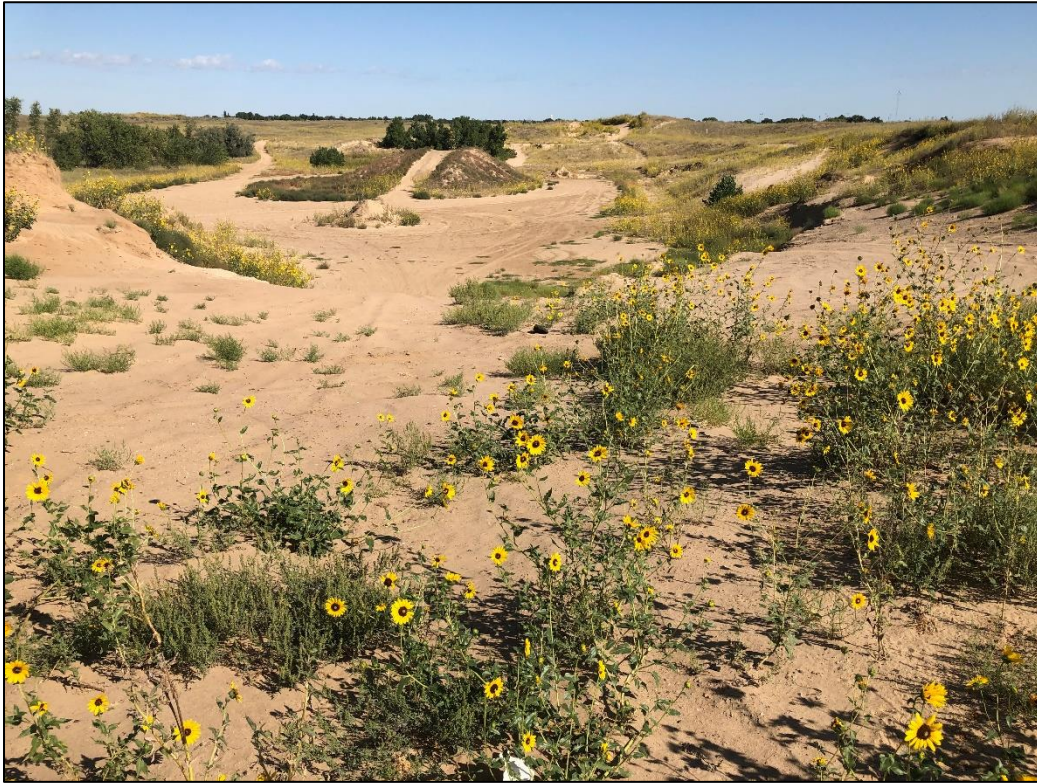
**Photo 1.** View looking north across pit area from its southern edge. Note large material stockpile stored on pit floor (with dirt bike trail across its middle).

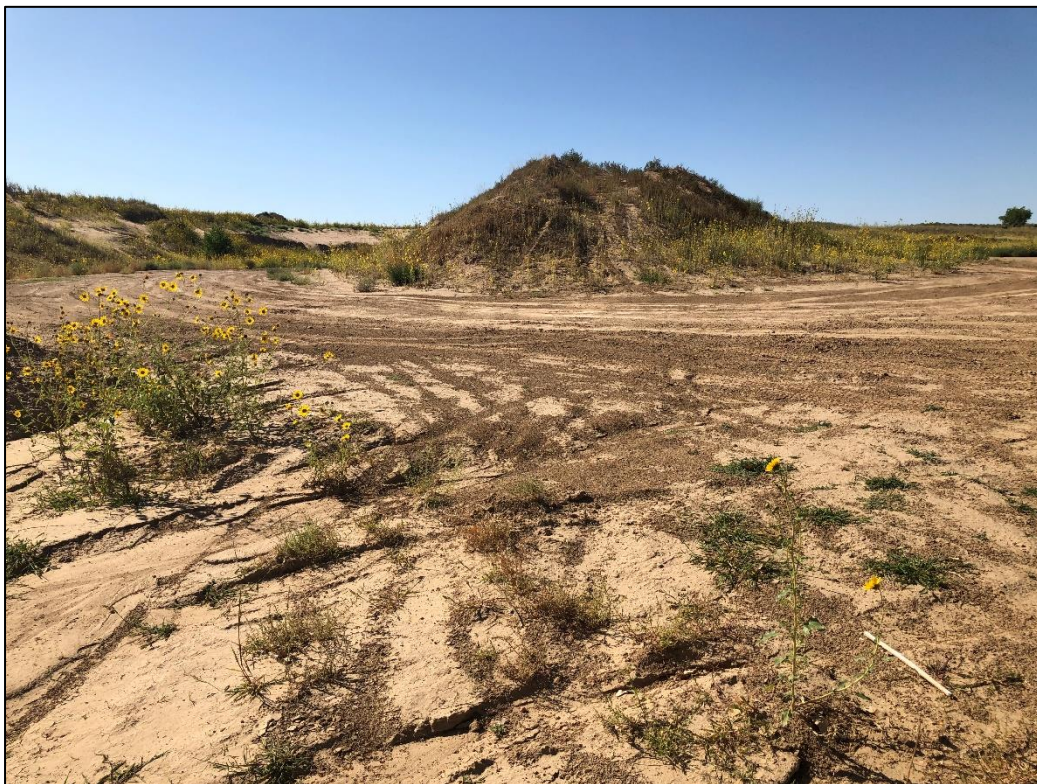
**Photo 2.** View looking south across pit area, showing large material stockpile stored on pit floor.

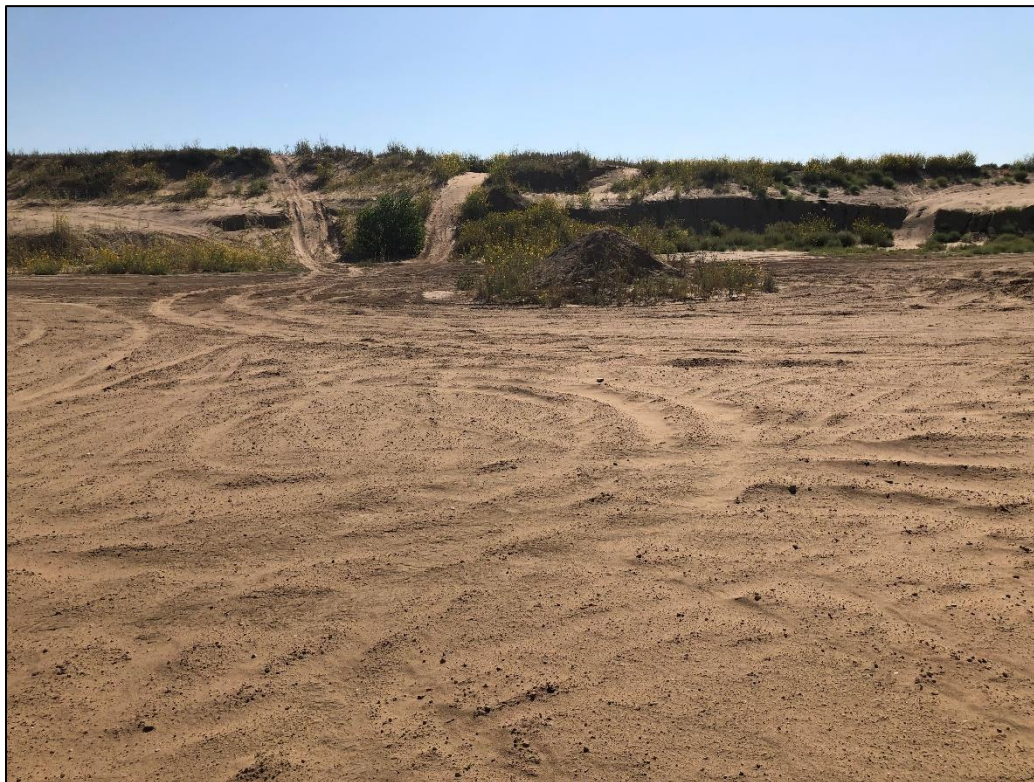
**Photo 3.** View looking east across pit area, showing small material stockpile stored on pit floor and eastern pit wall (in background) with dirt bike trails across its slope.

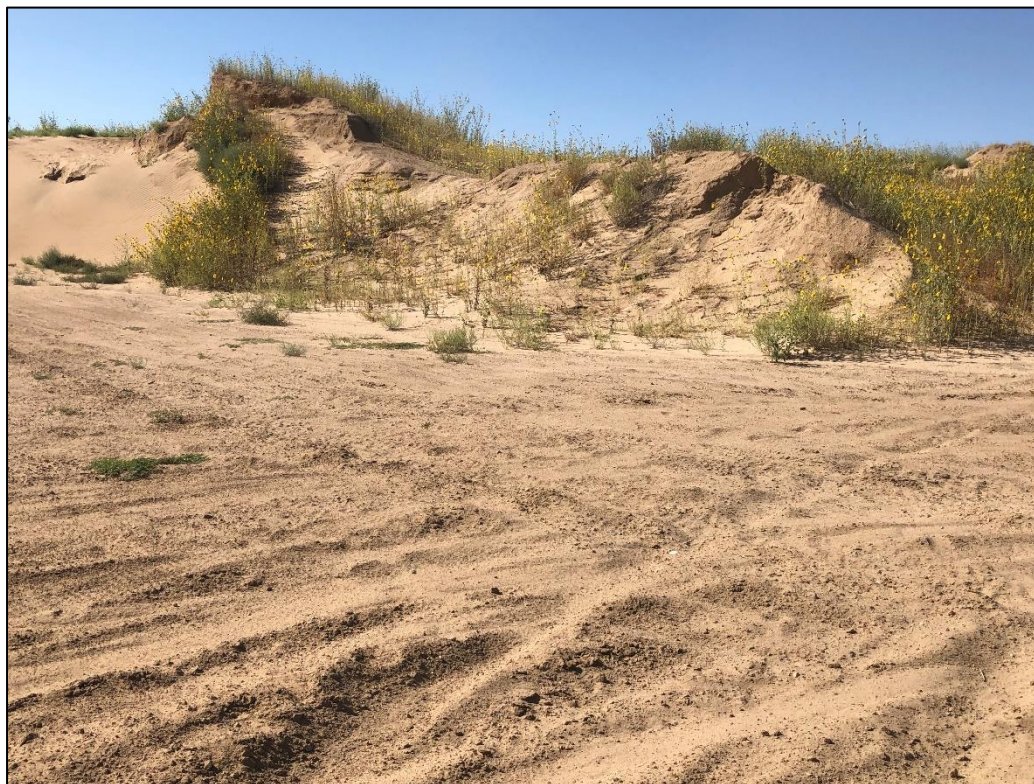
**Photo 4.** View looking north at southern pit wall.

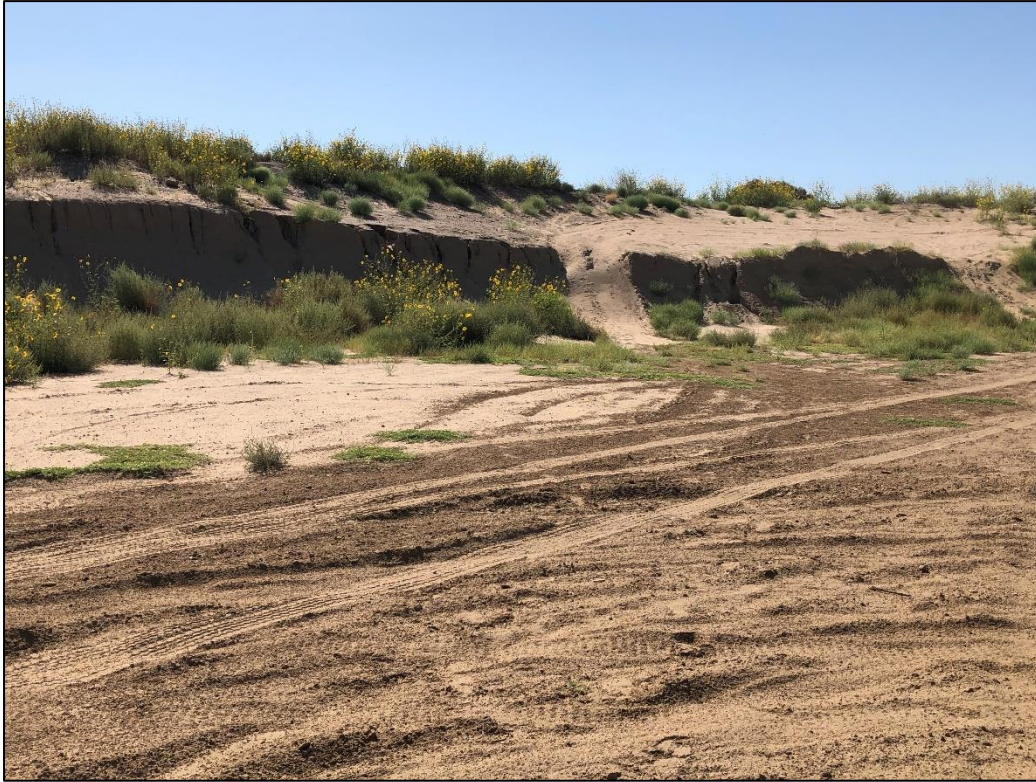
**Photo 5.** View looking east at eastern pit wall with dirt bike trails across its slope.

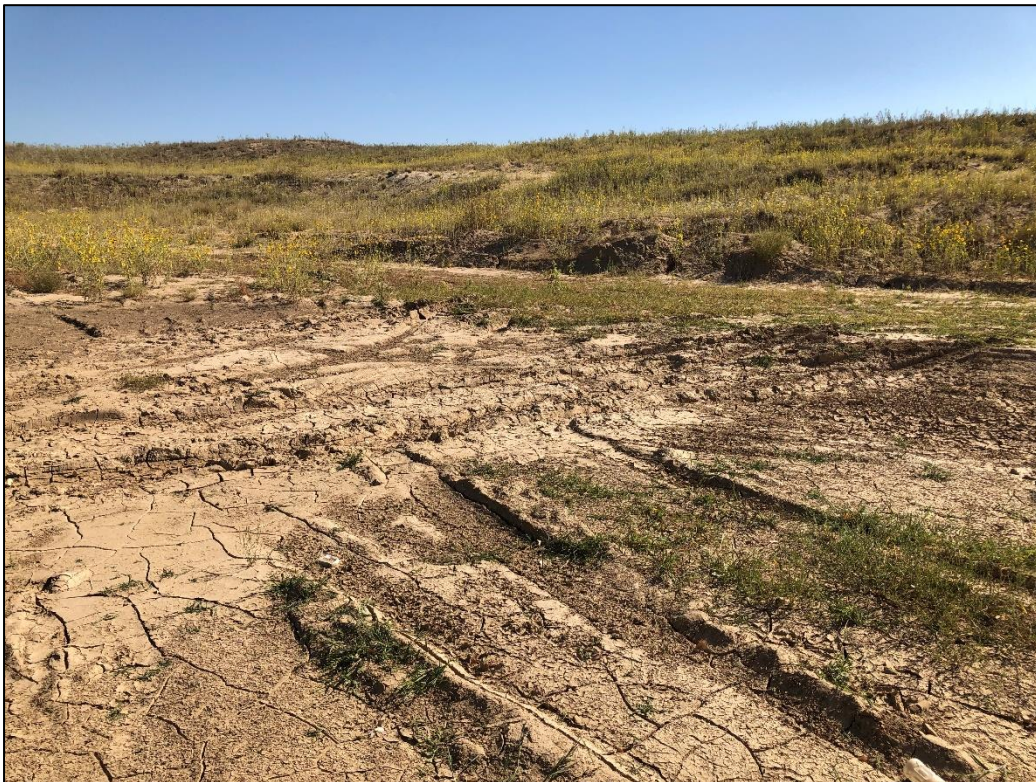
**Photo 6.** View looking north at northeastern pit wall, which has more vegetative cover consisting primarily of annual weeds (e.g., kochia, wild sunflower).

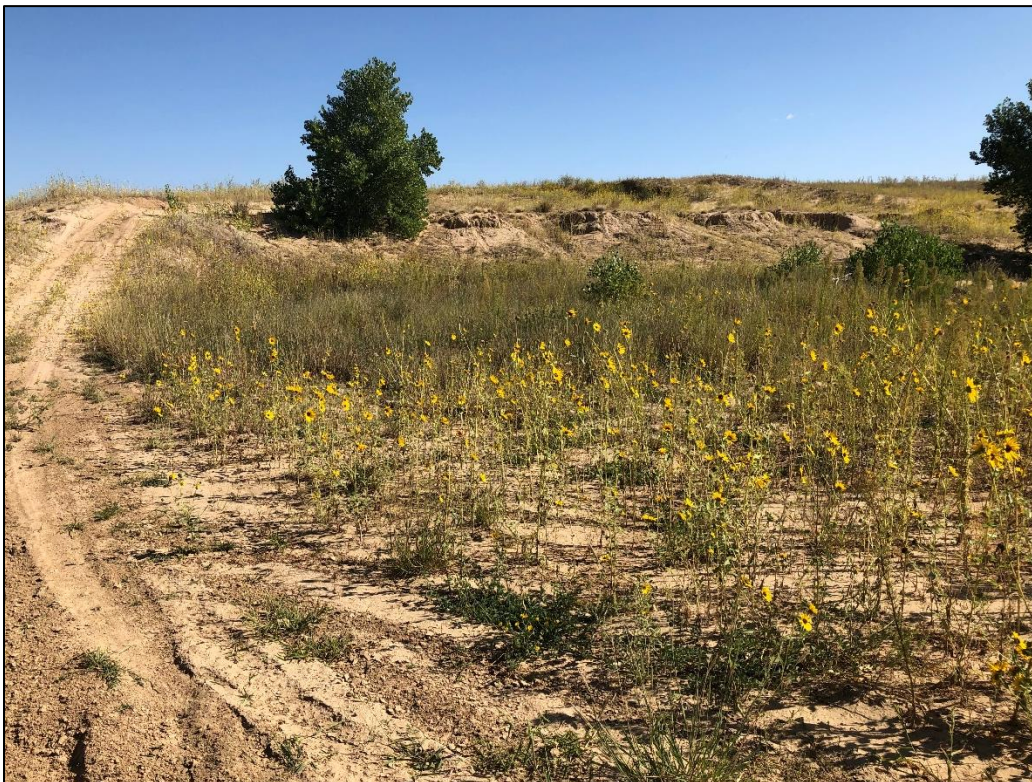
**Photo 7.** View looking north at northern pit wall. Note vegetative cover across pit area consists primarily of annual weeds (e.g., kochia, wild sunflowers) and some volunteer cottonwood trees.

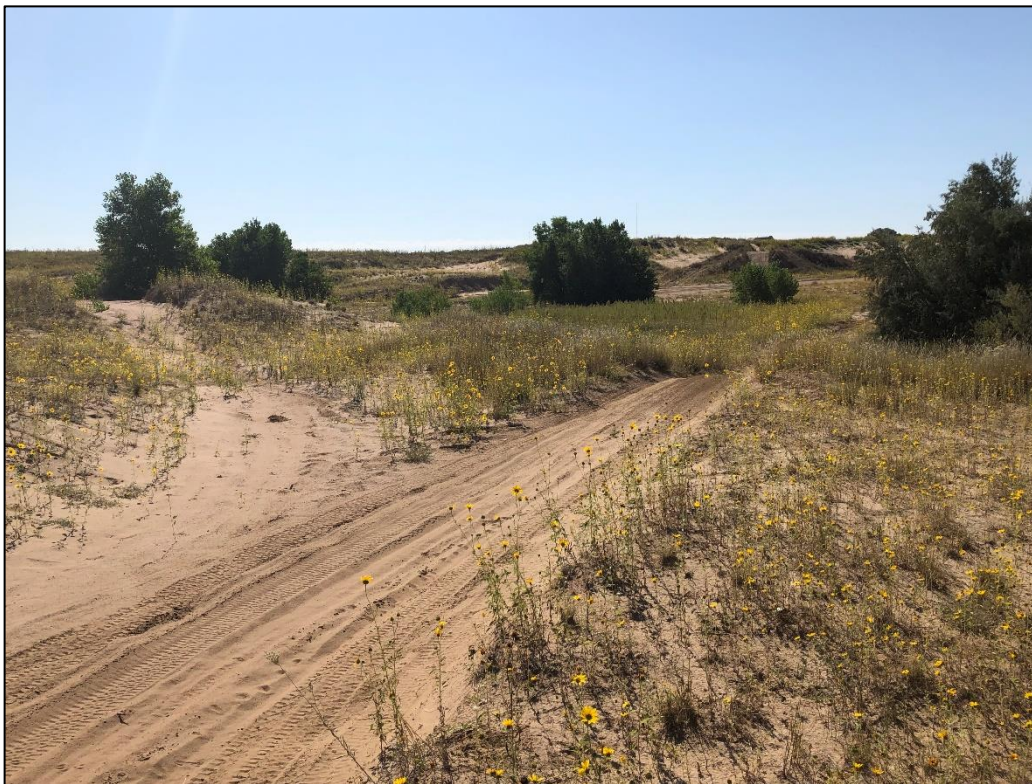
**Photo 8.** View looking south across permit area from its northern boundary. Pit area is located below (in background).

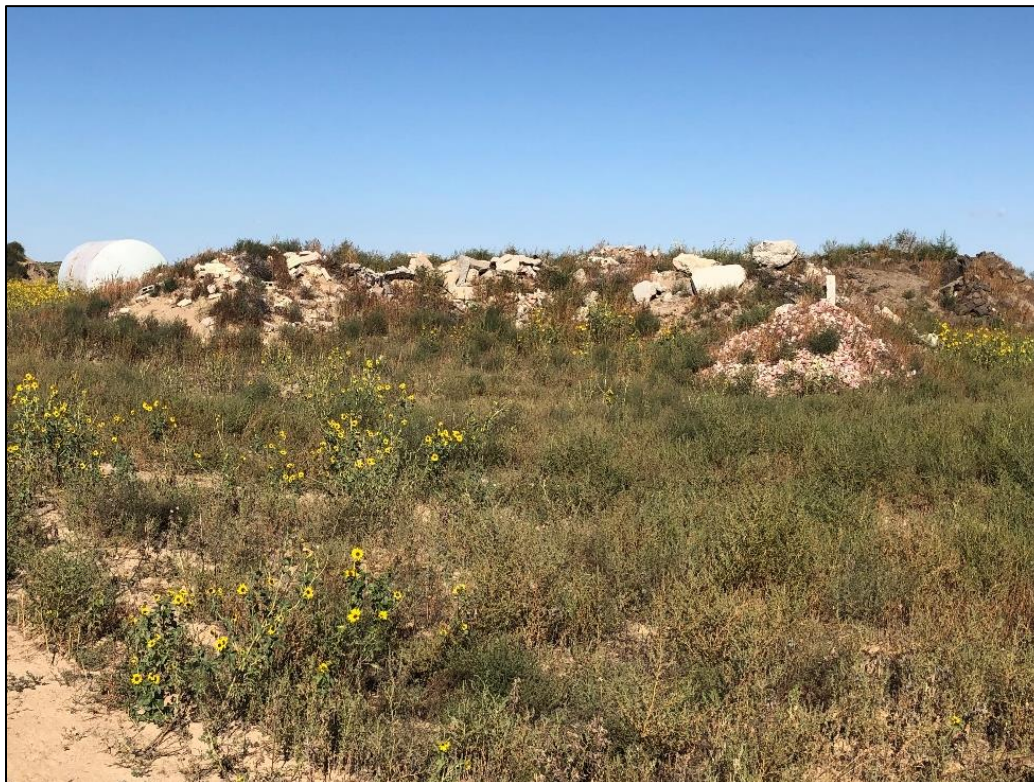
During the inspection, the Division observed an area located directly southeast of the permit area in which the operator is storing concrete rubble, asphalt rubble, slash piles, dirt piles, and old (empty) storage tanks. The Division estimates this storage area to cover approximately 5.75 acres. The Division found documentation in the permit file (November 30, 1993 inspection report) indicating these materials had been initially stored within the permit area, and the Division required the operator to either remove them from the permit area, or to revise the approved mining and reclamation plans to account for the temporary or permanent storage of these materials within the permit area. The Division also informed the operator if the materials were not removed from the permit area in a timely fashion, the operator would need to post additional bond to cover costs of removing and/or disposing of the materials. The Division never issued a bond increase for the materials as they were removed from the permit area onto a nearby portion of the operator's property. According to the operator, these materials were brought to his property from various construction jobs that were completed off site and they are not associated with the mine site in any way. Because this area is located directly adjacent to the permit area, it could potentially be interpreted as affected lands as described by Rule 1.1(3). Therefore, the operator should be careful not to utilize this offsite storage area in any way for the mining operation, including storing material mined from the pit, storing material to be used for reclamation of the pit, using the area for mine operation parking, equipment storage, or any other use associated with the mining operation.

**Photo 9.** View looking north at off-site storage area located directly southeast of permit area, showing concrete rubble and dirt stockpiles stored in this area.

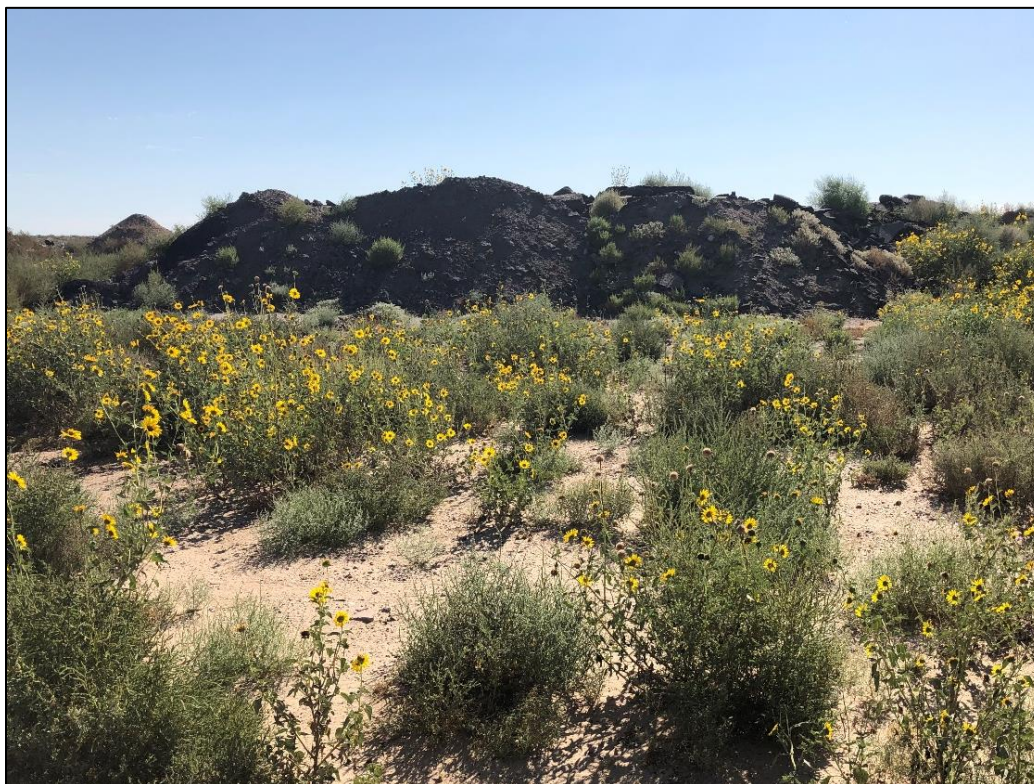
**Photo 10.** View looking south across off-site storage area located directly southeast of permit area, showing asphalt rubble stored in this area.

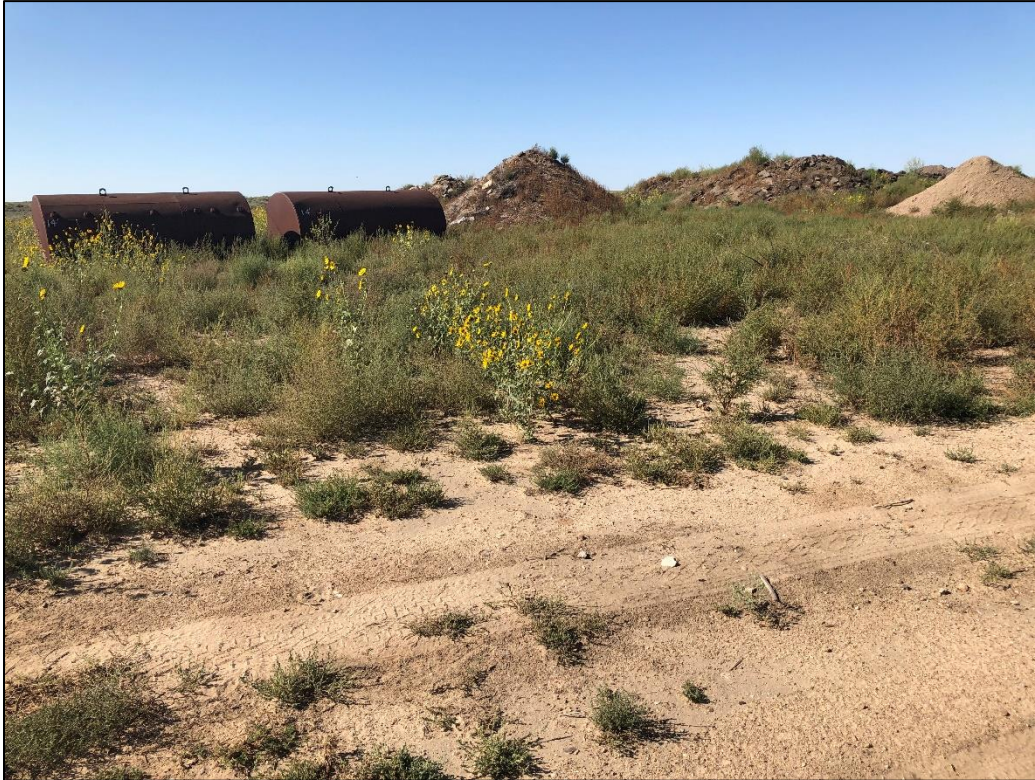
**Photo 11.** View looking south across off-site storage area located directly southeast of permit area, showing old storage tanks and dirt stockpiles stored in this area.

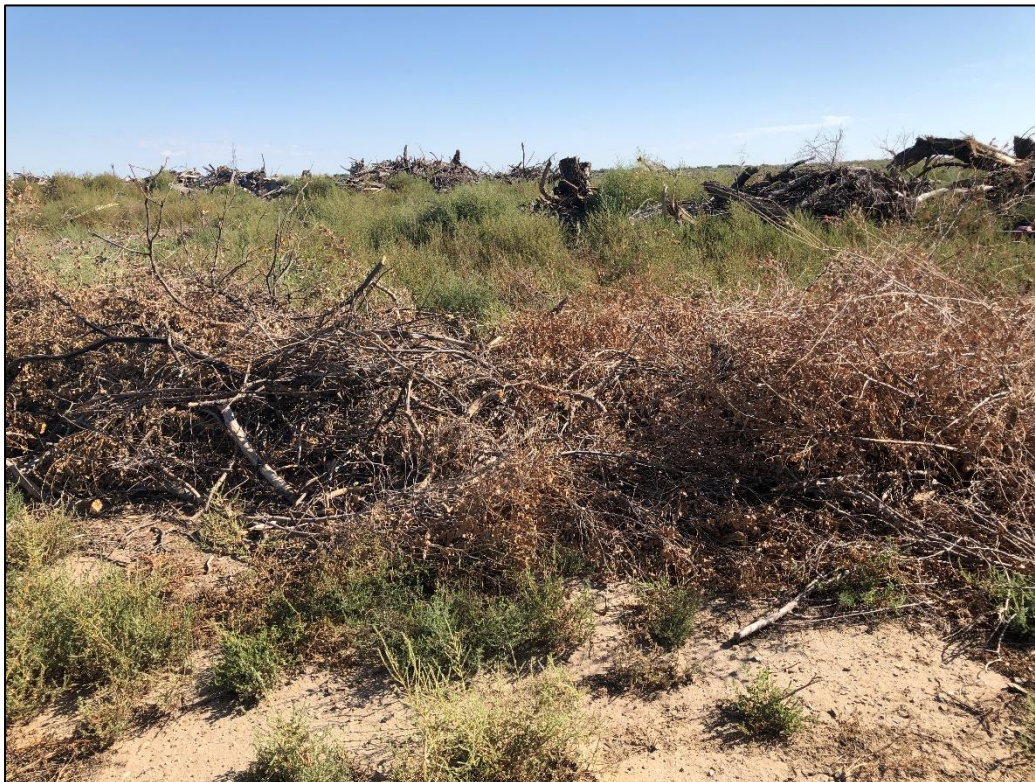
**Photo 12.** View looking north across off-site storage area located directly southeast of permit area, showing slash piles stored in this area.

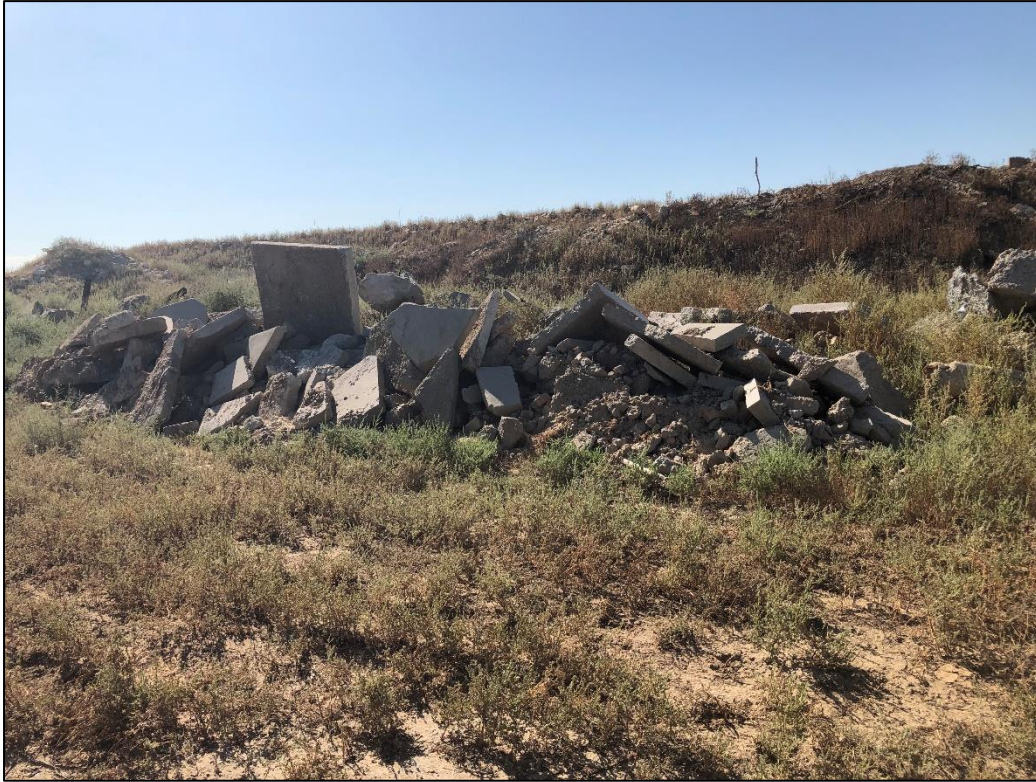
**Photo 13.** View looking southeast across off-site storage area located directly southeast of permit area, showing concrete rubble and large dirt stockpile stored in this area.

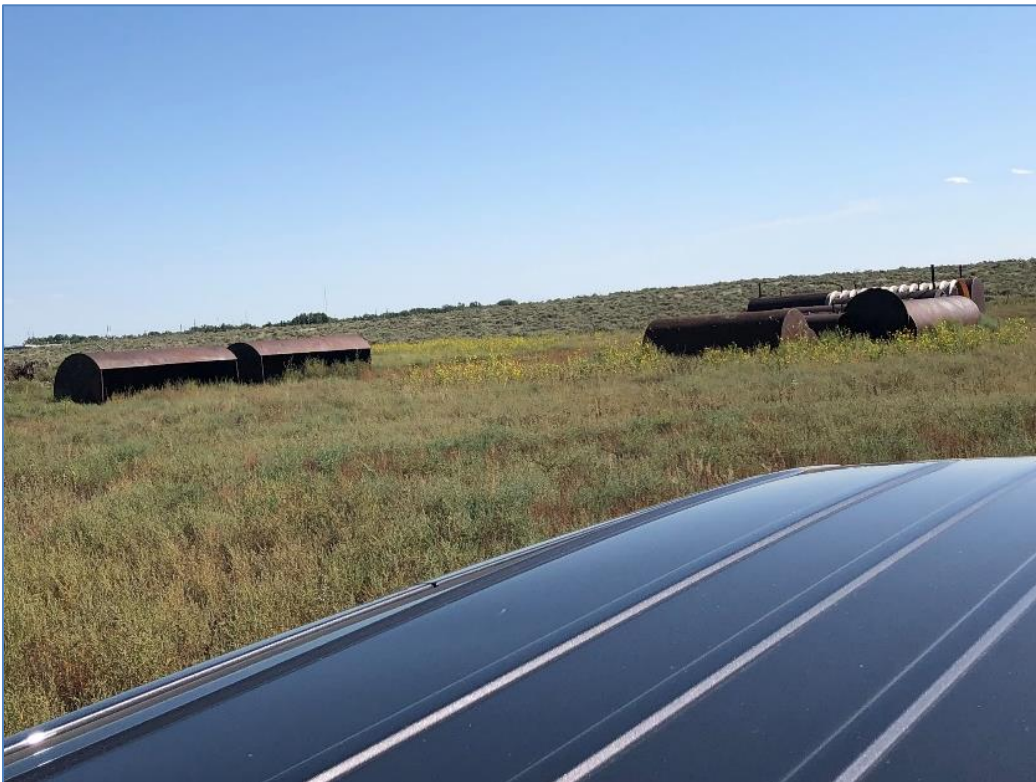
**Photo 14.** View looking northeast across off-site storage area located directly southeast of permit area, showing old (empty) storage tanks stored in this area.

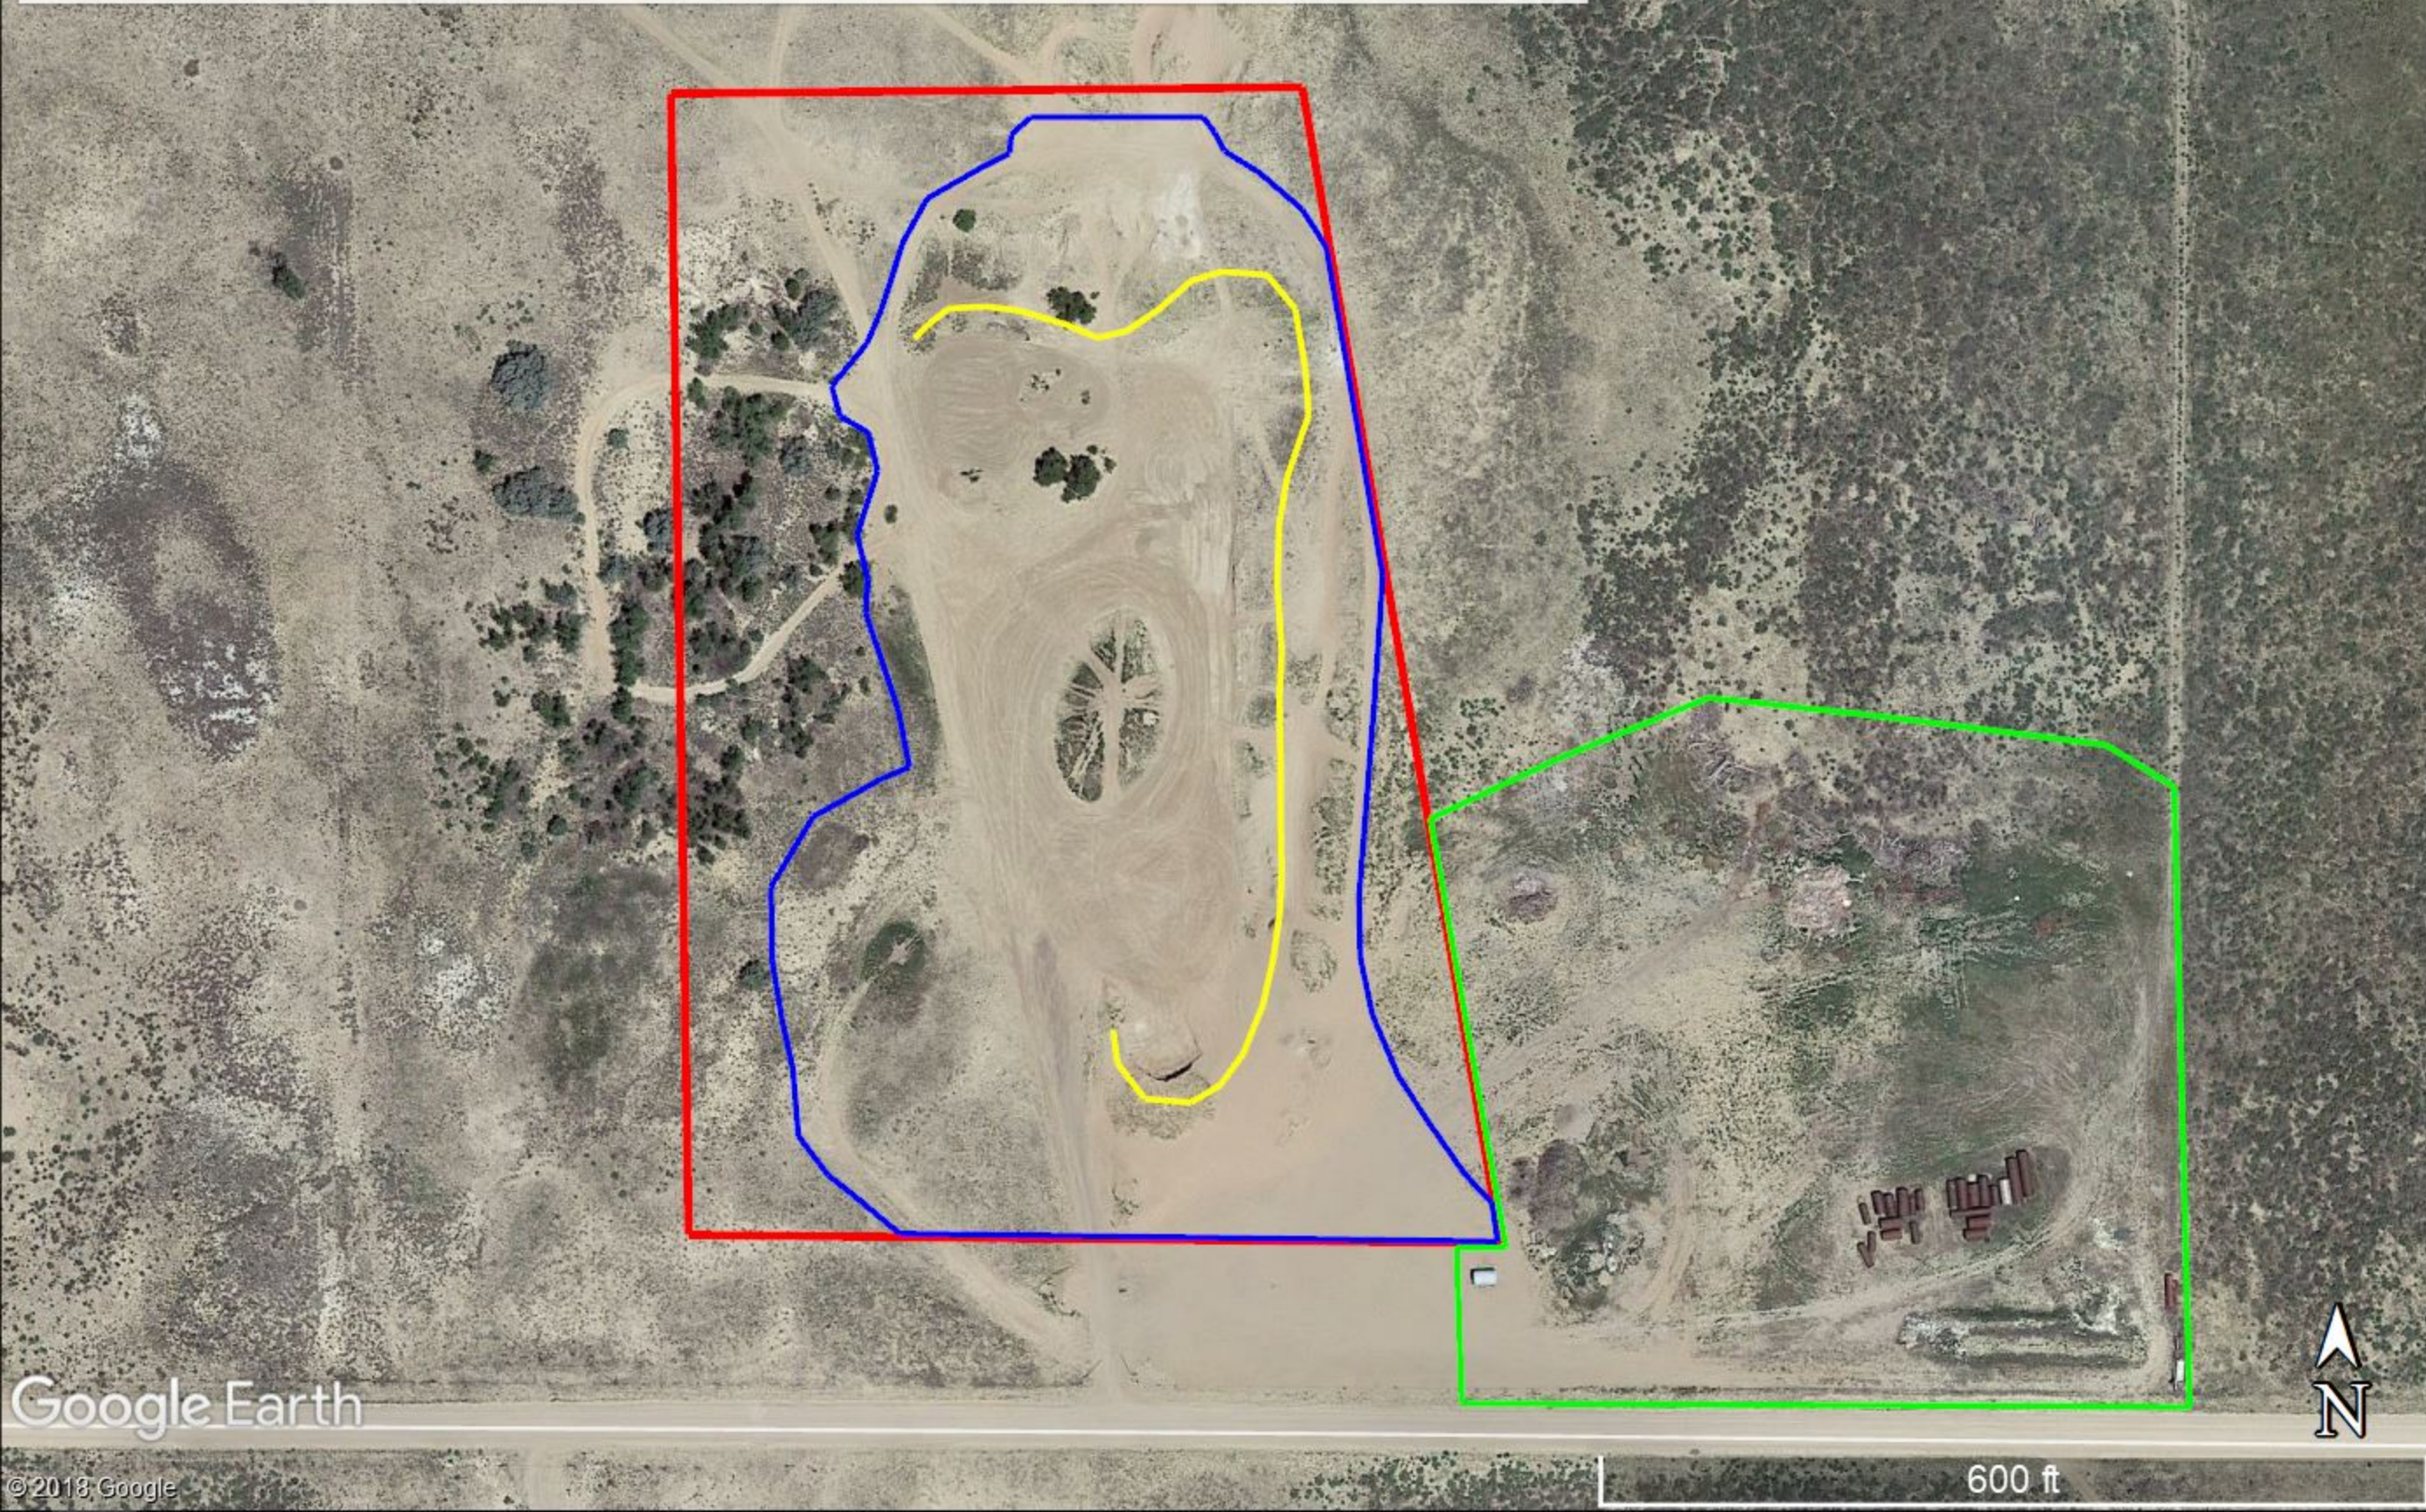
# M-1983-132 / Dewitt Excavating / Dewitt Excavating, Inc.

The Division estimates current disturbance requiring reclamation to be approximately 6.85 acres (see enclosed Google Earth image of site). It appears the pit has almost been mined out given its proximity to the northern and eastern permit boundaries. The Division recommends the operator be very careful during mining and reclamation activities to not disturb land outside these boundaries. Previously (on June 9, 2003), the operator requested a partial release of the permit area (Revision No. AR-1) and to expand the permit area to the north and east. The Division notified the operator (on June 10, 2003) of deficiencies in the partial release request that needed to be addressed before it could be considered filed for review. The Division also informed the operator the permit area could be expanded in one of two ways: 1) Obtain approval of a partial release, then submit an

Blue Outline = 6.85 acres = Disturbed Area (as of 9/12/2019 inspection)

Yellow Line = 1,000 feet = Approximate Length of Highwall

Green Outline = 5.75 acres = Operator's Adjacent Storage Area
