MINERALS PROGRAM INSPECTION REPORT
PHONE: (303) 866-3567

MINE NAME: Pitch Project	MINE/PROSPECTING ID#: M-1977-004	MINERAL: Uranium	COUNTY: Saguache
INSPECTION TYPE: Monitoring	INSPECTOR(S): Dustin Czapla	INSP. DATE: September 30, 2019	INSP. TIME: 12:00
OPERATOR: Homestake Mining Company	OPERATOR REPRESENTATIVE: David Wykoff	TYPE OF OPERATION: 112d-3 - Designated Mining Operation	
REASON FOR INSPECTION: Normal I&E Program	BOND CALCULATION TYPE: None	BOND AMOUNT: \$2,263,000.00	
DATE OF COMPLAINT: NA	POST INSP. CONTACTS: None	JOINT INSP. AGENCY: None	
WEATHER: Clear	INSPECTOR'S SIGNATURE:

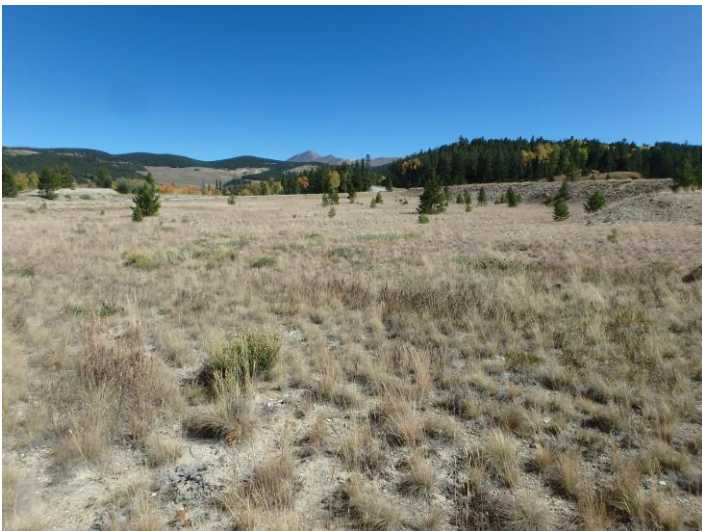
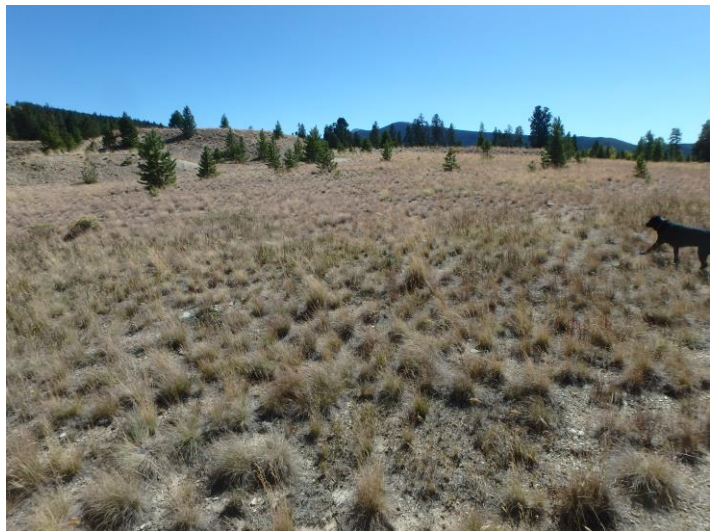
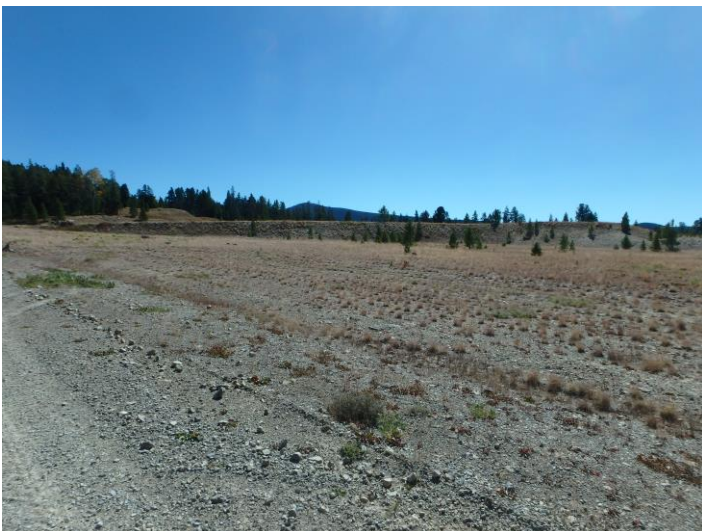
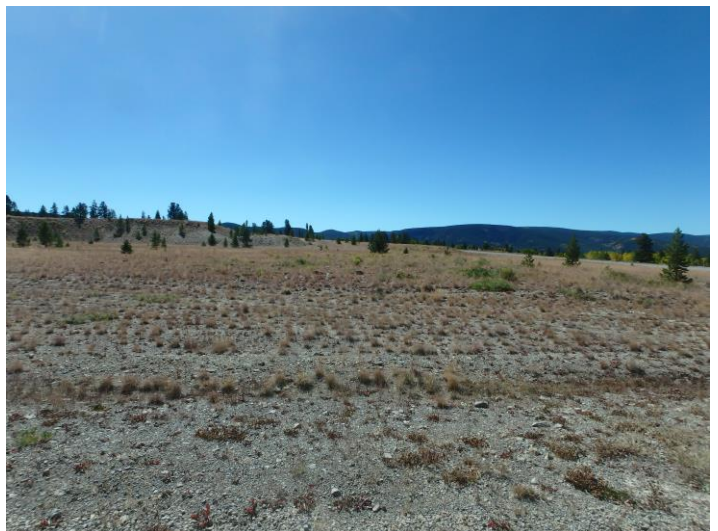
Mill Site: Final reclamation grading has been completed in the mill site area. The area has been seeded and vegetation is well established.

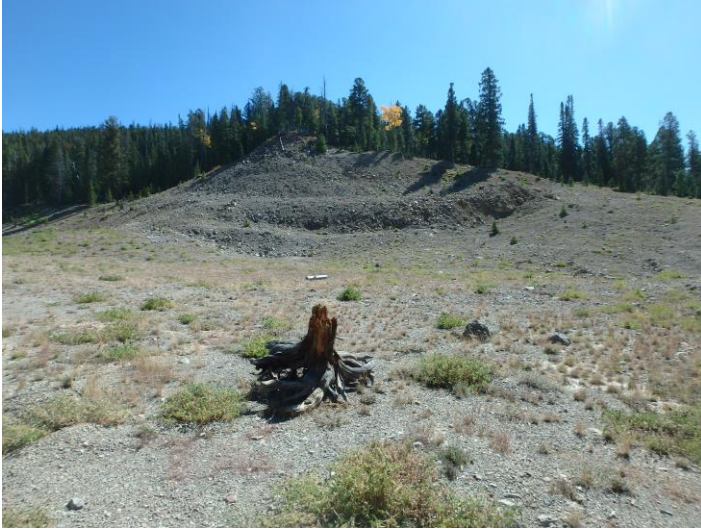
Limestone Quarry: The limestone quarry slopes appear stable. Reclamation has not occurred in this area yet. Slope reduction, topsoil replacement and revegetation will be required in this area for final reclamation.

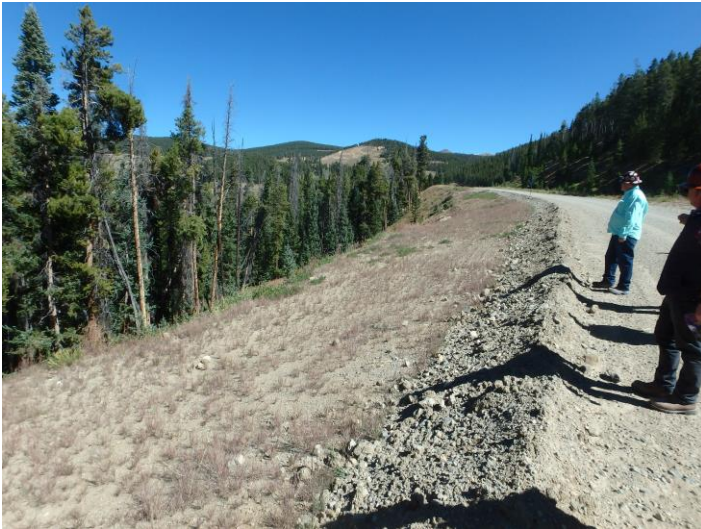
Roads: No problems were noted with any of the internal roads. The roads are well maintained. The repair work completed in 2015 on the failed portion of the access road appears stable. The repair area has been seeded and vegetation is becoming well established.

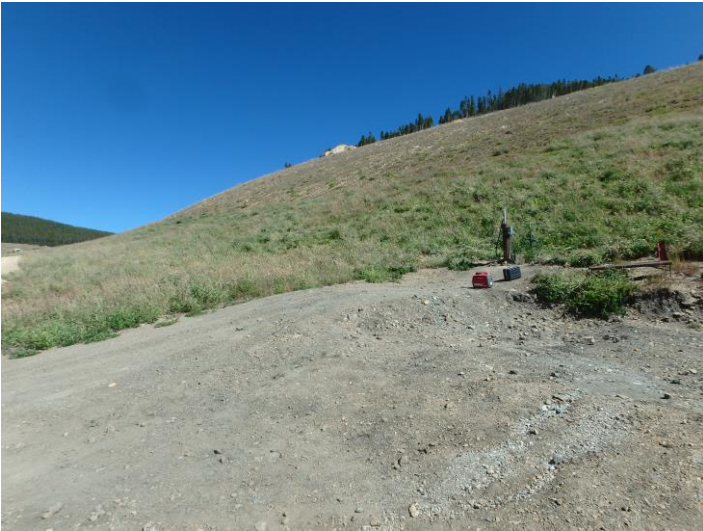
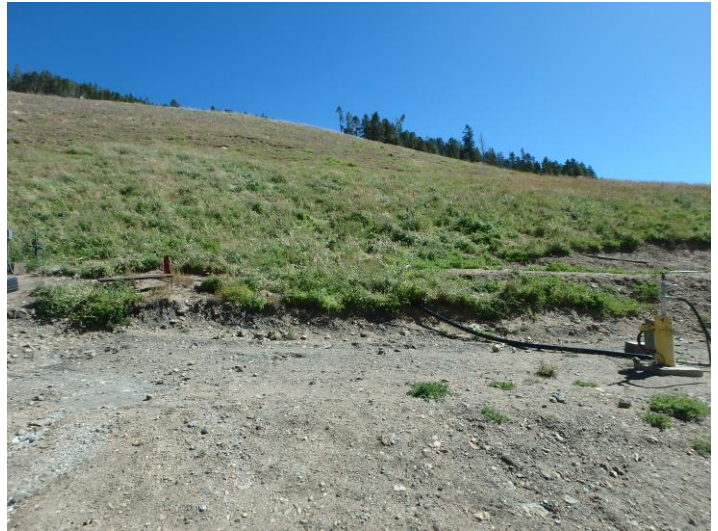
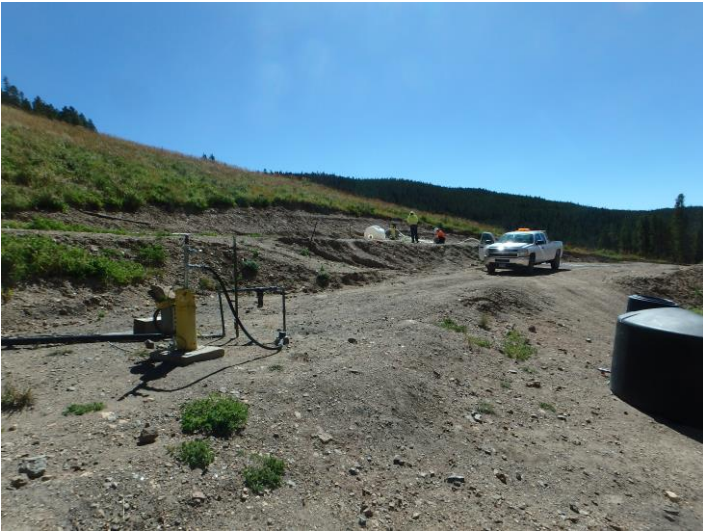
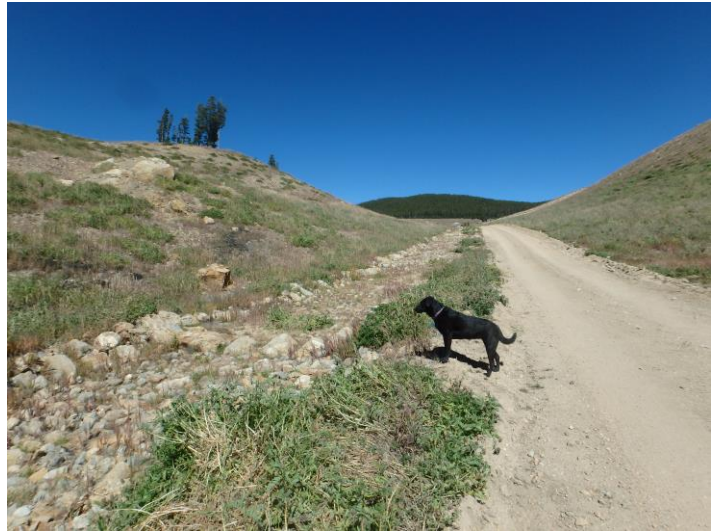
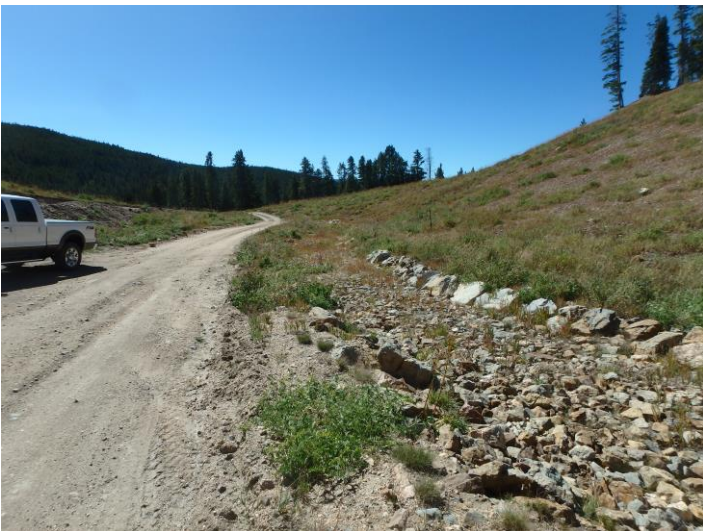
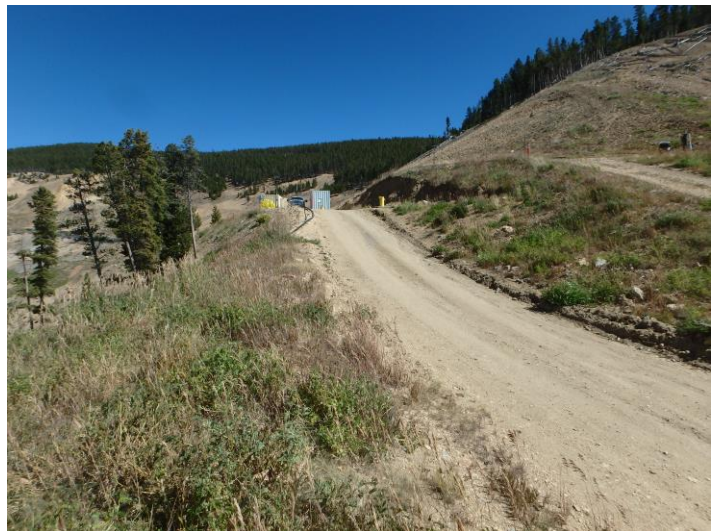
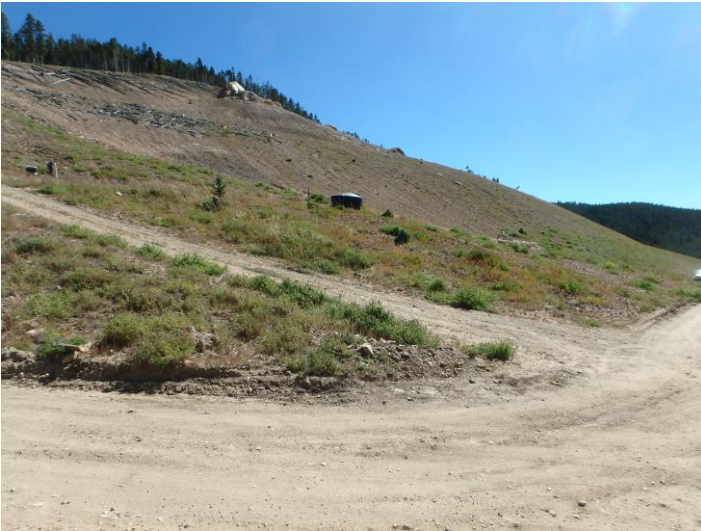
South Pit: The phosphate injection program is ongoing in this area. No problems were noted with the drill pads, wells or associated equipment. The Division's June 2017 inspection report noted an area of slope failure in the upper part of the south pit. The failure area was not inspected during this inspection. Repair work has not yet taken place on the slope. The repair work is scheduled to commence in 2020. The failure poses no risk to public safety.

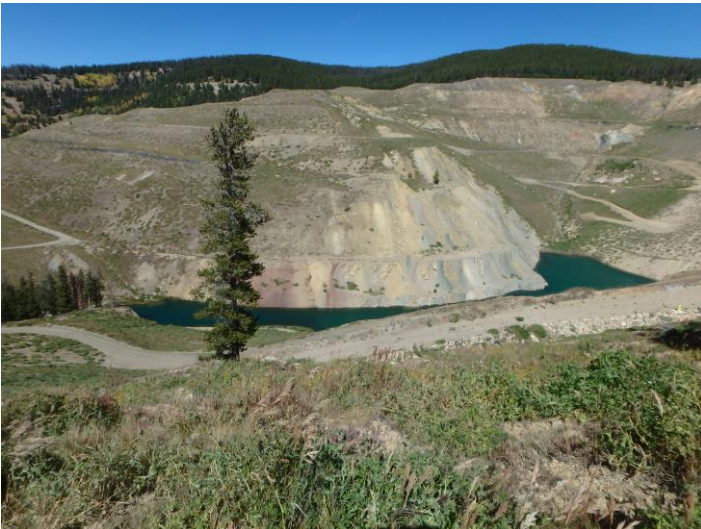
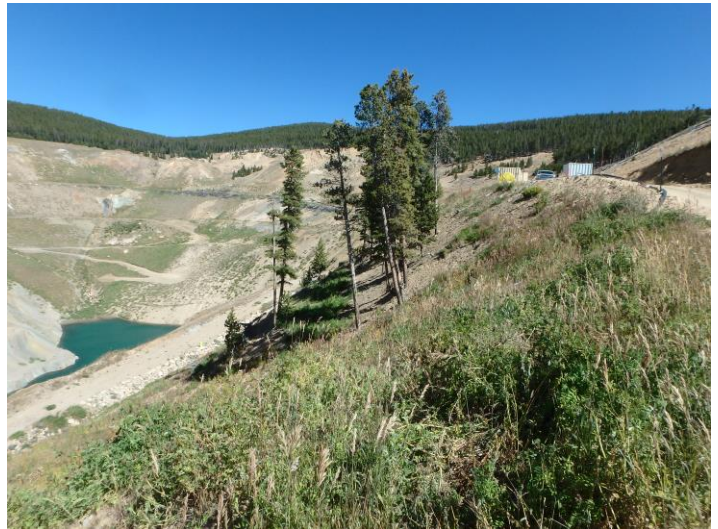
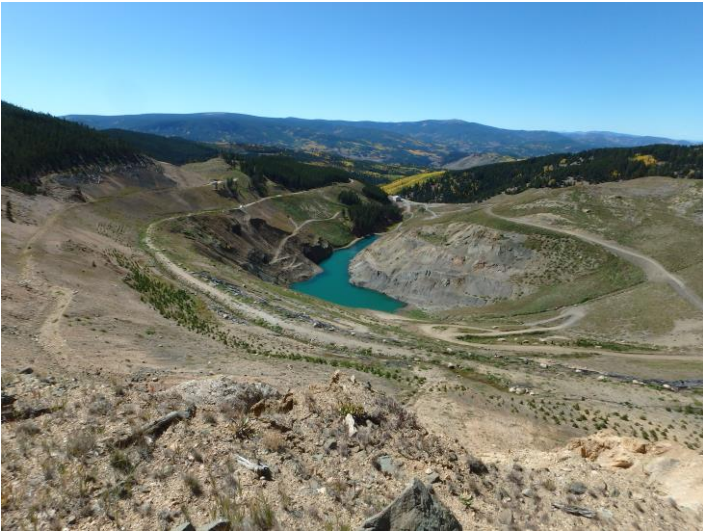
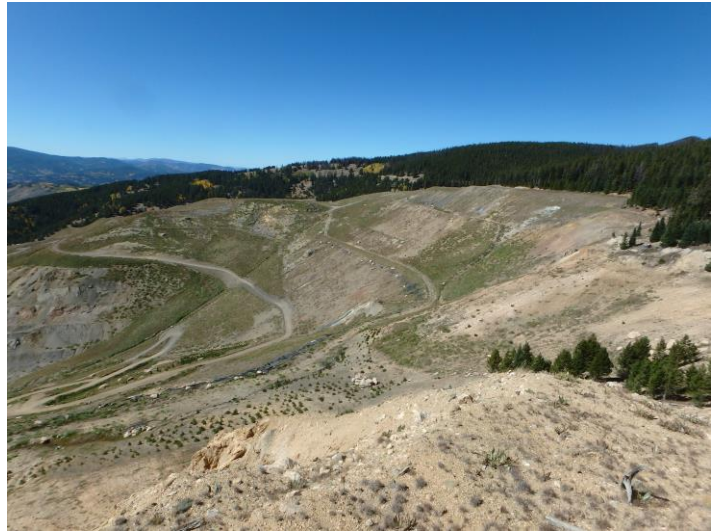
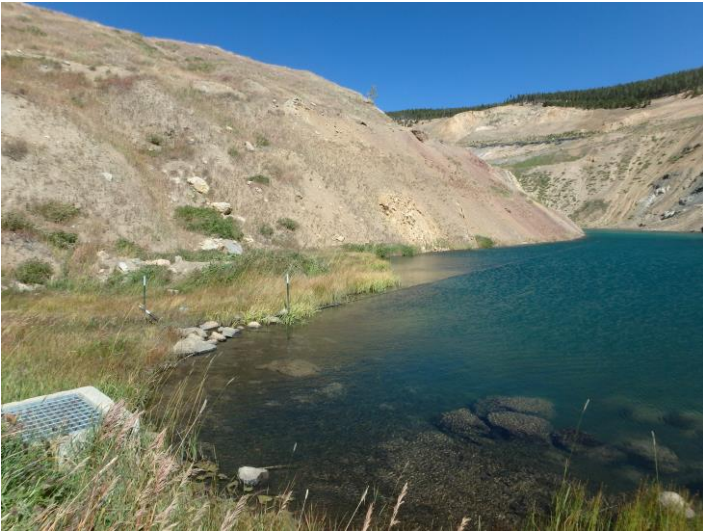
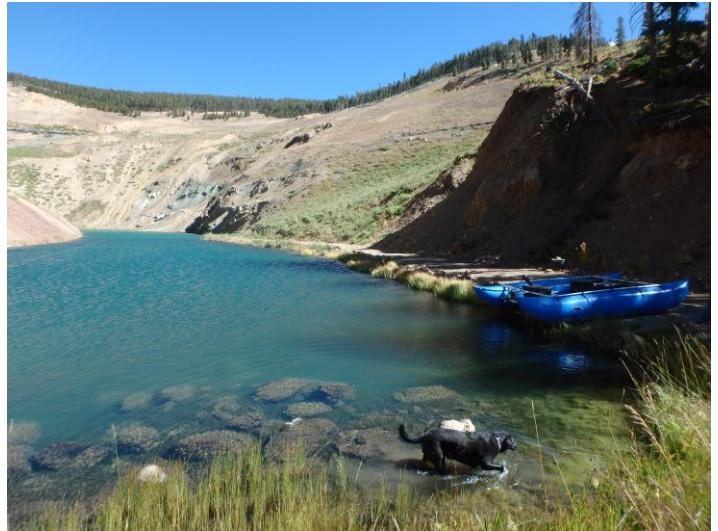
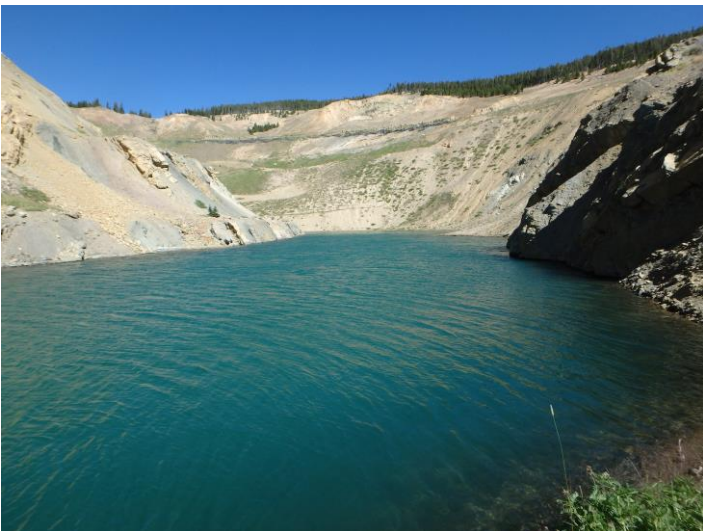
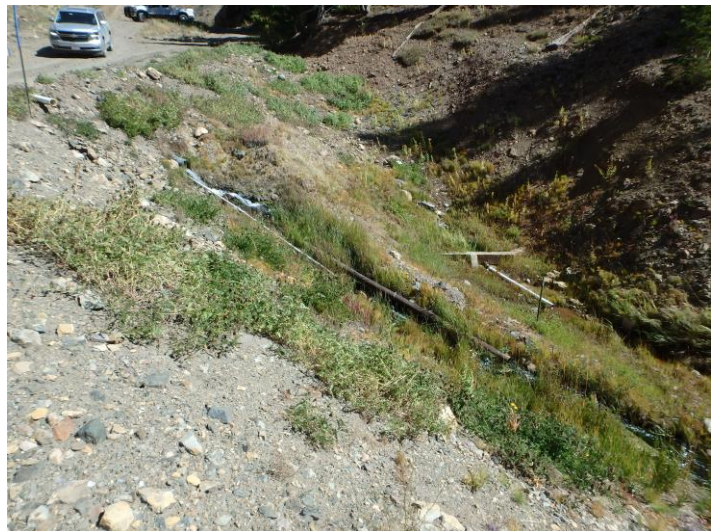
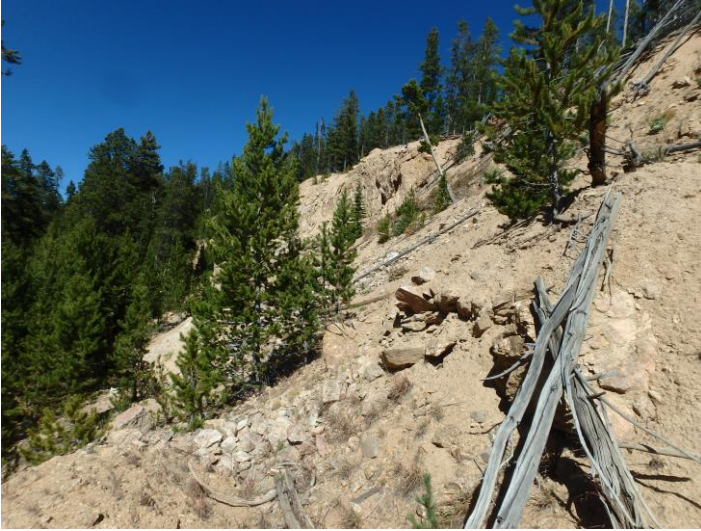
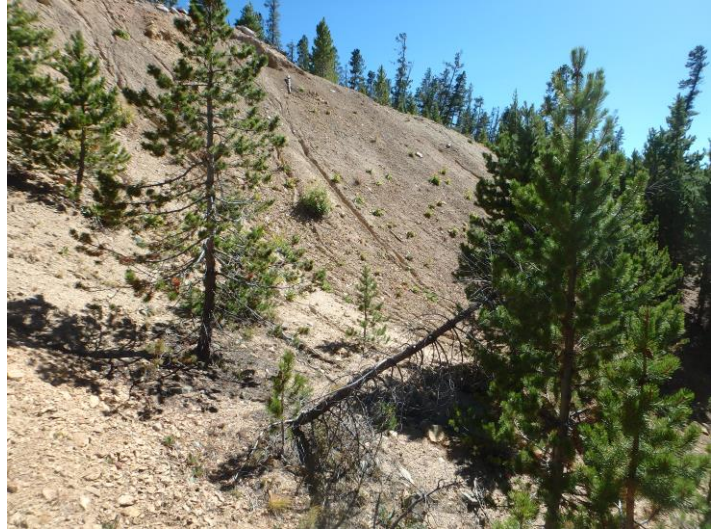
North Pit: Slope movement above the North Pit continues to be monitored. No new evidence of significant movement was observed in the area of tension cracks above the pit. A final reclamation/stabilization plan has been developed for this area. The application, AM-1, is currently under review. Efforts are ongoing to control erosion and drainage on the east wall of the north pit.

Discharge from the North Pit Lake flows through the valve and culvert as designed. The Pinnacle Portal continues to discharge and flow is measured through a v-notch weir. The discharge reports to a marsh area above the facilities shop building.

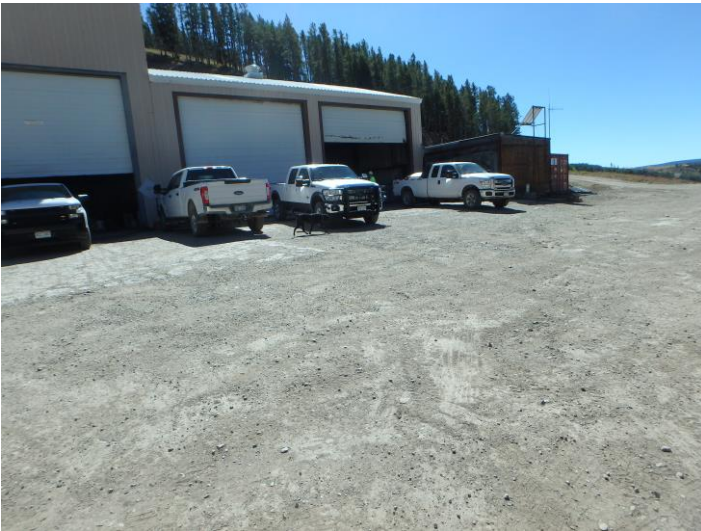
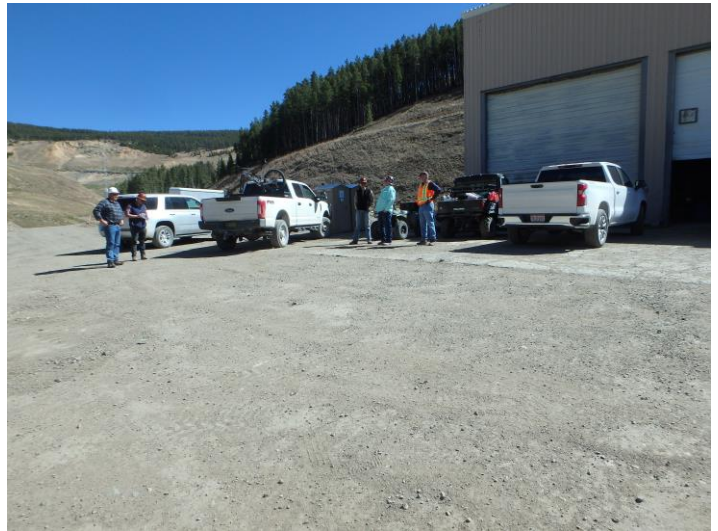
Shop Area: No problems were noted in the shop area. The area is well maintained.

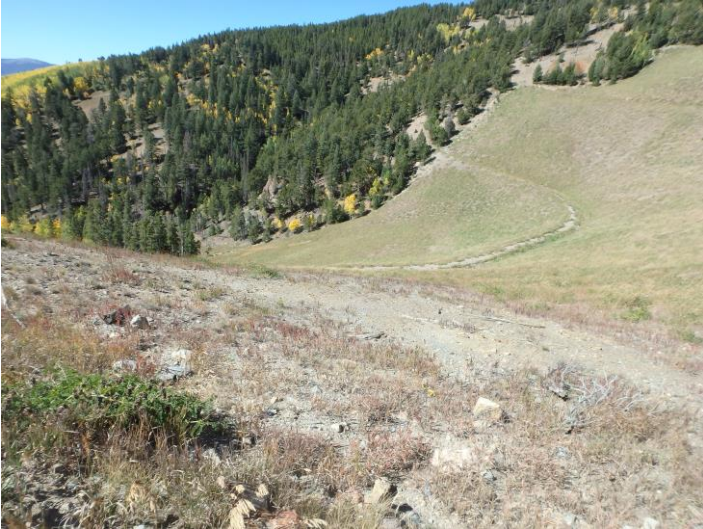
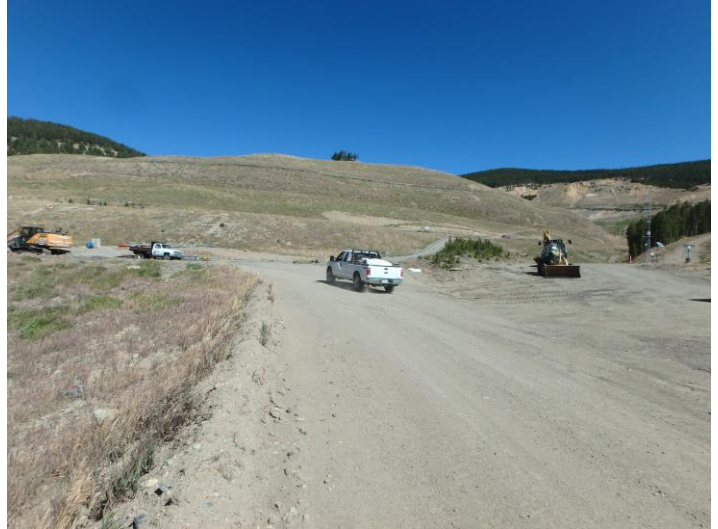
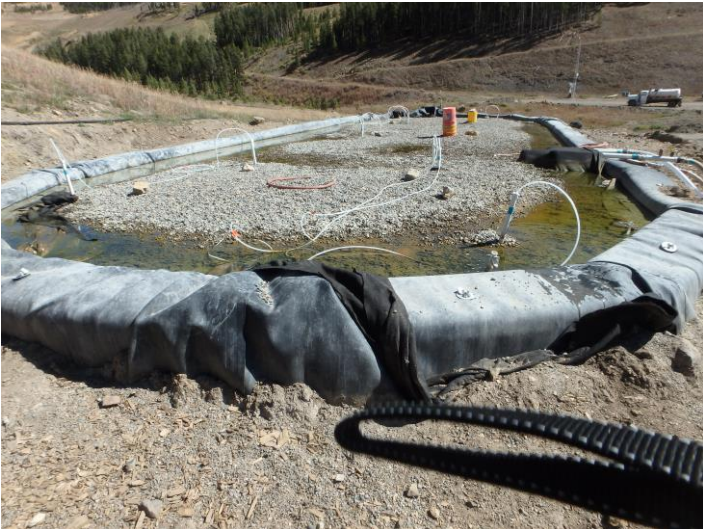
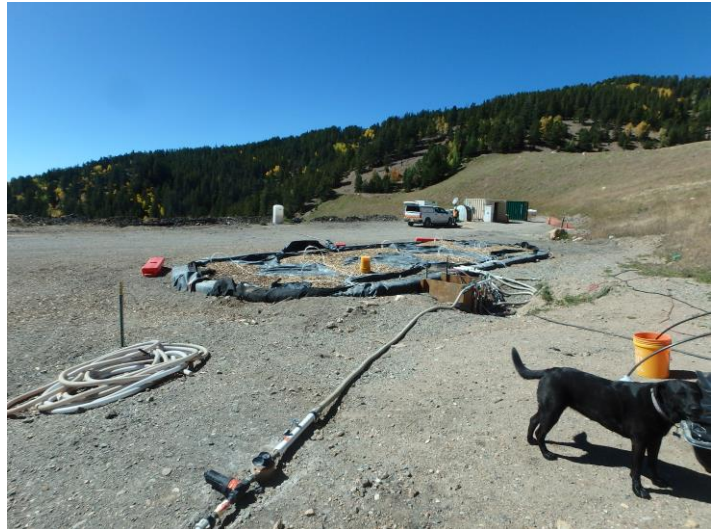
Indian Rock Dump: Slopes appear stable and vegetation is becoming well established on the reclaimed slopes. No significant erosional features were noted. The phosphate injection program is ongoing in this area. Test cells are located on the bench above the rock dump. No problems were noted in this area.

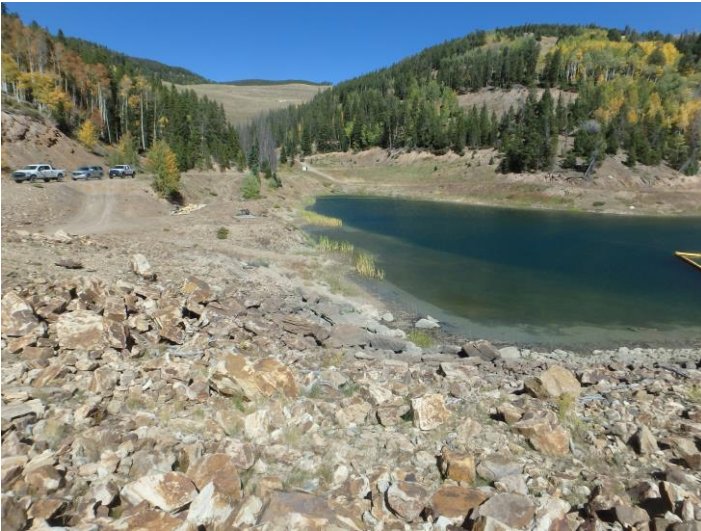
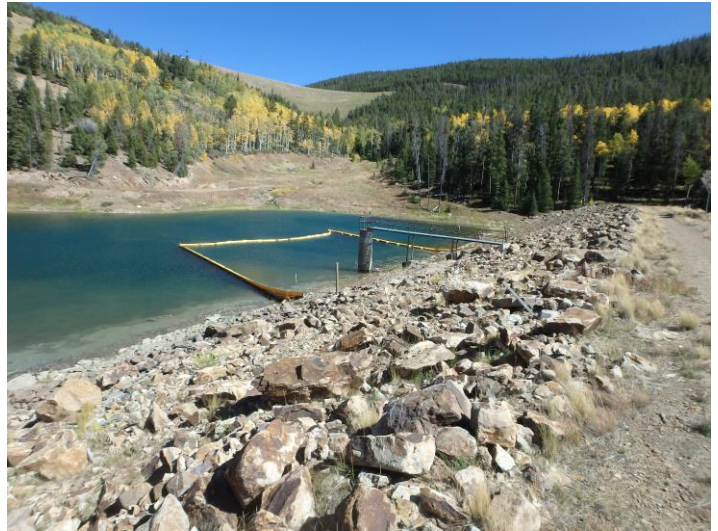
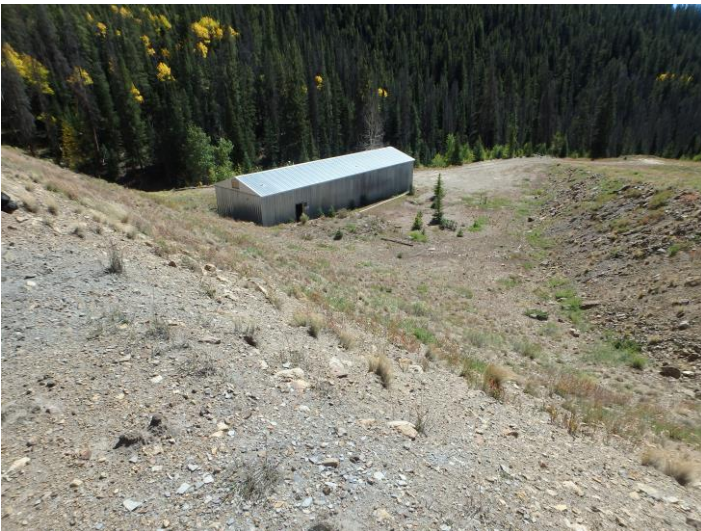
Sediment Pond: The sediment pond appears functional and the pond slopes appear stable. Surface filter booms placed at the upper and lower ends of the pond are maintained and appear in good working order. No seepage or stability concerns were noted around the dam. The spill way channel appears to be maintained and in good working order. The treatment building at the base of the dam is scheduled for removal in 2020.

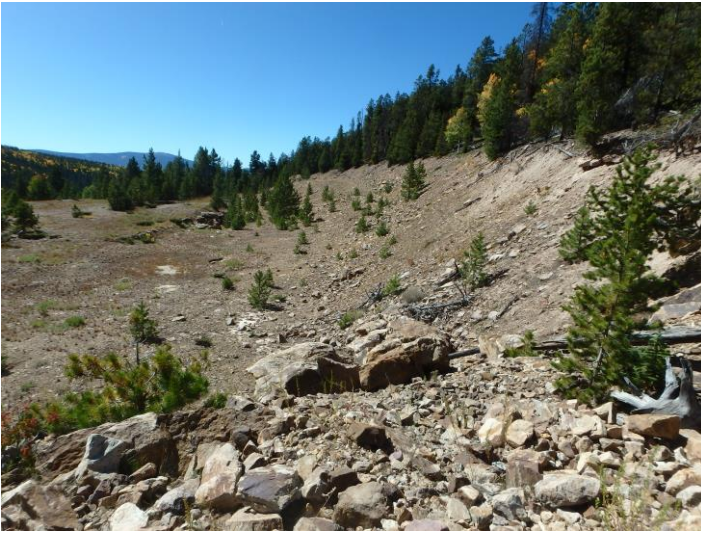
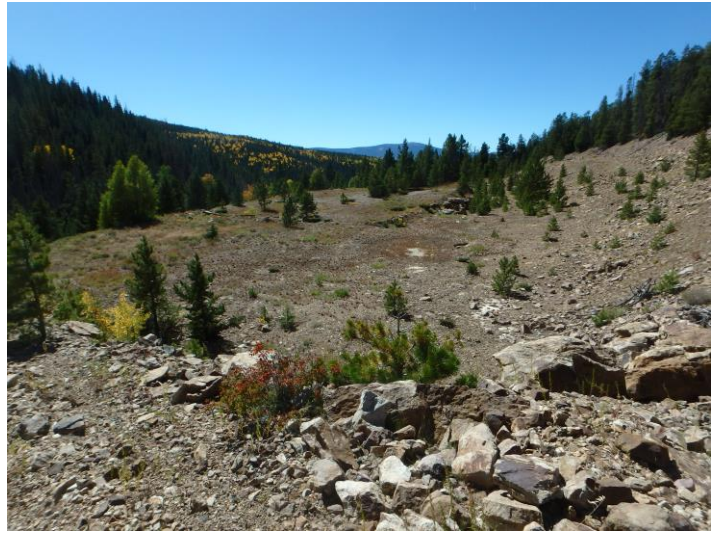
Sandstone Quarry: The sandstone quarry area is in final reclamation. The area has been regraded and reseeded. Vegetation is well established over most of the area. There is a small portion of the slope at the northeast end of the quarry that will require some “touch up” grading, topsoil replacement and reseeded in order to establish a vegetative cover.
