MINERALS PROGRAM INSPECTION REPORT
PHONE: (303) 866-3567

MINE NAME: Funk & Hooker Pit	MINE/PROSPECTING ID#: M-1979-058	MINERAL: Sand and gravel	COUNTY: Routt
INSPECTION TYPE: Monitoring	INSPECTOR(S): Peter Hays	INSP. DATE: October 8, 2019	INSP. TIME: 13:00
OPERATOR: Routt County	OPERATOR REPRESENTATIVE: Mike Mordi	TYPE OF OPERATION: 112c - Construction Regular Operation	
REASON FOR INSPECTION: Normal I&E Program	BOND CALCULATION TYPE: None	BOND AMOUNT: No Bond Held	
DATE OF COMPLAINT: NA	POST INSP. CONTACTS: None	JOINT INSP. AGENCY: None	
WEATHER: Clear	INSPECTOR'S SIGNATURE:

October 8, 2019 Inspection Map

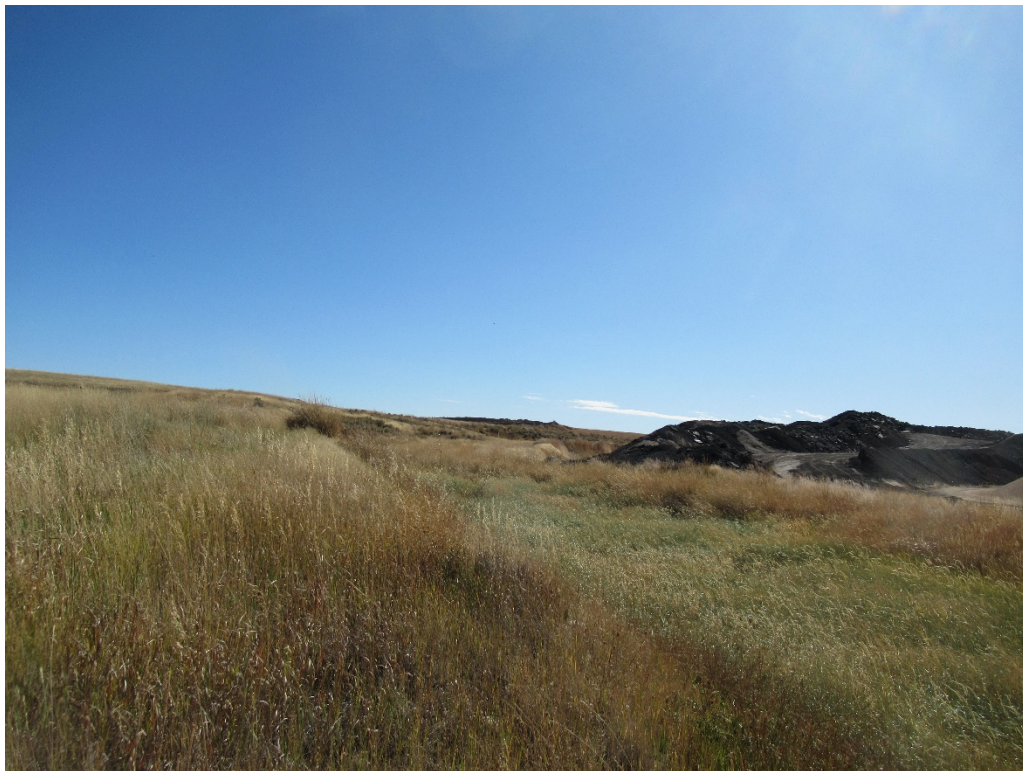
The western acreage reduction area partially overlaps the permit boundary of the adjacent Hayden Pit operated by Oldcastle SW Group, Inc. and includes an undisturbed ephemeral drainage. During the inspection, a portion of the proposed western acreage reduction area was observed to be disturbed land for a former access road between Lathe 1 and Lathe 3 on the technical revision map. The Division will require the Operator to reclaim this area or removed the area from the proposed acreage reduction area. The northern acreage reduction area contains the visual berm adjacent to Hwy 40. The western acreage reduction area,

View of the pending acreage reduction area along the western boundary looking southeast from west corner (Lathe 1)

The Division recommends the Operator submit a request for acreage reduction of the areas within 60 days of the inspection date of this report (December 7, 2019) to allow the Division to use this inspection as the required acreage reduction inspection. A copy of the acreage reduction request form is available on the Division's website at: <https://mining.state.co.us/SiteCollectionDocuments/MineralsReleaseRequestForm.pdf>

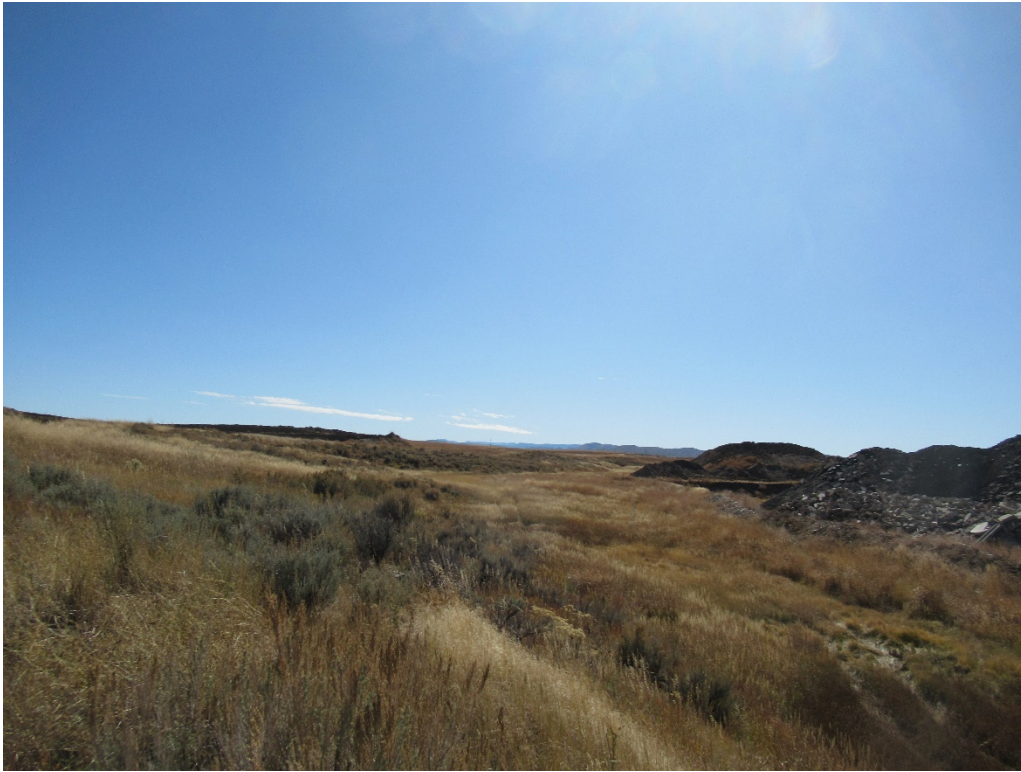
View of the pending acreage reduction area along the western boundary looking southeast from Lathe 3

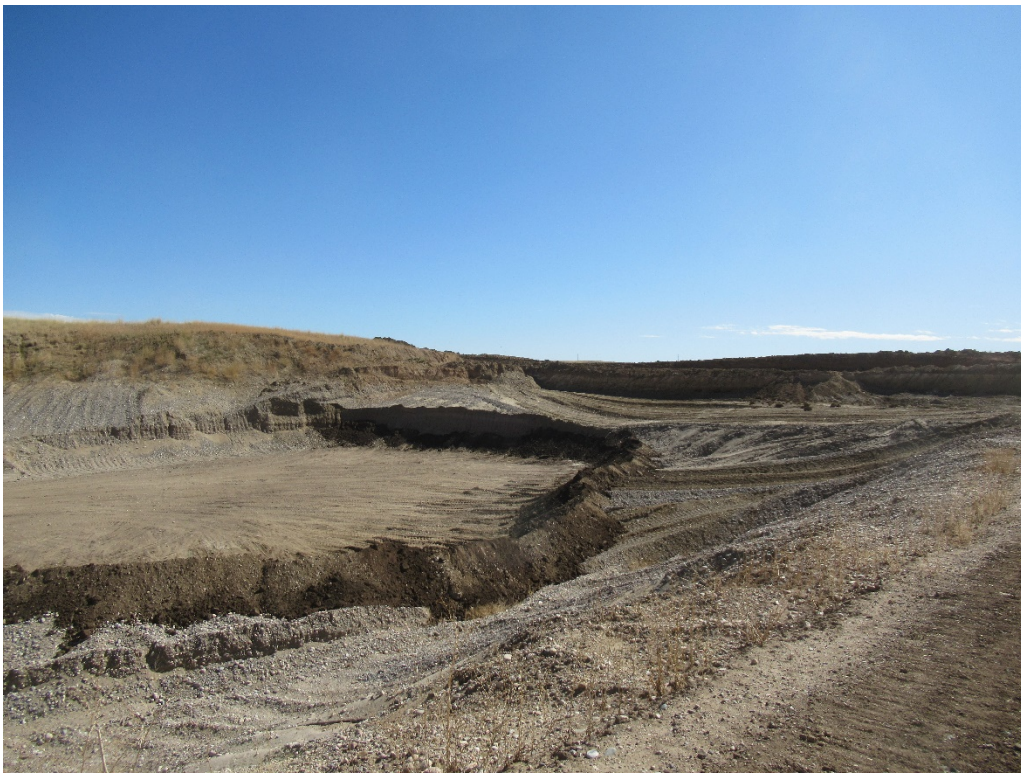
View of the current highwall in the south portion of Phase 2 with overburden and topsoil removed ahead of excavation

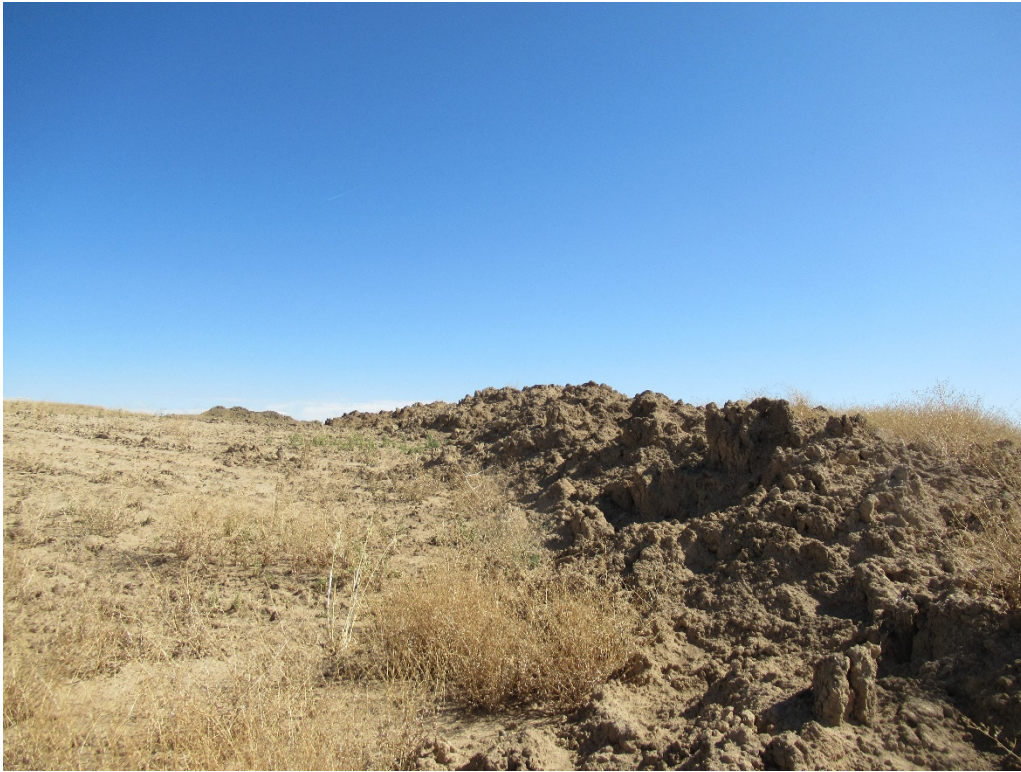
Recently stripped topsoil stockpile south of current highwall

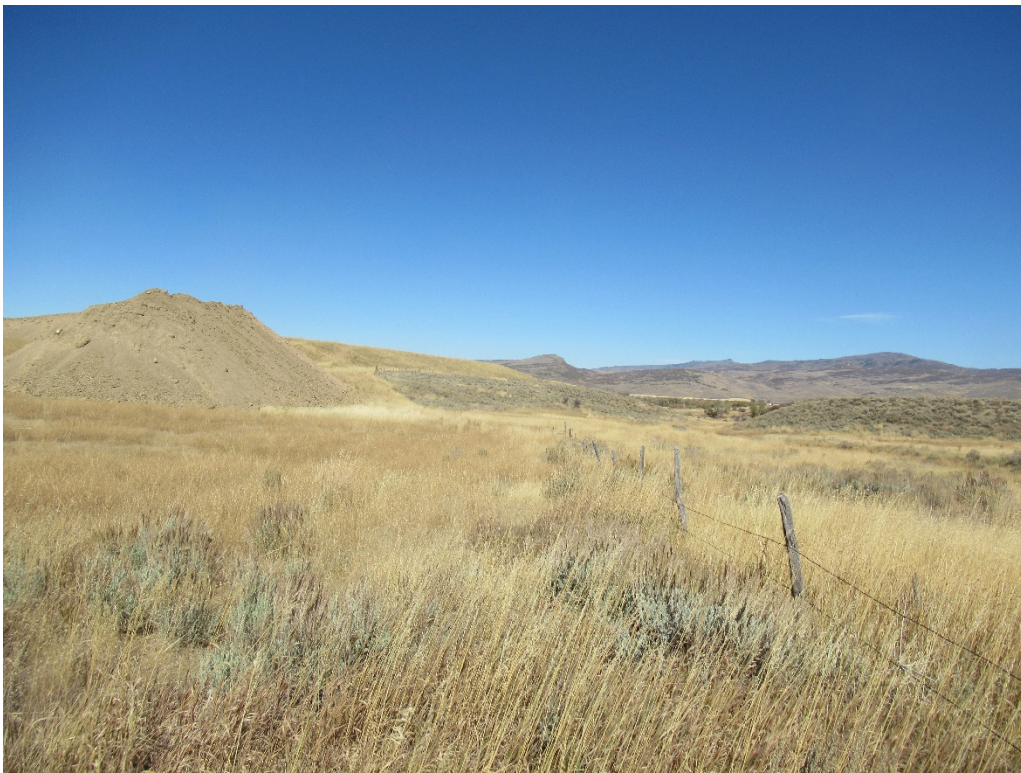
View of southern portion of site, recently place overburden and existing overburden stockpiles from the southeast corner (Lathe 5) looking north

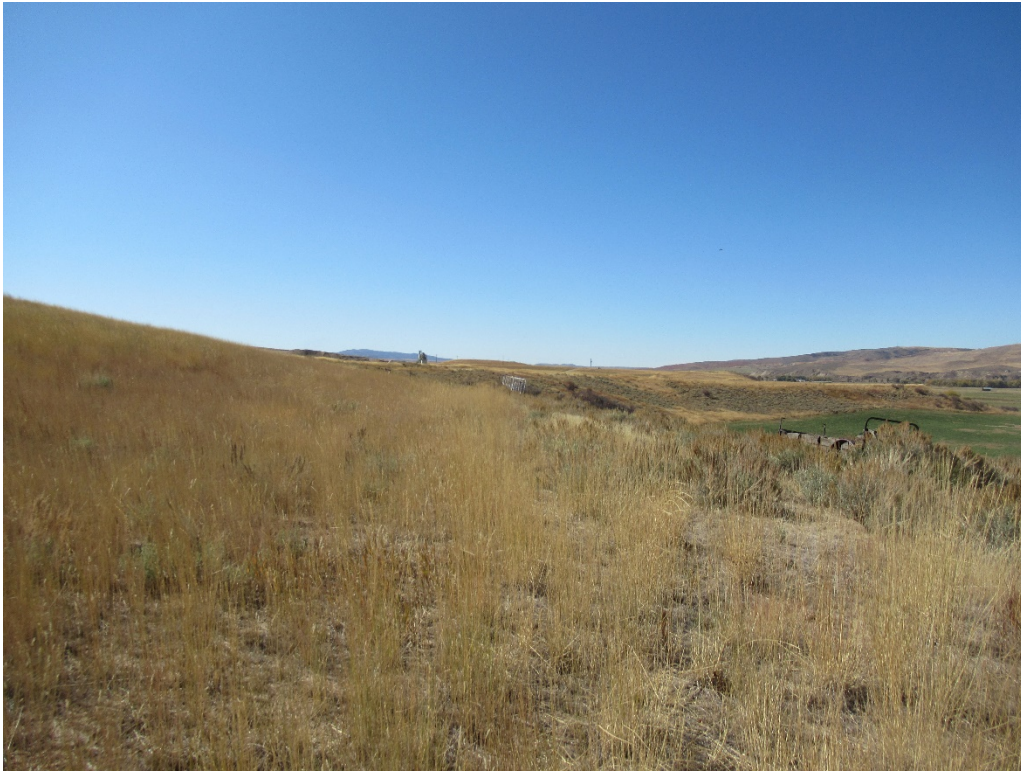
with the exception of the disturbed area mentioned above, and the northern acreage reduction area were determined to be eligible for release by the Division during the inspection, since the areas are permitted by another operator, undisturbed by mining activity or reclaimed according to the approved Reclamation Plan.

View of the pending acreage reduction area along the northern boundary looking west from northeast corner
(Lathe 6)

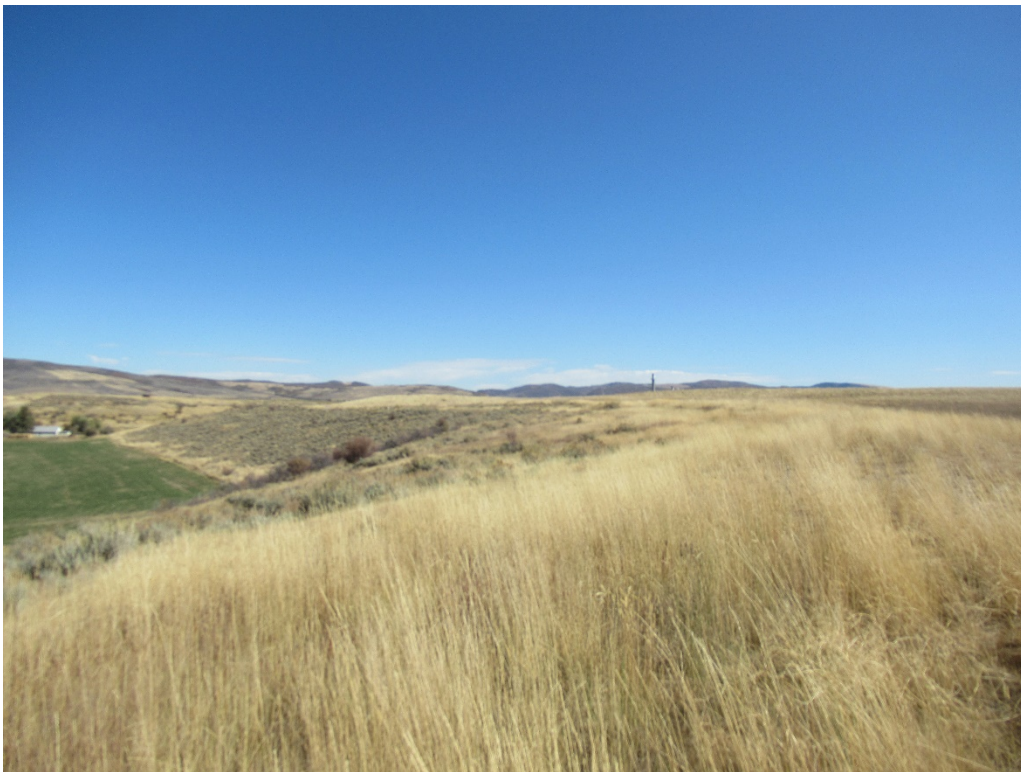
View of the pending acreage reduction area along the northern boundary looking east from northwest corner
(Lathe 9)

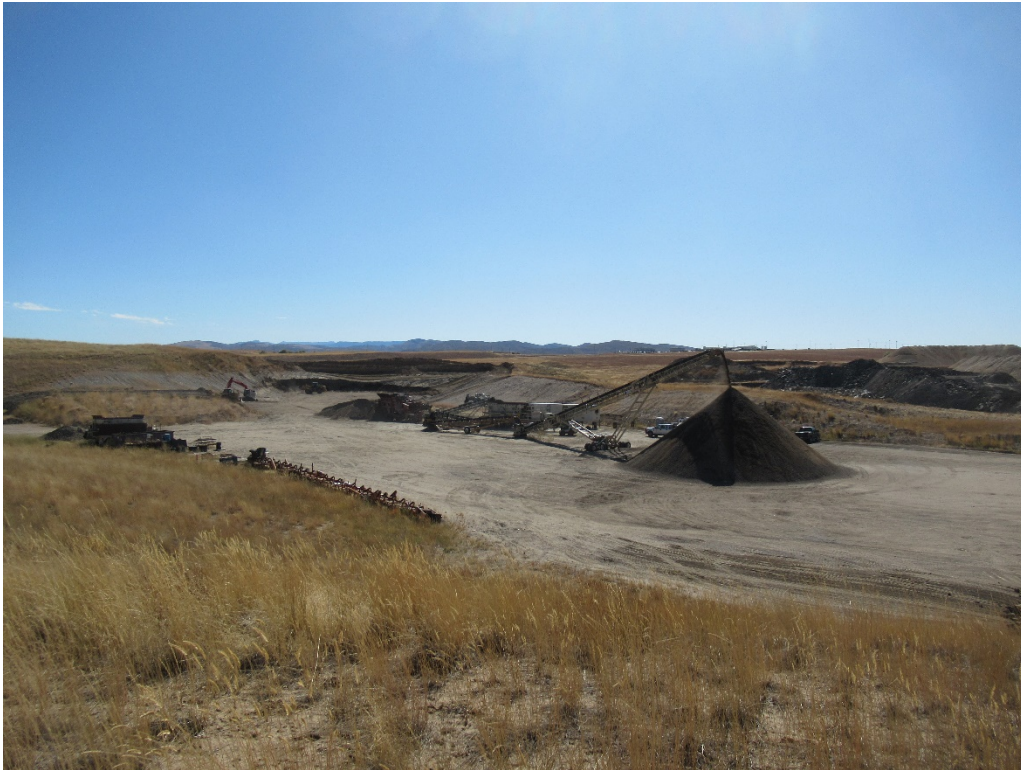
View of the mine site from the northwest corner of the site looking southeast
