MINERALS PROGRAM INSPECTION REPORT
PHONE: (303) 866-3567

MINE NAME: Gillette Pit	MINE/PROSPECTING ID#: M-1992-009	MINERAL: Gravel	COUNTY: Teller
INSPECTION TYPE: Monitoring	INSPECTOR(S): Elliott Russell, Patrick Lennberg	INSP. DATE: October 4, 2019	INSP. TIME: 10:00
OPERATOR: Gillette Sand and Gravel, Inc.	OPERATOR REPRESENTATIVE: Chris Pyles	TYPE OF OPERATION: 112c - Construction Regular Operation

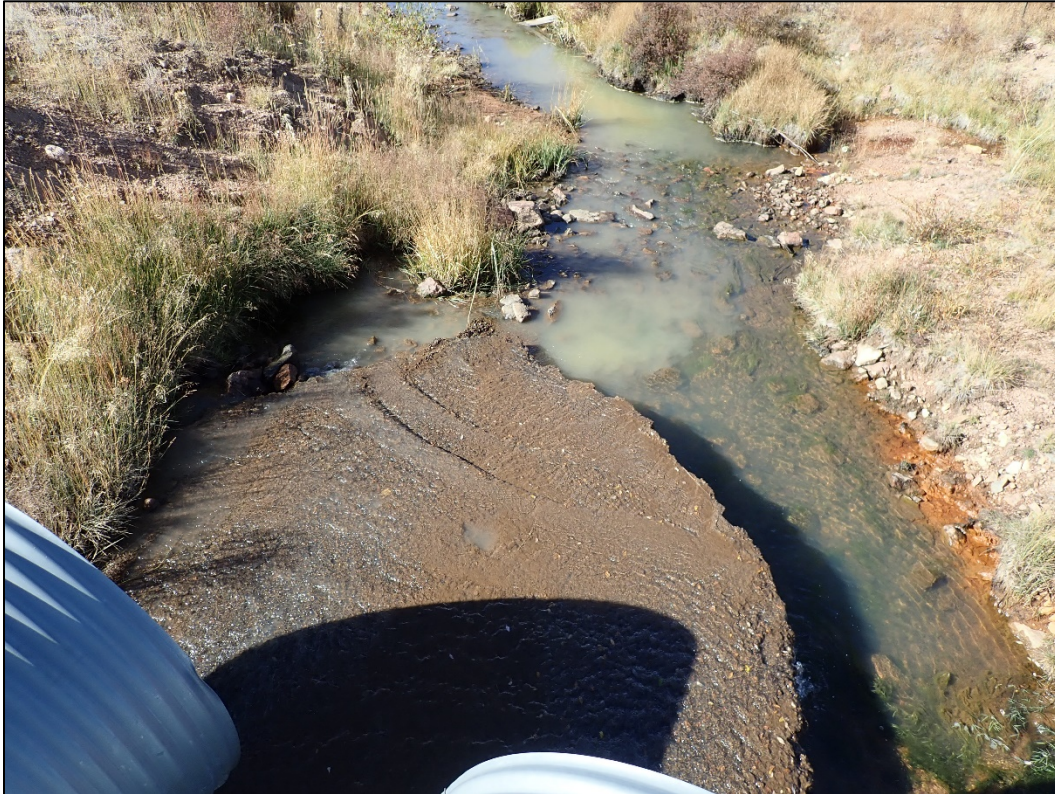
The Division met Chris Pyles at the mine site entrance on the east side of CR 81, approximately ¼ mile south of SH 67. Near the turn off to the site, Beaver Creek flows through a culvert under CR 81. The Division observed a milky discoloration indicative of a large amount of suspended fine sediment particles in Beaver Creek (**Photo 1 and 2**). Mr. Pyles led the Division to the Wetlands Area within the permit boundary where a haul road connects the northern and southern portions of the site. Mr. Pyles pointed out a slight milky discoloration within this area which he believed to be related to beaver activity and the Operator's frequent attempts to clear a plugged culvert under the haul road. The Operator stated they use an excavator about two times each week to clear out debris placed by beavers to unplug the haul road culvert to prevent water from over-topping and washing out the haul road crossing. The Operator had recently cleaned this culvert out and believed this is the cause of the off-site discoloration in Beaver Creek (**Photo 3**). The Division observed some cloudiness to the water within the beaver pond just upstream of the access road, however this didn't appear to be the same type of suspended fine sediment observed downstream near CR 81.

Photo 1. Downstream side of CR 81 culvert; looking southwest.

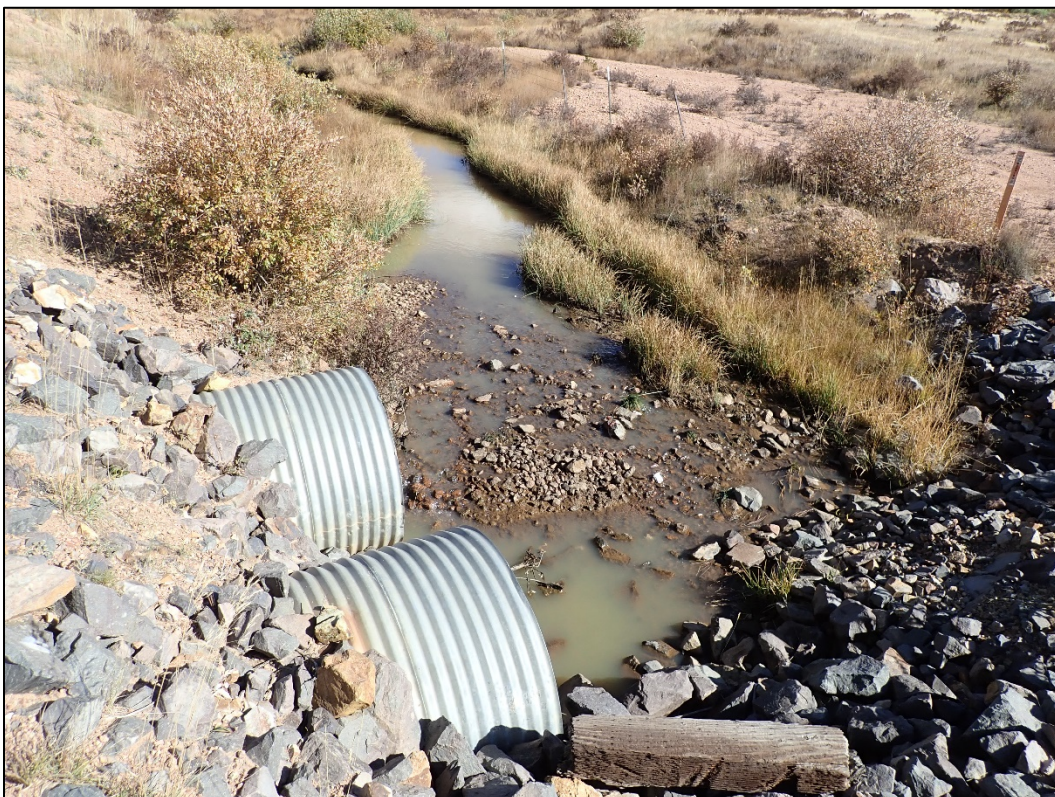
Photo 2. Upstream side of CR 81 culvert; looking north.

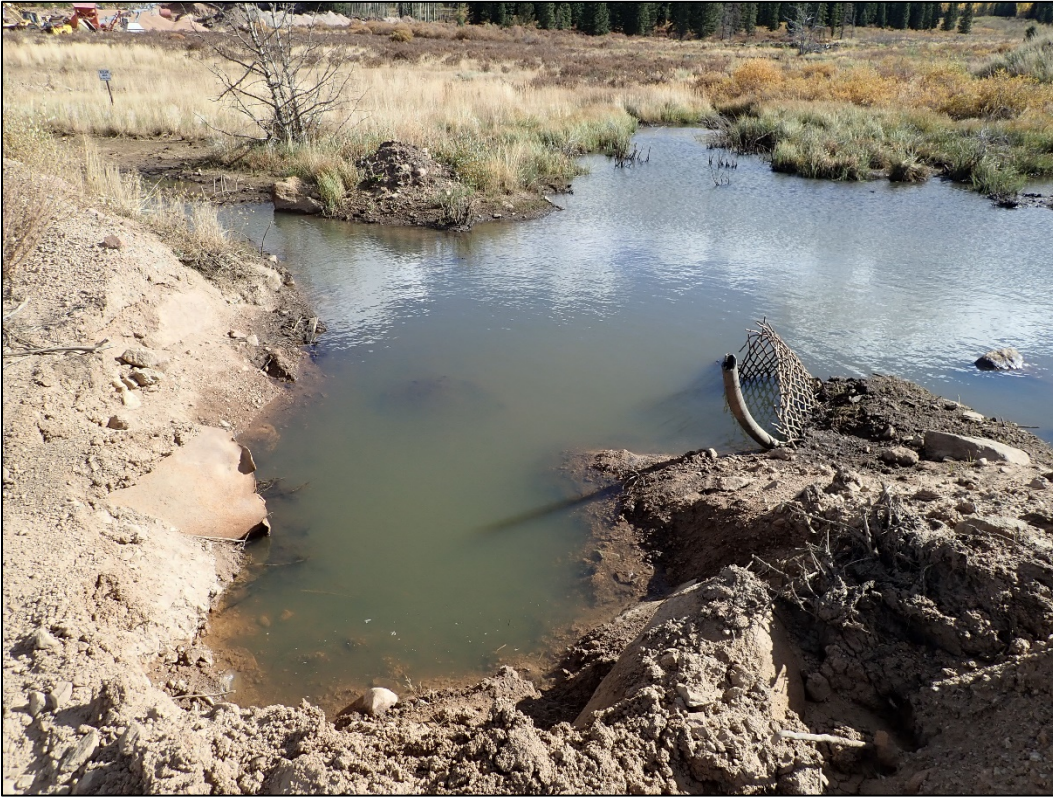
Photo 3. Access road culvert and area of cleaned-out beaver pond debris; looking northeast.

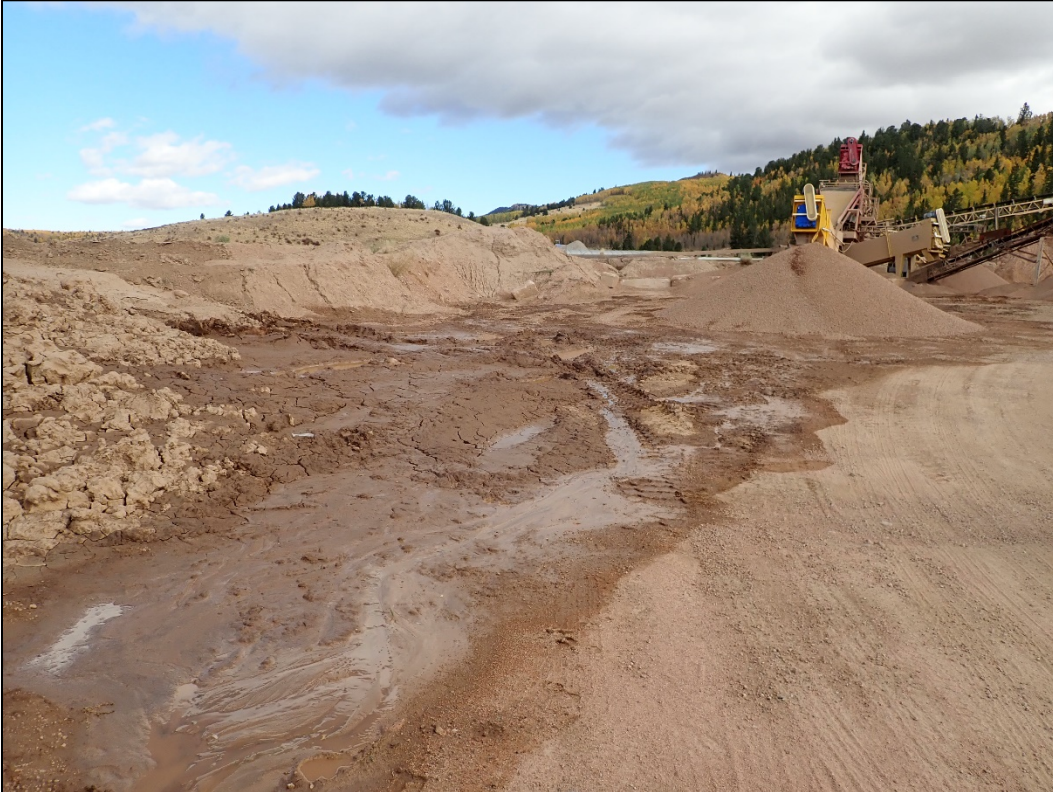
The Division then proceeded to inspect the processing plant and wash water ponds. While approaching the wash plant, the Division observed water draining from washed product stockpiles as well as from a heap of sediment fines which had been excavated out of the wash water ponds (**Photo 4**). This draining water was leaving the process plant area through a cut-out in a perimeter berm and reporting to the Wetlands Area tributary, downstream of the haul road crossing (**Photo 5**).

Photo 4. Draining product and sediment fines; looking north.

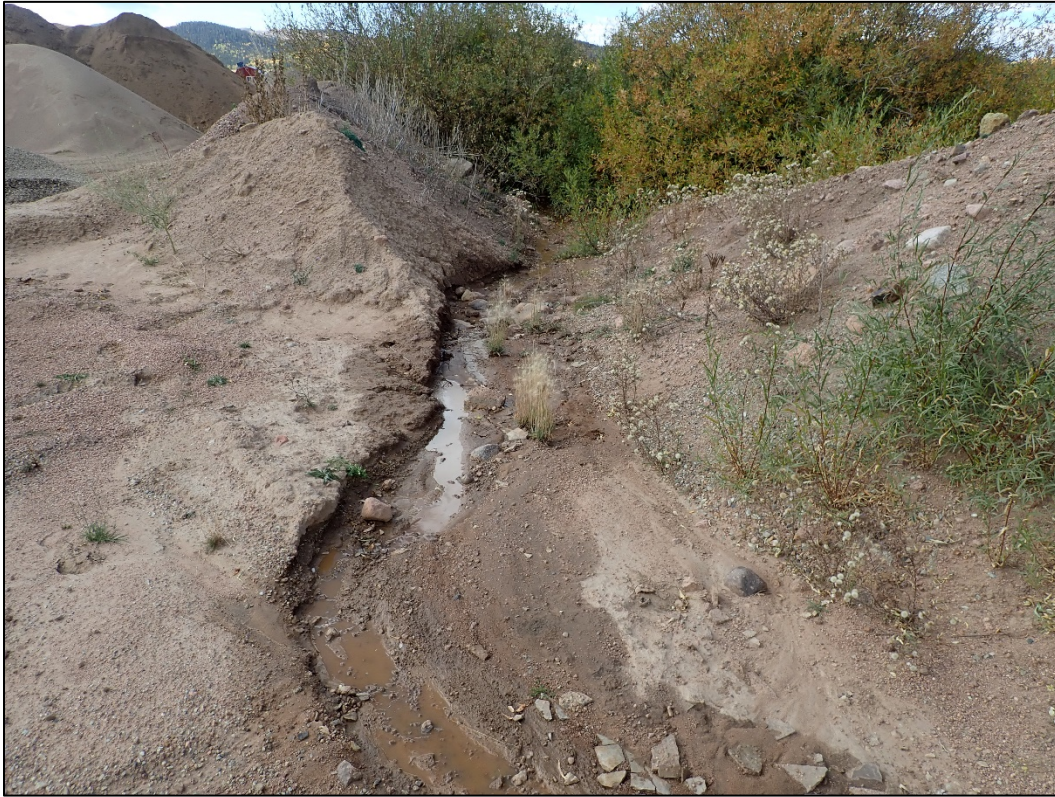
Photo 5. Draining product and sediment fines water leaving site through berm cut-out; looking south.

Before the Division left the site, the Operator had placed material in the berm cut-out south of the Process Plant and was constructing a taller berm around the northwest corner of the northern process pond where the over-topping had occurred.

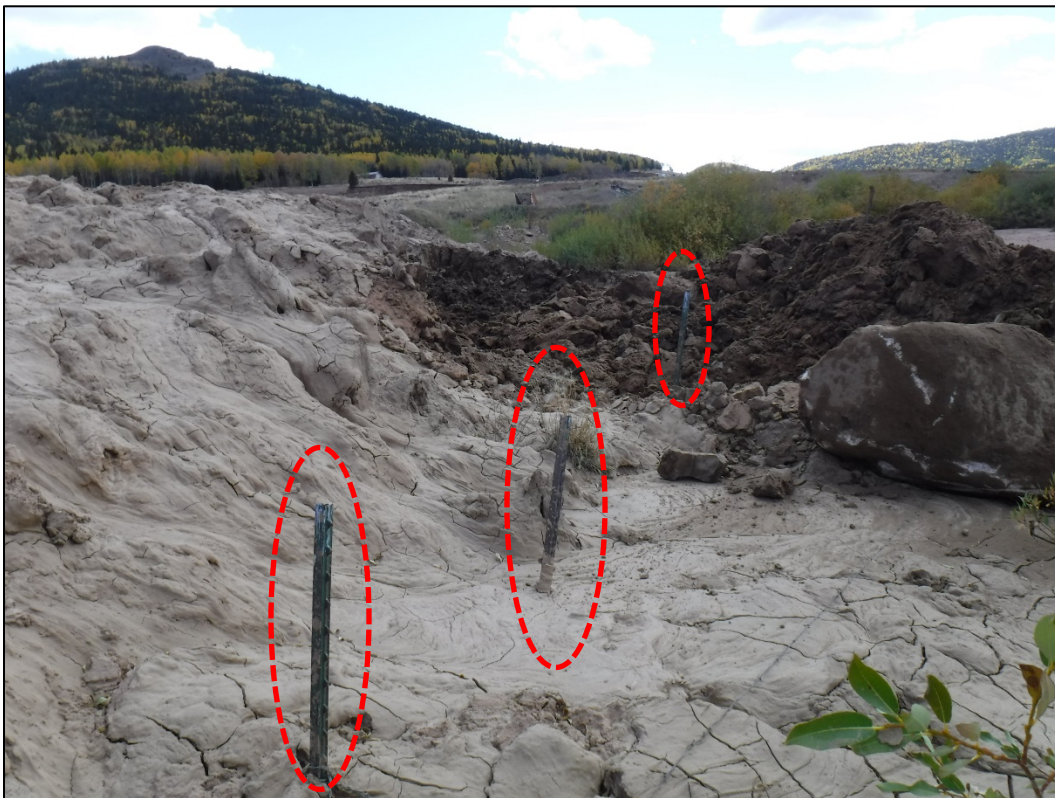
POSSIBLE VIOLATIONS: Wash water from the process ponds was released into Beaver Creek and sediment fines from the process ponds have been piled outside of the approved permit boundary. This is a possible violation of C.R.S. 34-32.5-116(4)(h) for failure to minimize disturbances to the prevailing hydrologic balance of the affected land and of the surrounding area and to the quality of quantity of water in surface and groundwater systems both during and after the mining operation and during reclamation and C.R.S. 34-32.5-116(4)(i) for failure to protect areas outside of the affected land from slides or damages occurring during the mining operation and reclamation. This is also a possible violation of C.R.S. 34-32.5-121 for failure to notify the Division of a failure or imminent failure, as soon as reasonably practicable after such person has knowledge of such condition or of any impoundment, embankment, or slope that poses a reasonable potential for danger to any persons or property and C.R.S. 34-32.5-124 for failure to follow the conditions of an order, permit or regulation.

Photo 6. Permit boundary markers (circled) and piled sediment fines; looking south.

CORRECTIVE ACTIONS: These possible violations will require a hearing before the Mined Land Reclamation Board scheduled for the November 13-14, 2019 Board meeting. The schedule and other details for the MLRB hearing has been provided under a separate document, sent via certified mail to the Operator on October 9, 2019.

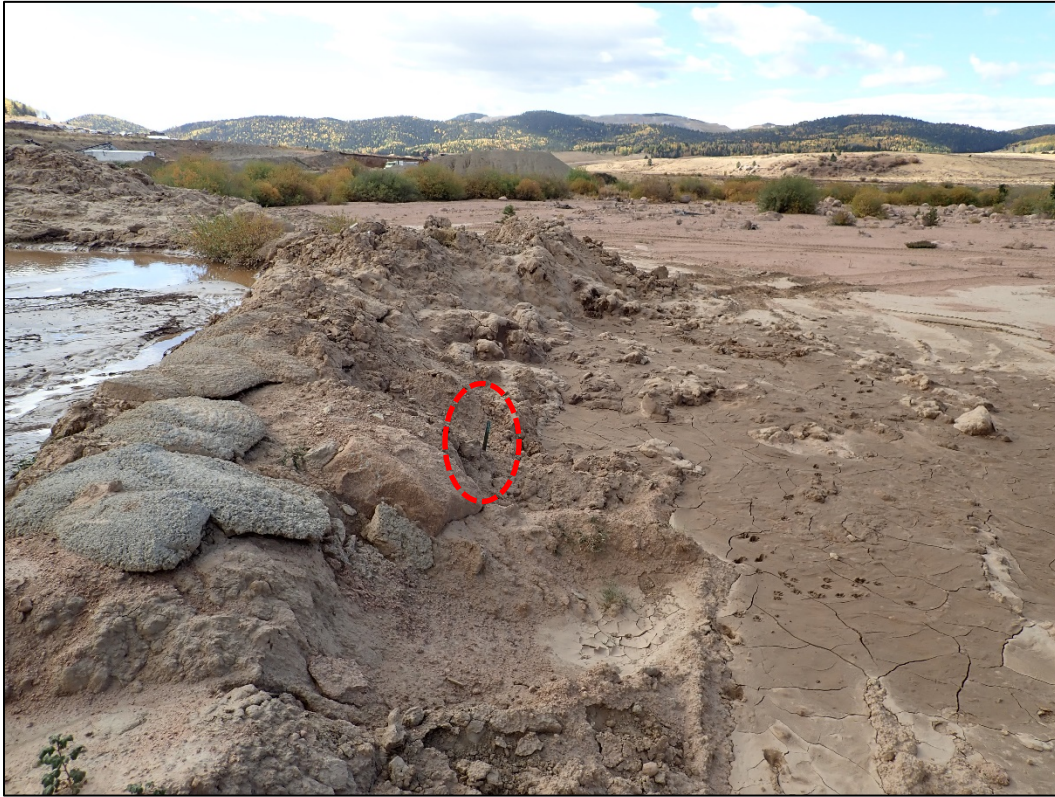
Photo 7. Permit boundary marker (circled) and piled sediment fines; looking south.

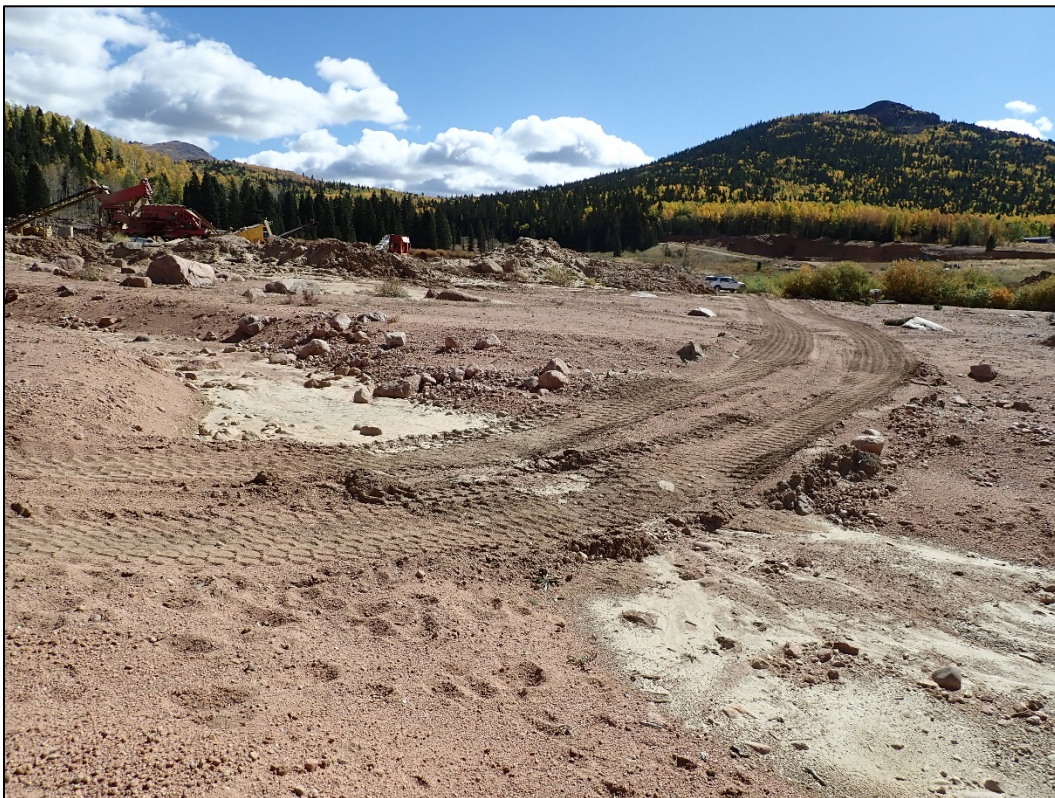
Photo 8. Two track located west of the western permit boundary; looking southeast.

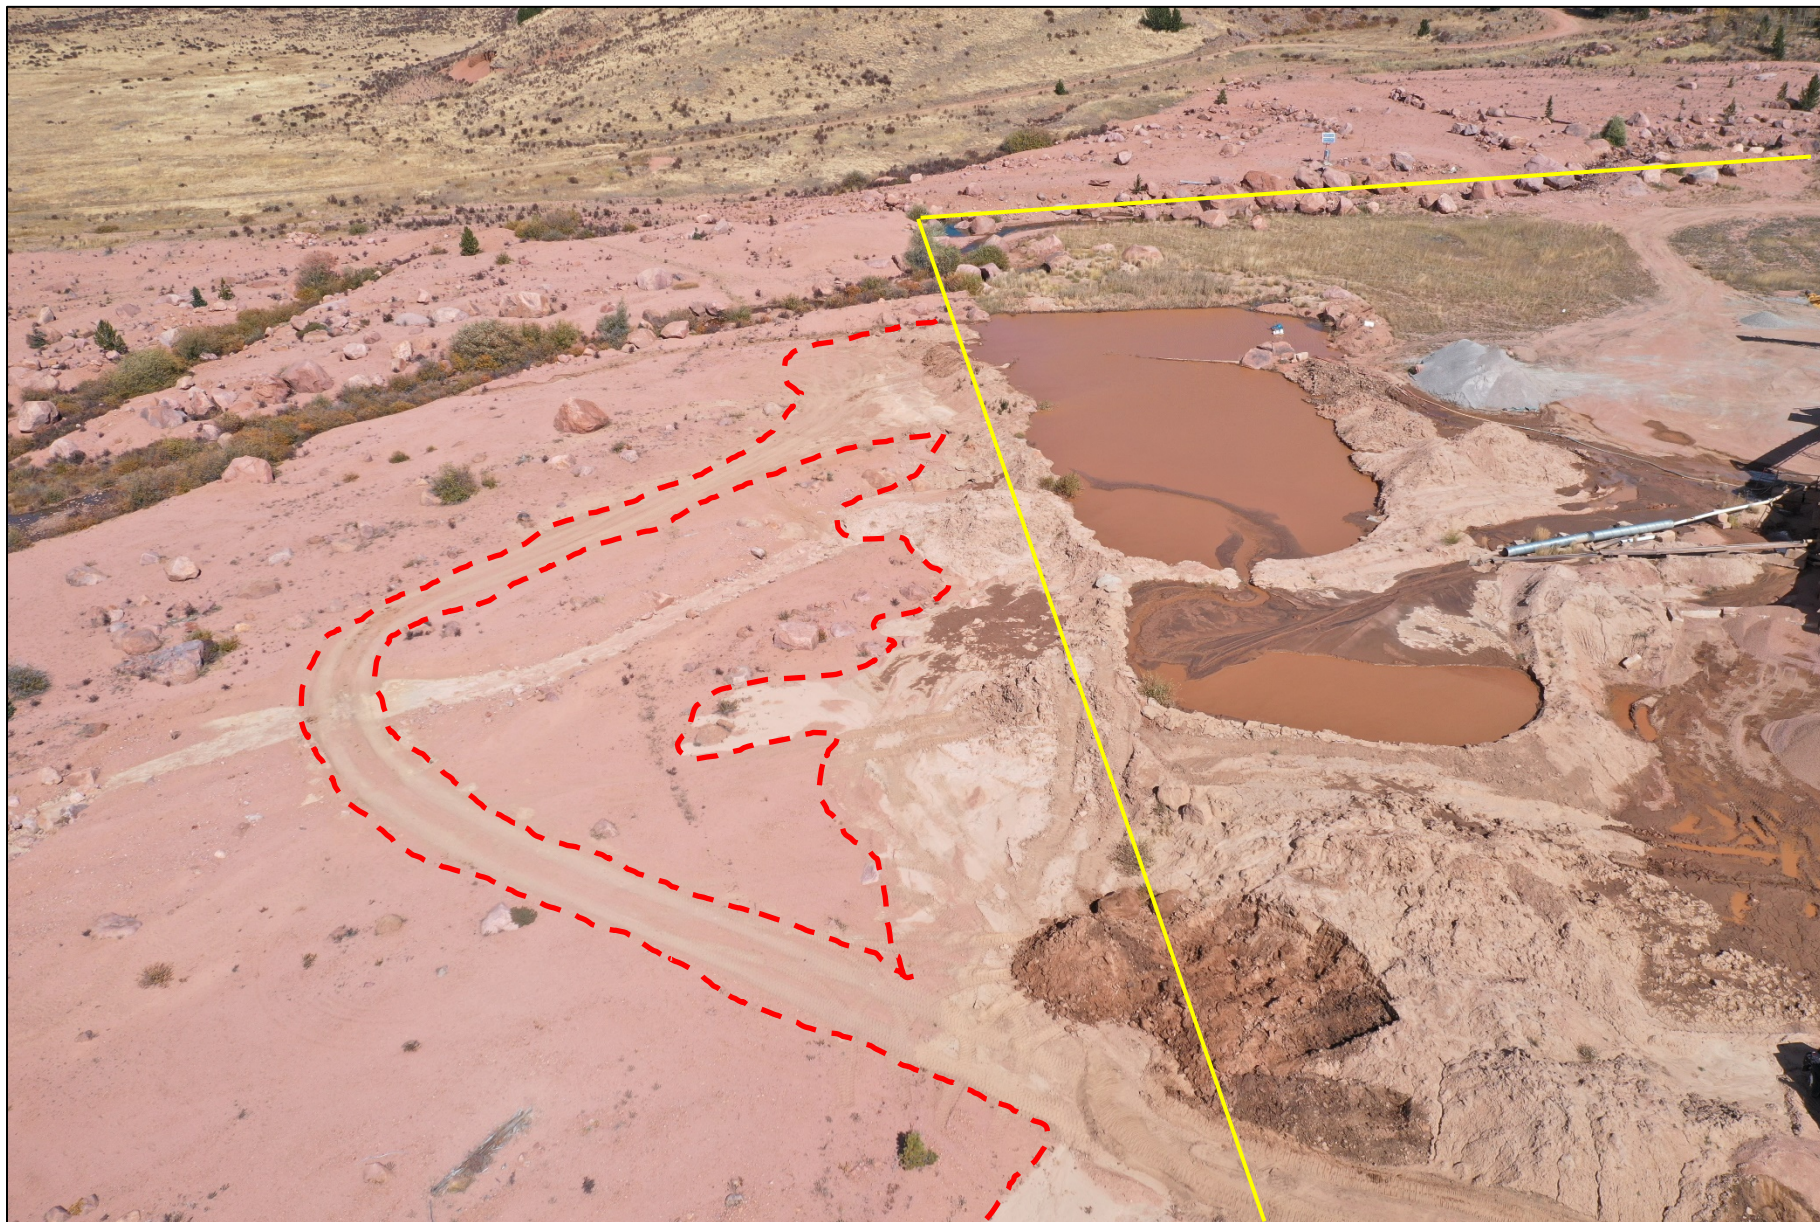
Photo 9. Overview of western permit boundary (yellow solid line) and off-site disturbance (red dashed line); looking north.

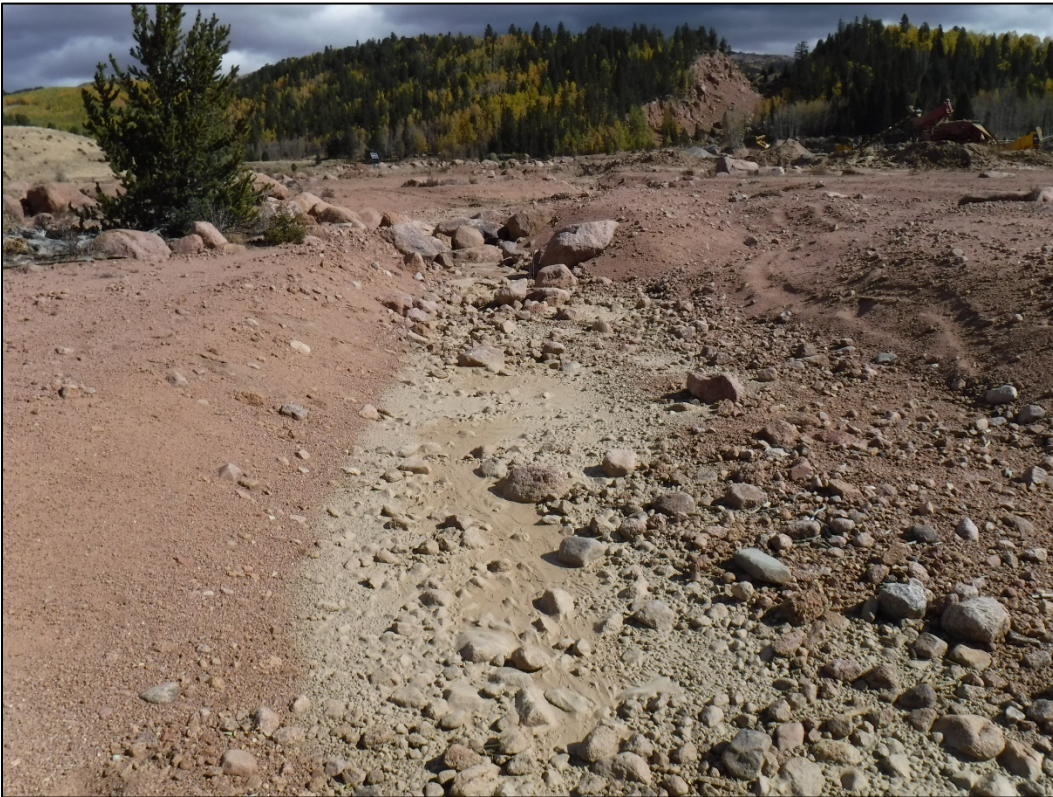
Along the western embankment, the Division observed a drainage area leading to the southwest which contained dry sediment fines (**Photo 10 and 11**). The Division believes this drainage had been affected by over-topping wash water and sediment fines, but not recently. The Division observed the northwest corner of the northern wash pond and discovered evidence of recent wash water which had over-topped the western pond embankment and reported directly to Beaver Creek (**Photo 13-15**). The Operator was unaware of the discharge event, however site personnel stated this is where some of the process pond water was overflowing on Thursday. The Operator stated the wash plant was shut down at 4 P.M. on Thursday. Although the wash water was no longer discharging, suspended fine sediment was still lingering at the point where the wash water had entered Beaver Creek. The Division walked just upstream of this point and observed clear water and even numerous brook trout (**Photo 16**). Following Beaver Creek downstream, the Division observed increasing turbidity and evidence of off-site sedimentation (**Photo 17**). The discharge of wash water into Beaver Creek, the stockpiling of sediment fines off-site, and the failure to notify the Division of the failure of the process pond impoundment has been cited as a possible violation requiring a hearing before the Mined Land Reclamation Board (MLRB).

Photo 10. Off-site drainage with sediment fines; looking northeast.

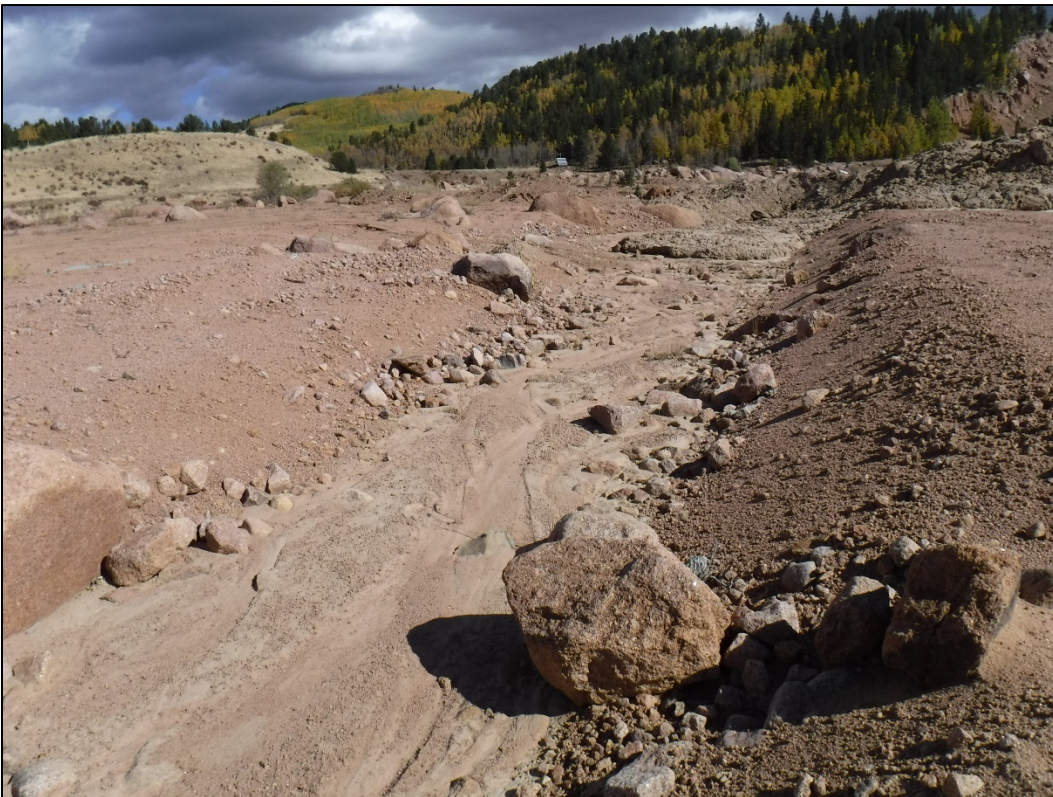
Photo 11. Off-site drainage with sediment fines; looking northeast.

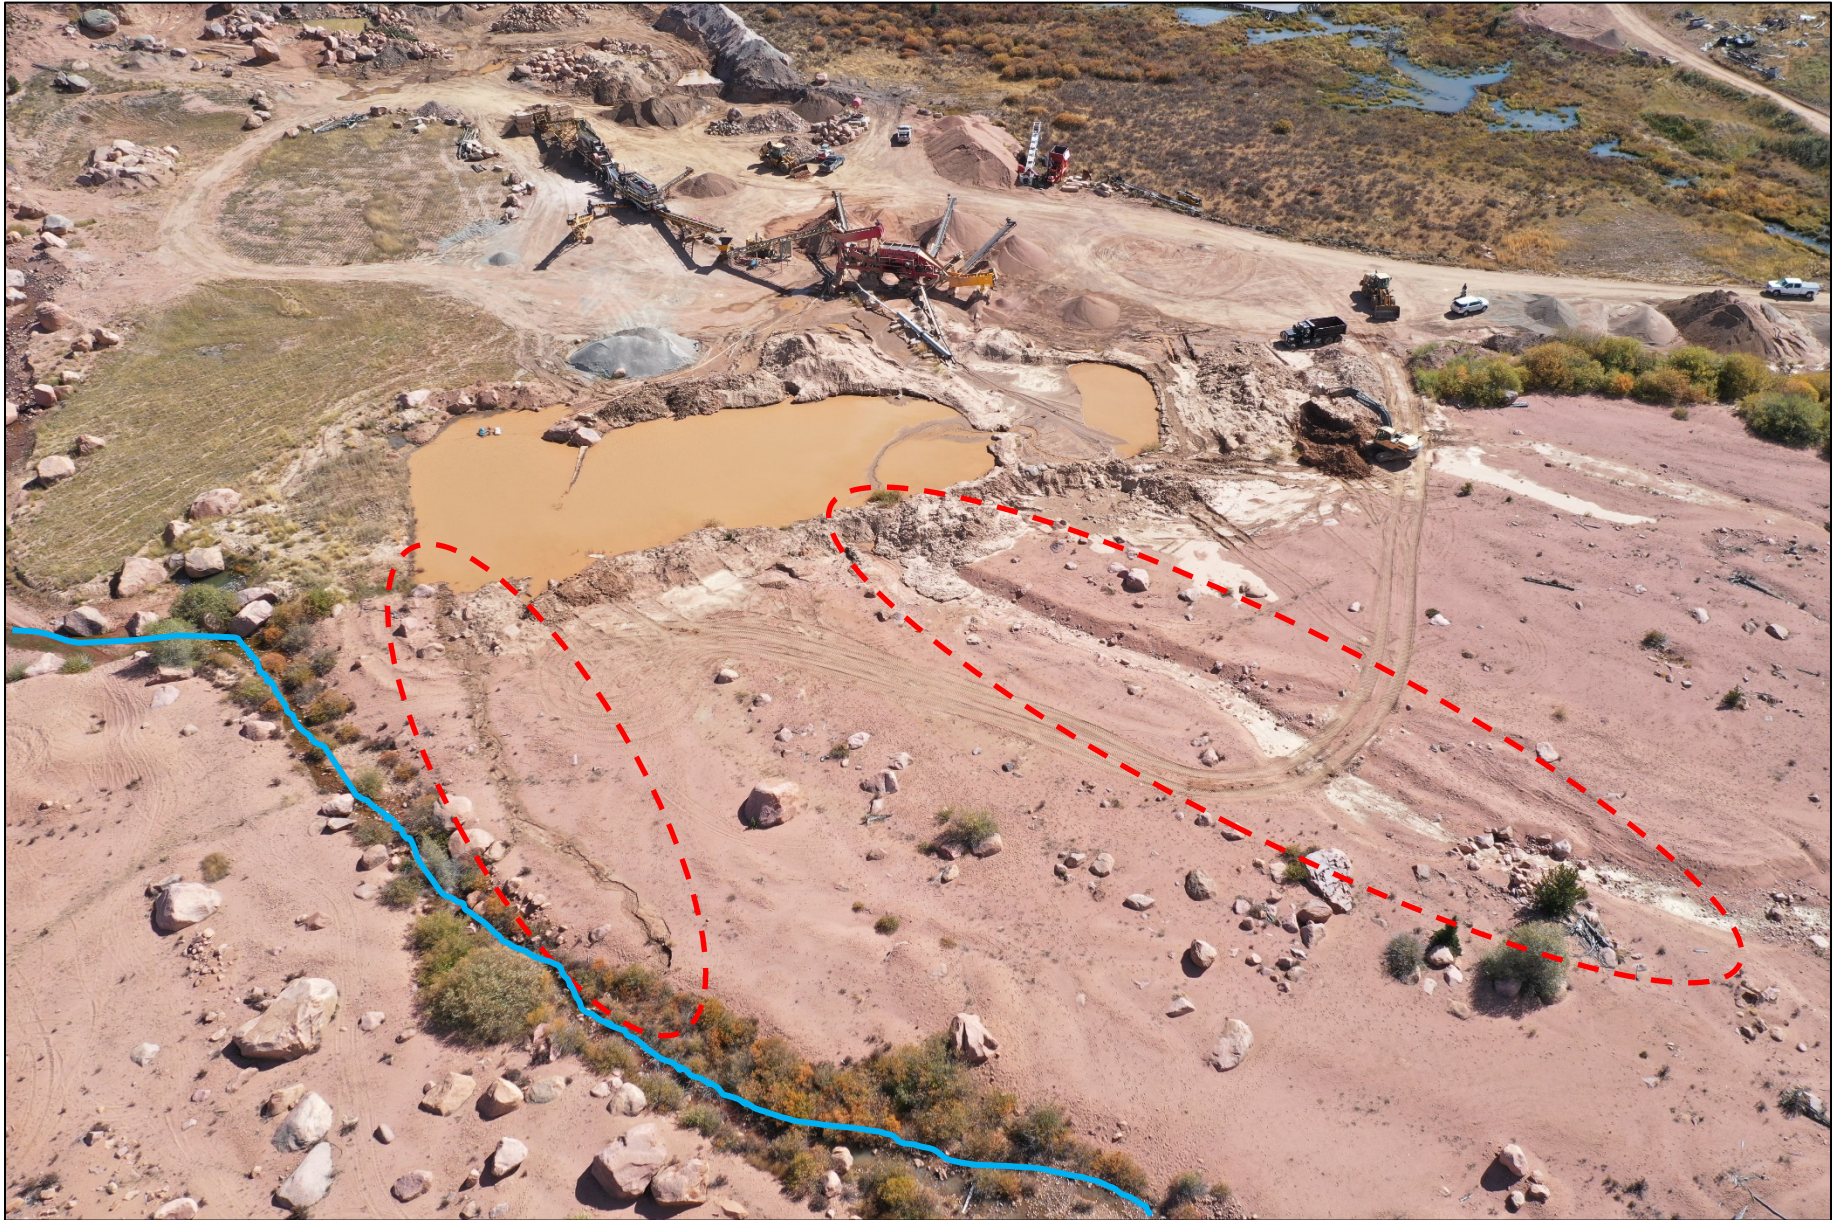
The Division inspected the wash water ponds and observed the ponds were extremely close to capacity and a large amount of sediment had built up in the first pond. The Operator stated process water flows from the wash plant into the first pond, through a weir into the second pond, and then through another weir into the northern portion of the second pond where water is then pumped back into the wash plant. When more water is needed, the Operator purchases water from the City of Cripple Creek from a main near the northwest corner of the permit, as approved in Technical Revision TR-03 in 2005. The process water level was so high, the first pond's western embankment was nearly over-topping and the weir within the second pond was completely inundated. The Division observed a large amount of sediment fines piled along the west side of both of the wash ponds' western embankment. Mr. Pyles stated he had cleaned out the sediment ponds a week before the inspection. The Division observed several western permit boundary markers had been partially buried by the sediment fines generated from clean out (**Photo 6 and 7**). There was also a two-track road created from the processing plant area around the west side of the ponds to the northwest corner of the northern pond (**Photo 8**). The western permit boundary follows the western embankment of the wash ponds, thus the piled sediment fines and two-track have affected off-site lands (**Photo 9**). The Division used a Garmin 64st to acquire GPS data of the off-site disturbance. After the inspection, the Division used the GPS data, observations made and photographs taken during the inspection, and Google Earth, to determine that approximately 0.3 acres have been disturbed outside of the approved permit boundary. This has been cited as a possible violation requiring a hearing before the Mined Land Reclamation Board.

Photo 12. Overview of process ponds, wash water flow paths (circled in dashed red), and Beaver Creek (solid blue line); looking east.

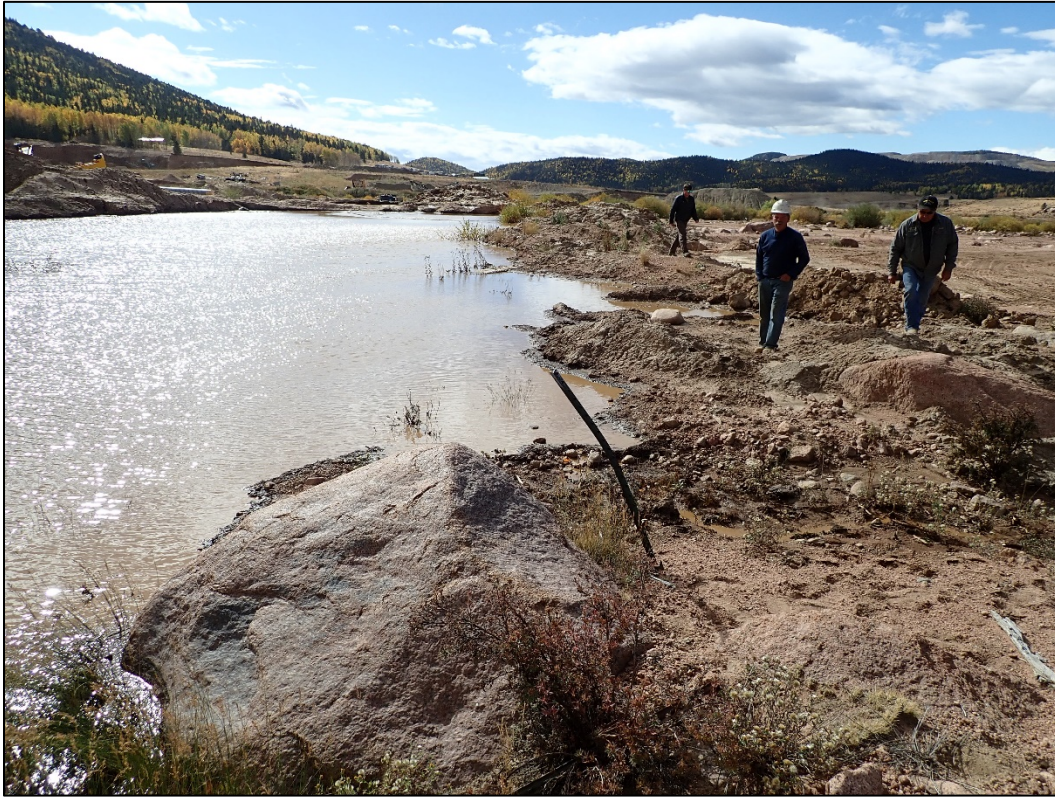
Photo 13. Northwest corner of Pond 2 where wash water overtopped the embankment; looking south.

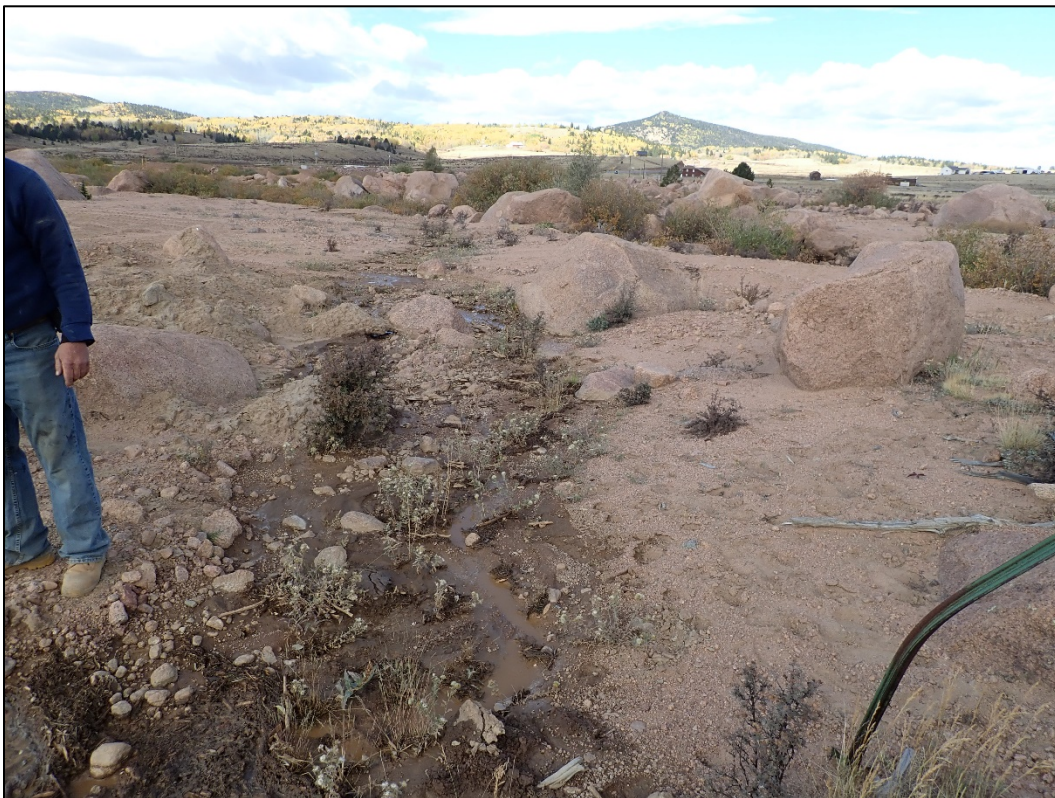
Photo 14. Wash water off-site flow path; looking west.

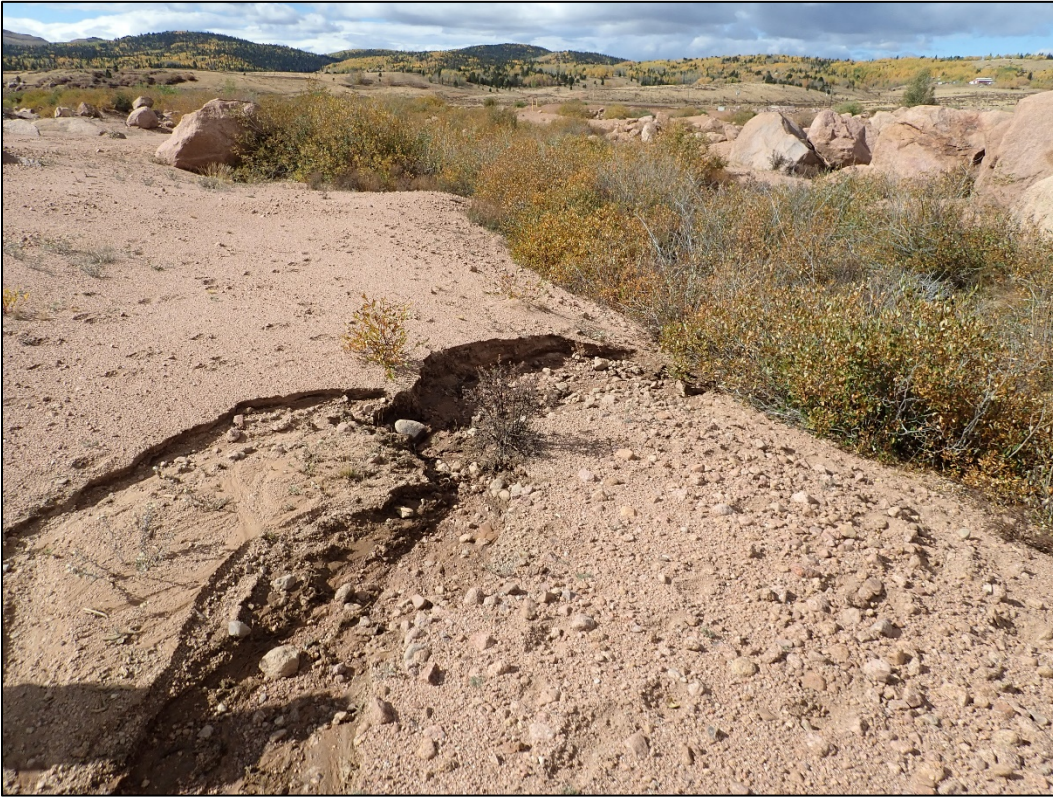
Photo 15. Erosional feature where wash water entered Beaver Creek; looking west.

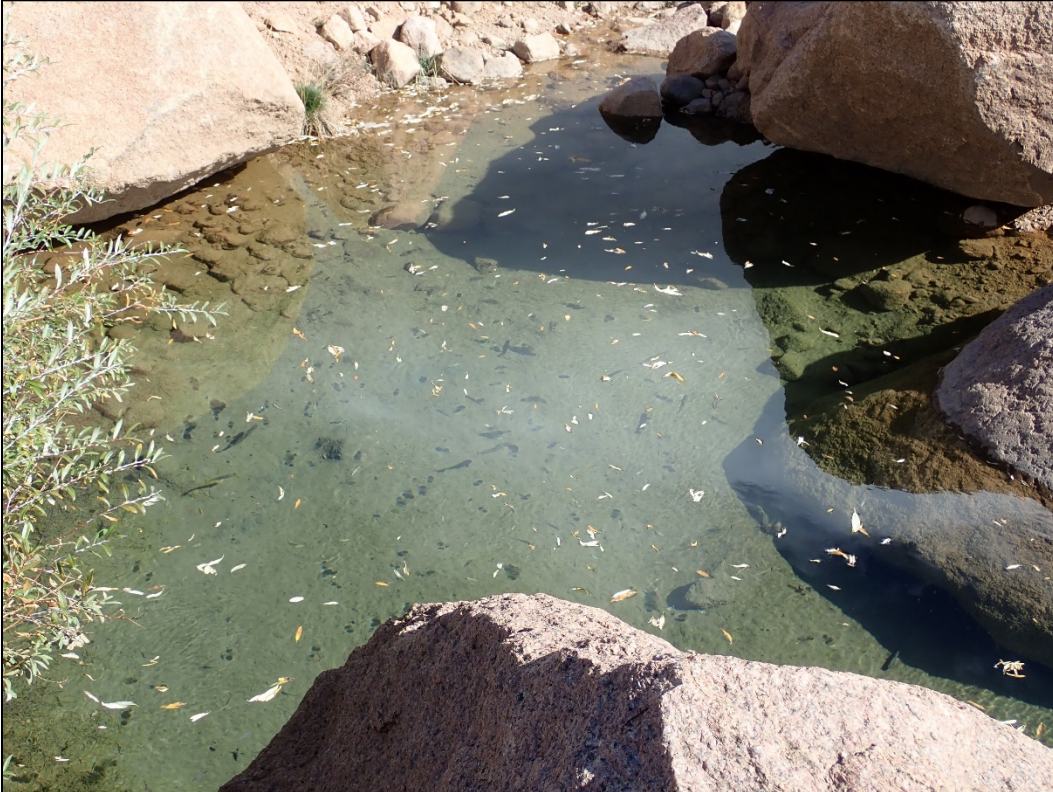
Photo 16. Beaver Creek upstream of the wash water inflow with brook trout present and no turbidity; looking north.

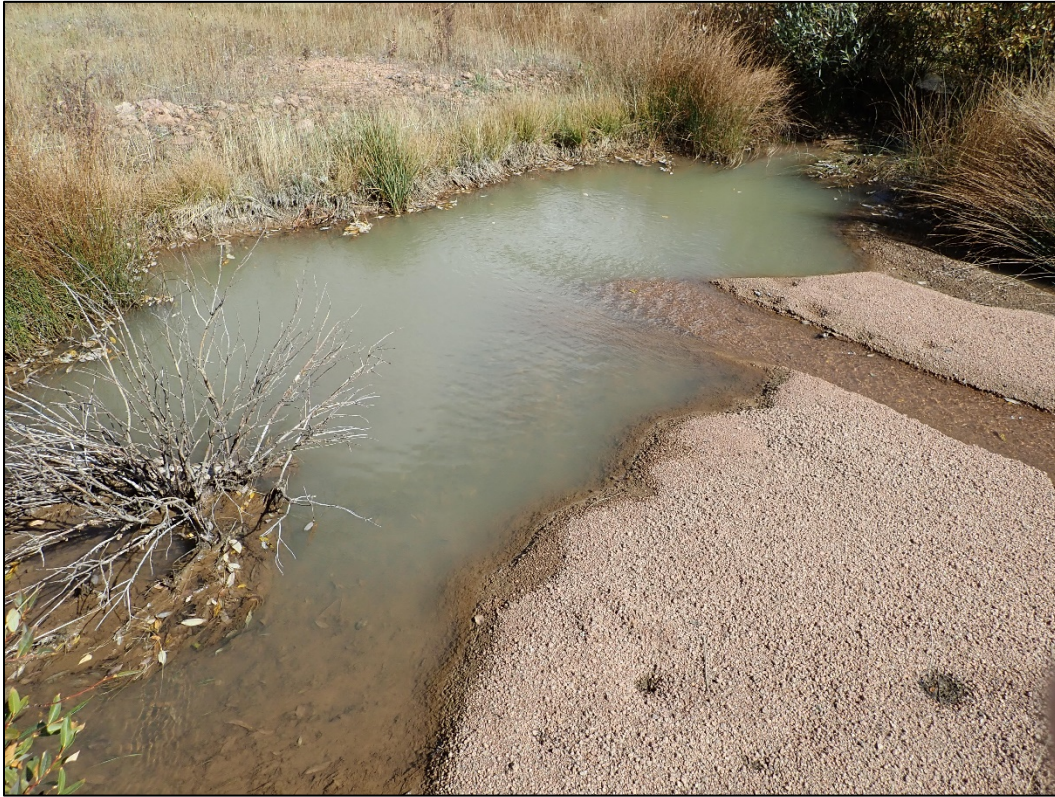
Photo 17. Beaver Creek downstream of the wash water inflow; looking north.

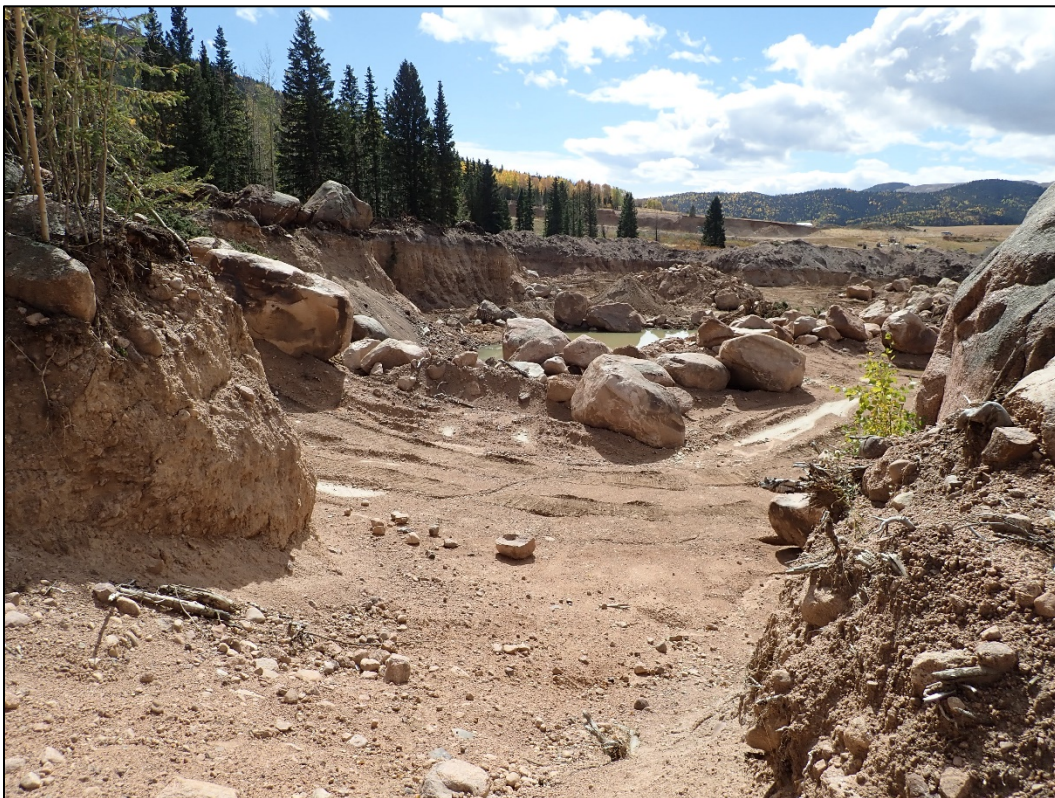
COMPLIANCE PROBLEM #1: Groundwater has been exposed in the Northern Pit. The Division has no evidence that the operator has a valid well permit, substitute water supply plan, or approved water augmentation plan for the exposed groundwater at the site. This is a problem related to 34-32.5-116(4)(h) of the Colorado Revised Statutes and 3.1.6(1)(a) of the Construction Materials Rules and Regulations governing injury to existing water rights.

The Division inspected the Northern Pit, which is a u-shaped excavation with highwalls ranging from 15-20 feet tall on the eastern side that daylight on the western side near the processing plant. The Operator had recently stripped topsoil above the eastern highwall in preparation of advancing the highwall further east. The Operator stated he is planning on backfilling the northern highwall with the wash plant sediment fines to the approved final reclamation slope of no steeper than 2H:1V. The Division observed one large area of standing water as well as several smaller areas (**Photo 18**). The Operator stated that the floor of the pit is nearing the water table and the large ponded area was approximately 4 to 6 feet deep. As the operation is not authorized to expose groundwater and the permit file does not reflect the Operator has a Substitute Water Supply Plan with the Division of Water Resources (DWR), this has been cited as a Compliance Problem #1 requiring corrective action. The Operator will need to backfill these areas to at least two feet above the groundwater table to ensure groundwater is not exposed or gain authorization with DWR and submit the appropriate revision to the Division.

Photo 18. Northern Pit with exposed groundwater on pit floor; looking south.

CORRECTIVE ACTIONS: The operator shall demonstrate that the operation is in compliance with the Office of the State Engineer, show evidence that the operator is taking measures to bring the site into compliance with the SEO, or backfill the pits to at least two feet above the groundwater surface by the corrective action date specified.

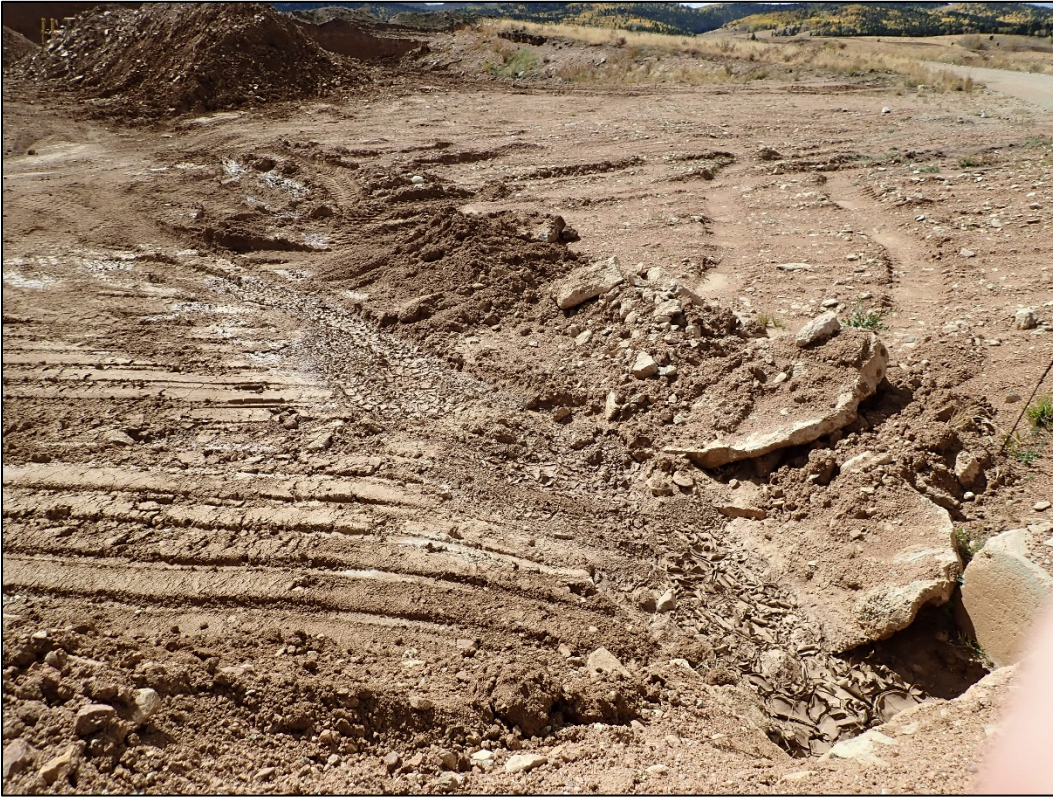
COMPLIANCE PROBLEM #2: The drainage from the Southern Pit reports to a culvert under the private access road and into the Wetlands Area. This is a problem pursuant to C.R.S. 34-32.5-116(4)(h) and C.R.S. 34-32.5-116(4)(j).

The Division inspected the Southern Pit, which the Operator stated is used primarily as road base and requires minimal processing for the product. The highwall along the southern and eastern portions of the Southern Pit ranges from 15 feet to 35 feet and is the tallest in the southeast corner. The Division observed a drainage along the western side of the Southern Pit which flows through a culvert under a private access road constructed by the Operator which passes through the site (**Photo 19**). This culvert reports directly to a large beaver pond within the central Wetlands Area (**Photo 20**). A review of an aerial photograph taken with the Division's UAV drone at the time of the inspection shows that this large beaver pond contains suspended sediment while upstream beaver ponds do not (**Photo 21**). The Division has determined that the uncontrolled drainage from the Southern Pit has allowed sediment to reach the Wetlands Area, which is the cause of the cloudiness in the downstream beaver ponds inspected earlier near the haul road crossing. This has been cited as Compliance Problem #2, requiring the Operator to manage storm water from the Southern Pit. The Operator will need to install adequate erosion control measures to ensure sediment remains within the Southern Pit and doesn't report to the Wetlands Area.

Photo 19. Drainage along western portion of the Southern Pit; looking southwest.

CORRECTIVE ACTIONS: The operator shall implement erosion control measures in the Southern Pit to ensure there is no sedimentation into the Wetlands Area and provide photo documentation to the Division by the corrective action due date.
