MINERALS PROGRAM INSPECTION REPORT
PHONE: (303) 866-3567

MINE NAME: Gillette Pit	MINE/PROSPECTING ID#: M-1992-009	MINERAL: Gravel	COUNTY: Teller
INSPECTION TYPE: Monitoring	INSPECTOR(S): Elliott Russell, Patrick Lennberg	INSP. DATE: October 4, 2019	INSP. TIME: 10:00
OPERATOR: Gillette Sand and Gravel, Inc.	OPERATOR REPRESENTATIVE: Chris Pyles	TYPE OF OPERATION: 112c - Construction Regular Operation

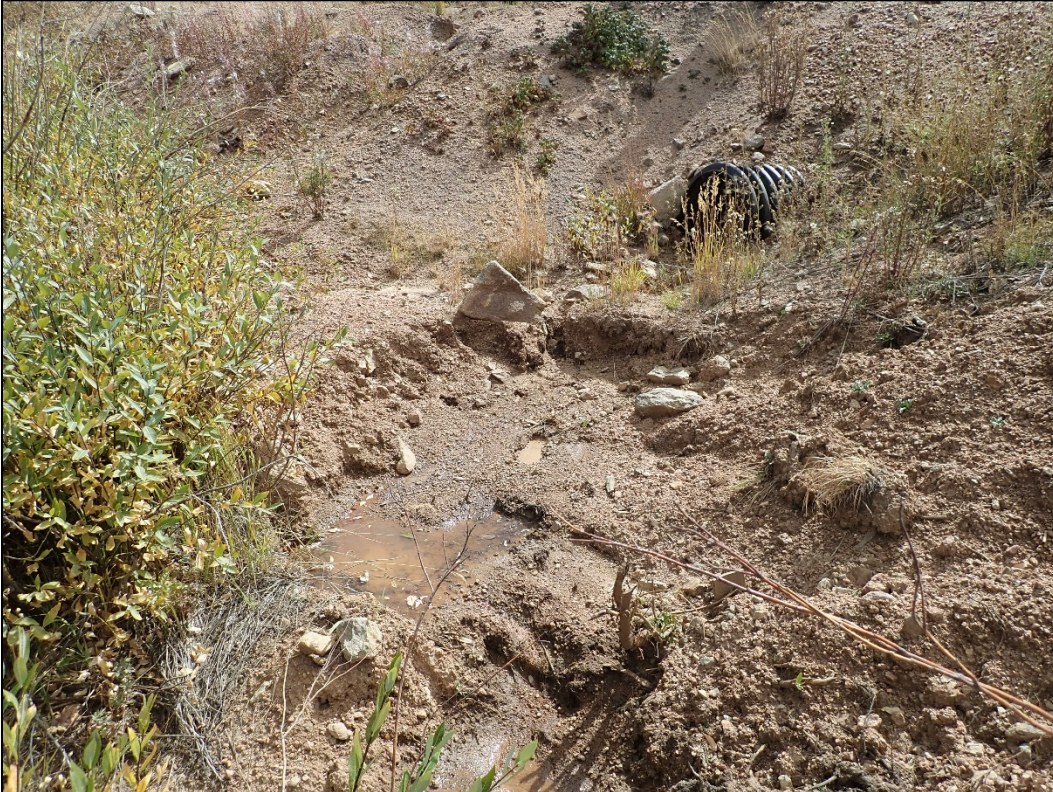
COMPLIANCE PROBLEM #2: The drainage from the Southern Pit reports to a culvert under the private access road and into the Wetlands Area. This is a problem pursuant to C.R.S. 34-32.5-116(4)(h) and C.R.S. 34-32.5-116(4)(j).

Photo 20. Culvert from Southern Pit drainage entering the Wetlands Area; looking southeast.

CORRECTIVE ACTIONS: The operator shall implement erosion control measures in the Southern Pit to ensure there is no sedimentation into the Wetlands Area and provide photo documentation to the Division by the corrective action due date.

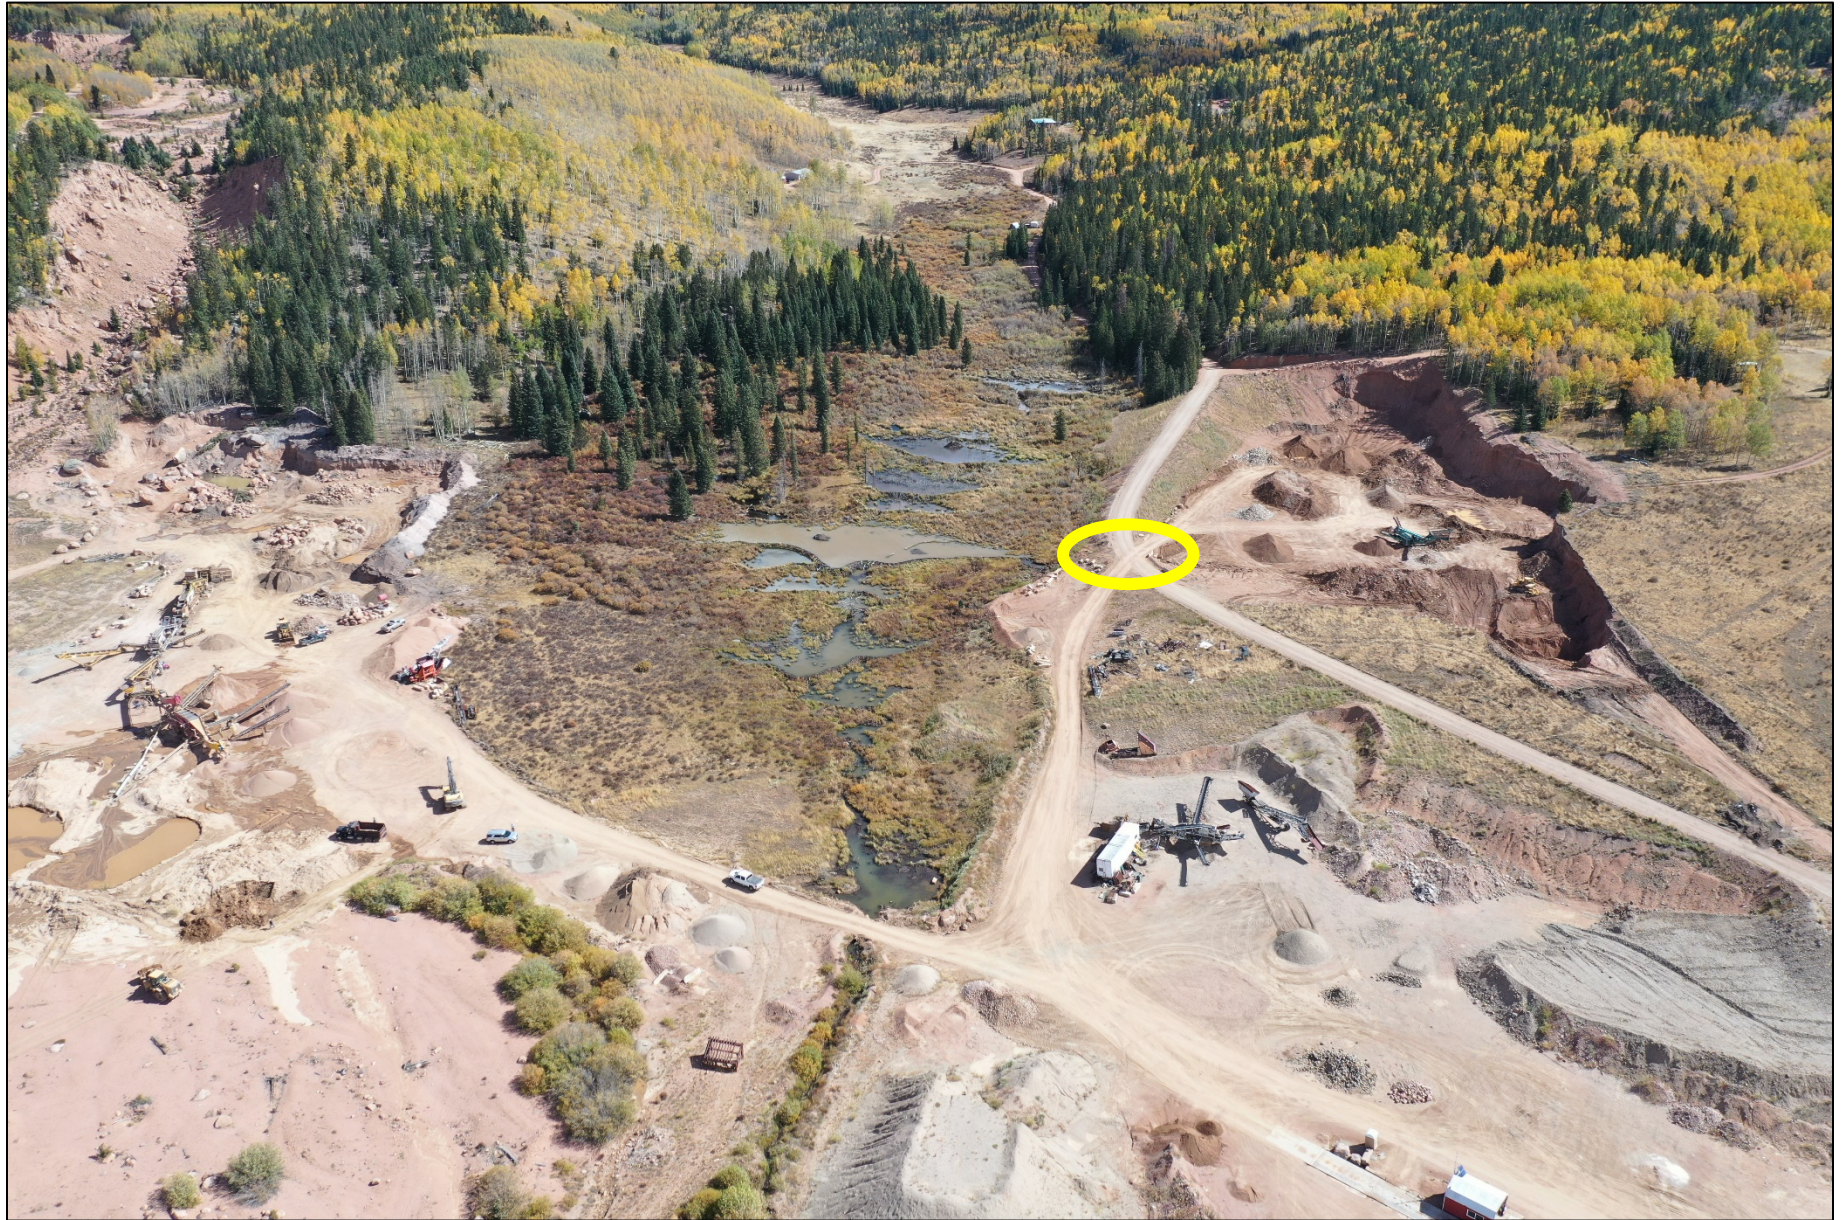
Photo 21. Overview of Wetlands Area and Southern Pit, culvert area circled in yellow; looking east.
