RE: Western Slope Flagstone Quarry No. 2, Permit No. M-1996-076, Unresolved Problem Noted in a Past Inspection Report, 2nd Notice

MINERALS PROGRAM INSPECTION REPORT
PHONE: (303) 866-3567

MINE NAME: Western Slope Flagstone Quarry No. 2	MINE/PROSPECTING ID#: M-1996-076	MINERAL: Gravel	COUNTY: Mesa
INSPECTION TYPE: Monitoring	INSPECTOR(S): Amy C. Yeldell	INSP. DATE: July 9, 2019	INSP. TIME: 18:00
OPERATOR: Rudolph Fontanari	OPERATOR REPRESENTATIVE: None	TYPE OF OPERATION: 112c - Construction Regular Operation	
REASON FOR INSPECTION: High Priority	BOND CALCULATION TYPE: None	BOND AMOUNT: \$88,251.00	
DATE OF COMPLAINT: NA	POST INSP. CONTACTS: None	JOINT INSP. AGENCY: State Engr. (Water Resources)	
WEATHER: Clear	INSPECTOR'S SIGNATURE:

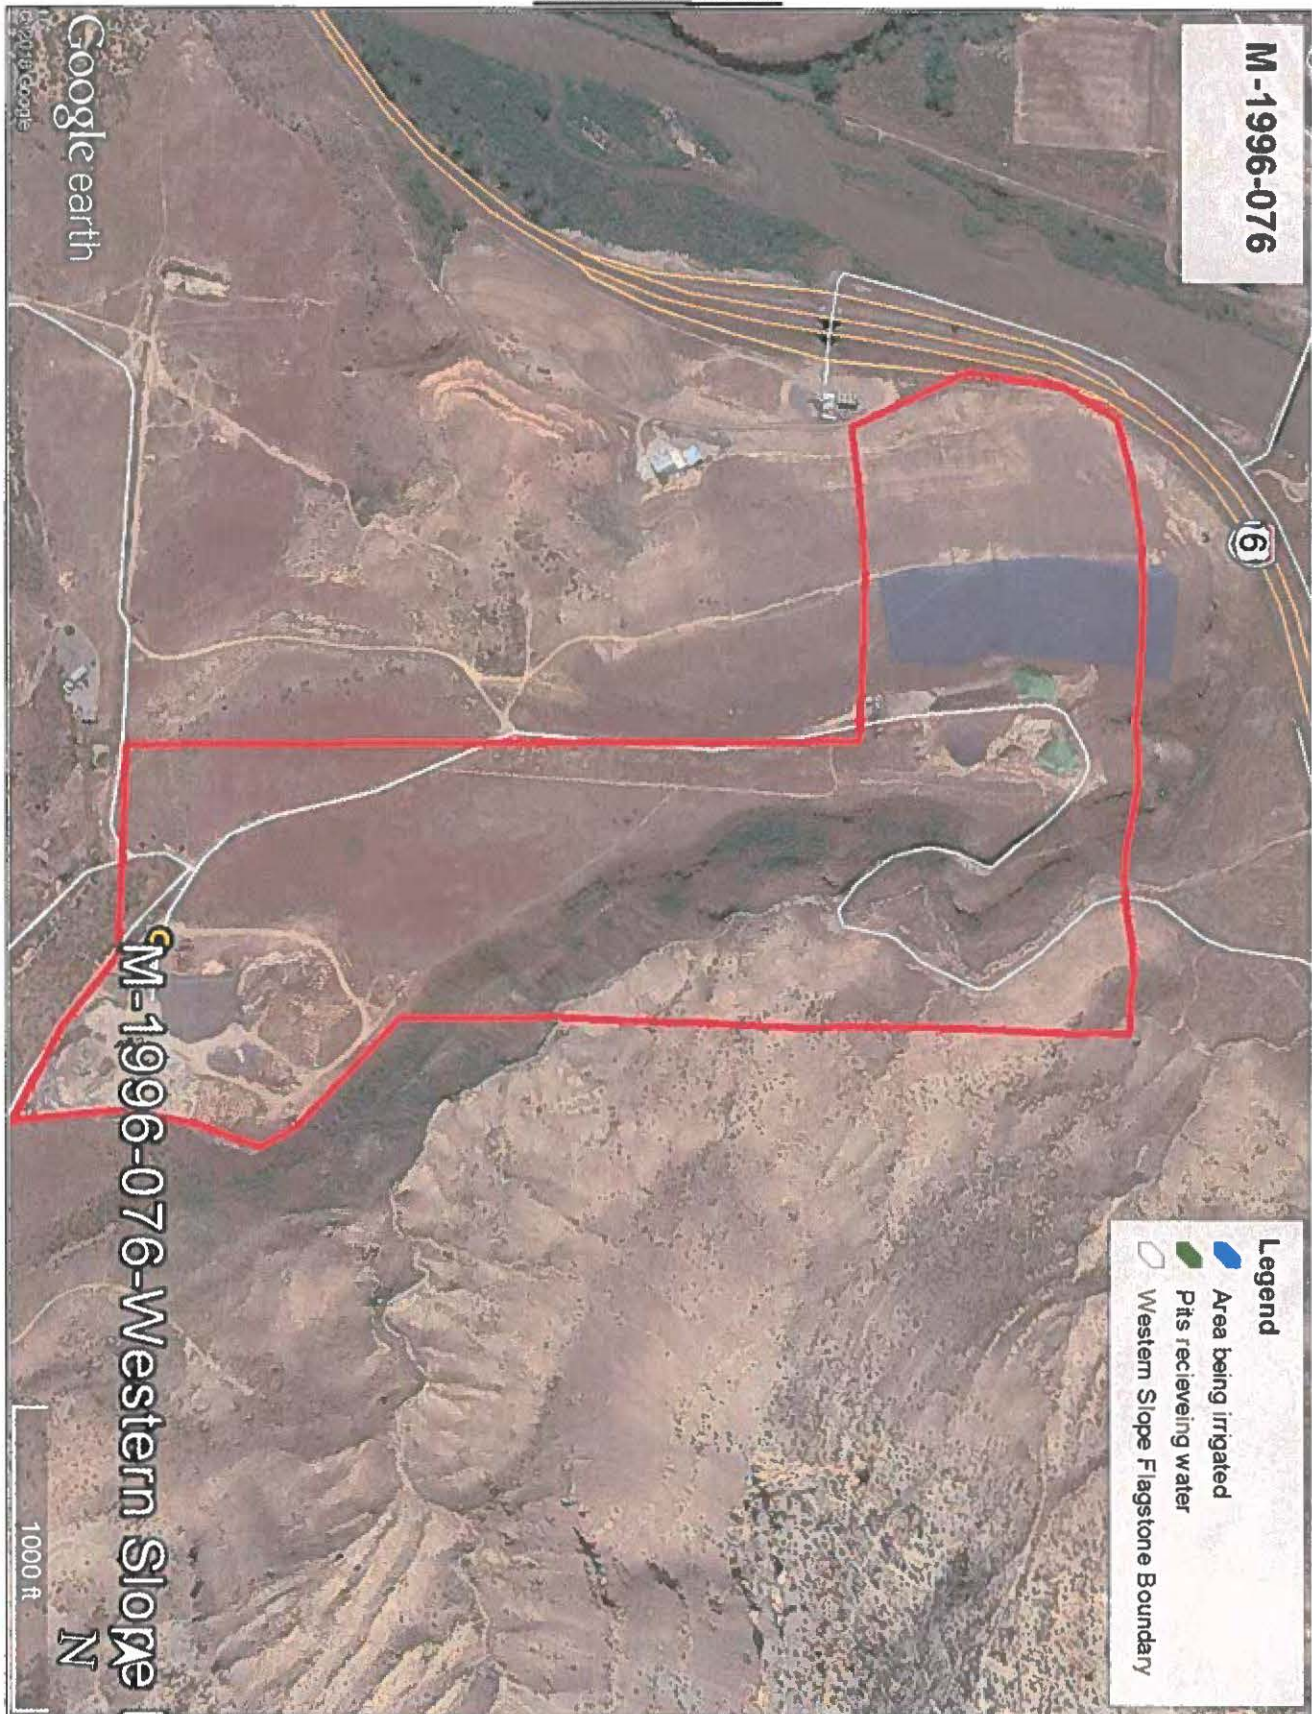
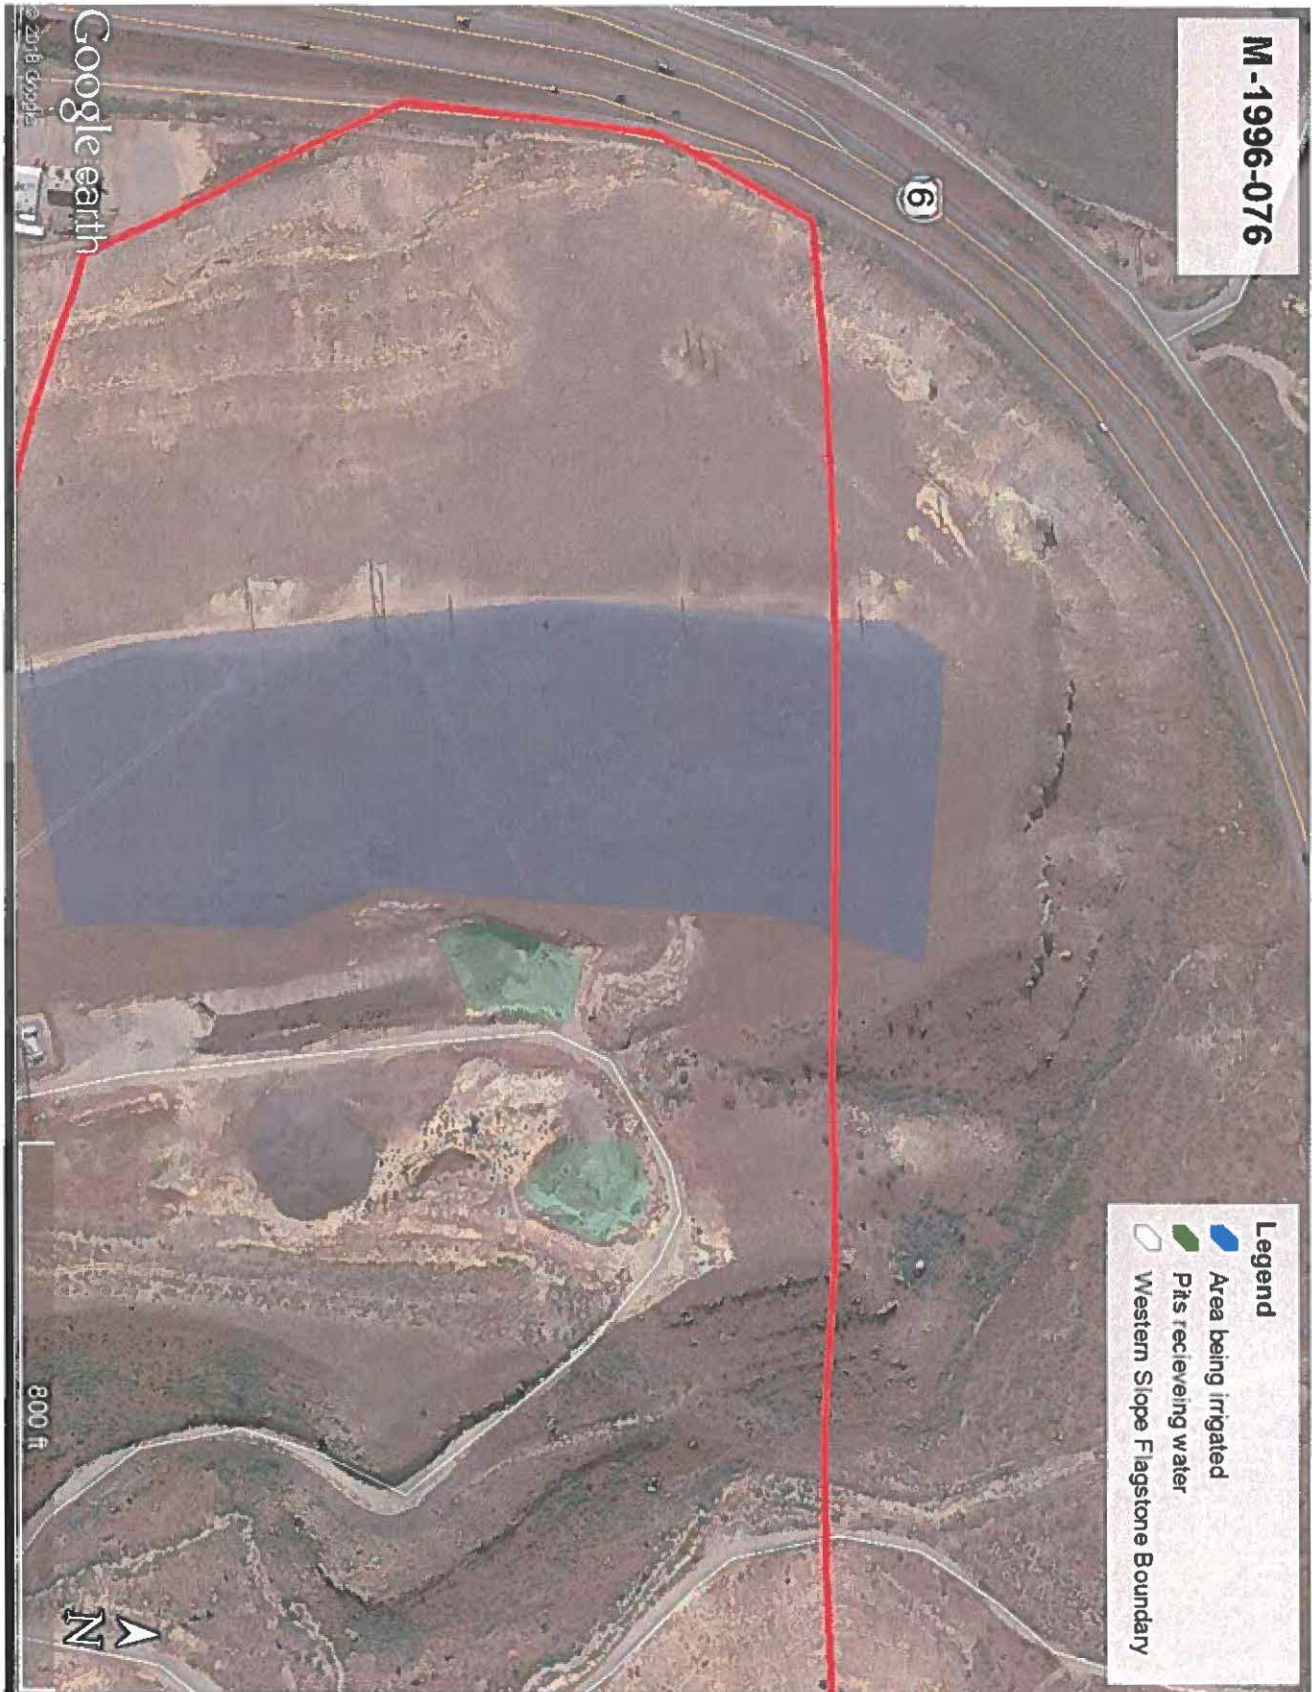
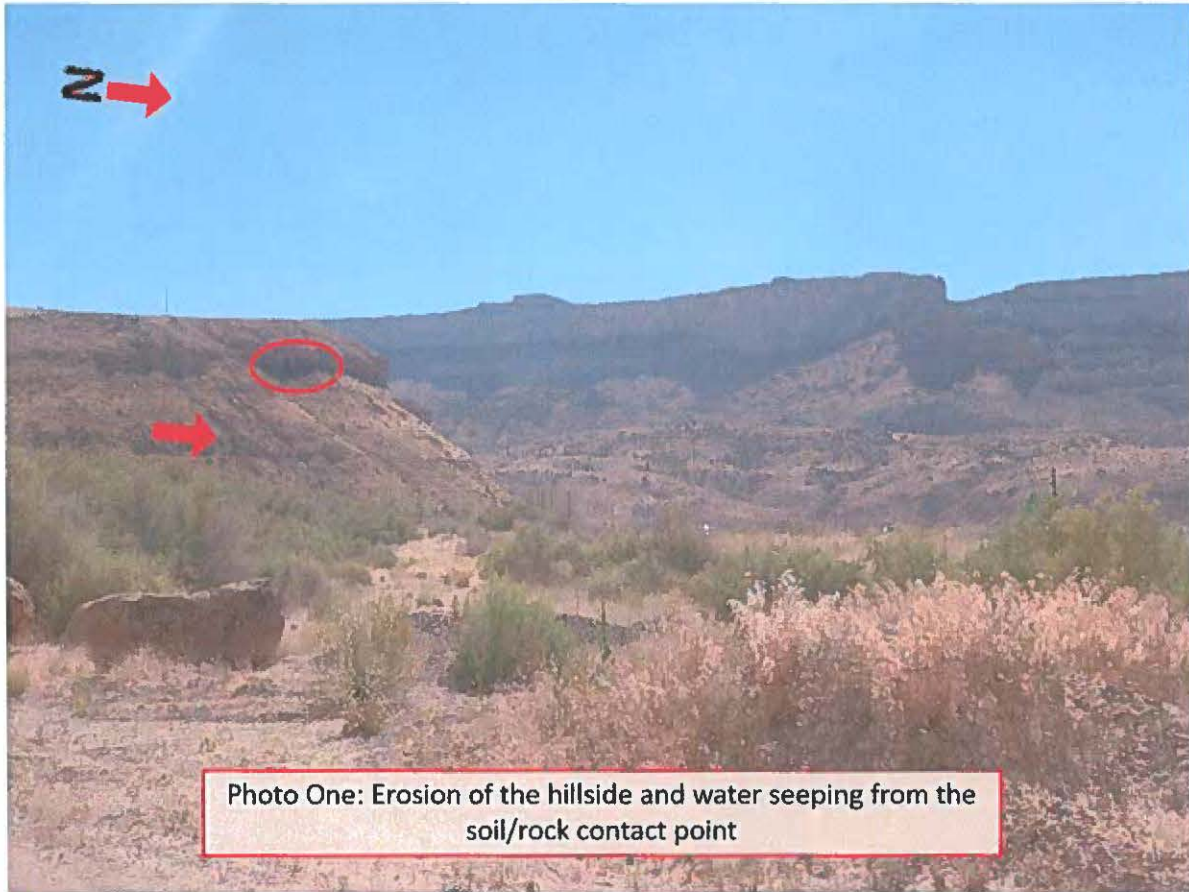
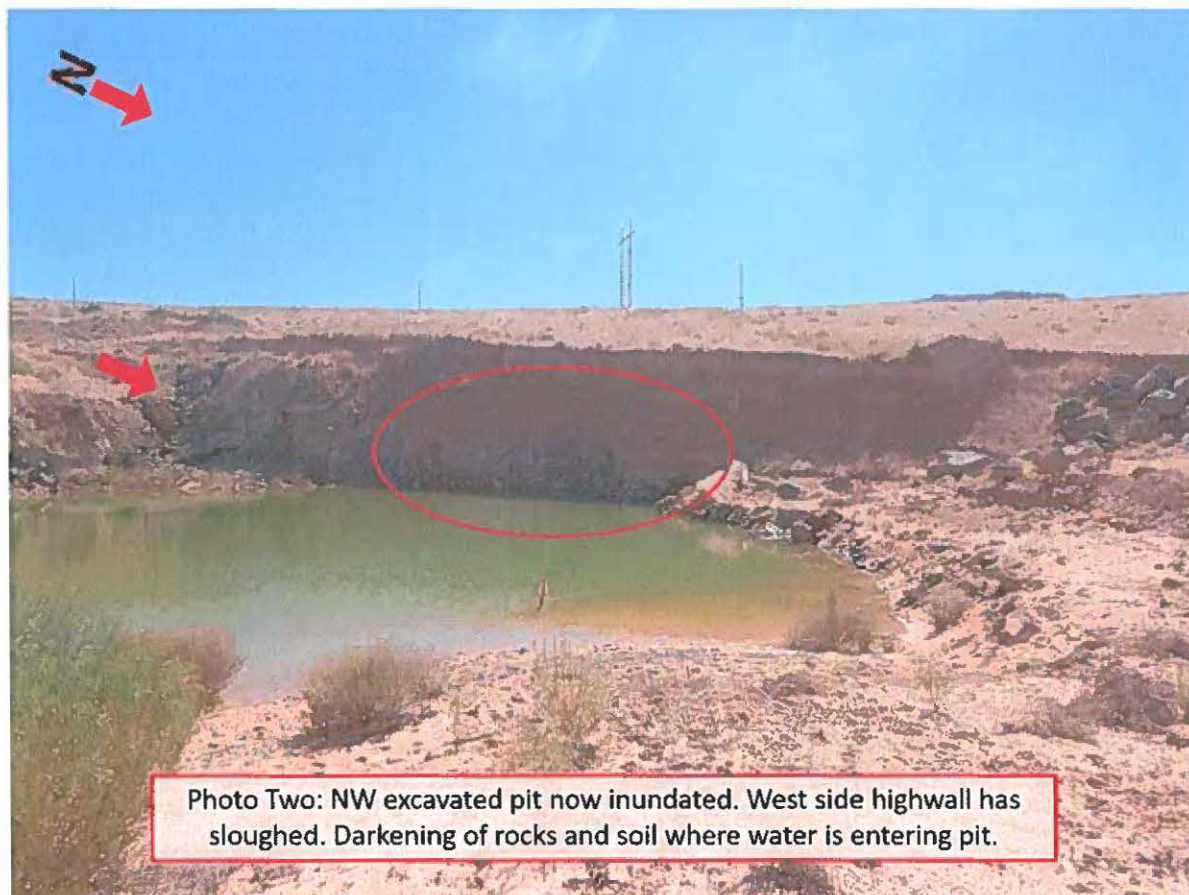
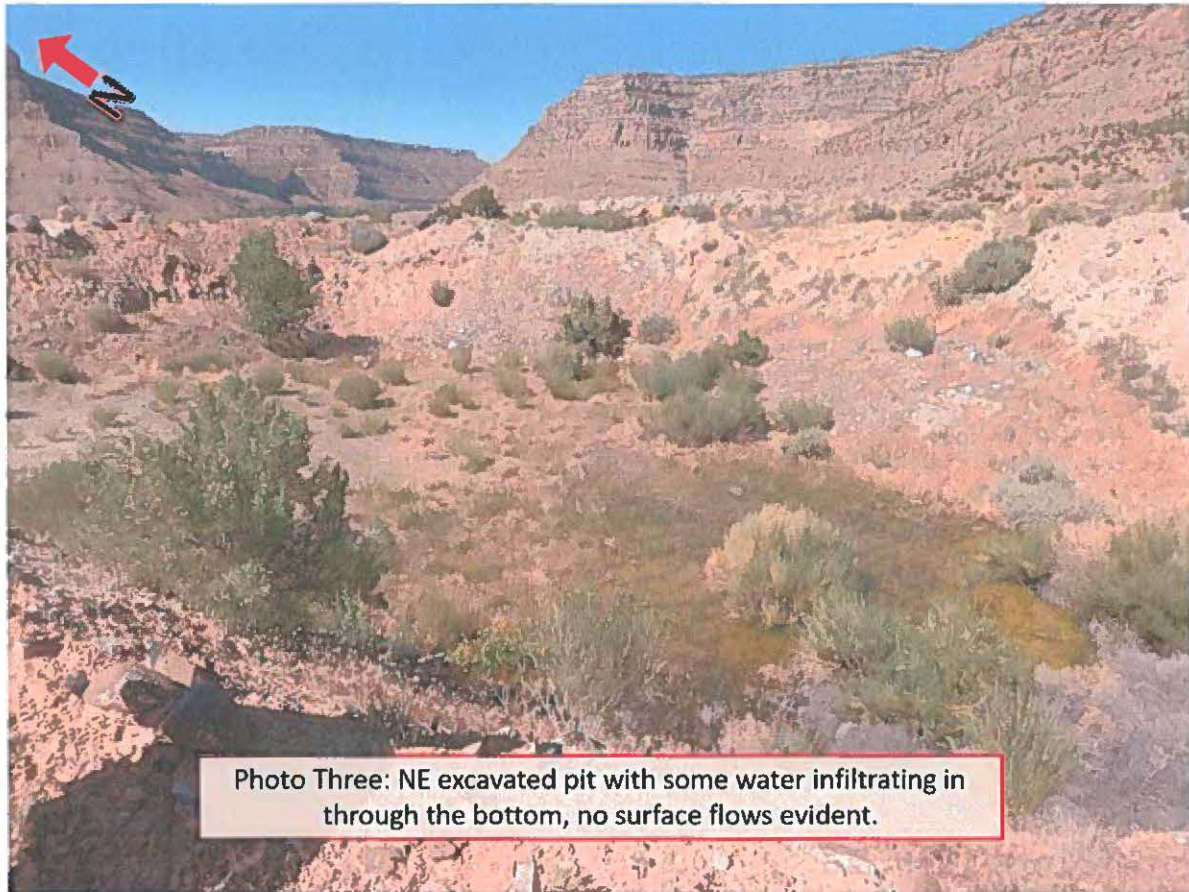
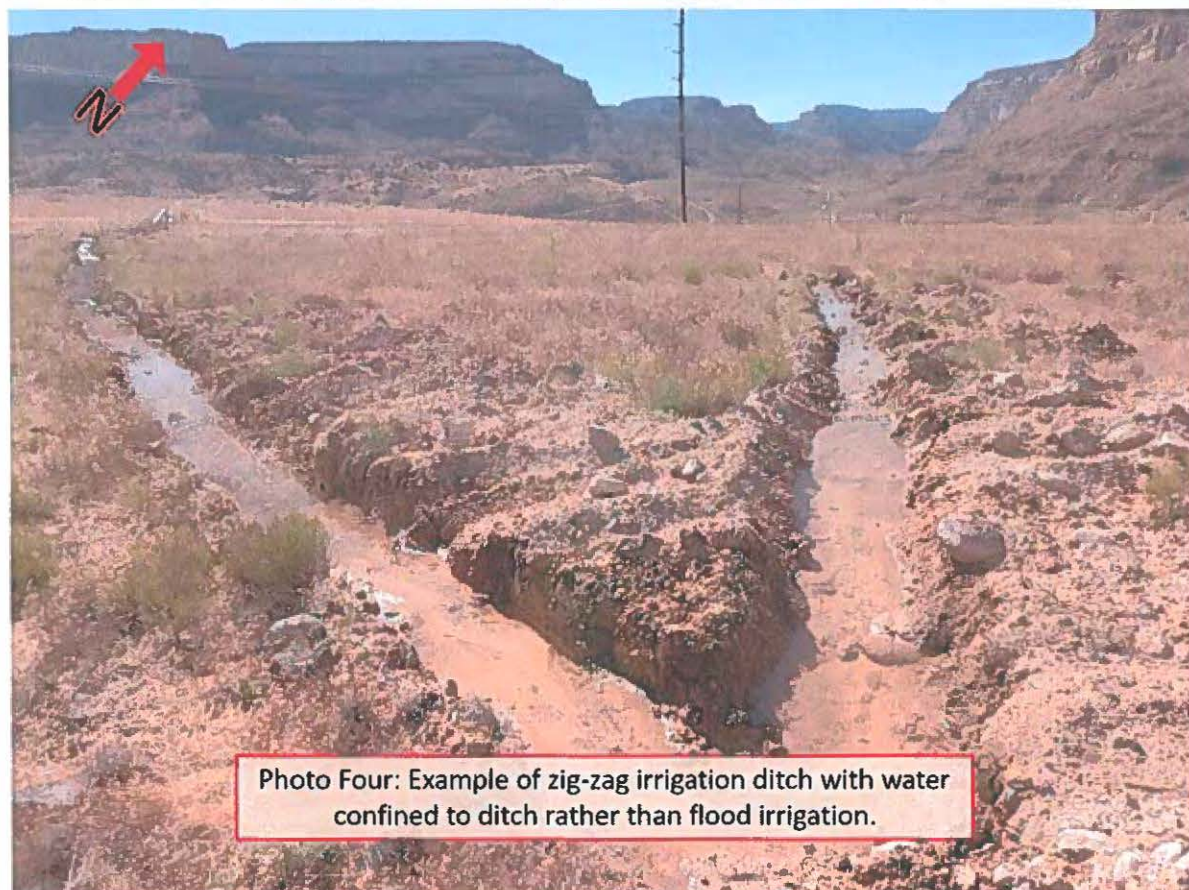
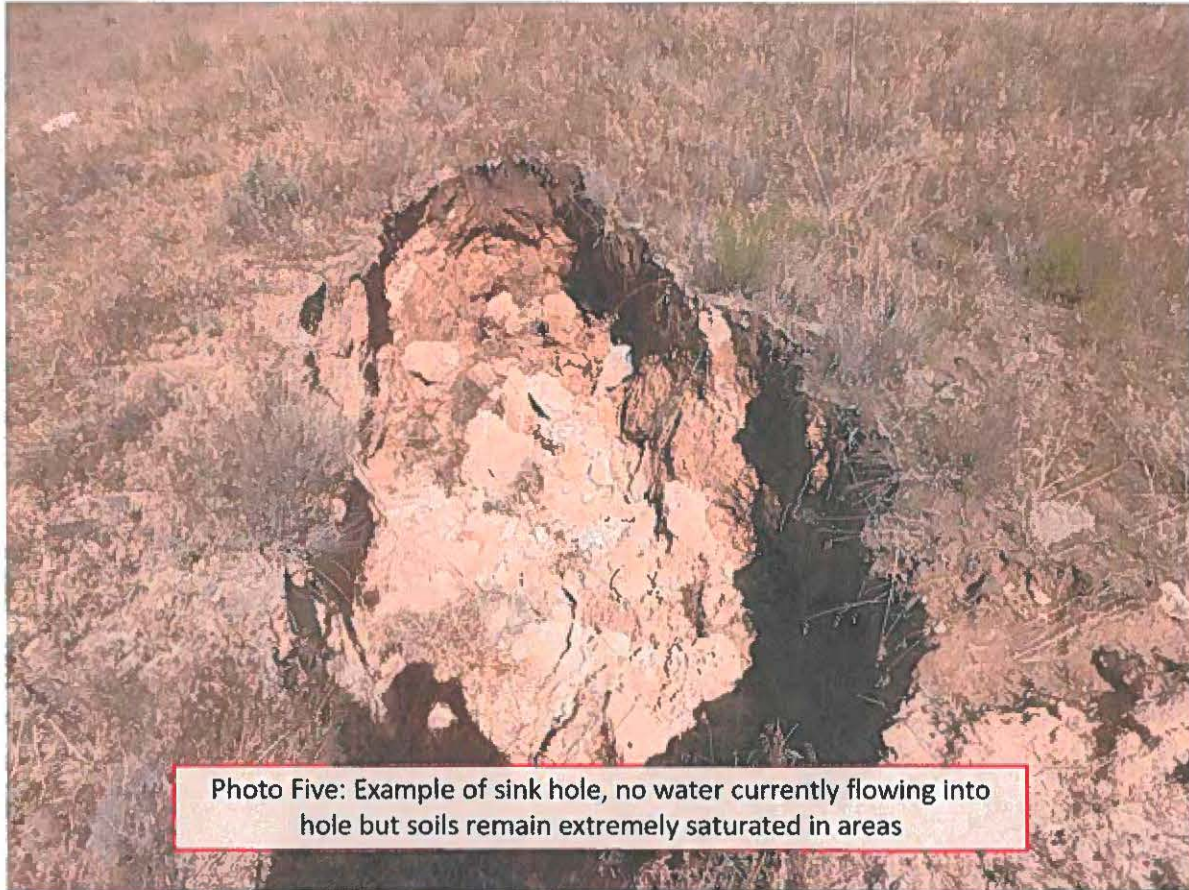
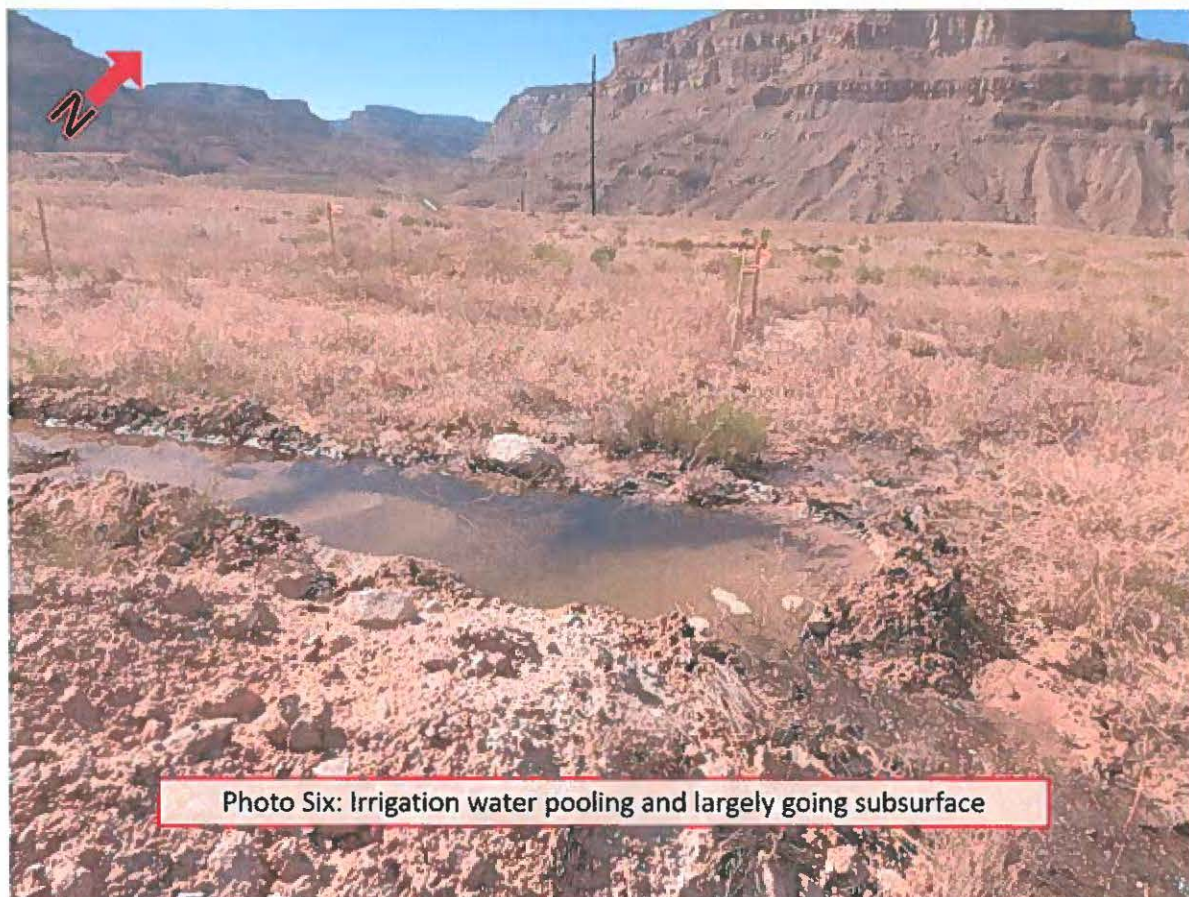
The Division entered the mine via the haul access road off of I-70. When the mine is observed from the haul access road (I-70 corridor) discoloration in the contact point between soil and bedrock is visible. The hillside has visible erosion and evidence of water seeping out of the hillside could be seen. DWR indicated that they would contact CDOT regarding possible safety concerns on I-70. The following afternoon rocks had fallen onto I-70 and on Thursday (7/11/19) morning CDOT was on site with lane closures around the hillside adjacent to the mine.

In the northern affected lands of the mine are two pits. In no recent inspections had water ever been observed or encountered in these pits. At the time of this inspection the northwestern pit was inundated with several feet of water. Soil was saturated several feet higher than the current water level indicating that the water level previously was much higher. Mrs. Hammond indicated that on recent previous site visits the water was overtopping the pit sides and flowing outside of the pit and potentially out of the mine permit boundary. At the time of the inspection it did not appear that additional water was entering the pit. Darkening of the rocks and soil was still visible indicating recent water flows on the west side of the pit. Water appeared to primarily be entering the pit via the contact point between the soil and bedrock. Soil sloughing on the western highwall was evident. An approximately 15 foot wide section has collapsed. The pre-existing wall was near vertical and estimated to be 15 feet above the observed water level.

The second pit is located on the east side of the northern permit area. Historically this pit has also been dry. This pit too had water in the bottom. Water levels in the east pit were estimated to be only a few feet in depth. Due to the high porosity of the soils, connectivity between the two pits rather than direct surface flows is highly probable.

West of the affected lands within the permit boundary the Division observed several alleged "irrigation" ditches being utilized. Water was supplied via a buried pipe where it was then brought to surface and allowed to flow in a zig-zag pattern along the surface. In most areas water appeared to be confined to the ditches rather than flood irrigating the surface. In several instances water 'disappeared' subsurface leaving holes of varying sized. In other areas soil sloughing or collapses were observed with the saturated soils visible by a distinct dark patches. This activity does not appear to be in support of the mining operation and is contrary to the conditions of a permit. The approved mine and reclamation plans are conditions of the approved permit. Neither plan is approved for water storage retention either for irrigation or stormwater. Reclamation plans do not cite irrigation as a method to establish reclamation.

Conversion CN-01, specifically states the operation is a high and dry pit and will remain dry throughout the life of the mine. The observed water within the mined lands has the potential for off-site damages including safety concerns of the I-70 corridor and should be stopped immediately. Unauthorized water retention within the pits is cited as a possible violation Pursuant to C.R.S. 34-32.5-124(1) for failure to comply with the conditions of an order, permit or regulation. The Operator shall provide the Division with photo documentation that irrigation within the mining permit boundary has ceased. Any retained water within the pits must be pumped out of the pit area within 72 hours of receipt of this report. The Division will be conducting follow up site inspections to verify compliance with Cease and Desist Orders and monitor site conditions to evaluate if areas outside of the permit boundary are or were affected.

As the result of an inspection problem in 2018 the Operator was required to delineate the permit boundary. In areas where topography was unsafe and unsuitable for mining the Operator indicated that the permit boundary would be inset. At the time the Division approved this as a reasonable practice. Upon site inspection the permit boundary marker was placed well within the permit boundary on flat land. This mis-identification of the permit boundary delineates the irrigated areas as being outside of the mine permit boundary which is not the case. The incorrectly delineated permit boundary is cited as an inspection problem. The Operator shall place boundaries on the mine permit boundary, regardless of the mining feasibility. Alternatively the Operator may request an acreage reduction of un-affected lands thus reducing the permit boundary to that which is delineated on the ground and/or suitable for mining. The Operator shall provide photo documentation that boundary markers have been properly placed on the mine permit boundary by the corrective action deadline listed on page two of this report. If the Operator wishes to request an acreage reduction the request must be made prior to the corrective action date, however the problem will not be abated until the revision is approved.

CORRECTIVE ACTIONS: A Cease and Desist Order is attached. The Operator shall immediately cease irrigation activities within the approved permit boundaries upon receipt of this report.

CORRECTIVE ACTIONS: The Operator shall place boundaries on the mine permit boundary, regardless of the mining feasibility. Alternatively the Operator may request an acreage reduction of un-affected lands thus reducing the permit boundary to that which is delineated on the ground and/or suitable for mining. The Operator shall provide photo documentation that boundary markers have been properly placed on the mine permit boundary by the corrective action deadline listed on page two of this report. If the Operator wishes to request an acreage reduction the request must be made prior to the corrective action date, however the problem will not be abated until the revision is approved.
