MINERALS PROGRAM INSPECTION REPORT
PHONE: (303) 866-3567

| MINE NAME: George Ansley Pit | MINE/PROSPECTING ID#: M-1978-078-SG | MINERAL: Sand and gravel | COUNTY: Lincoln |
| INSPECTION TYPE: Monitoring | INSPECTOR(S): Patrick Lennberg | INSP. DATE: October 11, 2019 | INSP. TIME: 11:50 |

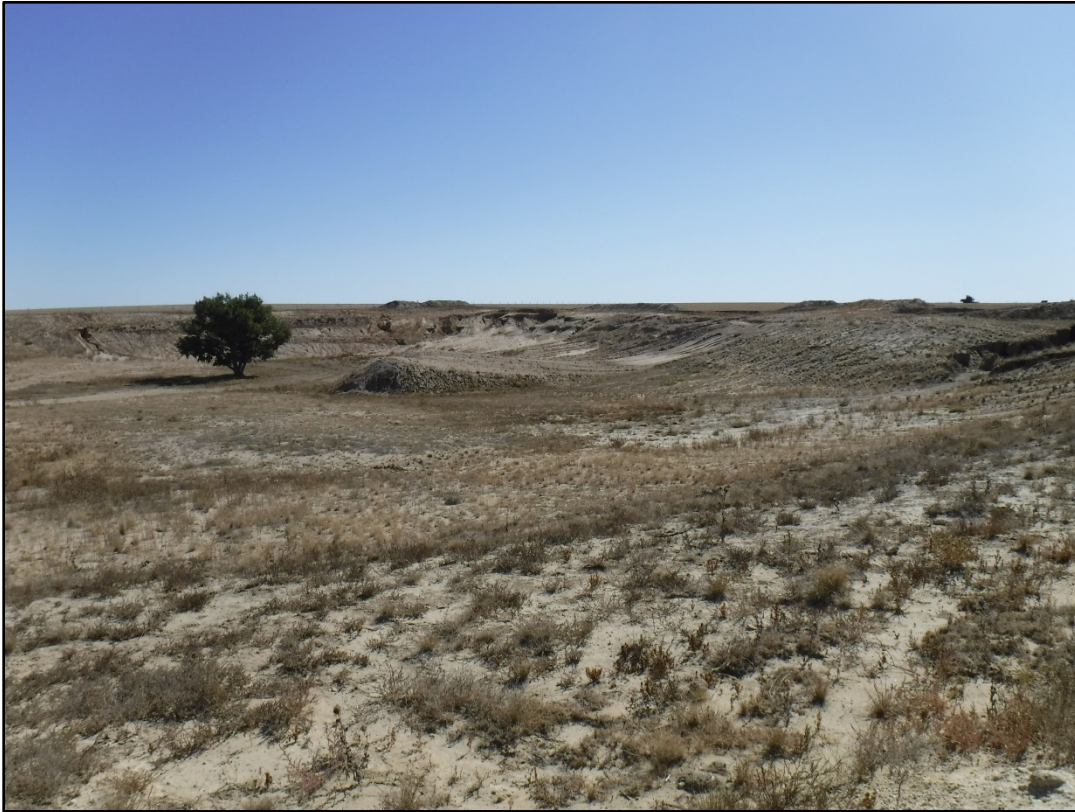
Photo 1: Looking southeast across the pit area from the haul road entrance

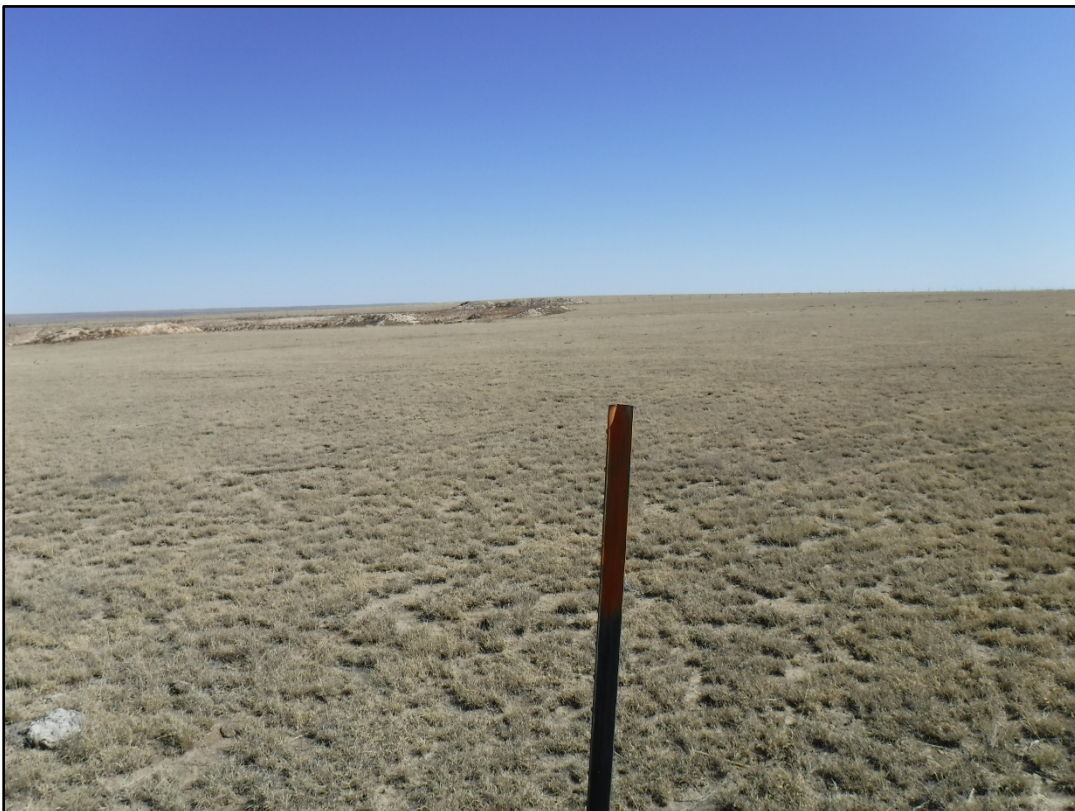
Photo 2: Typical permit boundary marker, southwestern corner marker pictured

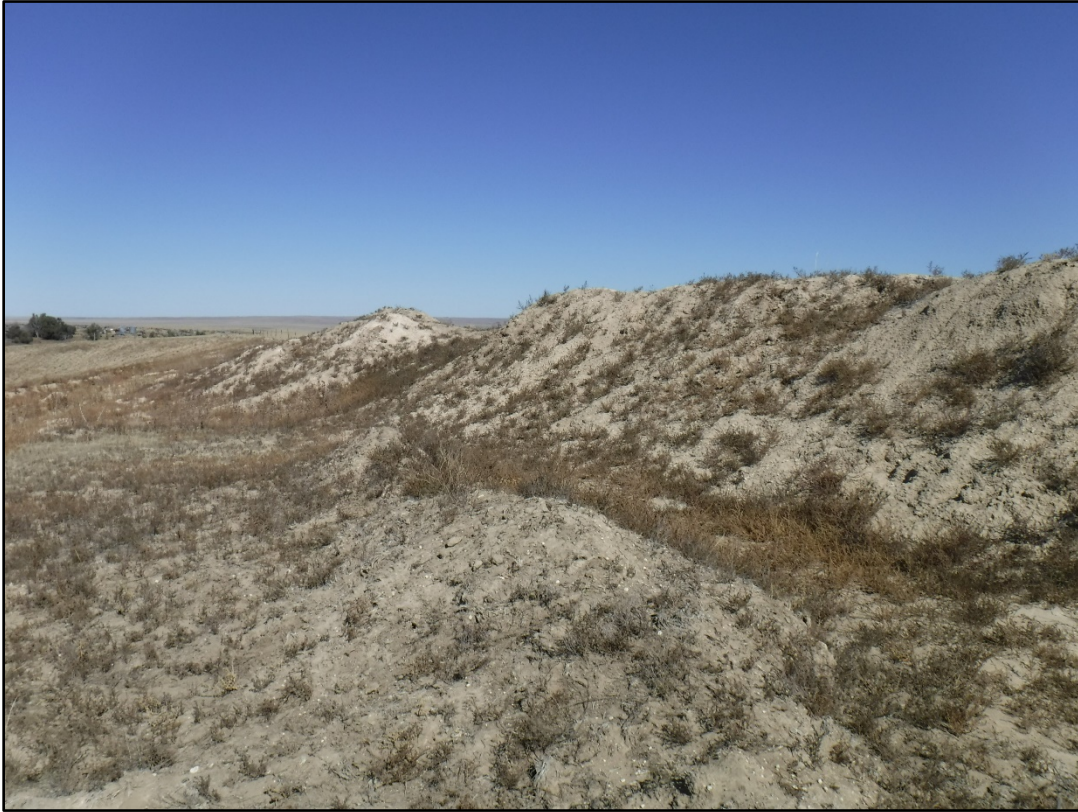
Photo 3: Topsoil stockpile located along the southwestern edge of pit

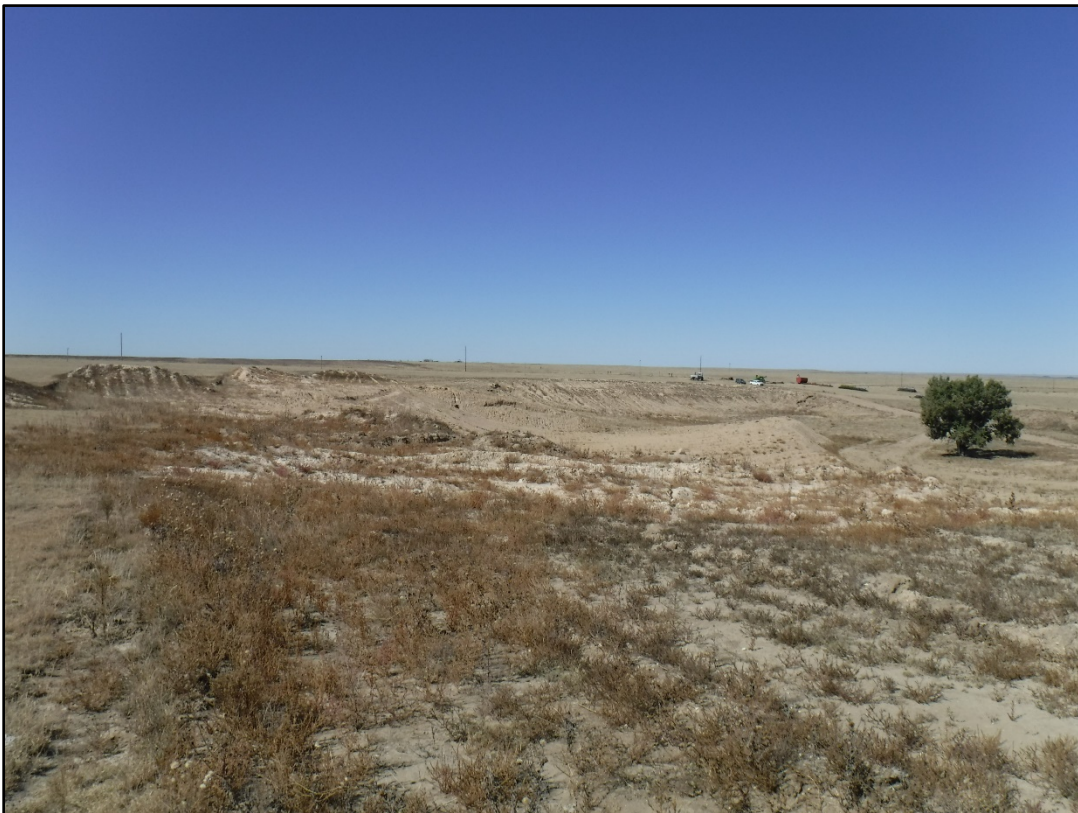
Photo 4: Looking northwest across the pit area back towards the haul road entrance

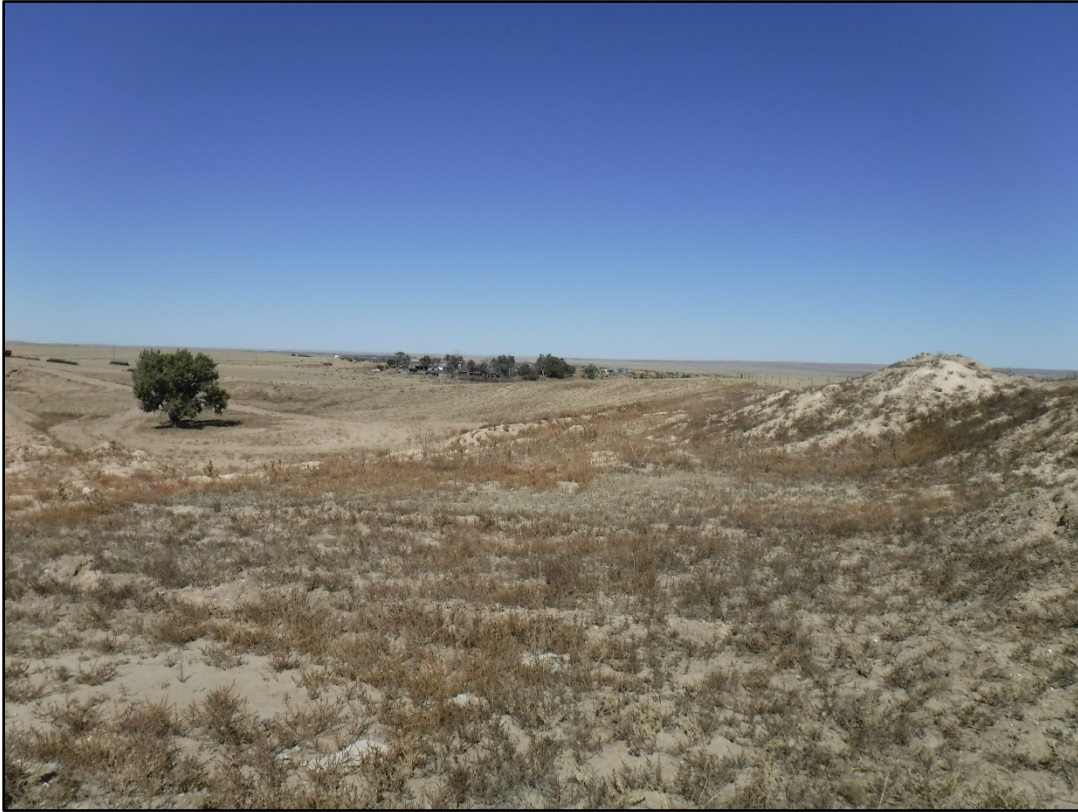
Photo 5: Looking north along the eastern boundary of the pit, topsoil stockpile center right of picture

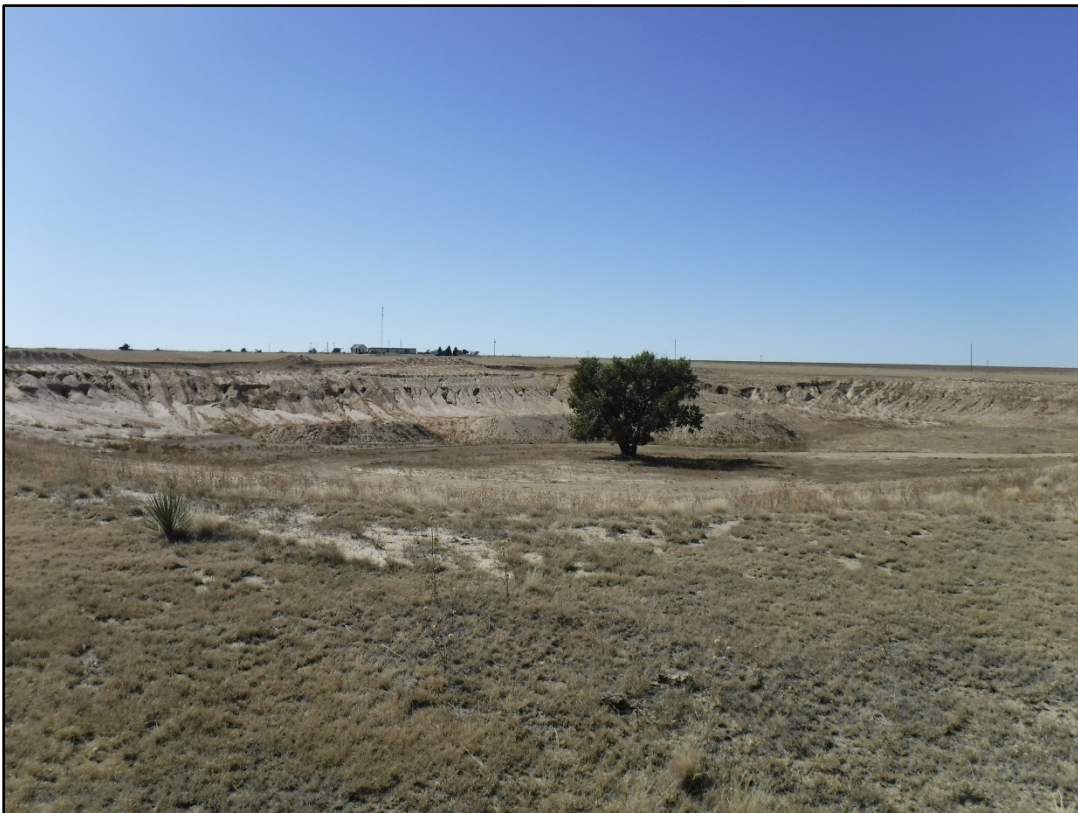
Photo 6: Looking west across the southern half of pit area

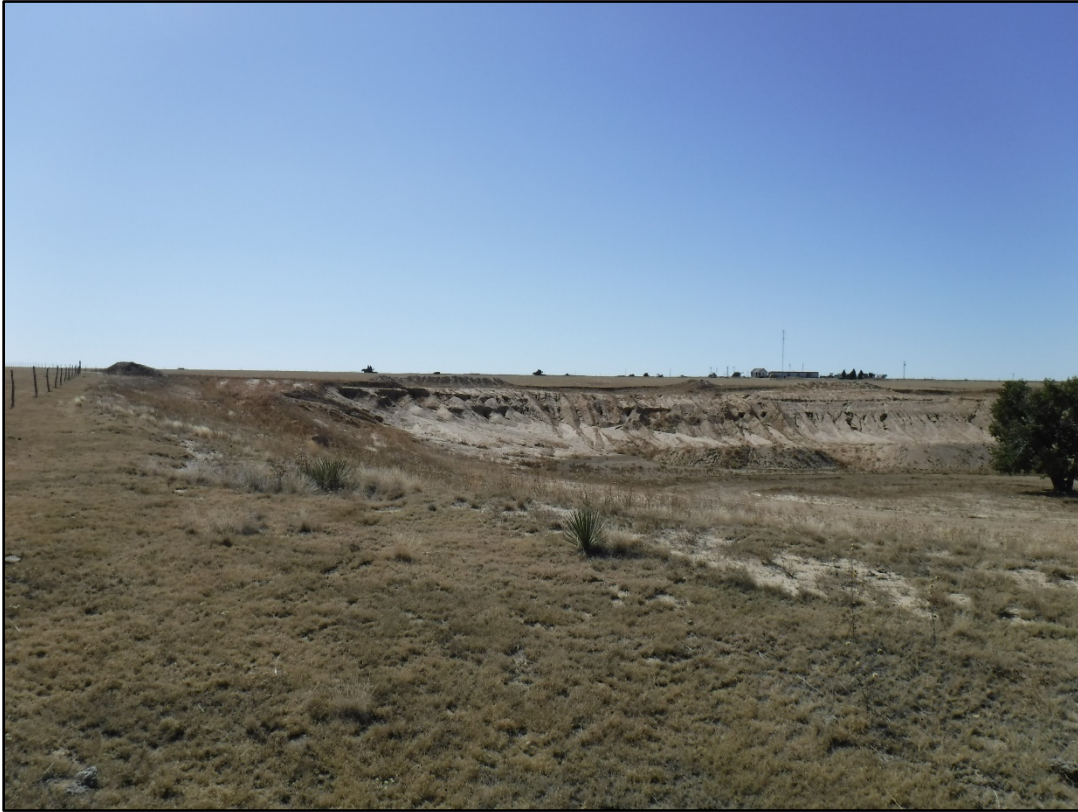
Photo 7: Looking south along the eastern permit boundary, barbed wire fence (center left) marks permit boundary

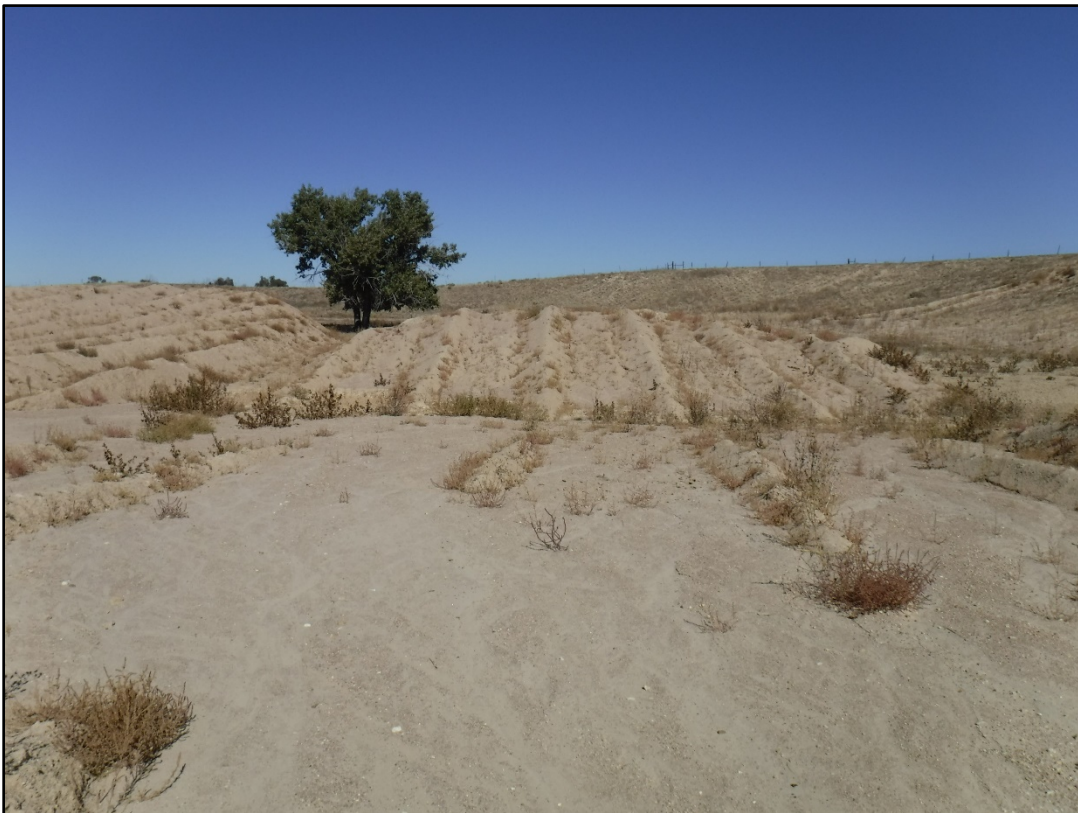
Photo 8: Product stockpile, looking north

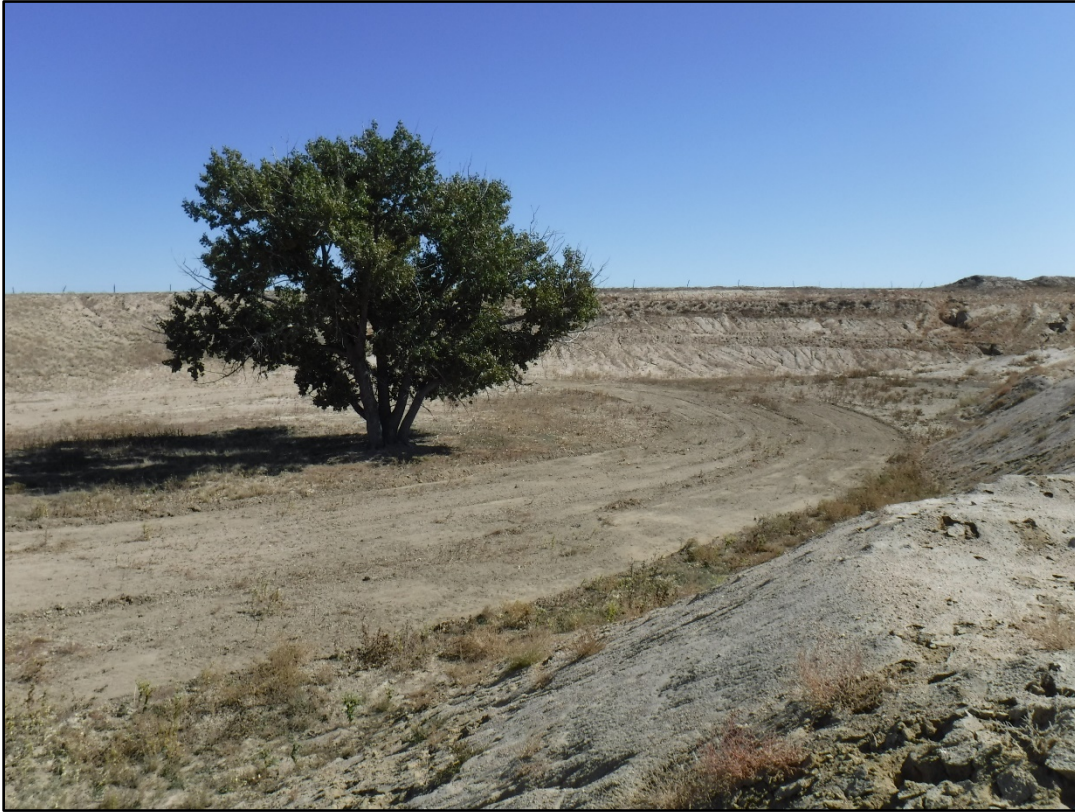
Photo 9: Recent grading of haul road through pit in preparation for activity

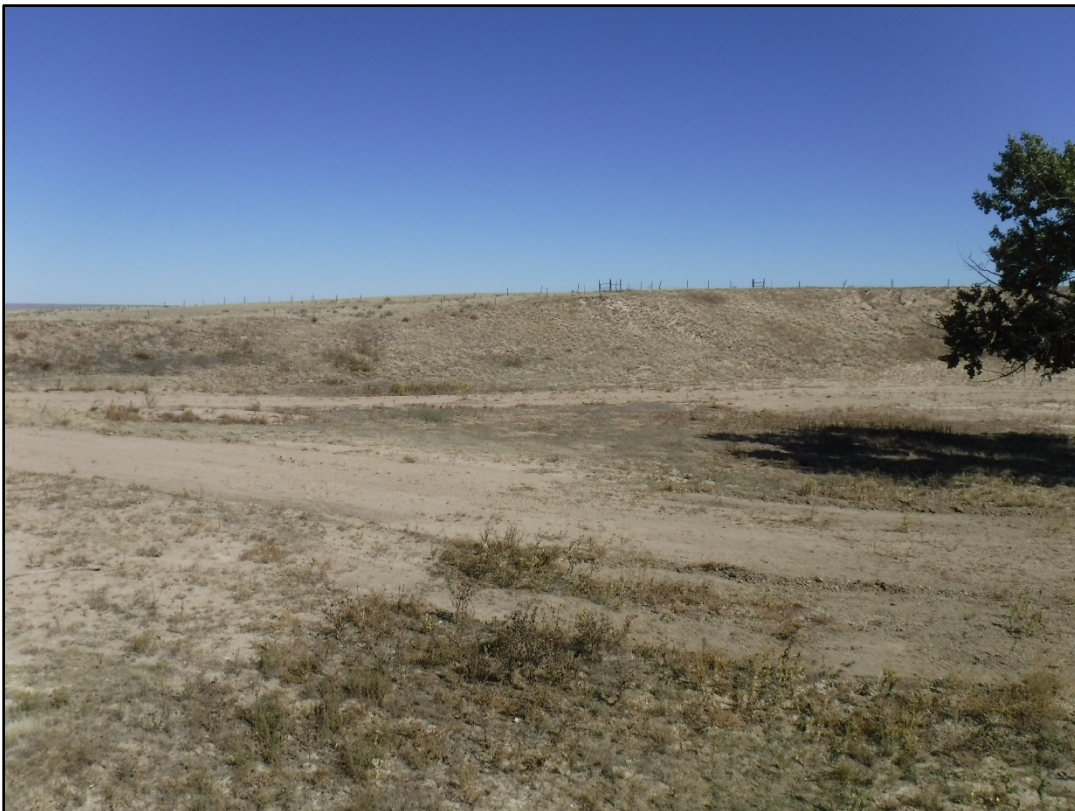
Photo 10: Reclamation success of the northern permit boundary
