MINERALS PROGRAM INSPECTION REPORT

MINE NAME: Clark Pit	MINE/PROSPECTING ID#: M-2007-084	MINERAL: Sand and gravel	COUNTY: Lincoln
INSPECTION TYPE: Monitoring	INSPECTOR(S): Patrick Lennberg	INSP. DATE: October 11, 2019	INSP. TIME: 09:45
OPERATOR: Lincoln County	OPERATOR REPRESENTATIVE: Fred Lundy	TYPE OF OPERATION: 110c - Construction Limited Impact

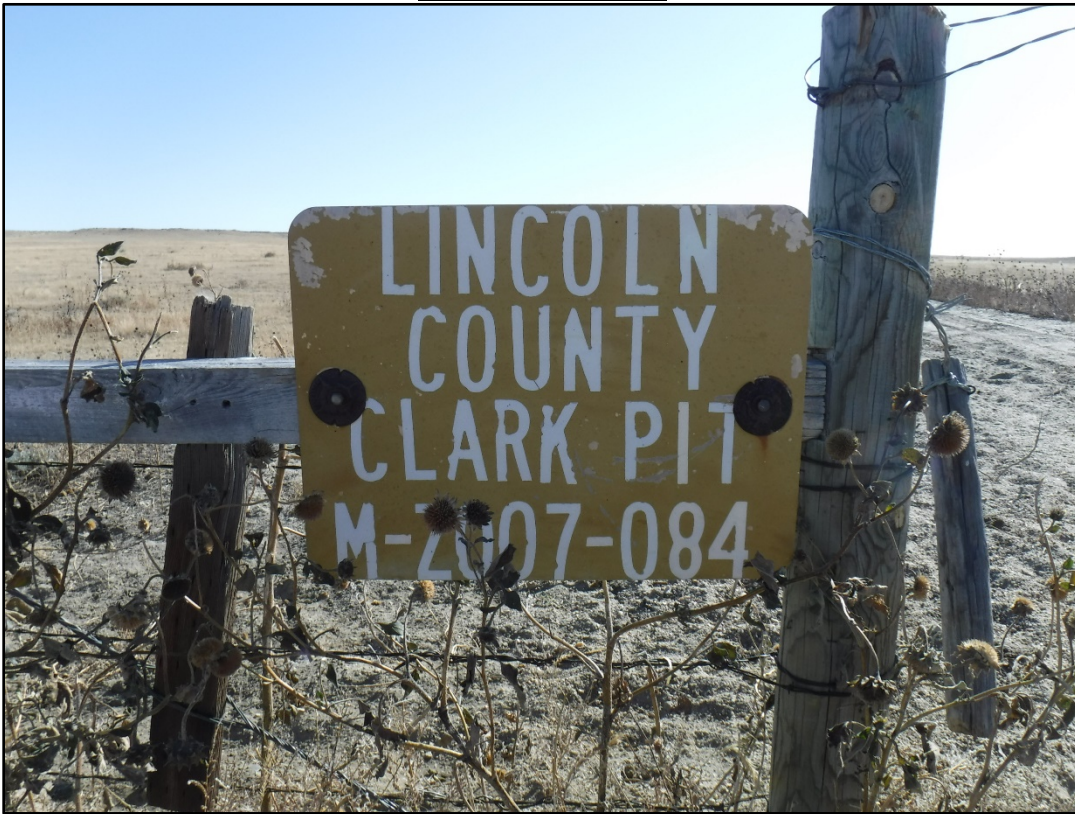
The Clark Pit is located approximately 4 miles southeast of Karval, CO. Access to the site is off of Co Rd 31. The affected land is owned by Clinton A. Clark and Betty Clark and leased to Lincoln County through 2022. The pit is a 110c operation permitted for 9.83 acres for the removal of sand and gravel for county road maintenance and repair. The site is surrounded by rangeland and the post-mining land use is rangeland. A mine sign was observed as required by Rule 3.1.12.

Photo 1: Mine sign at entrance off of County Road 31

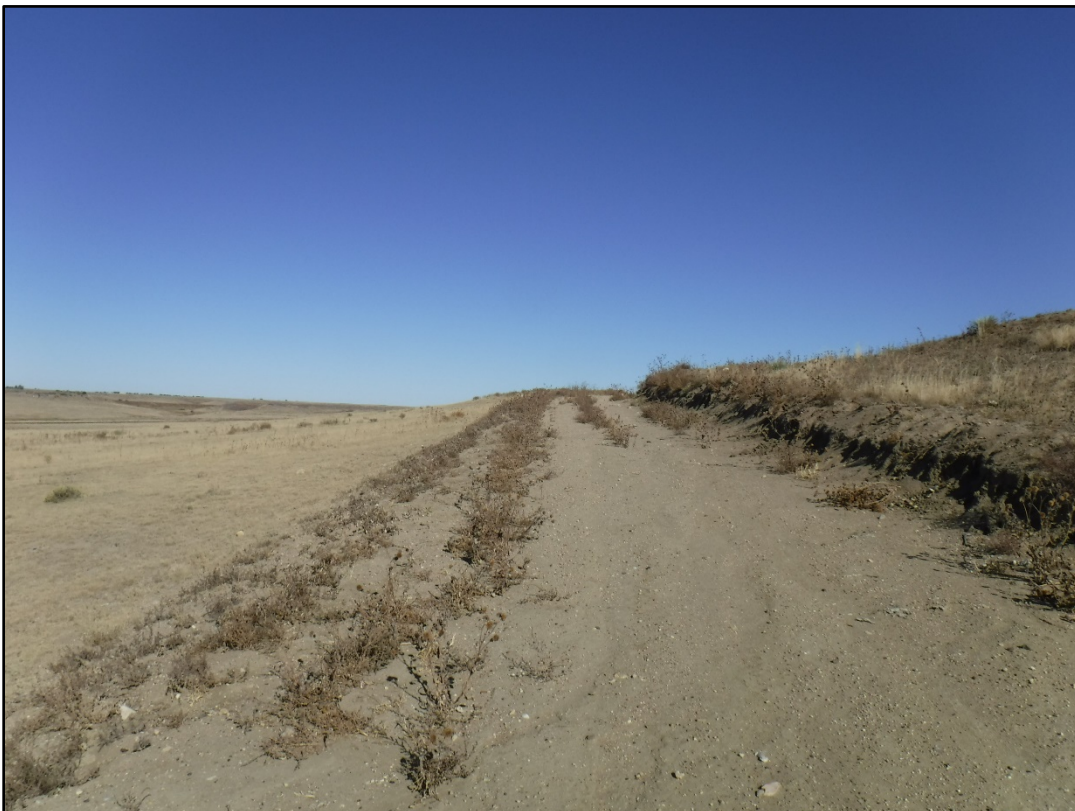
Photo 2: Haul road on west side of boundary leading to active mine area

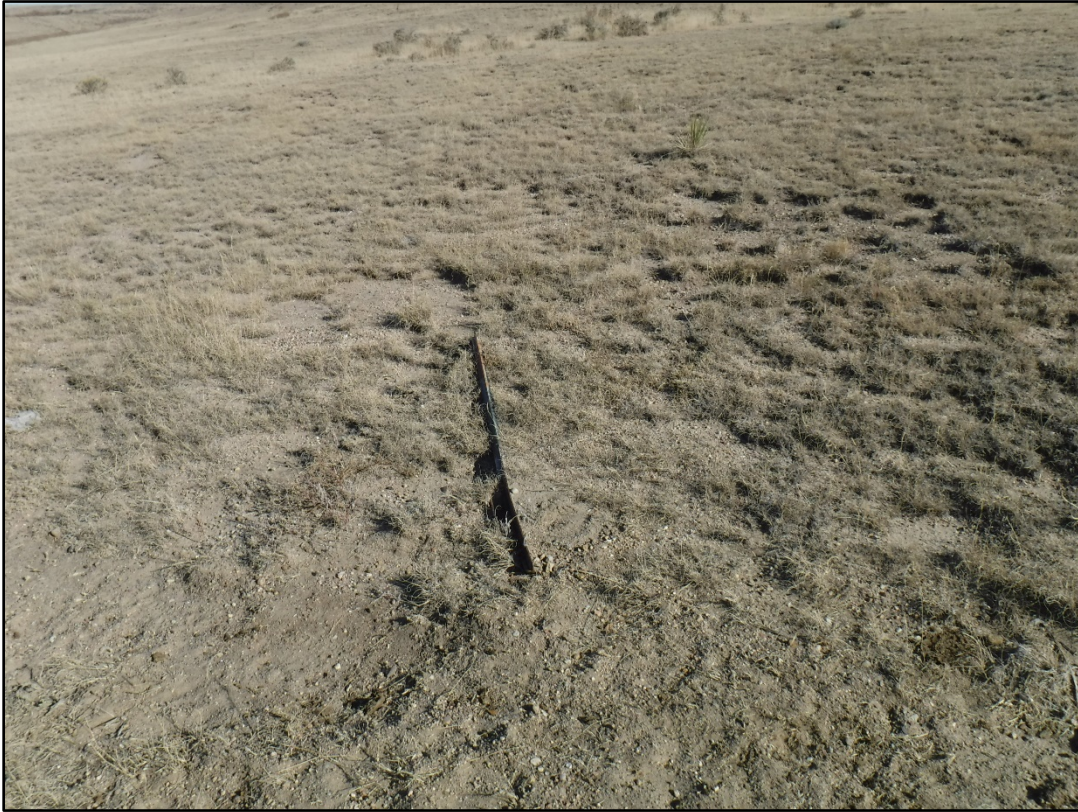
The permit boundary was delineated by tee-posts that were found to have been knocked down by cattle that grazes through the area. The Division took GPS coordinates of the laying down posts. The Division estimates the current level of mining disturbance to be between 5.5 and 6 acres. The majority of the mining has left slopes to be 3H:1V or shallower, except for the northern high wall. The northern high wall is 2H:1V to vertical over a length of approximately 150 feet and approaches 20 feet in height. A stock pile of mined material is stored on the pit floor. Salvaged top soil is stored in two stockpiles located above and southeast of the pit. These stockpiles appeared to be stable with vegetative cover mainly annual weeds. Volunteer vegetation across disturbed area consists primarily of annual weeds and native vegetation. Only the portion of the haul road located inside the permit area will be reclaimed. The remainder of the haul road, from Co Rd 31 to the permit boundary, will remain for use by the landowner. Reclamation of the site calls for grading all mined slopes to 3H:1V or flatter, replacing any salvaged overburden, and placing top soil an average of 6 inches on disturbed areas, and revegetating the site to rangeland.

Photo 3: Typical condition of boundary marker

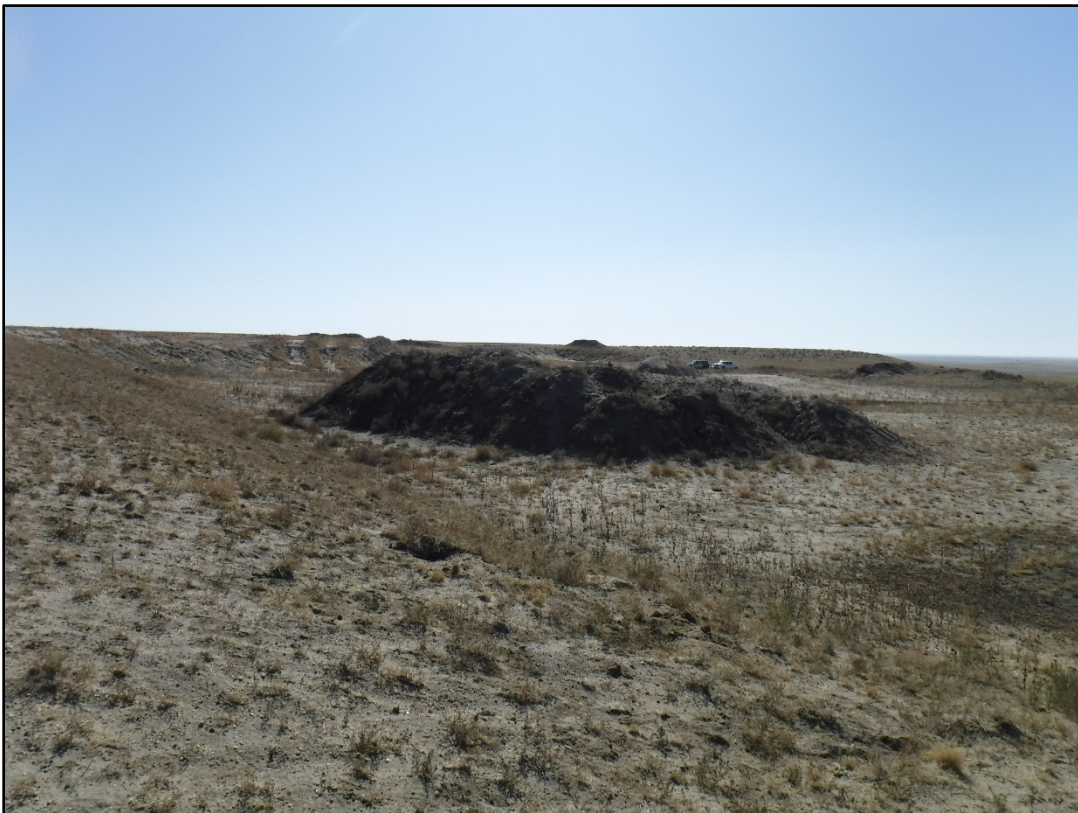
Photo 4: Looking southeast across the permit area, topsoil stockpile center of picture

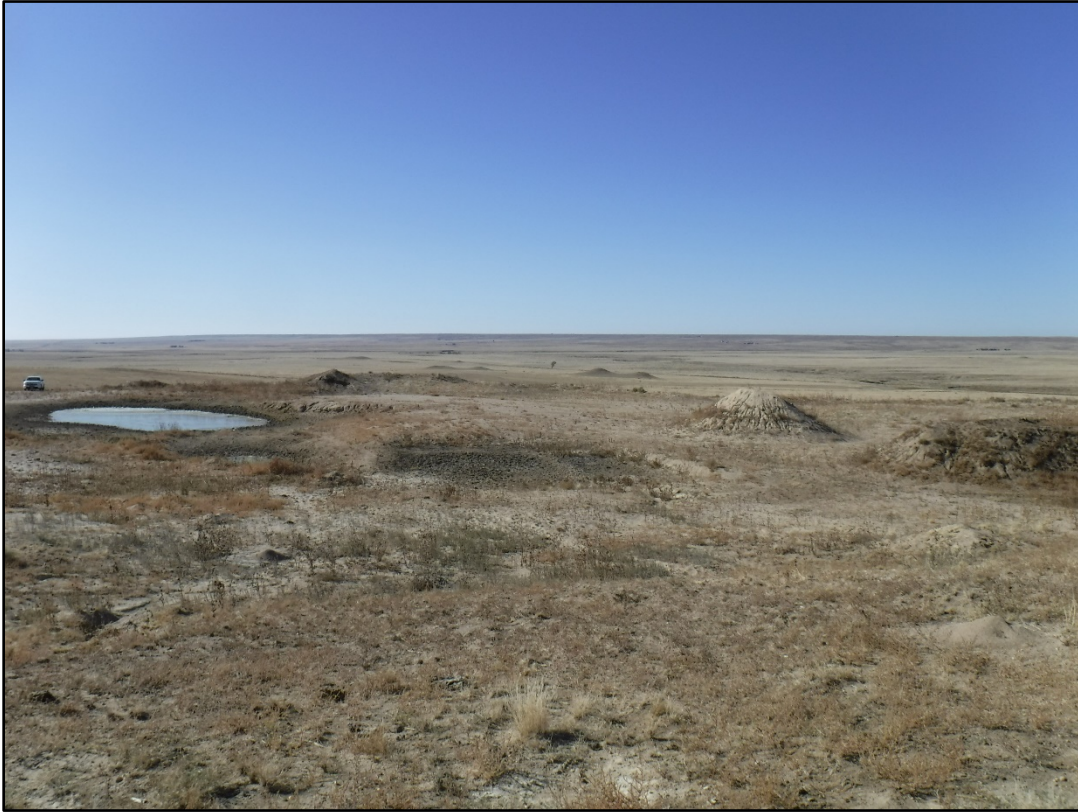
Photo 5: Looking south across the disturbed area from the northern extent of disturbance

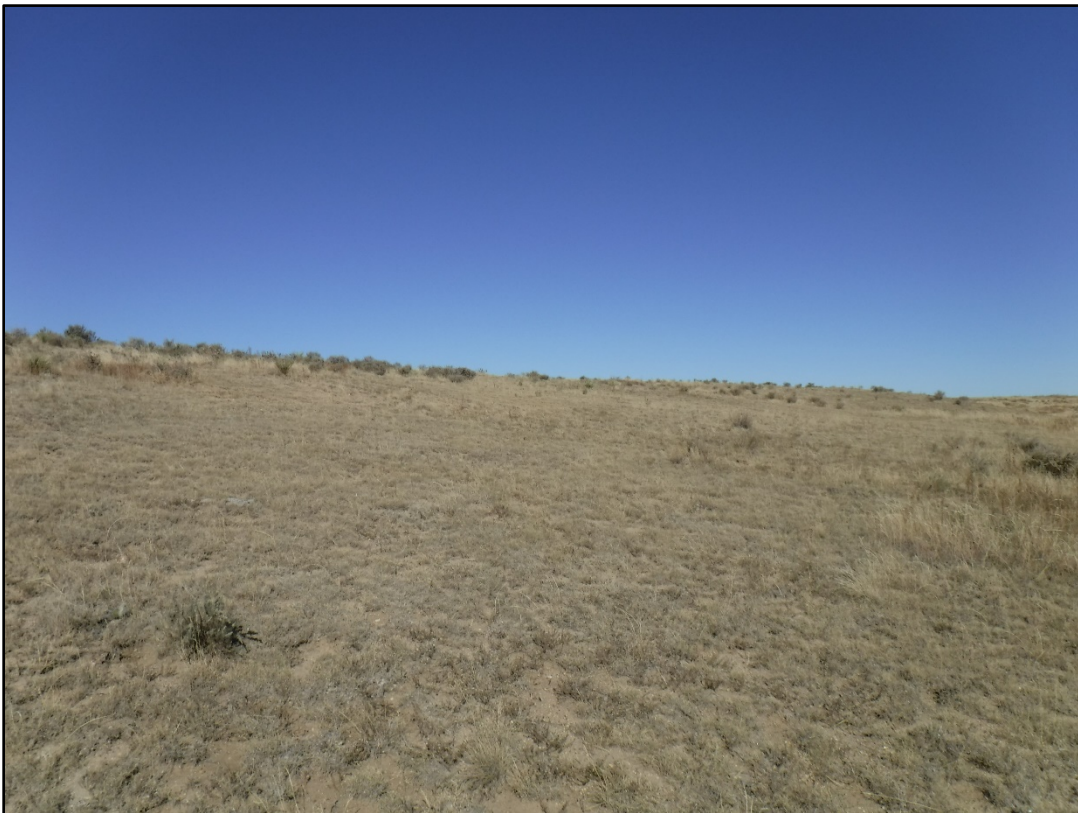
Photo 6: Typical conditions outside the disturbed area

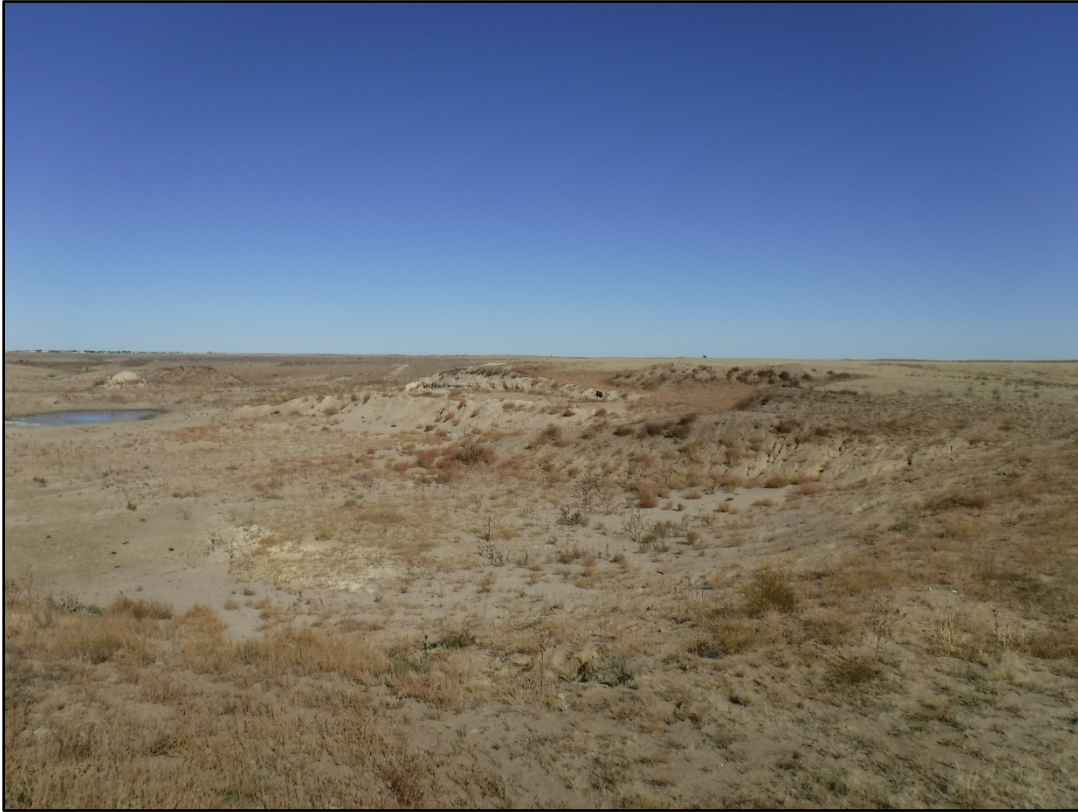
Photo 7: Looking west at the mining area highwall

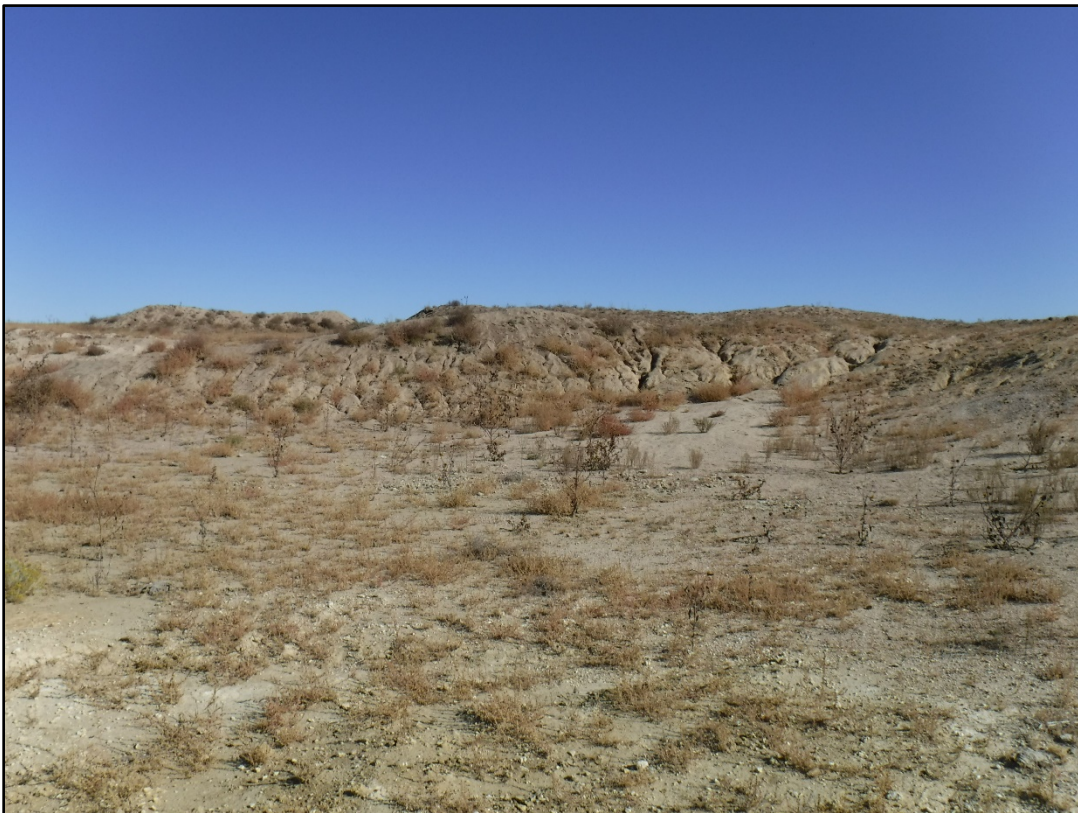
Photo 8: Looking north at the mining highwall from the pit floor.
