MINERALS PROGRAM INSPECTION REPORT
PHONE: (303) 866-3567

MINE NAME: Dougherty Pit	MINE/PROSPECTING ID#: M-1978-079	MINERAL: Sand and gravel	COUNTY: Lincoln
INSPECTION TYPE: Monitoring	INSPECTOR(S): Patrick Lennberg	INSP. DATE: October 11, 2019	INSP. TIME: 10:30
OPERATOR: Lincoln County	OPERATOR REPRESENTATIVE: Fred Lundy	TYPE OF OPERATION: 110c - Construction Limited Impact

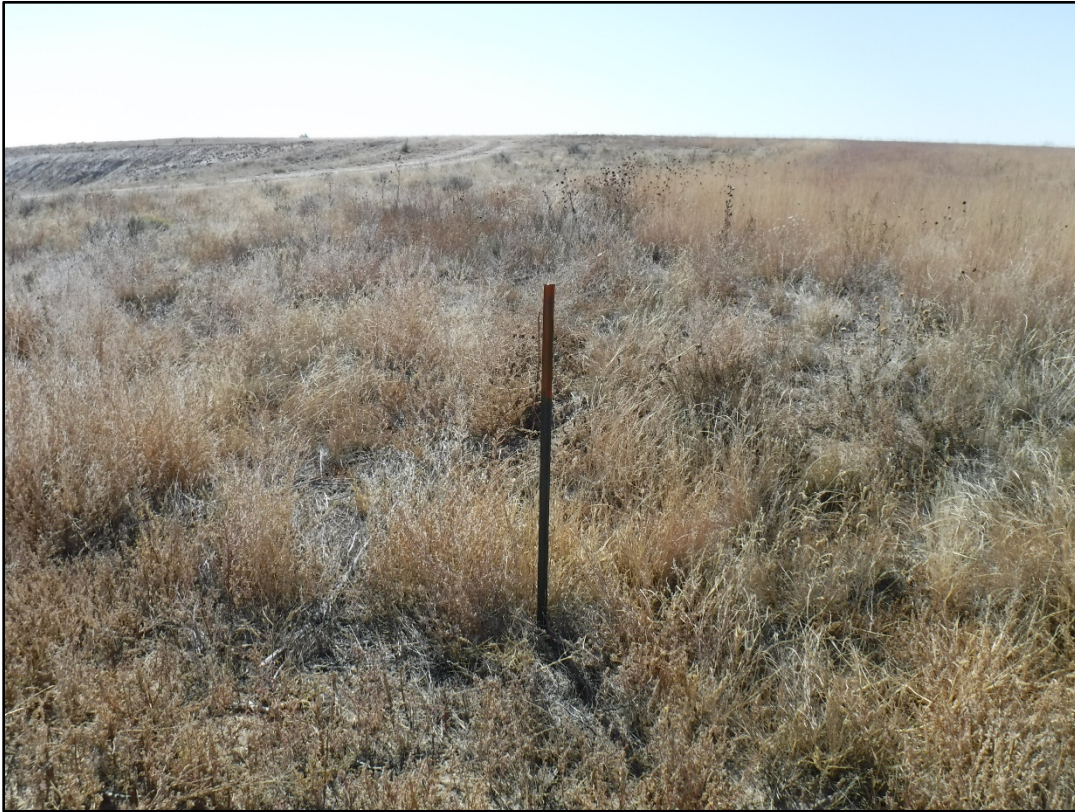
All the permit boundary markers are in place and the Division was able to collect GPS coordinates of them.

Photo 1: Typical permit boundary marker, NW marker looking south

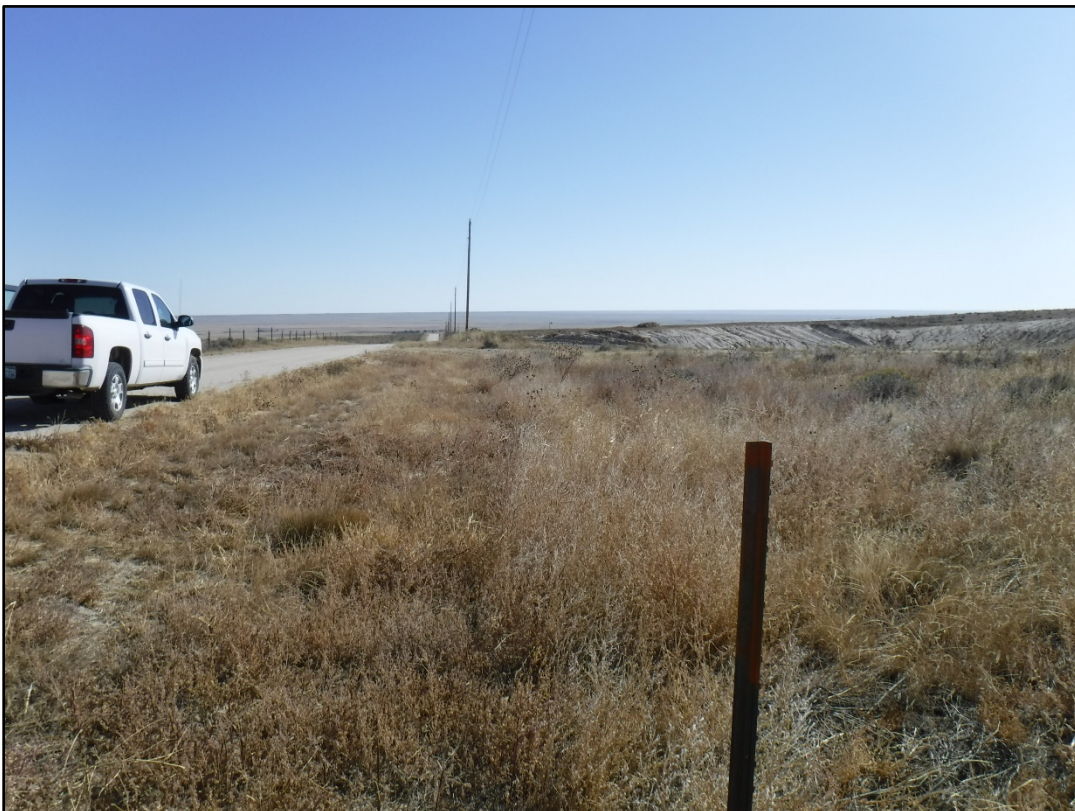
Photo 2: NW marker looking east

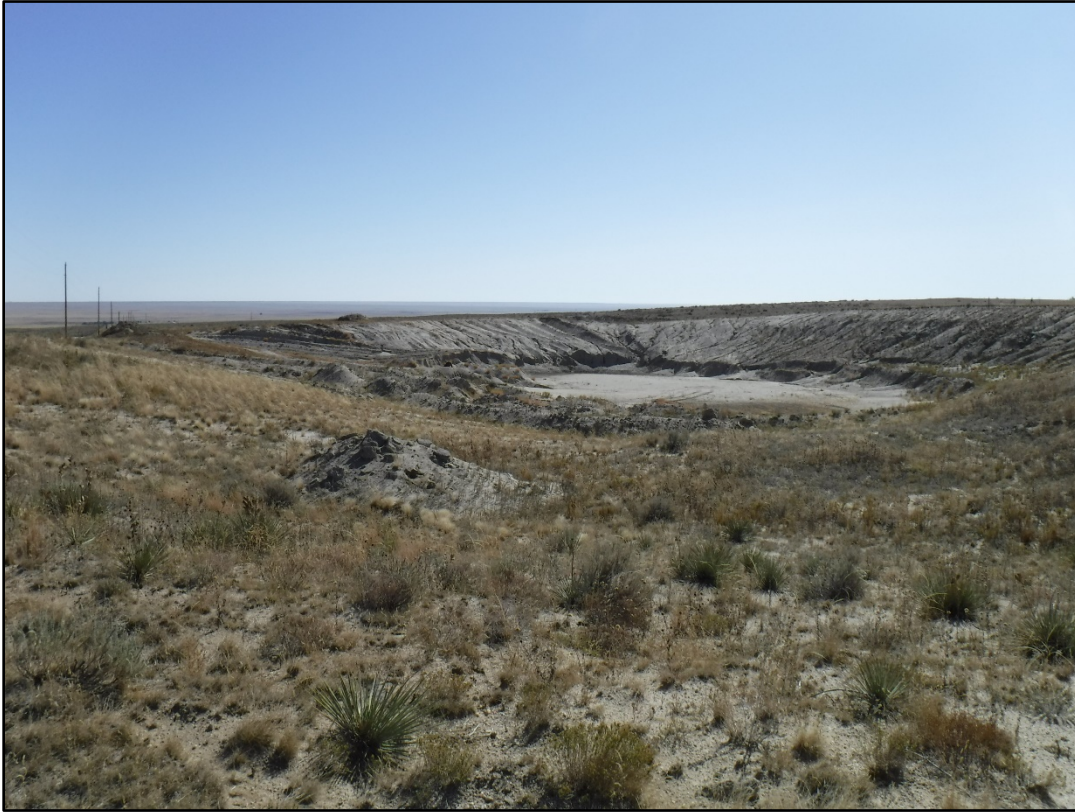
Photo 3: NW marker looking southeast across the mining area

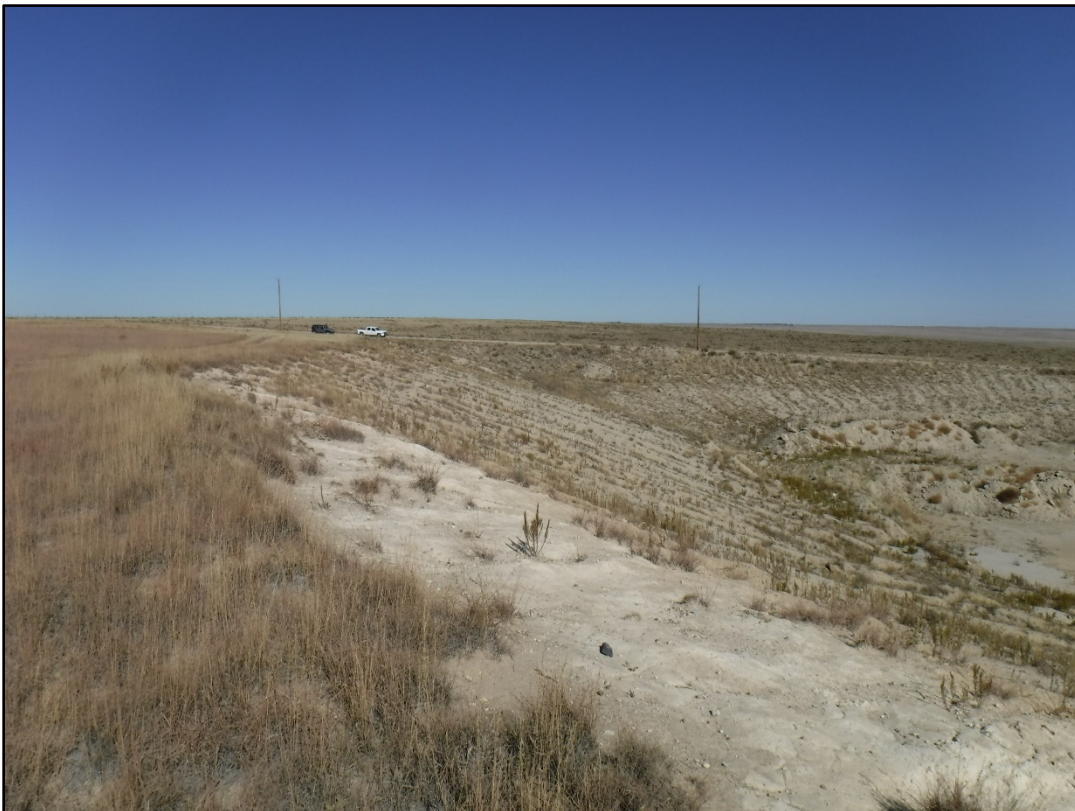
Photo 4: Looking north northwest from the SW extent of disturbed area

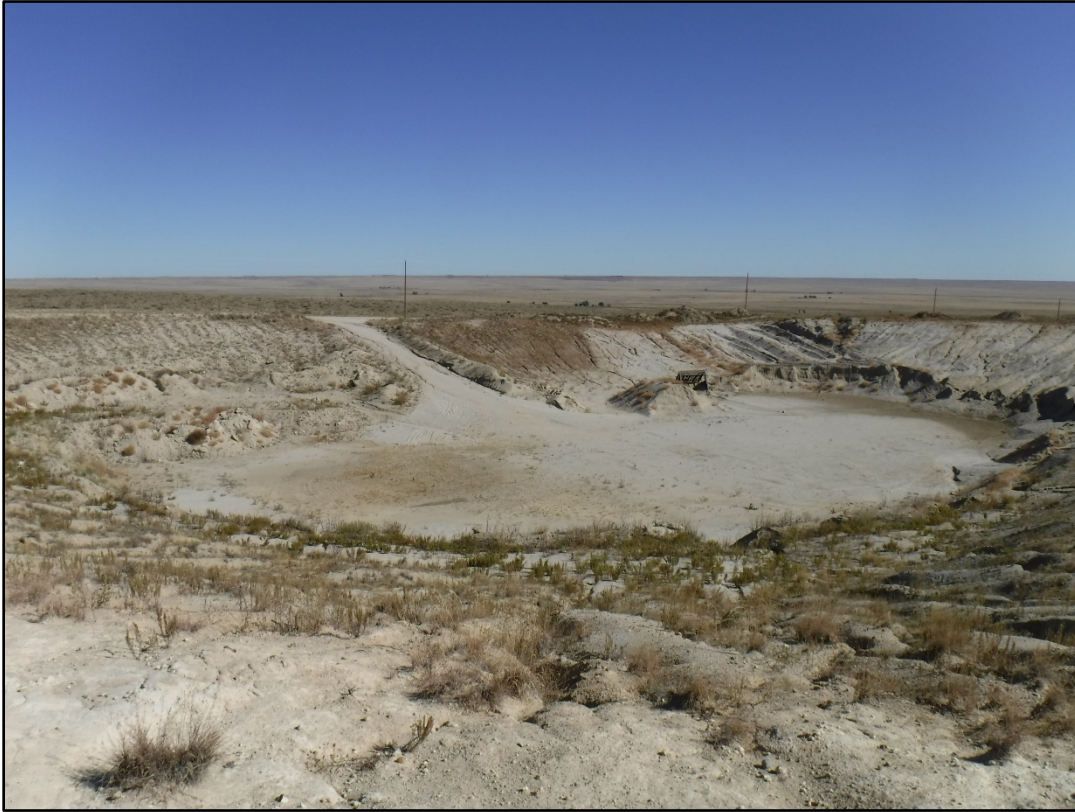
Photo 5: Looking NE from the SW extent of disturbed area across the active pit area

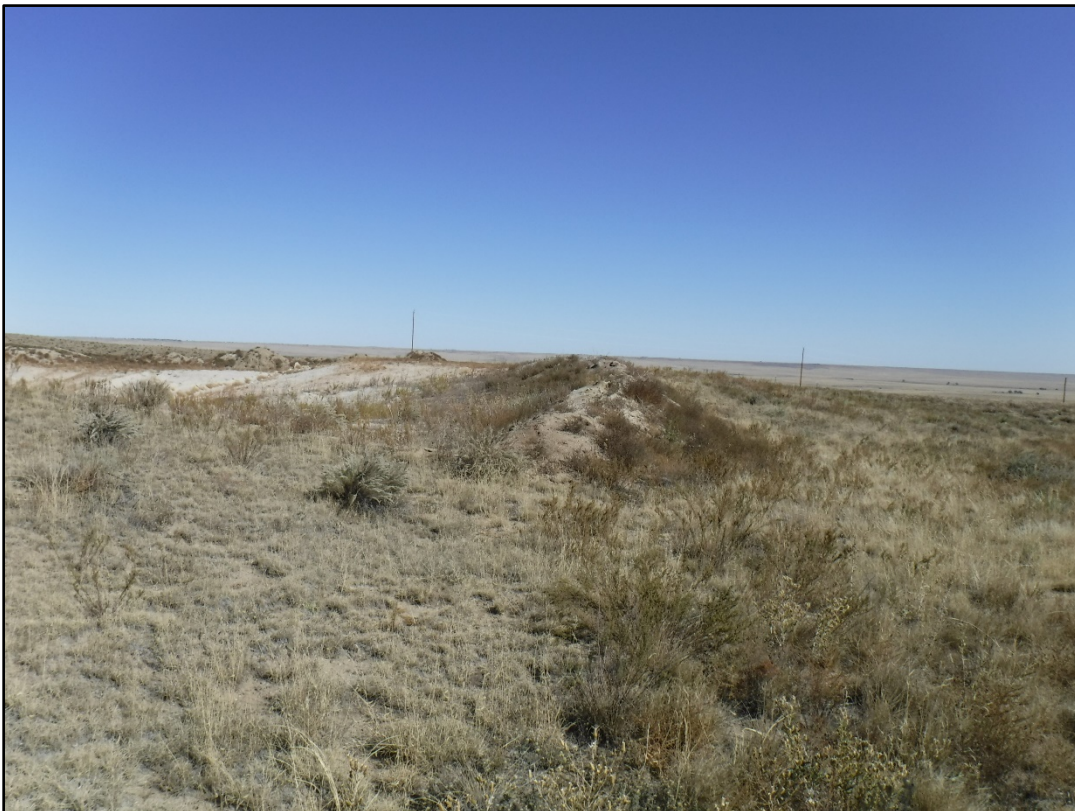
Photo 6: Topsoil stockpile located along the SE perimeter of mining area

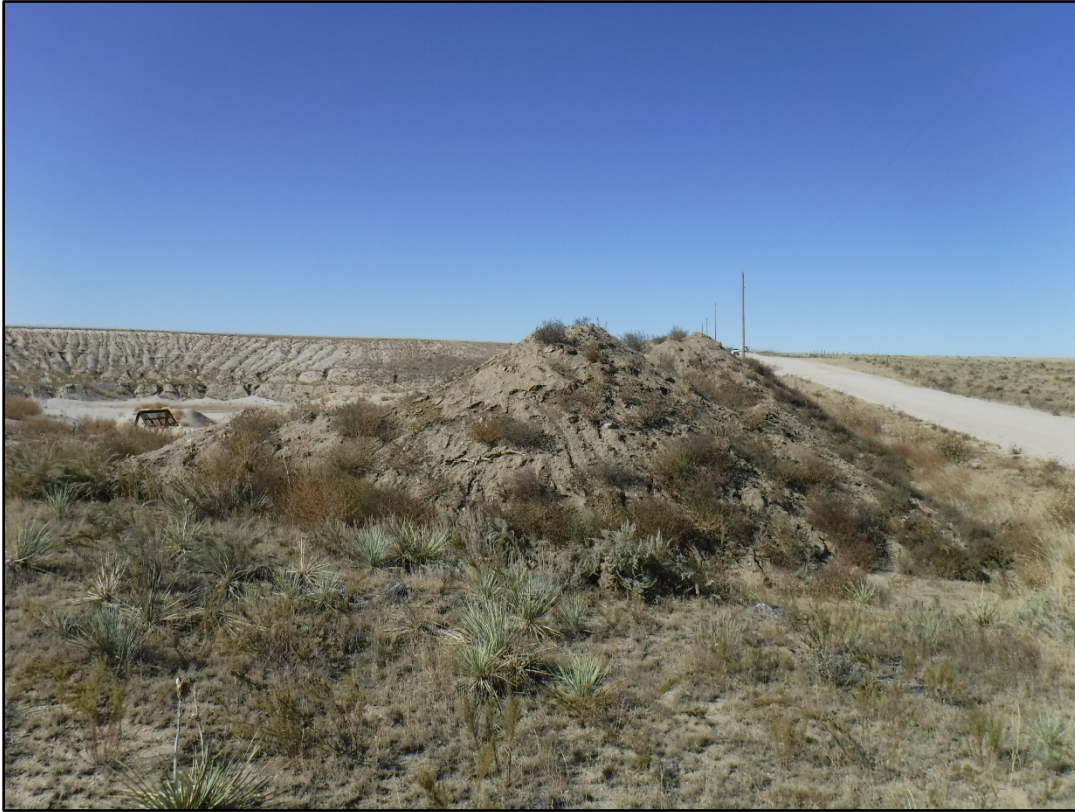
Photo 7: Topsoil stockpile near the NE corner of mining area

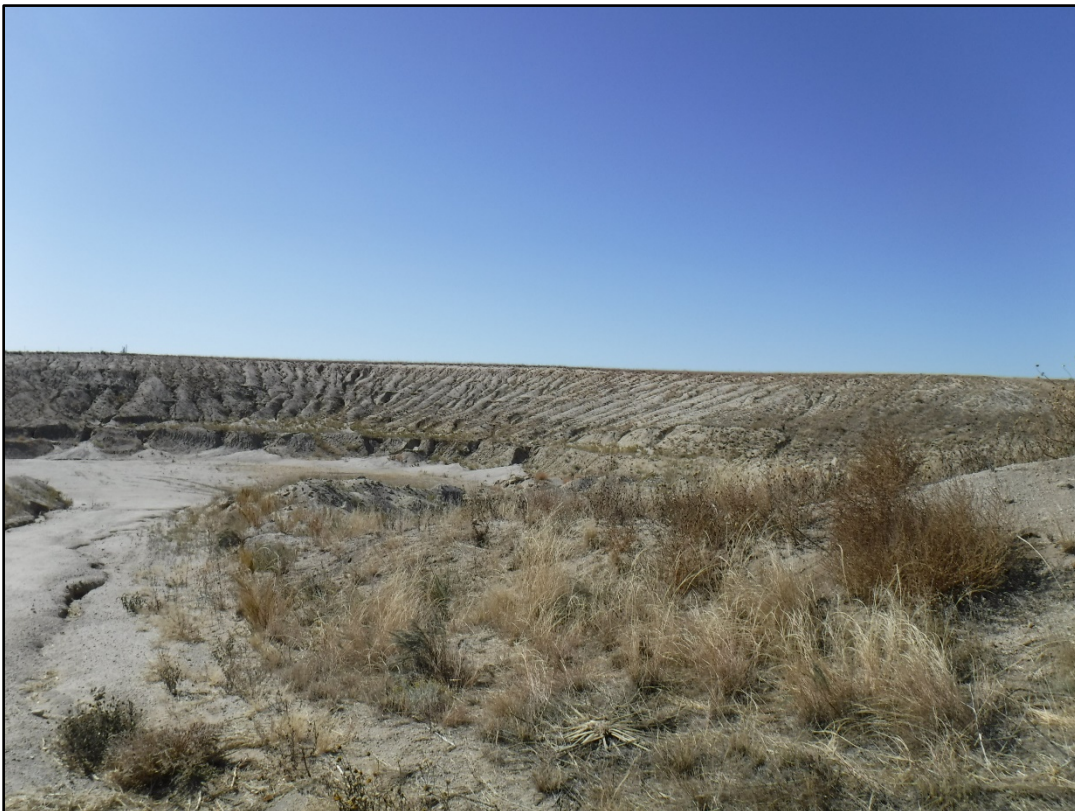
Photo 8: Looking south across the pit area from the entrance of the haul road, erosion contained on pit floor

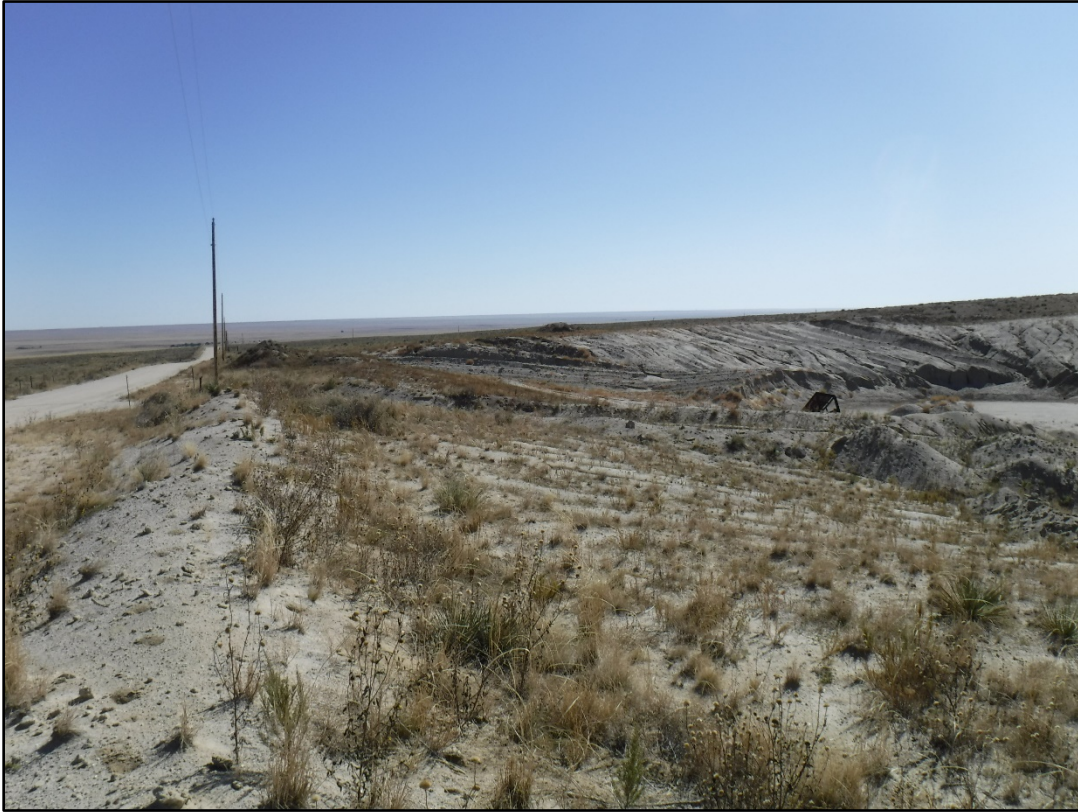
Photo 9: Looking ESE across the mining area

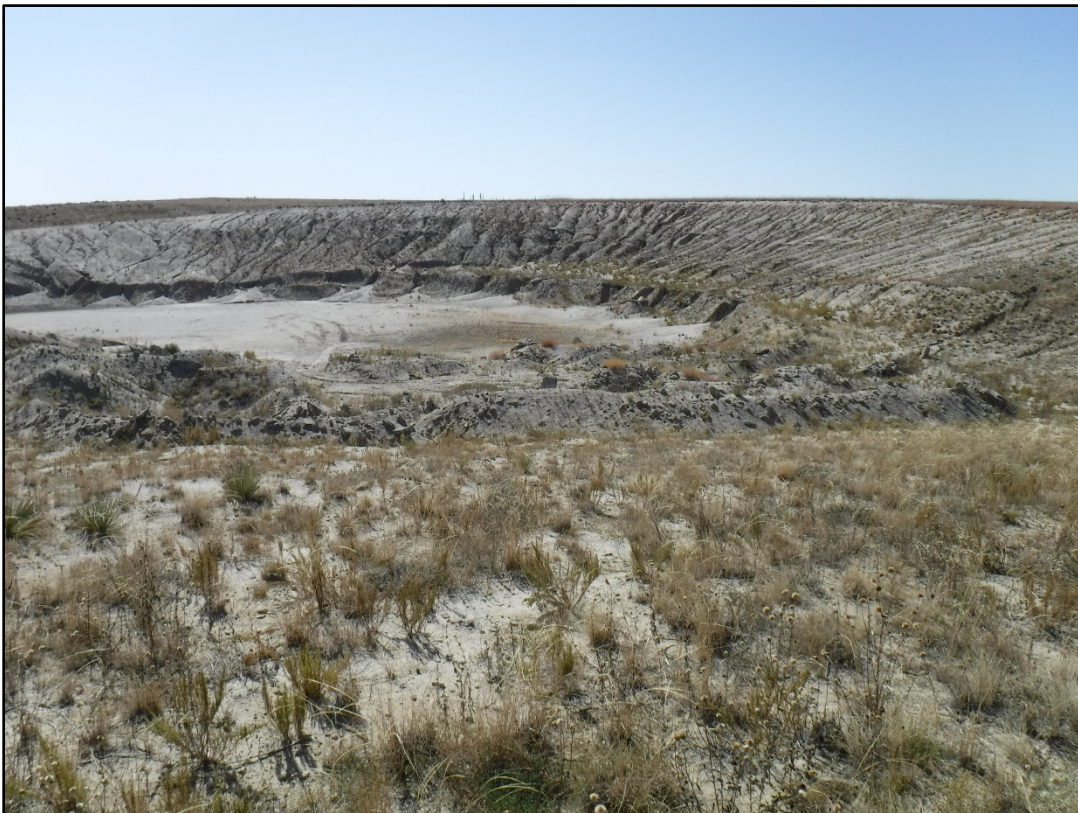
Photo 10: Looking SE across the mining area
