MINERALS PROGRAM INSPECTION REPORT

MINE NAME: Pueblo West Pit	MINE/PROSPECTING ID#: M-1977-573	MINERAL: Sand and gravel	COUNTY: Pueblo
INSPECTION TYPE: Surety-Related Inspection	INSPECTOR(S): Patrick Lennberg	INSP. DATE: October 17, 2019	INSP. TIME: 09:15
OPERATOR: Continental Materials Corporation	OPERATOR REPRESENTATIVE: Bruce Humphries	TYPE OF OPERATION: 112c - Construction Regular Operation	
REASON FOR INSPECTION: Surety Related	BOND CALCULATION TYPE: Partial Bond	BOND AMOUNT: \$343,323.00	
DATE OF COMPLAINT: NA	POST INSP. CONTACTS: None	JOINT INSP. AGENCY: None	
WEATHER: Clear	INSPECTOR'S SIGNATURE:

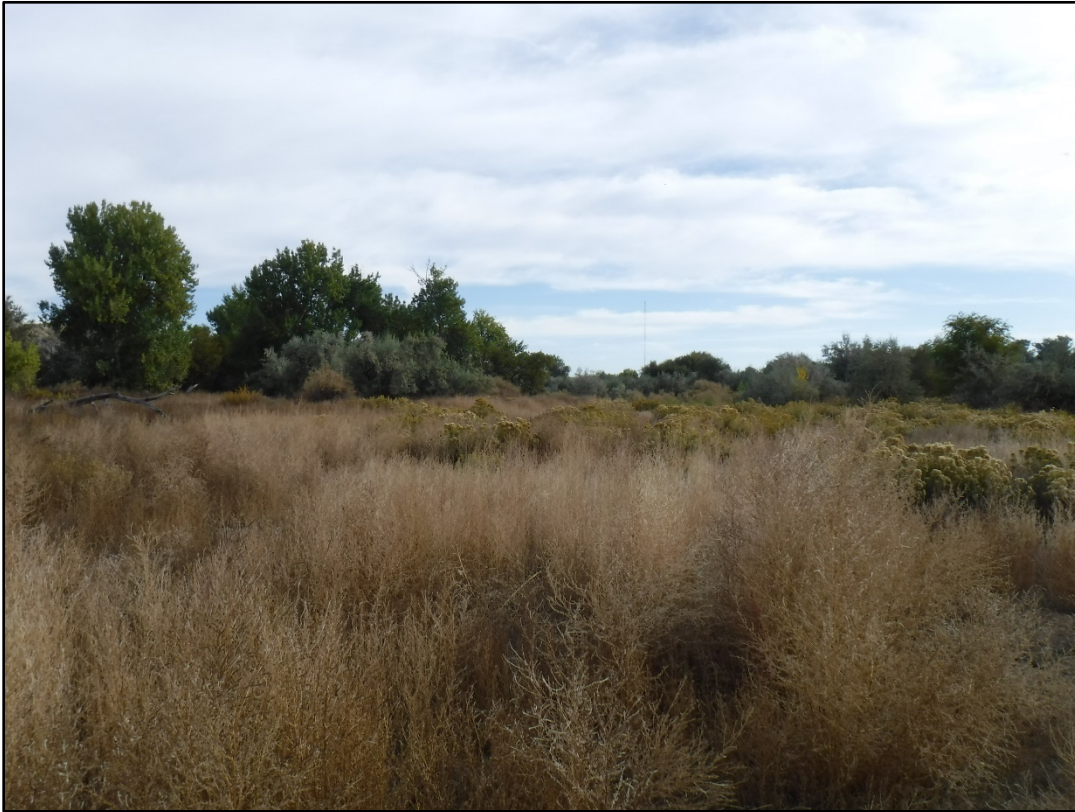
Photo 1: Looking from western edge of Finger Lakes Area to the east

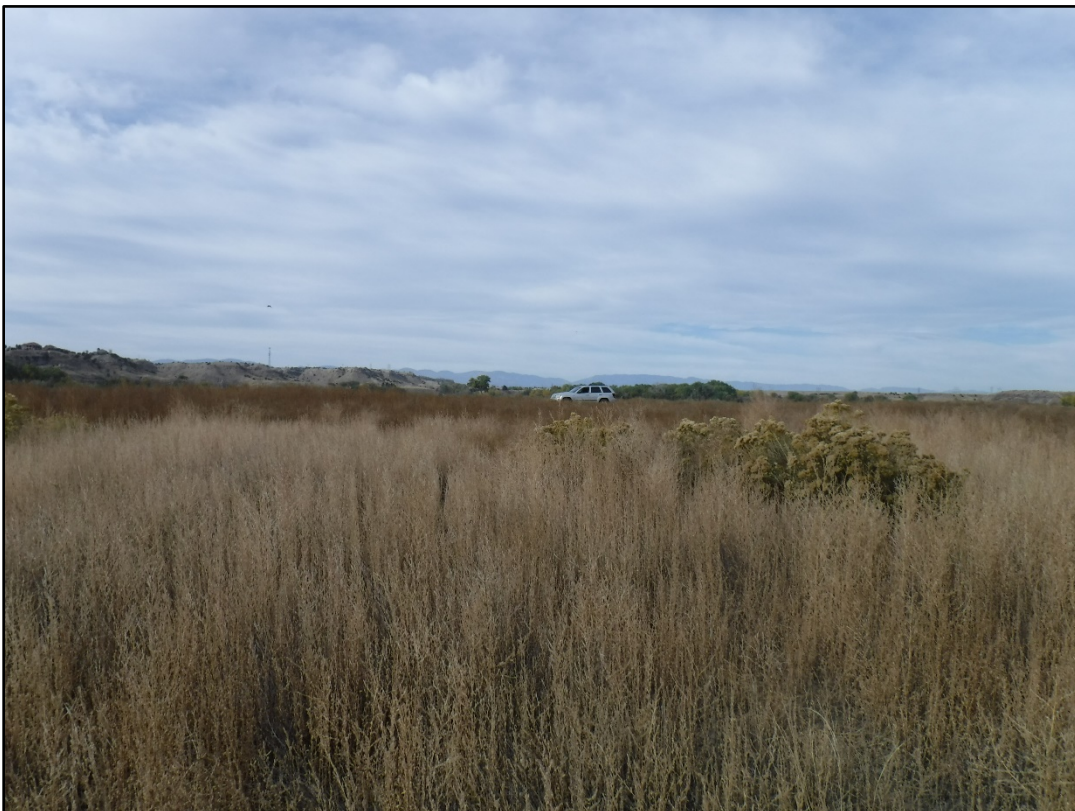
Photo 2: Looking west to the still permitted area

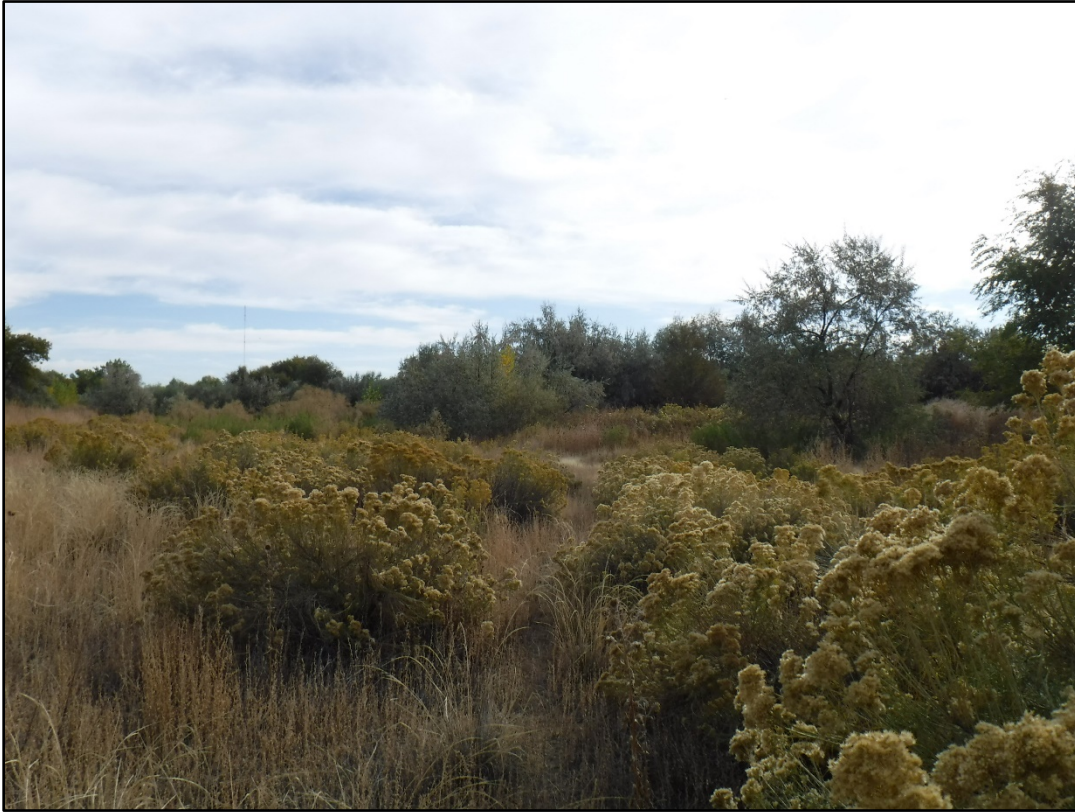
Photo 3: Area that has been mined and reclaimed, hill at center of picture was not affected

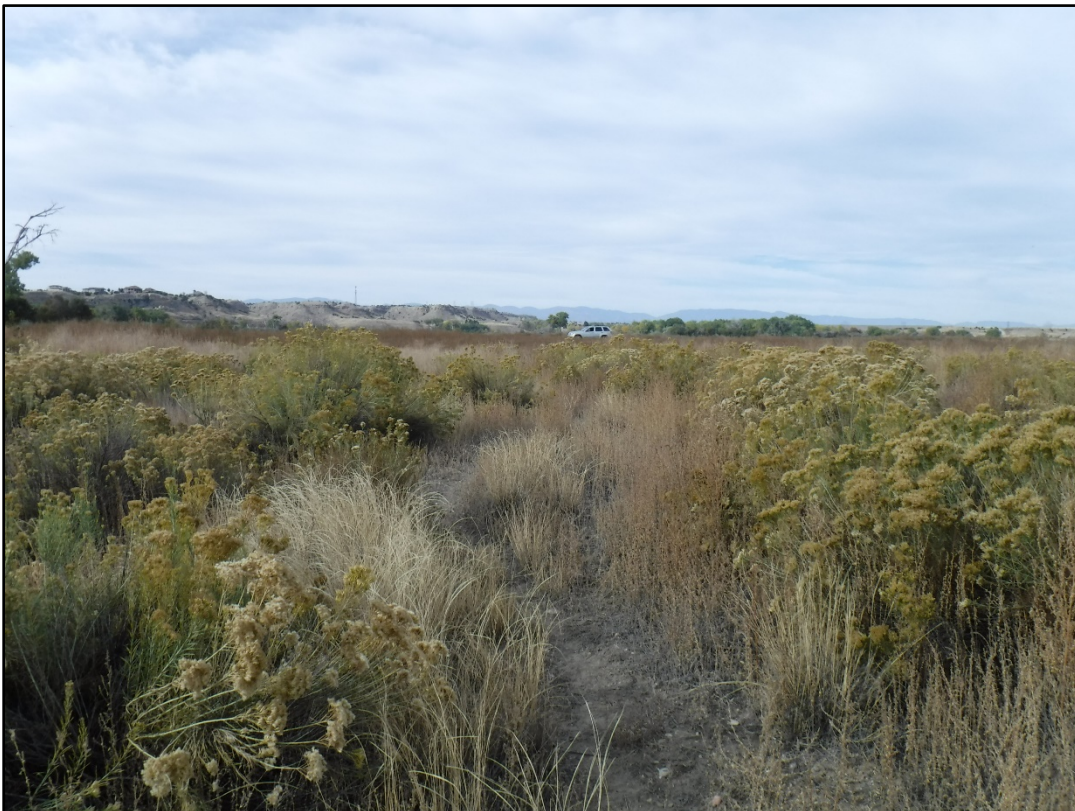
Photo 4: Well used game trail through release area

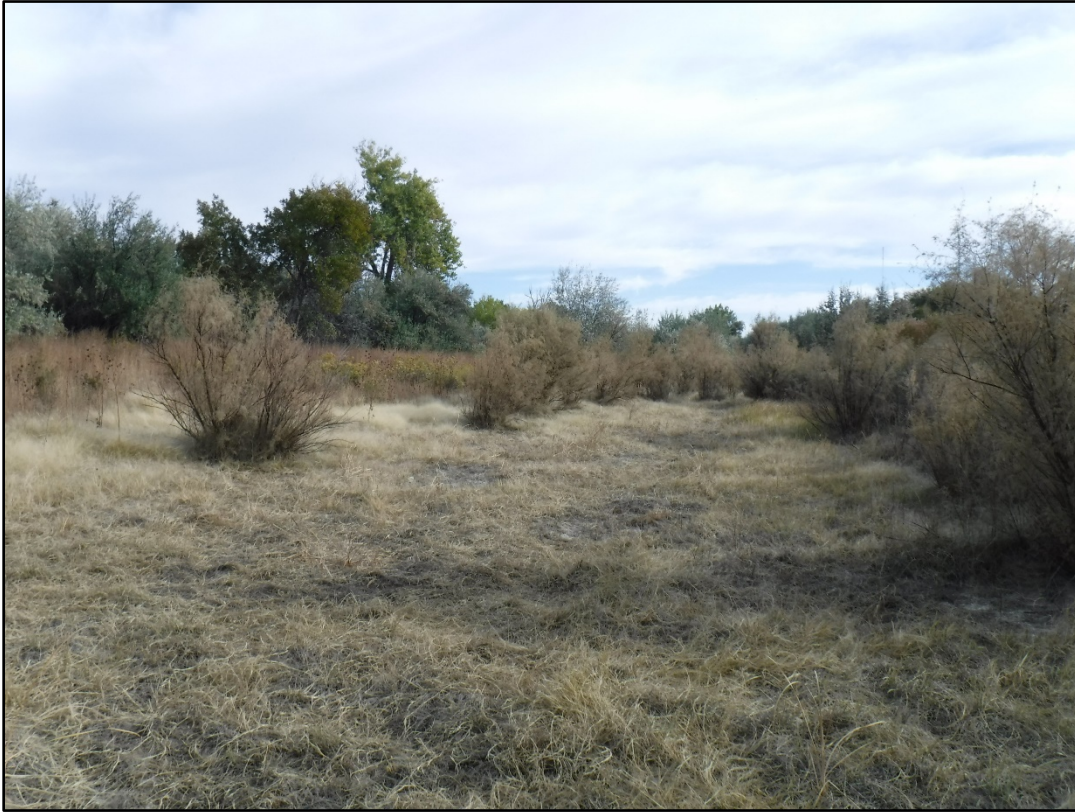
Photo 5: Area of matted down vegetation from overnighting herd animals

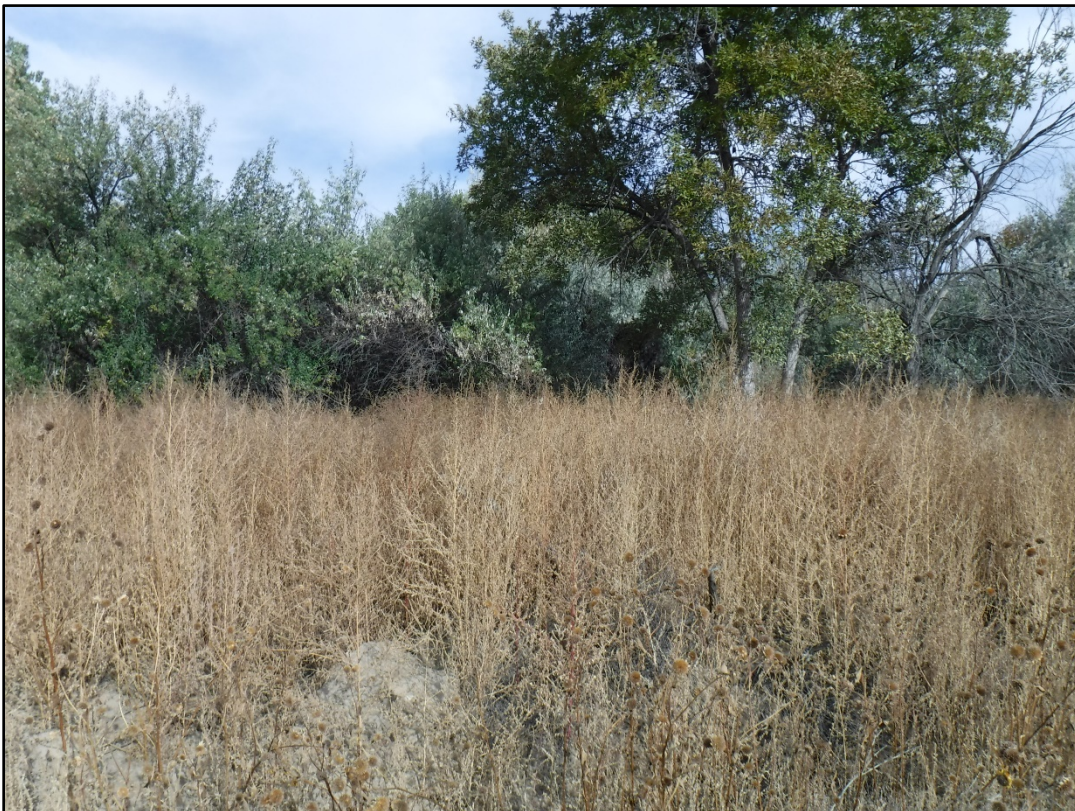
Photo 6: Vegetation conditions adjacent to release area

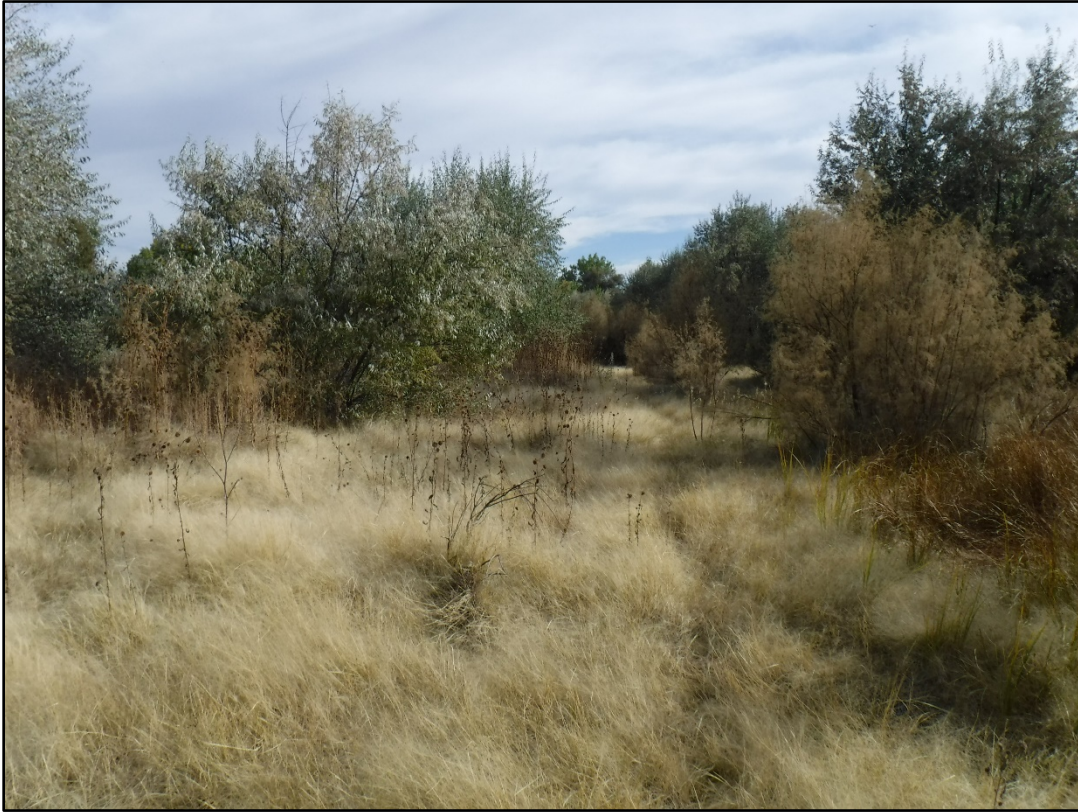
Photo 7: Game trail through the far eastern portion of release area

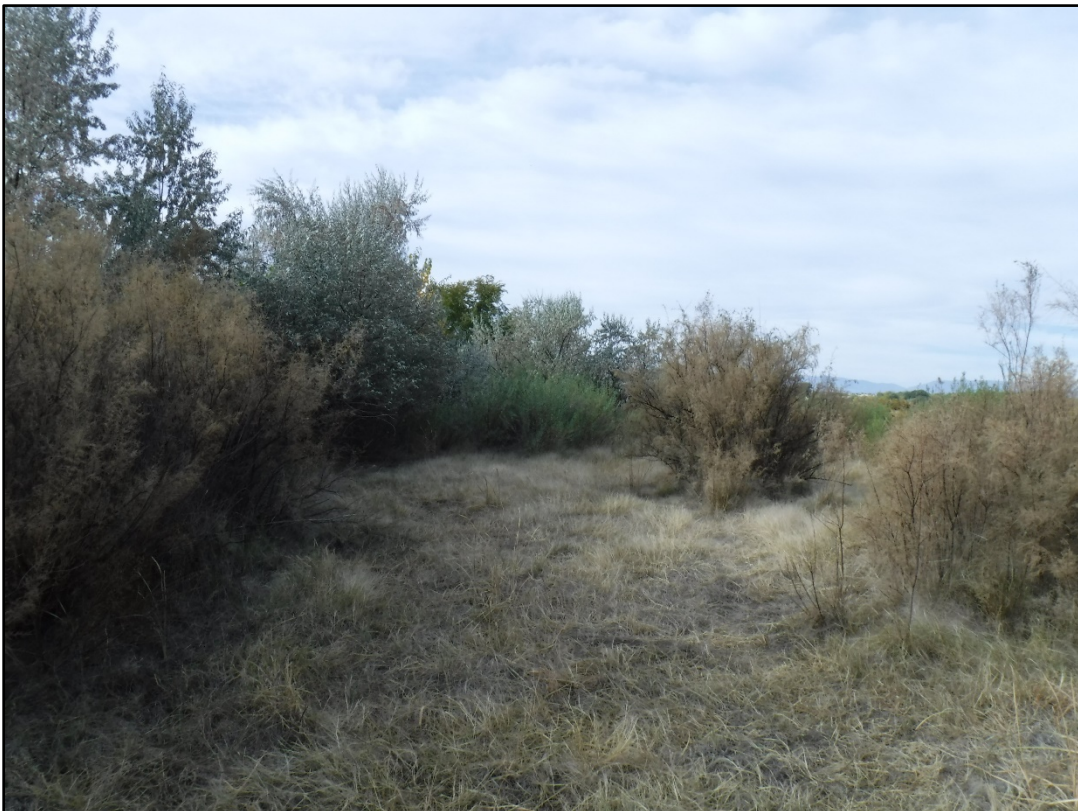
Photo 8: Vegetation to the left is outside release area
