**MINERALS PROGRAM INSPECTION REPORT**  
**PHONE: (303) 866-3567**

<b>MINE NAME:</b> Coaldale Quarry	<b>MINE/PROSPECTING ID#:</b> M-1977-247	<b>MINERAL:</b> Anhydrite, gypsum	<b>COUNTY:</b> Fremont
<b>INSPECTION TYPE:</b> Monitoring	<b>INSPECTOR(S):</b> Timothy A. Cazier	<b>INSP. DATE:</b> June 18, 2019	<b>INSP. TIME:</b> 10:00
<b>OPERATOR:</b> Holcim (US) Inc.	<b>OPERATOR REPRESENTATIVE:</b> Julio Villon	<b>TYPE OF OPERATION:</b> 112c - Construction Regular Operation	
<b>REASON FOR INSPECTION:</b> Normal I&E Program	<b>BOND CALCULATION TYPE:</b> Partial Bond	<b>BOND AMOUNT:</b> \$707,000.00	
<b>DATE OF COMPLAINT:</b> NA	<b>POST INSP. CONTACTS:</b> None	<b>JOINT INSP. AGENCY:</b> None	
<b>WEATHER:</b> Cloudy	<b>INSPECTOR'S SIGNATURE:</b>

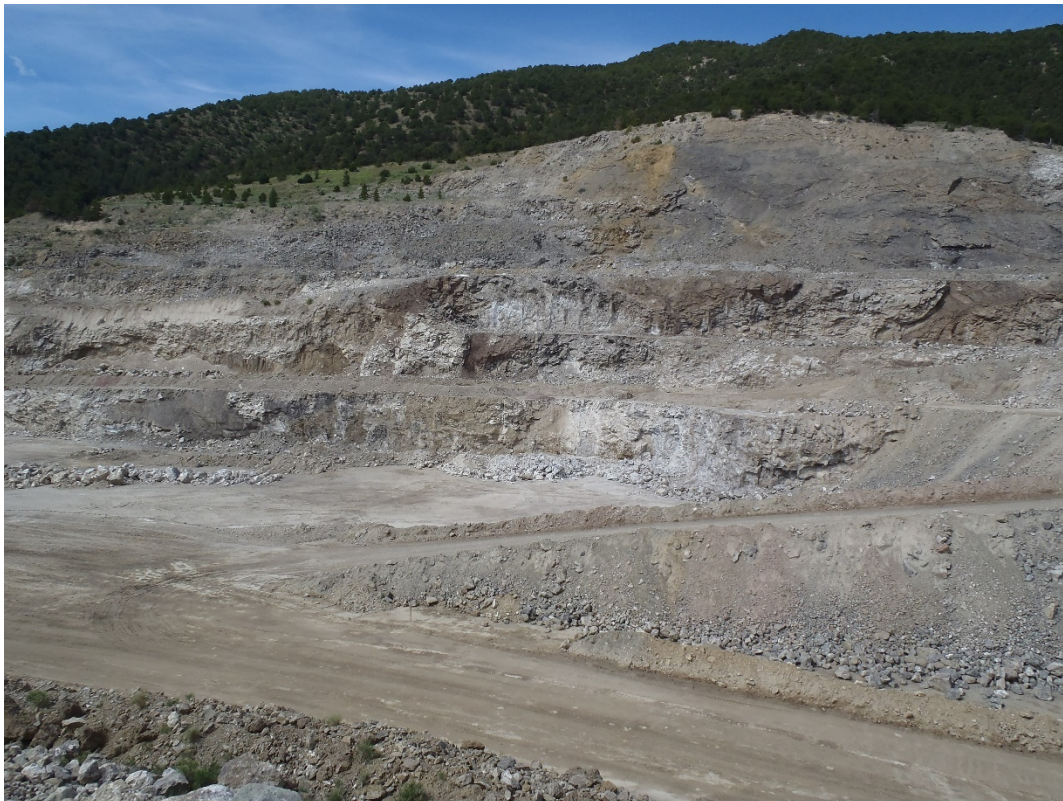
Gen. Compliance with Mine Plan: Google Earth was used to measure the disturbed area, which was estimated to be approximately 48 acres, based on 2016 imagery. During the site visit, highwalls were estimated to at 25 feet in height and appeared stable (see **Photo 1**). Mr. Villon pointed out the relatively new radar system (see **Photo 2**) installed to monitor highwall movement. He also stated the mine has two seismographs they use for blast monitoring. Mr. Villon indicated Holcim is considering expanding the pit to the south. As the highwall on the south side is currently very close to the permit/affected area boundary, [any expansion in this direction would require an amendment to the permit.](#)

Photo 1. Highwall in active portion of the pit (looking SW).

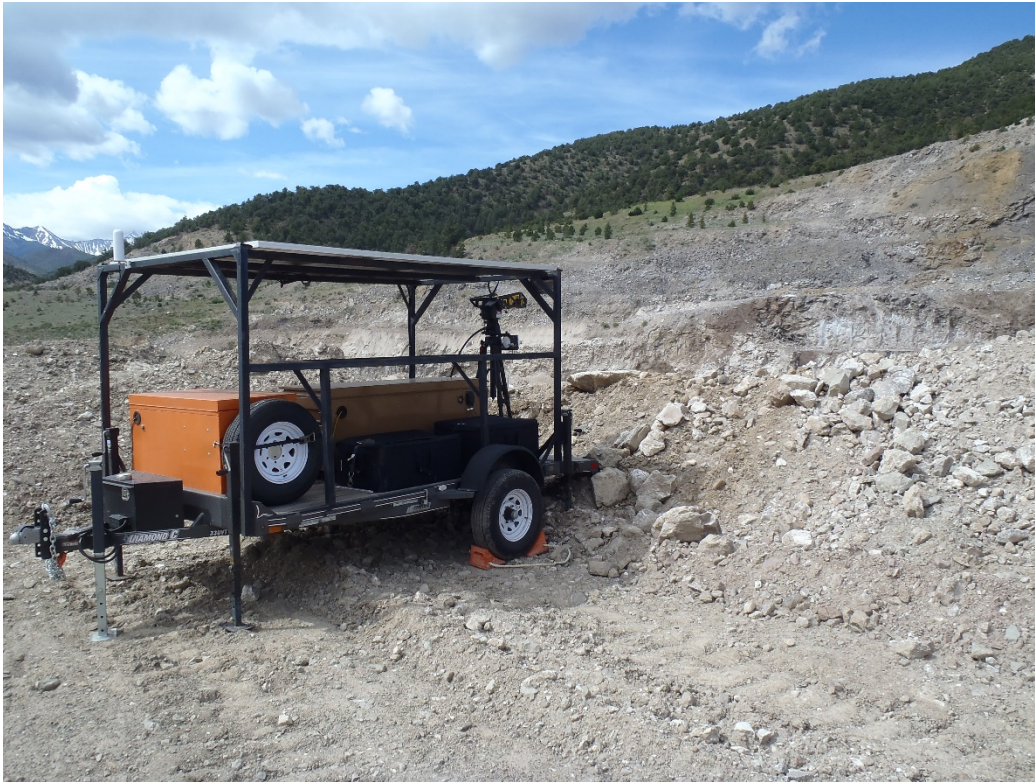
Photo 2. Radar system for monitoring the highwall (NE side of active pit).

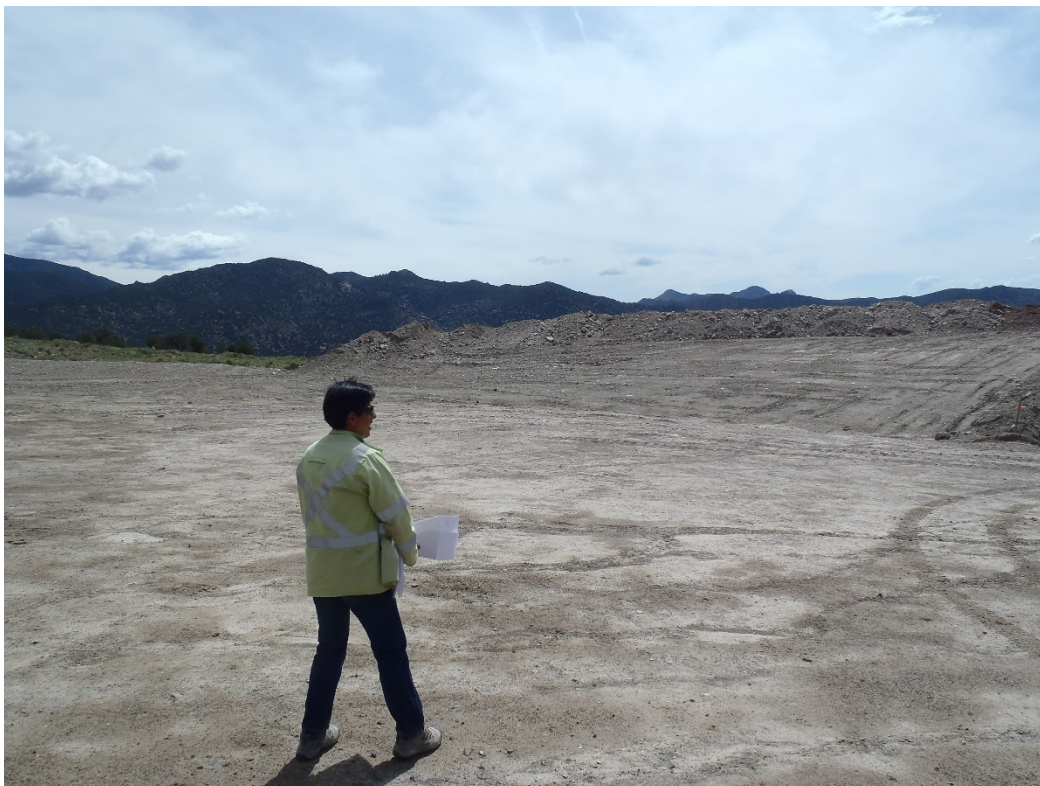
Off-site Damage: Some recently placed material (topsoil was indicated by site representatives) was placed (see **Photo 3**) outside what was thought to be the permit and affected area boundary (which are coincident for this permit). This was in an area previously disturbed (perhaps pre-law) and reclaimed. The equipment operator did not realize the area was outside the affected area boundary. The DRMS will perform a follow-up inspection to confirm whether or not this area is in fact outside the affected area boundary.

Photo 3. Topsoil likely placed outside affected area boundary (looking NE).

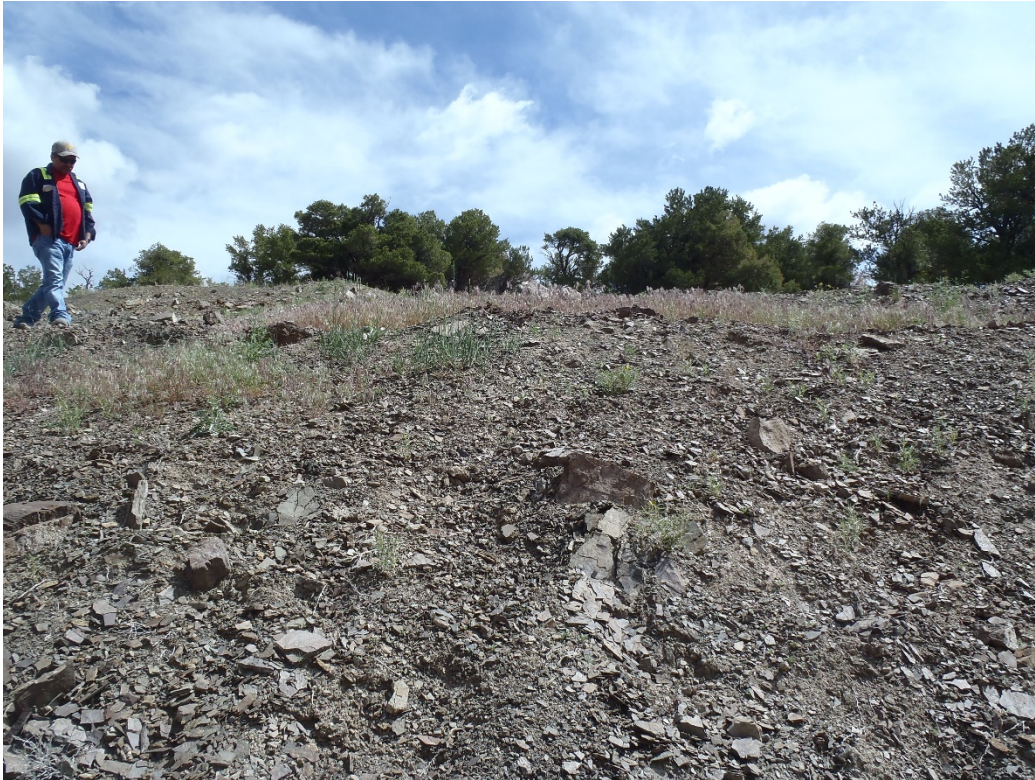
Revegetation: A relatively small area of Downy Brome (cheat grass) was observed on the east side of the permit area, on the west facing hill near the active pit (see **Photo 4**). As it is a noxious weed List C species, it was not

Photo 4. Small area of Downy Brome/cheat grass.

cited as a problem. However, the DRMS recommends the Permittee implement a weed control program to reduce the spread of cheat grass on site.

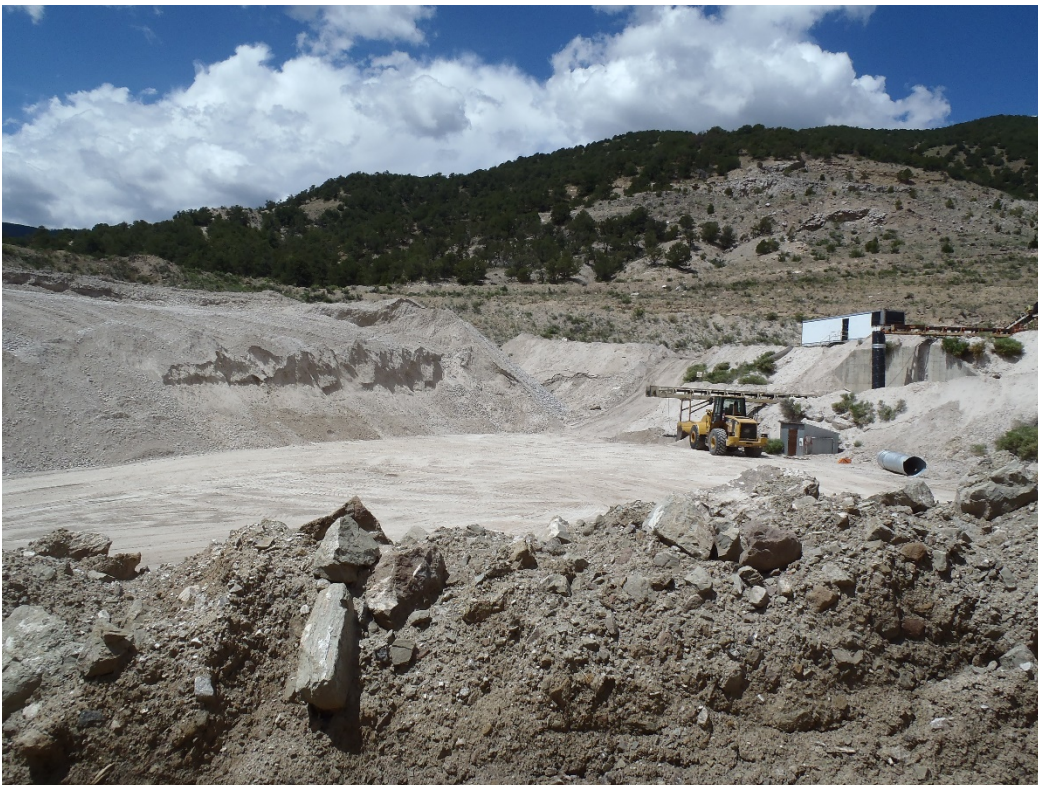
Support Facilities On-site: A dozer, loader and screen plant were observed on site (see **Photo 5**) near the large product stockpile.

Photo 5. Equipment and product stockpile observed in the processing area (SE corner, looking south).

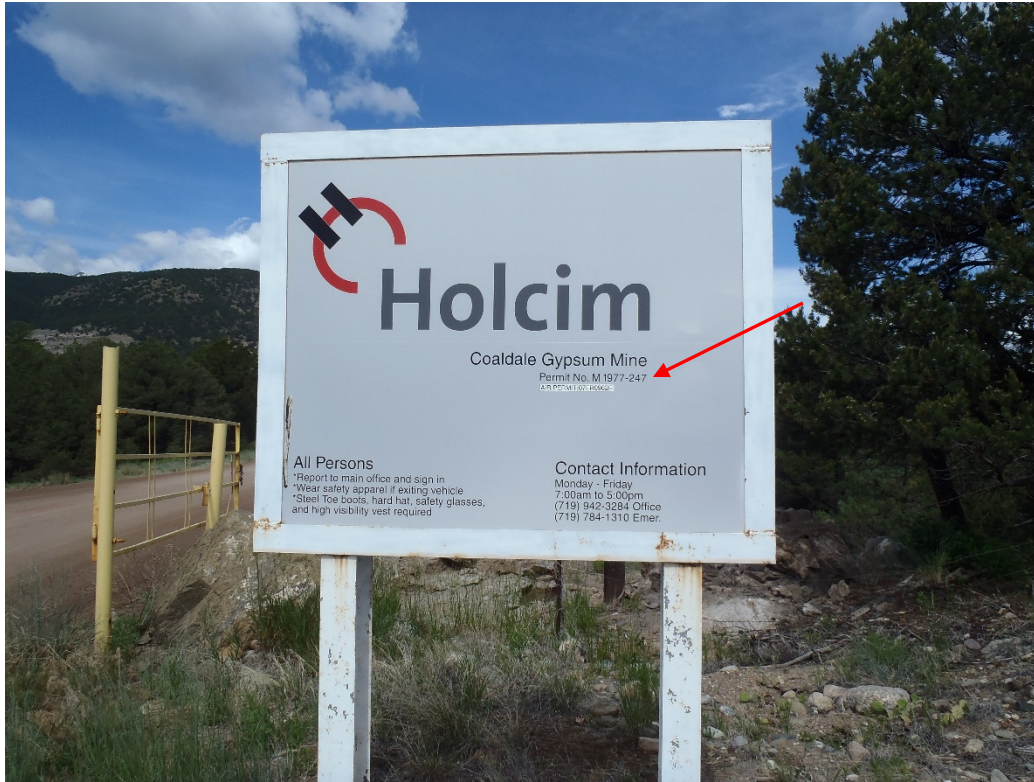
Photo 6. Permit sign at entrance of Hayden Creek Rd/County Rd 6 (arrow indicates permit number).

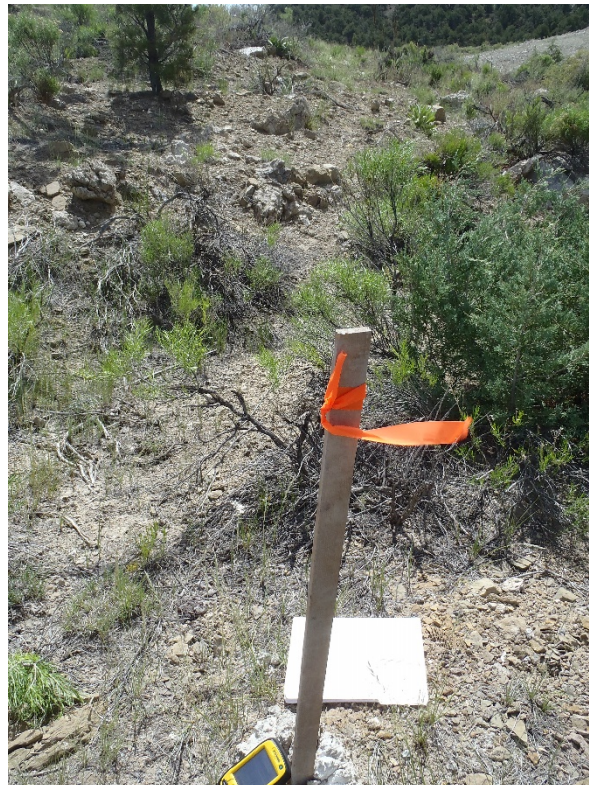
Signs and Markers: The permit sign was properly posted (see **Photo 6**). Some affected area and boundary markers (see **Photo 7**) were observed. However, given the irregular shape of the Locations of accessible affected area boundary markers were collected using a Juno 3B handheld GPS.

Photo 7. Typical Boundary marker (south side).

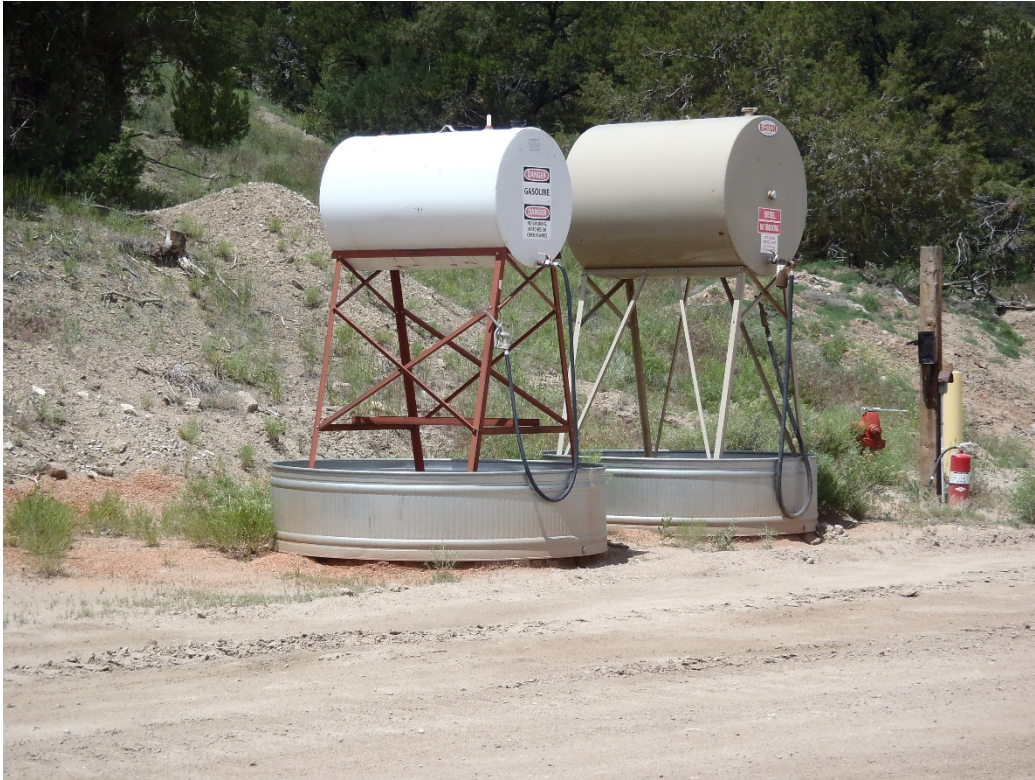
Photo 8. Fuel storage secondary containment.

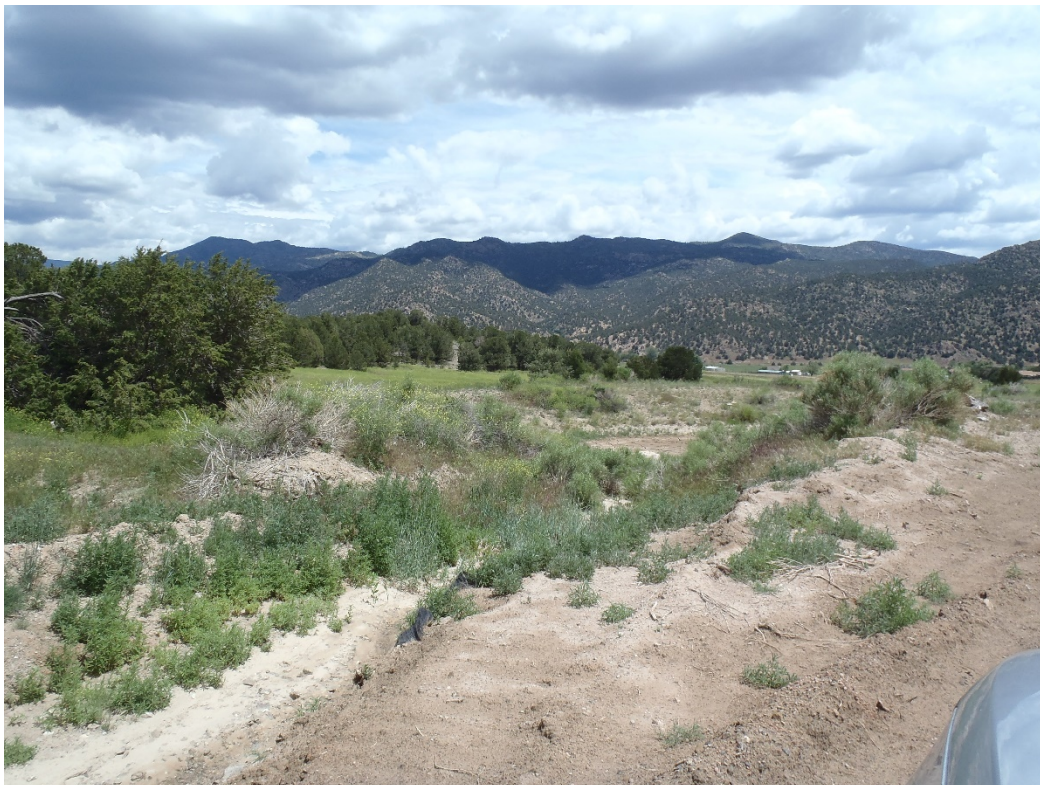
Storm Water MGT Plan: Above ground fuel storage tanks were observed with secondary containment (see **Photo 8**). No oil or fuel spills observed. Stormwater is directed to either the pit floor to infiltrate or is directed to a sediment pond (see **Photo 9**) near the access road on the southeast corner of the site.

Photo 9. Stormwater pond NE of site office (looking NE).
