MINERALS PROGRAM INSPECTION REPORT
PHONE: (303) 866-3567

| MINE NAME: Buss Barrow Pit | MINE/PROSPECTING ID#: M-2019-021 | MINERAL: Borrow material for construction | COUNTY: Fremont |
| INSPECTION TYPE: Monitoring | INSPECTOR(S): Timothy A. Cazier | INSP. DATE: August 6, 2019 | INSP. TIME: 13:00 |

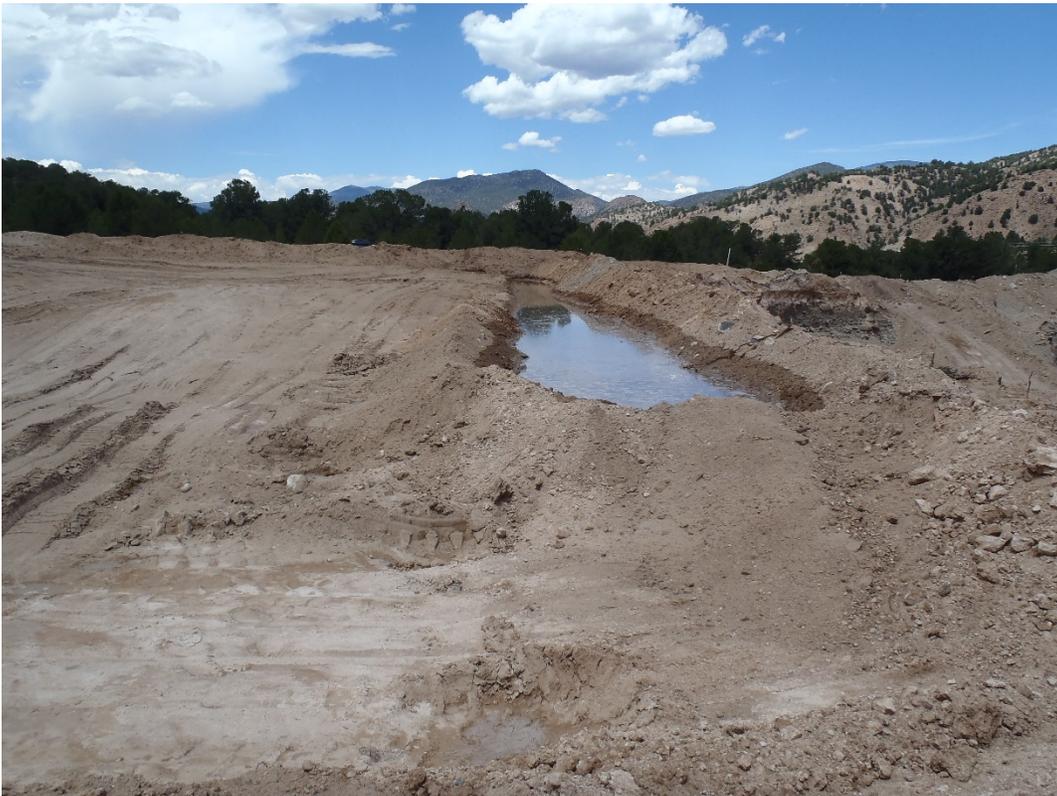
Hydrologic Balance: No standing water was observed in the pit and no exposed groundwater was observed. However, standing water was observed in a trench near the crest of the highwall (see **Photo 1**).

Photo 1. Standing water observed in trench near the crest of the highwall (looking NW).

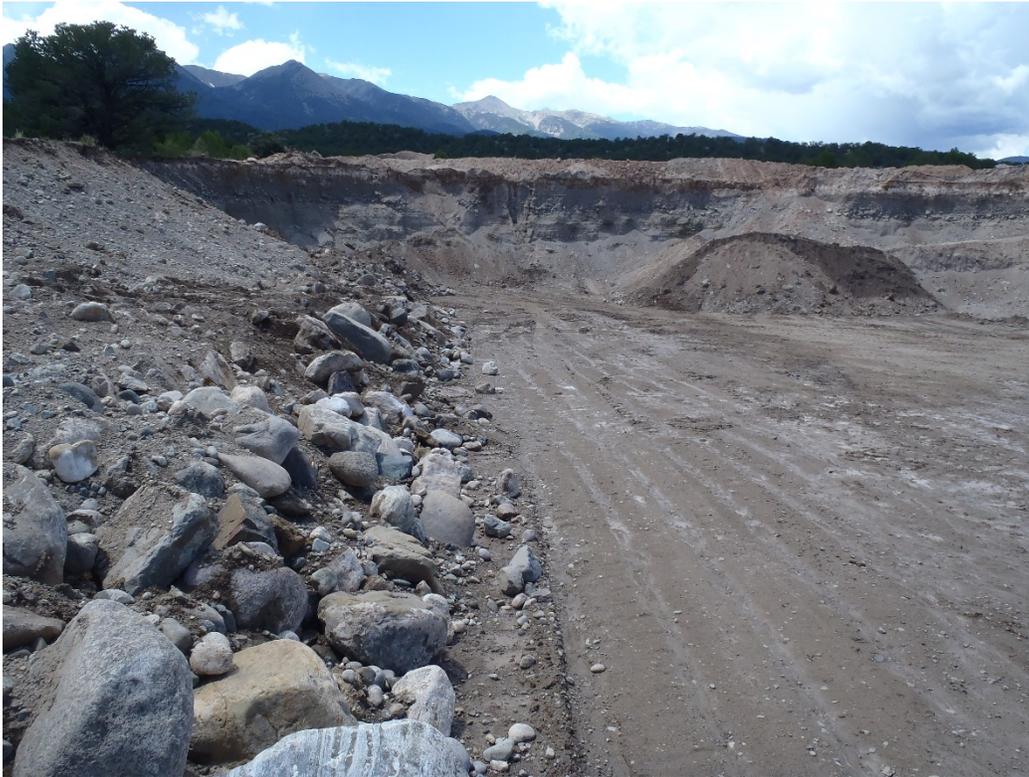
Gen. Compliance with Mine Plan: The operation appeared to be in compliance with the approved mine plan. Highwalls were estimated to vary between 0 and 15 feet in height and appeared stable (see **Photo 2**). An area southeast of the site entrance was cleared and grubbed, and used for haul truck and equipment staging. Ms. Schreiber explained this was the staging area for the Hwy 50 project and not directly related to the mining activity. She further explained the staging area was owned by the same landowner that owns the pit area, making it necessary to need only one agreement with a landowner for both project-related areas.

Photo 2. Pit highwall (looking west).

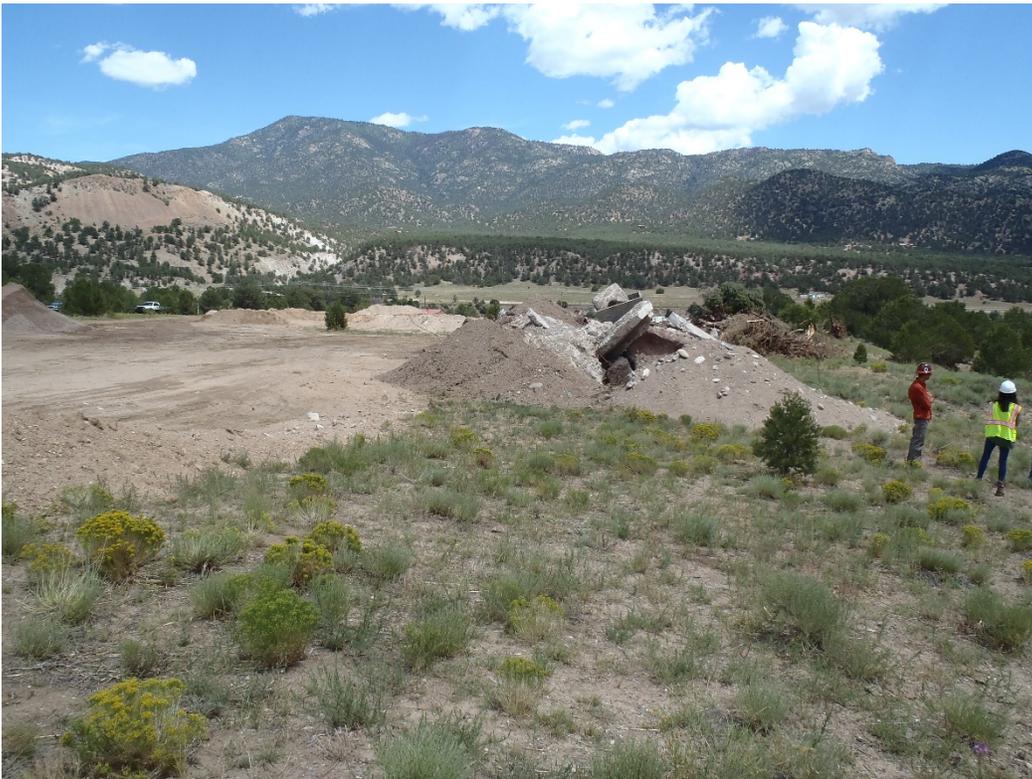
Processing Waste: Some debris from the associated Hwy 50 construction project was observed (see **Photo 3**).

Photo 3. Debris from construction project (south side, looking east).

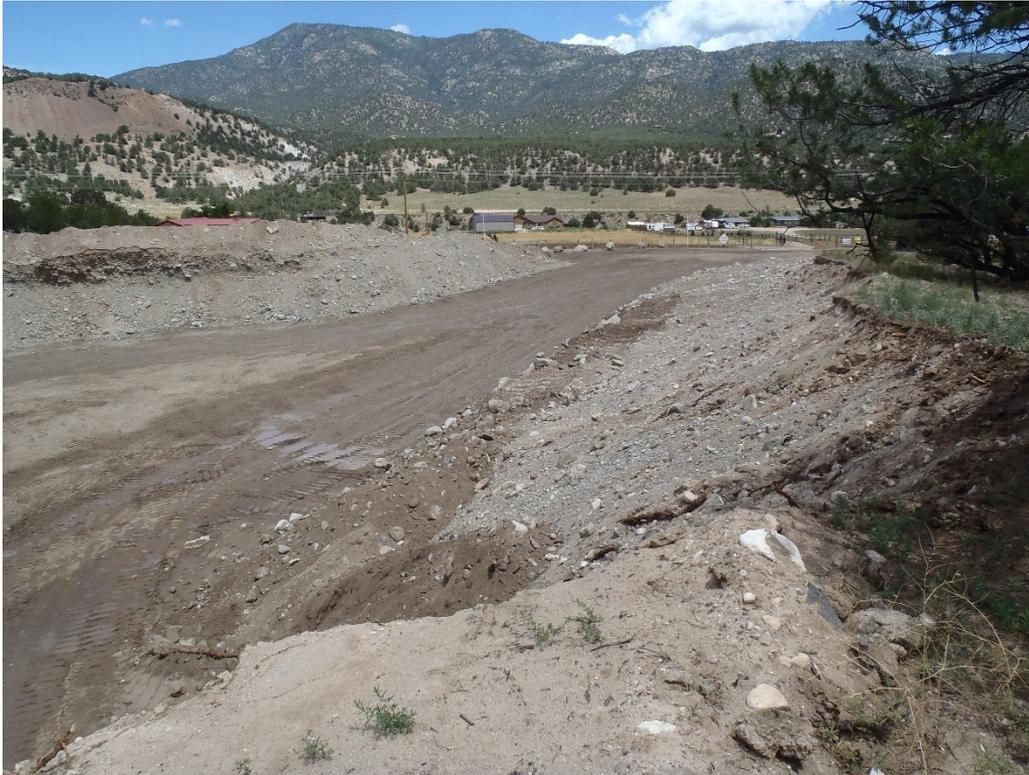
Roads: Haul and access roads did not appear to be a source of sediment that could be tracked offsite as access roads were dust controlled (see **Photo 4**) and vehicle tracking was in place between the site and Hwy 50.

Photo 4. Dust controlled access road (looking east from south side of pit).

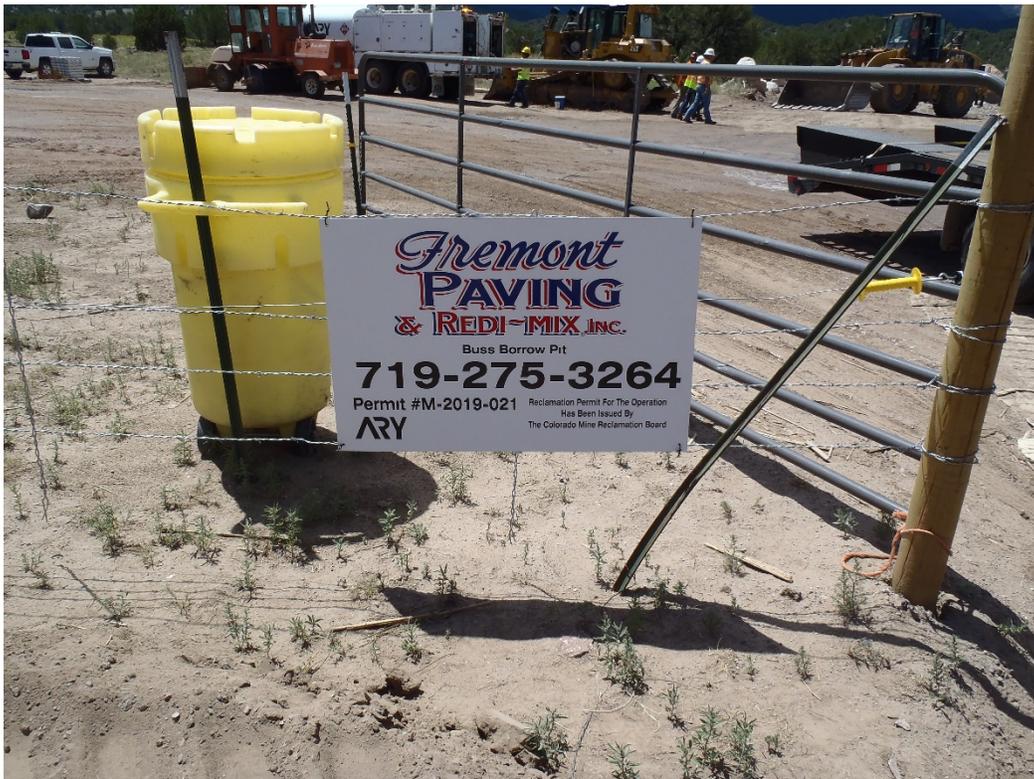
Signs and Markers: The permit sign was properly posted (see **Photo 5**) and boundary markers were observed to delineate the permit boundary (see **Photo 6**).

Photo 5. Permit sign (at entrance off Hwy 50).

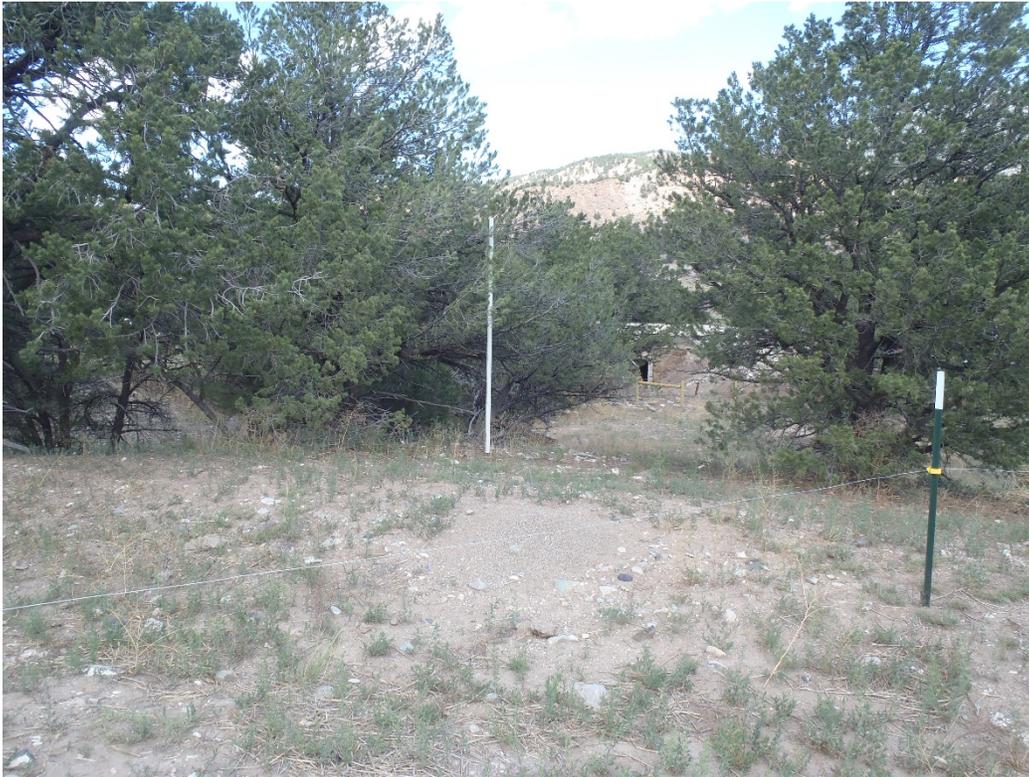
Photo 6. Typical permit boundary marker (north side).

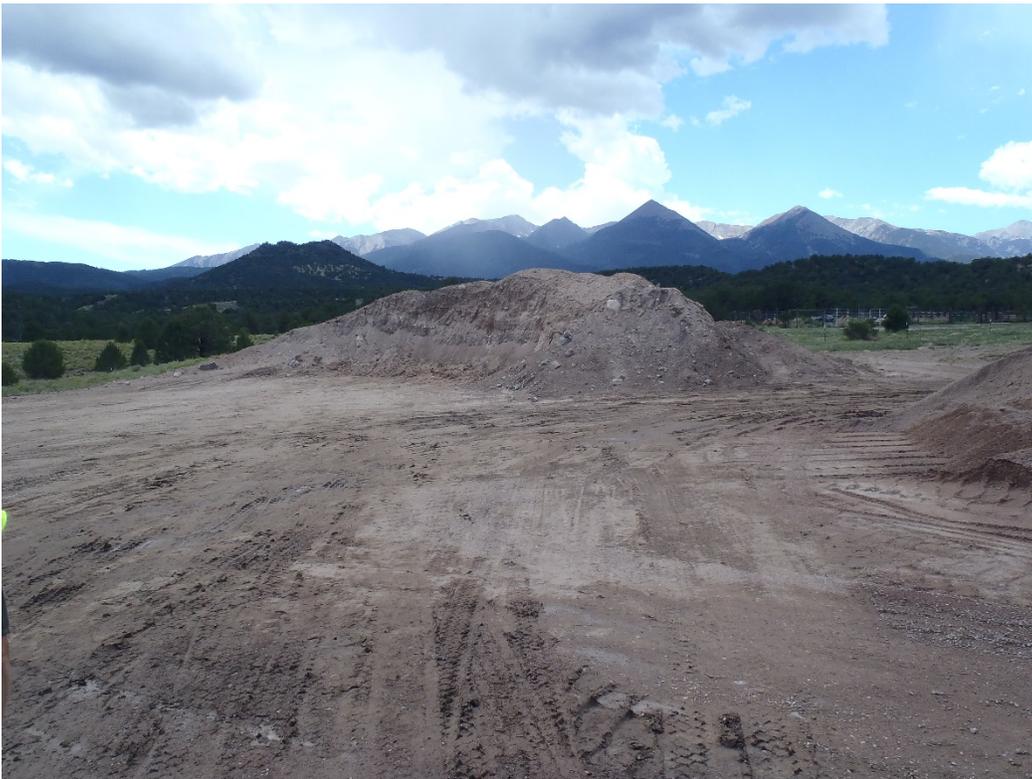
Topsoil: A topsoil stockpile was observed on the west end of the pit (see **Photo 7**).

Photo 7. Topsoil stockpile (west end, looking west).
