MINERALS PROGRAM INSPECTION REPORT
PHONE: (303) 866-3567

MINE NAME: Horsefly Rock Source	MINE/PROSPECTING ID#: M-2019-010	MINERAL: Sandstone (silica, st quartzite)	COUNTY: Ouray
INSPECTION TYPE: Preoperation Inspection	INSPECTOR(S): Lucas West	INSP. DATE: October 17, 2019	INSP. TIME: 10:34
OPERATOR: John Kuijvenhoven	OPERATOR REPRESENTATIVE: John Kuivenhoven	TYPE OF OPERATION: 110c - Construction Limited Impact	
REASON FOR INSPECTION: Pre-operation Inspection	BOND CALCULATION TYPE: Complete Bond	BOND AMOUNT: No Bond Held	
DATE OF COMPLAINT: NA	POST INSP. CONTACTS: None	JOINT INSP. AGENCY: None	
WEATHER: Clear	INSPECTOR'S SIGNATURE:

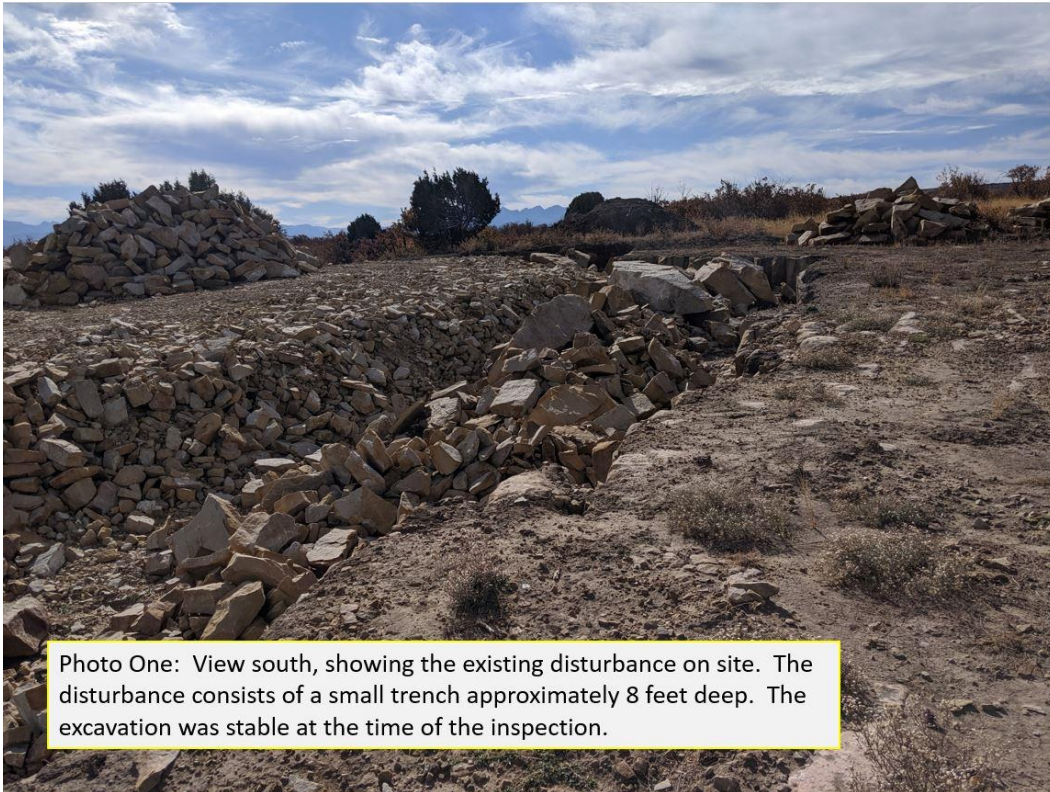
Photo One: View south, showing the existing disturbance on site. The disturbance consists of a small trench approximately 8 feet deep. The excavation was stable at the time of the inspection.

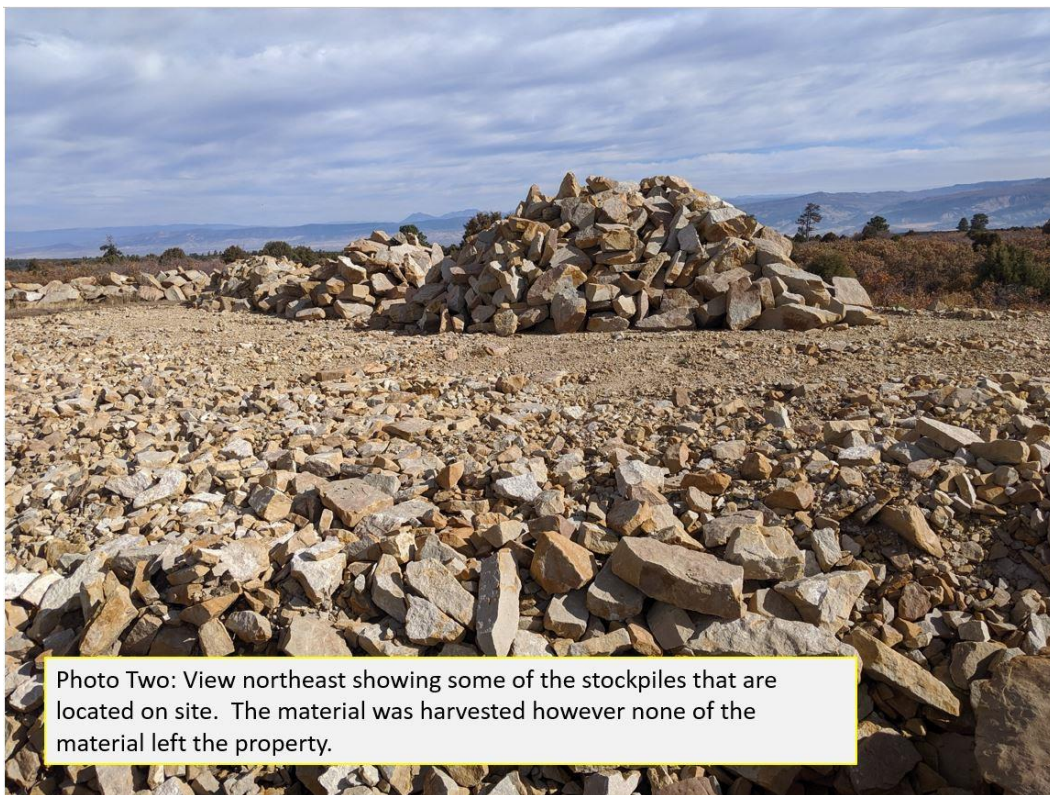
Photo Two: View northeast showing some of the stockpiles that are located on site. The material was harvested however none of the material left the property.

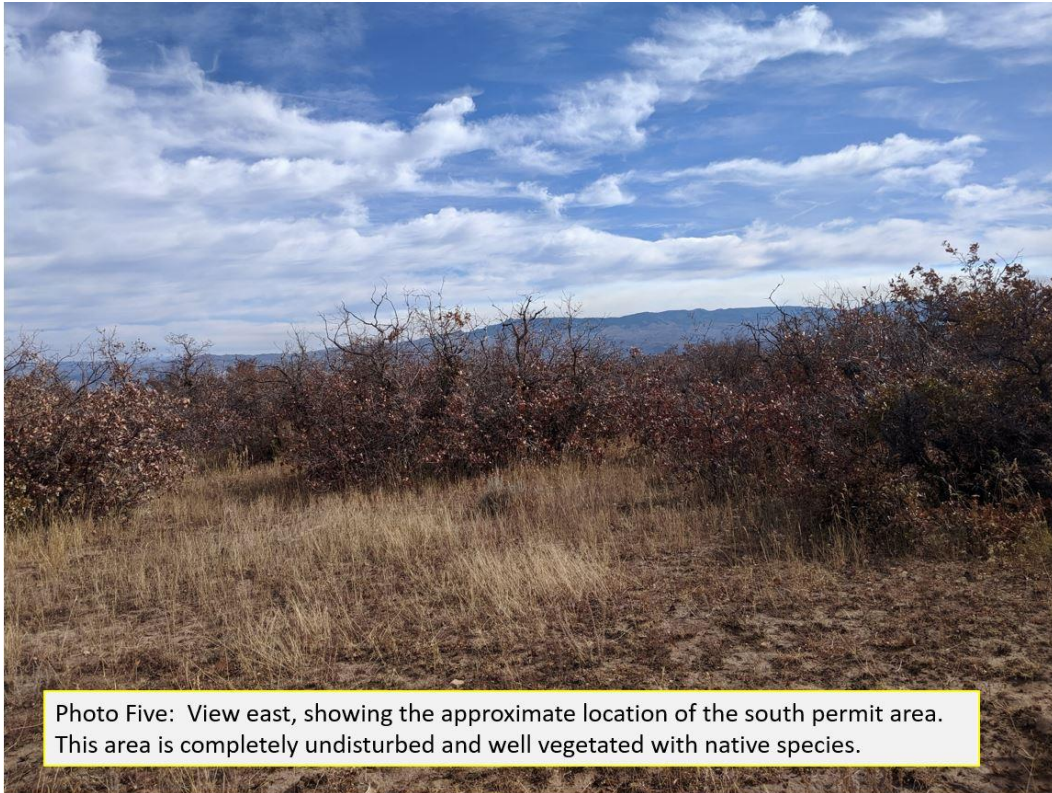
Photo Five: View east, showing the approximate location of the south permit area. This area is completely undisturbed and well vegetated with native species.
