MINERALS PROGRAM INSPECTION REPORT
PHONE: (303) 866-3567

MINE NAME: Hobo 2	MINE/PROSPECTING ID#: M-2017-044	MINERAL: Gemstones	COUNTY: San Juan
INSPECTION TYPE: Monitoring	INSPECTOR(S): Lucas J. West	INSP. DATE: September 25, 2019	INSP. TIME: 09:35
OPERATOR: McFarland Enterprises, Inc.	OPERATOR REPRESENTATIVE: Keith McFarland	TYPE OF OPERATION: 110(1) - Hard Rock Limited Impact	
REASON FOR INSPECTION: Normal I&E Program	BOND CALCULATION TYPE: None	BOND AMOUNT: \$10,000.00	
DATE OF COMPLAINT: NA	POST INSP. CONTACTS: None	JOINT INSP. AGENCY: None	
WEATHER: Clear	INSPECTOR'S SIGNATURE:

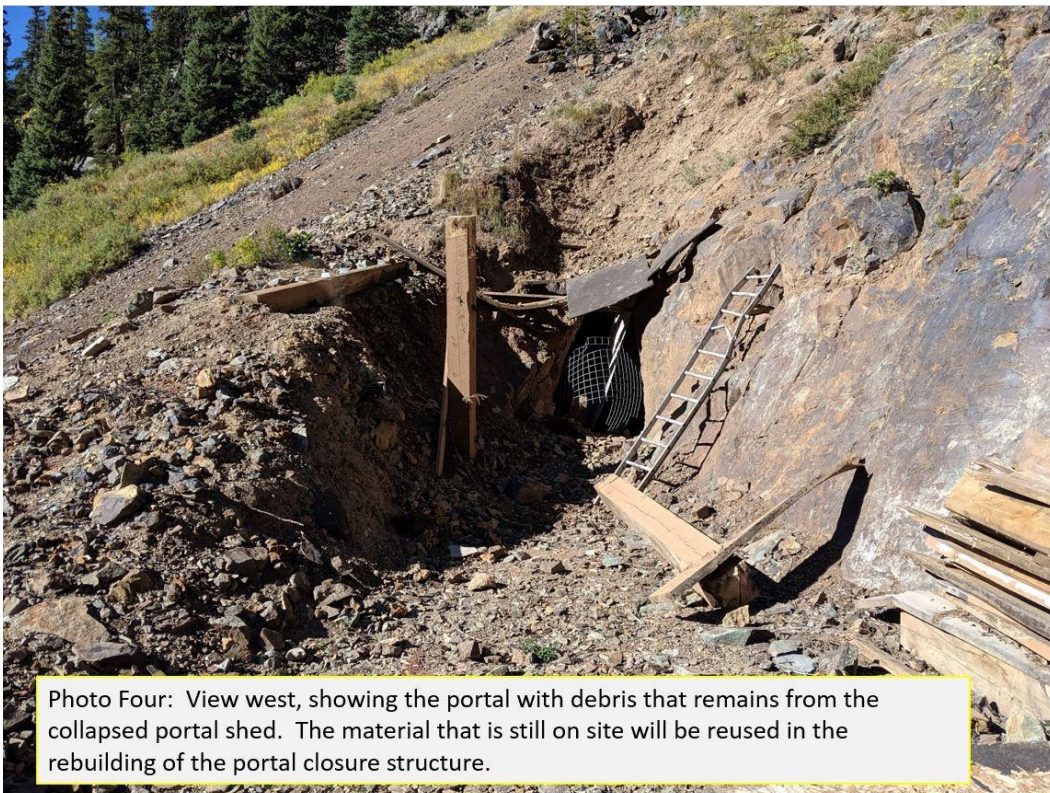
The main purpose of this inspection was to monitor the status of the site, as the permitting process is completed. The access road leading up to the portal from the Toltec Tunnel area appears to be stable and in good condition. No significant signs of settling, slumping or erosion were noted at this time. The initial area of concern, the uphill side of the road, also appears to be stable at this time. Photos One through Three show the condition of the road. The portal pad and work area appear to be in the same condition as the previous inspection. The Portal shed structure has collapsed due to excessive snow loading. Some of the building materials and debris has been removed from the site however some of the material that is reusable still remains. A written request to rebuild the structure this season has been submitted and approved however due to weather delays the repairs will not be able to be completed until the coming spring. The collapsed portal shed and portal can be seen in Photo Four.
