MINERALS PROGRAM INSPECTION REPORT

MINE NAME: Toltec No 2	MINE/PROSPECTING ID#: M-1984-039	MINERAL: Silver, gold, copper,	COUNTY: San Juan
INSPECTION TYPE: Monitoring	INSPECTOR(S): Lucas J. West	INSP. DATE: September 25, 2019	INSP. TIME: 10:10
OPERATOR: Wilbur F Benham	OPERATOR REPRESENTATIVE: None	TYPE OF OPERATION: 110(2) - Hard Rock Limited Impact	
REASON FOR INSPECTION: Normal I&E Program	BOND CALCULATION TYPE: Complete Bond	BOND AMOUNT: \$1,012.00	
DATE OF COMPLAINT: NA	POST INSP. CONTACTS: None	JOINT INSP. AGENCY: None	
WEATHER: Clear	INSPECTOR'S SIGNATURE:

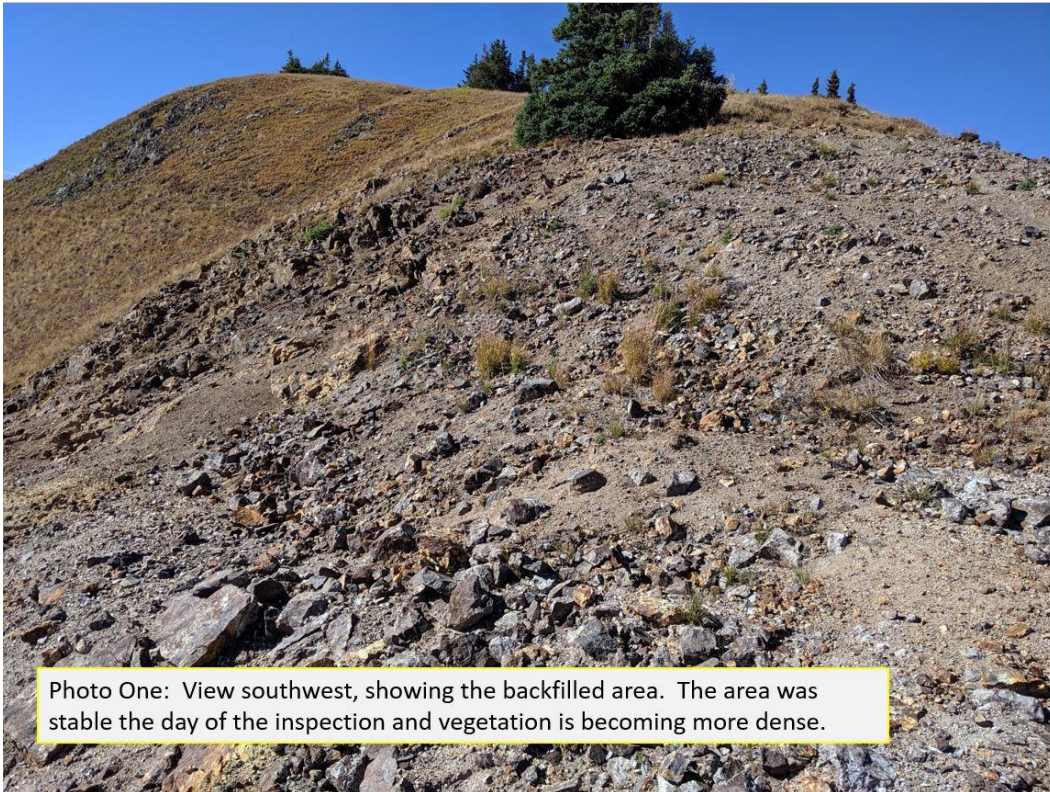
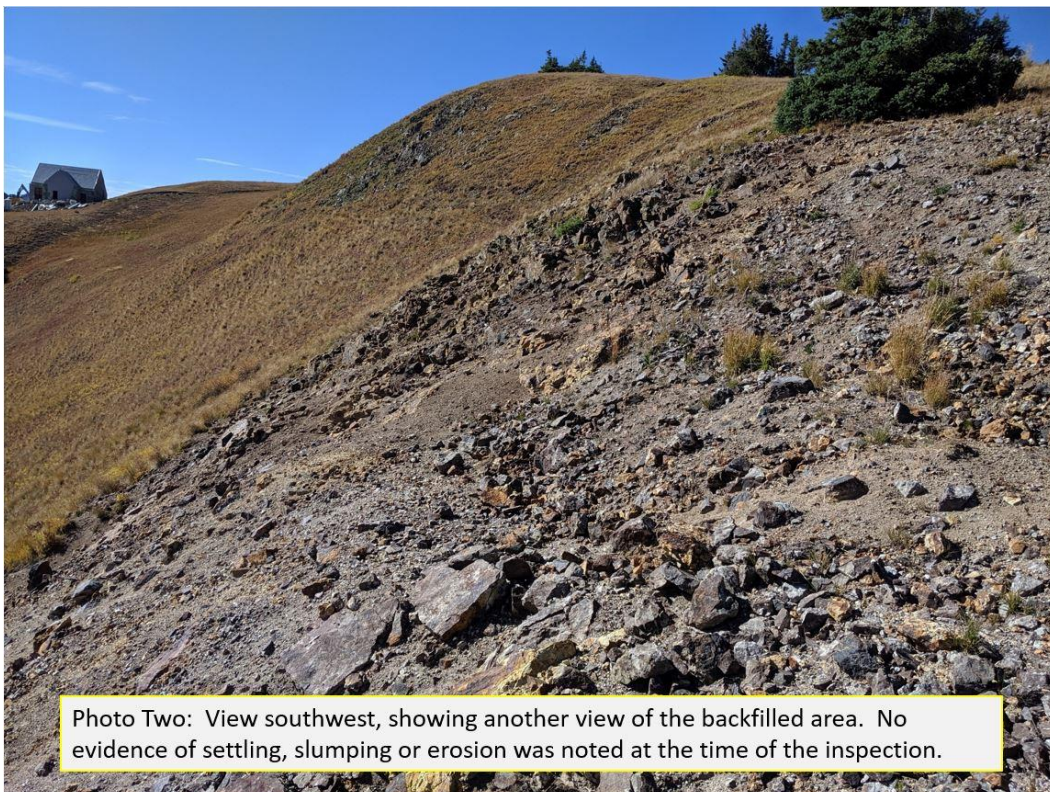
Reclamation activities were completed in 2016. The waste rock pile located on site has been blended into the rock face to match the surrounding topography. The backfilling and blending appears to be stable and in good condition. Photos One and Two show the backfilled area. The main work area adjacent to the rock face has been graded to ensure positive drainage. Topsoil has been replaced throughout the site. The grading of the topsoil appears to be stable and no erosional issues were noted on site. All earthwork and grading has been completed according to the approved reclamation plan that was recently modified through TR-02. The main work and parking area appears to be stable and in good condition and can be seen in Photo Three. Two stockpiles of dimensional stone are located on the work area. These are being stored by the adjacent property owner who is constructing a cabin. Revegetation is the only remaining task to achieve final reclamation of the site. In some small sections of the reclaimed area, some volunteer vegetation is beginning to grow. The species include various types of alpine grasses that were likely seeded from surrounding undisturbed areas. No State listed noxious weeds were observed during the inspection.

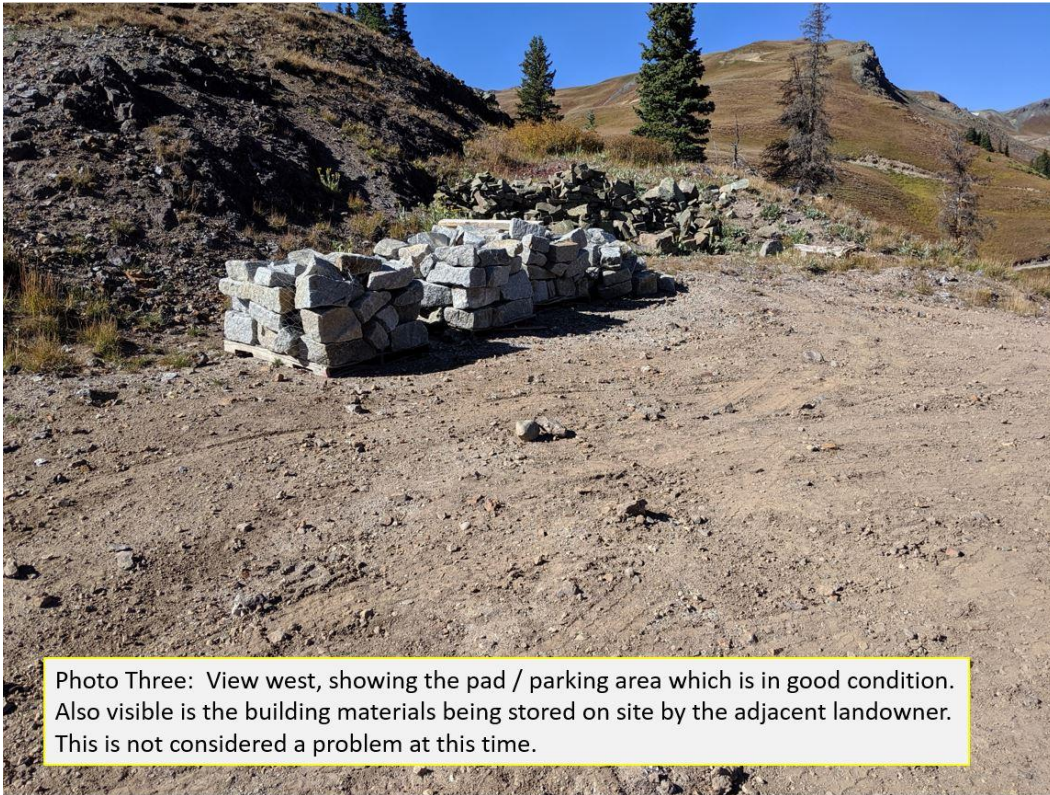
Photo Three: View west, showing the pad / parking area which is in good condition. Also visible is the building materials being stored on site by the adjacent landowner. This is not considered a problem at this time.
