MINERALS PROGRAM INSPECTION REPORT
PHONE: (303) 866-3567

MINE NAME: Eureka Gravel Pit	MINE/PROSPECTING ID#: M-1990-070	MINERAL: Gravel	COUNTY: San Juan
INSPECTION TYPE: Monitoring	INSPECTOR(S): Lucas J. West	INSP. DATE: September 25, 2019	INSP. TIME: 10:55
OPERATOR: San Juan County	OPERATOR REPRESENTATIVE: Clear	TYPE OF OPERATION: 110c - Construction Limited Impact	
REASON FOR INSPECTION: Normal I&E Program	BOND CALCULATION TYPE: None	BOND AMOUNT: \$0.00	
DATE OF COMPLAINT: NA	POST INSP. CONTACTS: None	JOINT INSP. AGENCY: None	
WEATHER: Clear	INSPECTOR'S SIGNATURE:

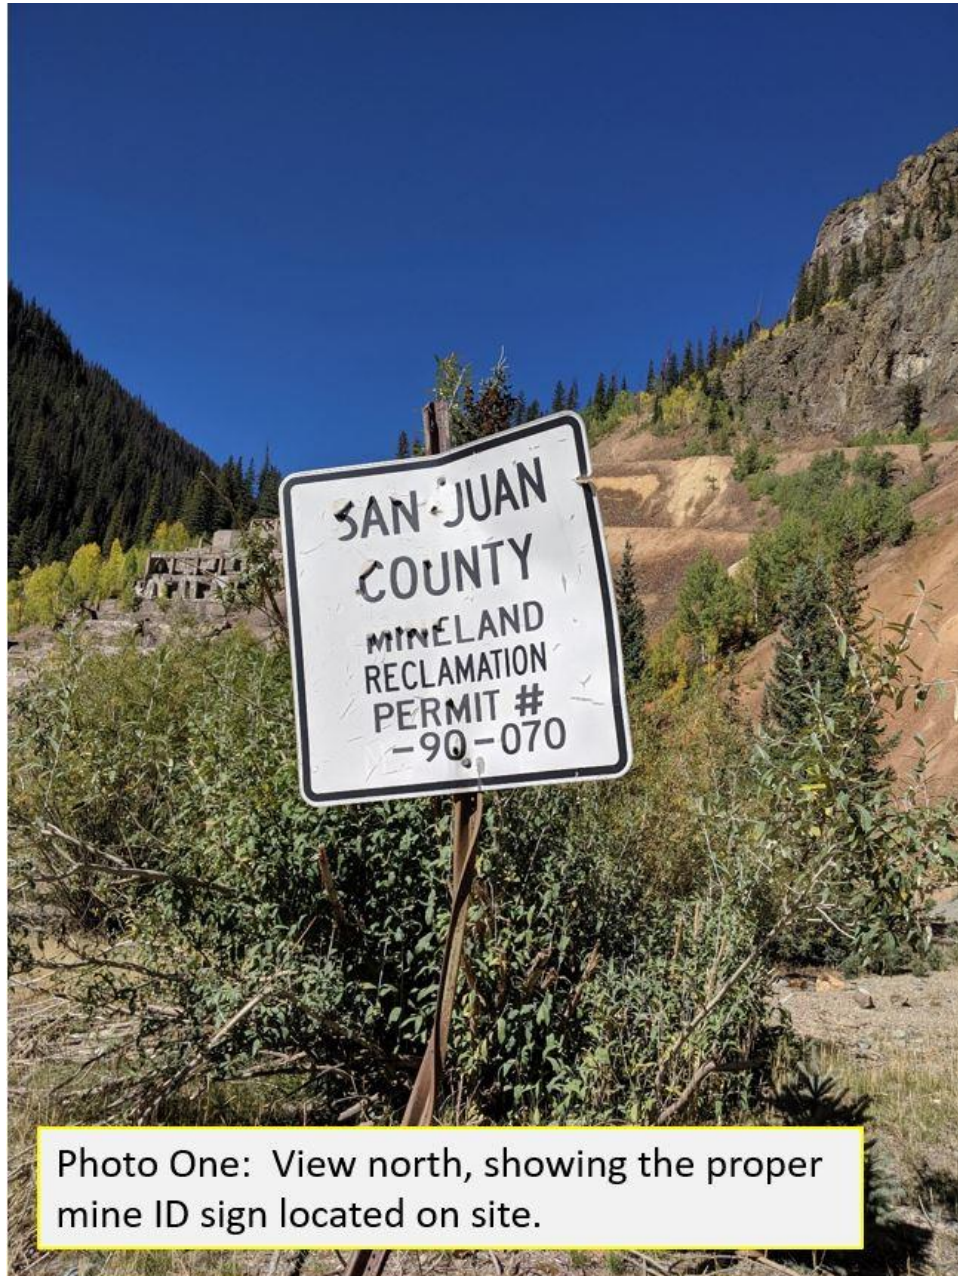
According to the annual reports provided by the Operator the site is no longer active, however is still used as a stockpiling and processing area. Proper signage was observed at the entrance to the site and as seen in Photo One, the boundaries are clearly marked with boulders and t-posts. Several small stockpiles are located within the permit area, as well as a portable grizzly screen as seen in Photos Two and Three. Some miscellaneous items are being stored on site, such as culverts and other road maintenance materials. The items are stored in neat and orderly fashion and not considered a problem at this time.

Photo One: View north, showing the proper mine ID sign located on site.

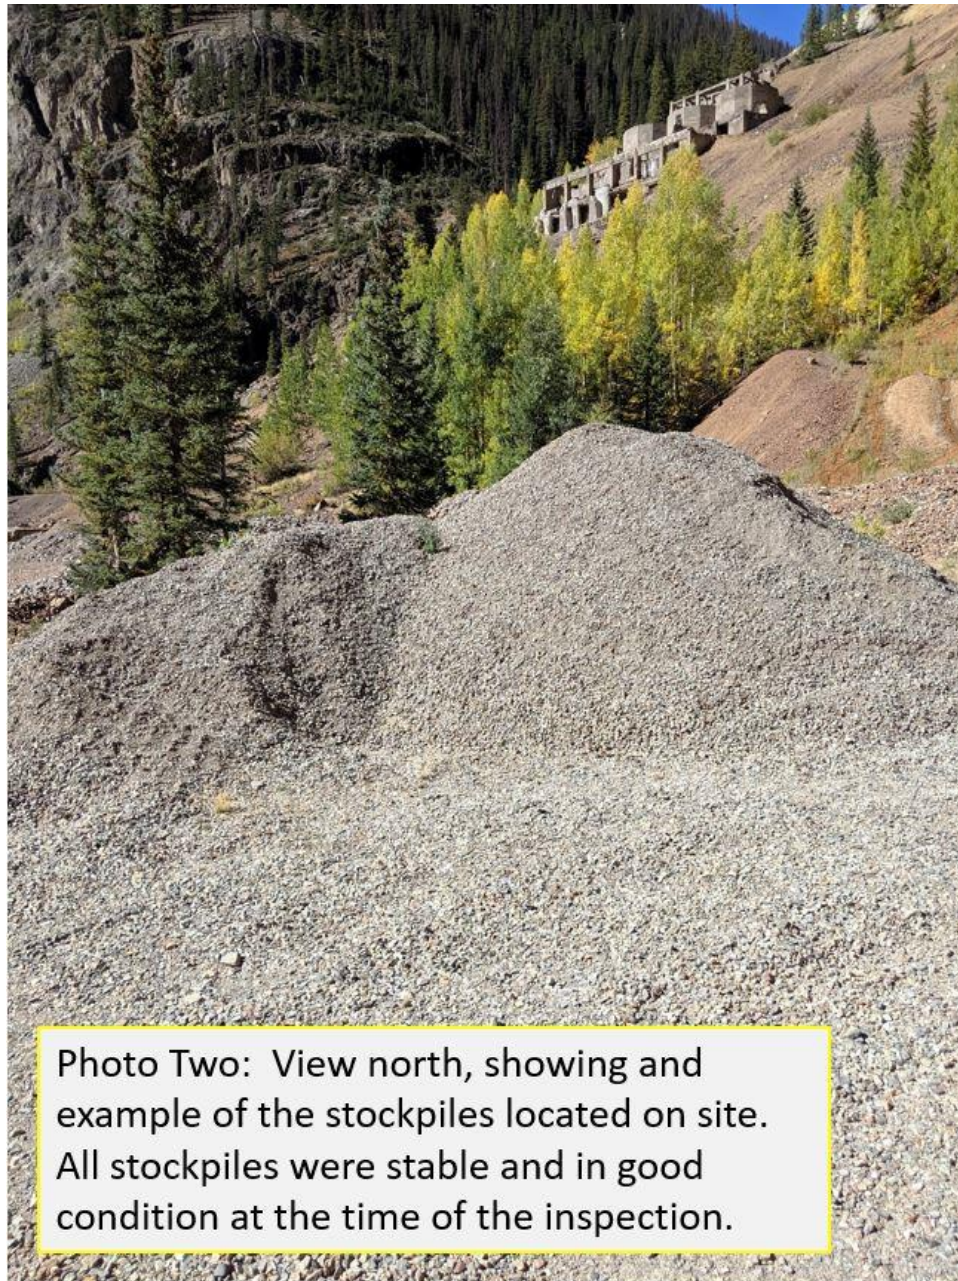
Photo Two: View north, showing and example of the stockpiles located on site. All stockpiles were stable and in good condition at the time of the inspection.

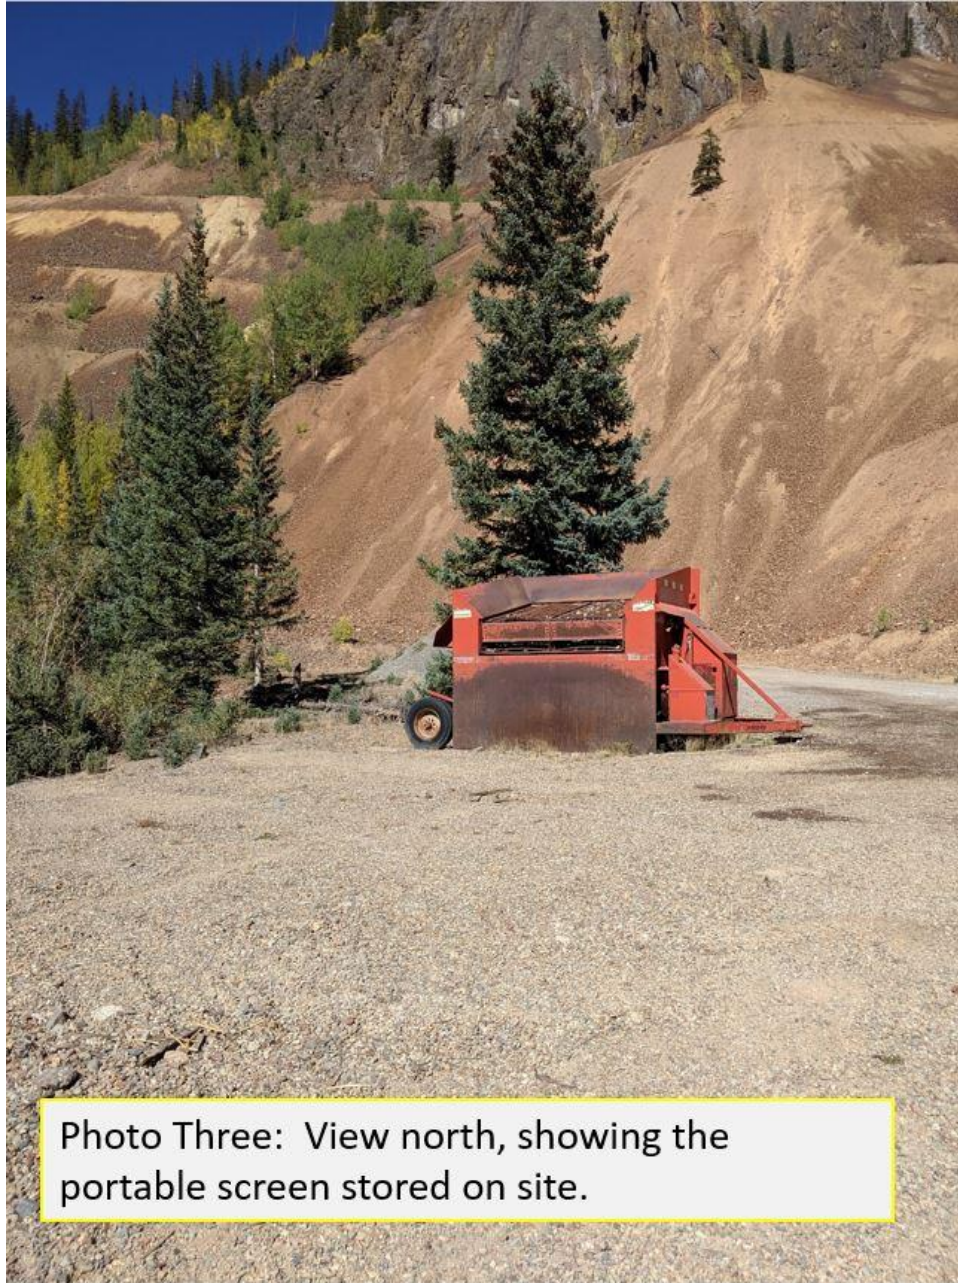
Photo Three: View north, showing the portable screen stored on site.
