**MINERALS PROGRAM INSPECTION REPORT**  
**PHONE: (303) 866-3567**

<b>MINE NAME:</b> Bachelor Mines	<b>MINE/PROSPECTING ID#:</b> M-1980-170	<b>MINERAL:</b> Silver	<b>COUNTY:</b> Ouray
<b>INSPECTION TYPE:</b> Monitoring	<b>INSPECTOR(S):</b> Lucas J. West	<b>INSP. DATE:</b> September 25, 2019	<b>INSP. TIME:</b> 13:00
<b>OPERATOR:</b> Bachelor Silver Mines Company	<b>OPERATOR REPRESENTATIVE:</b> Carl Dismant	<b>TYPE OF OPERATION:</b> 110(2) - Hard Rock Limited Impact	
<b>REASON FOR INSPECTION:</b> Normal I&E Program	<b>BOND CALCULATION TYPE:</b> Complete Bond	<b>BOND AMOUNT:</b> \$7,693.00	
<b>DATE OF COMPLAINT:</b> NA	<b>POST INSP. CONTACTS:</b> None	<b>JOINT INSP. AGENCY:</b> None	
<b>WEATHER:</b> Clear	<b>INSPECTOR'S SIGNATURE:</b>

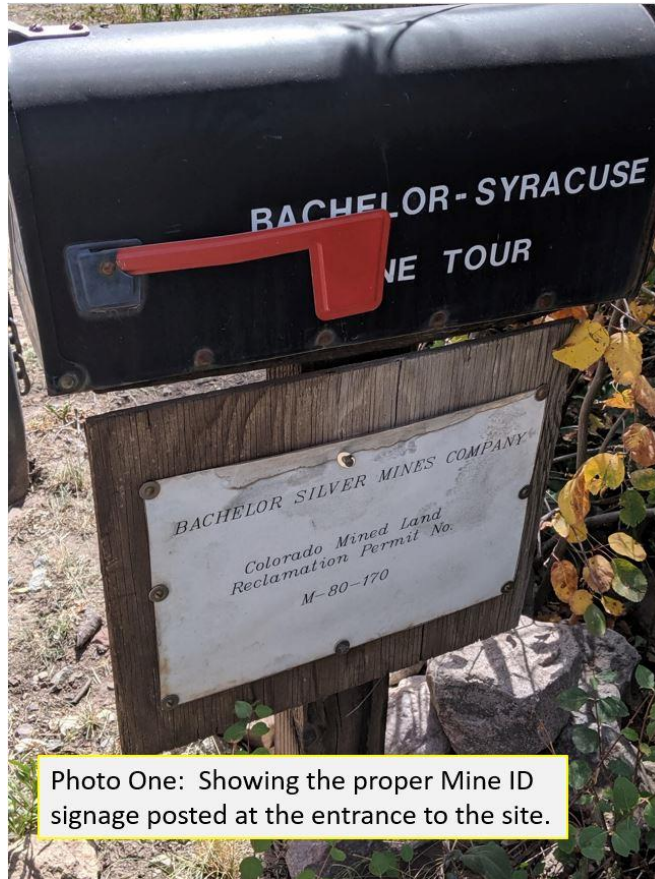
The site was not active at the time of the inspection however mining equipment, including historic mining equipment was observed on site. The proper Mine Identification signage was posted at the entrance to the site and can be seen in Photo One. The main underground portal was observed and is good condition. The portal and tracks to the loadout area is covered under a shed structure. The main portal, which is referred to as the Syracuse Portal, and the shed structure can be seen in Photo Two, both were stable at the time of the inspection. The portal does have an associated discharge that was visually estimated to be flowing at approximately 25 Gallons Per Minute. The flow enters Lake Lenore Estates and does not discharge to the nearby stream channel. The water was clear and no evidence of mineral staining or precipitates were noted.

Photo One: Showing the proper Mine ID signage posted at the entrance to the site.

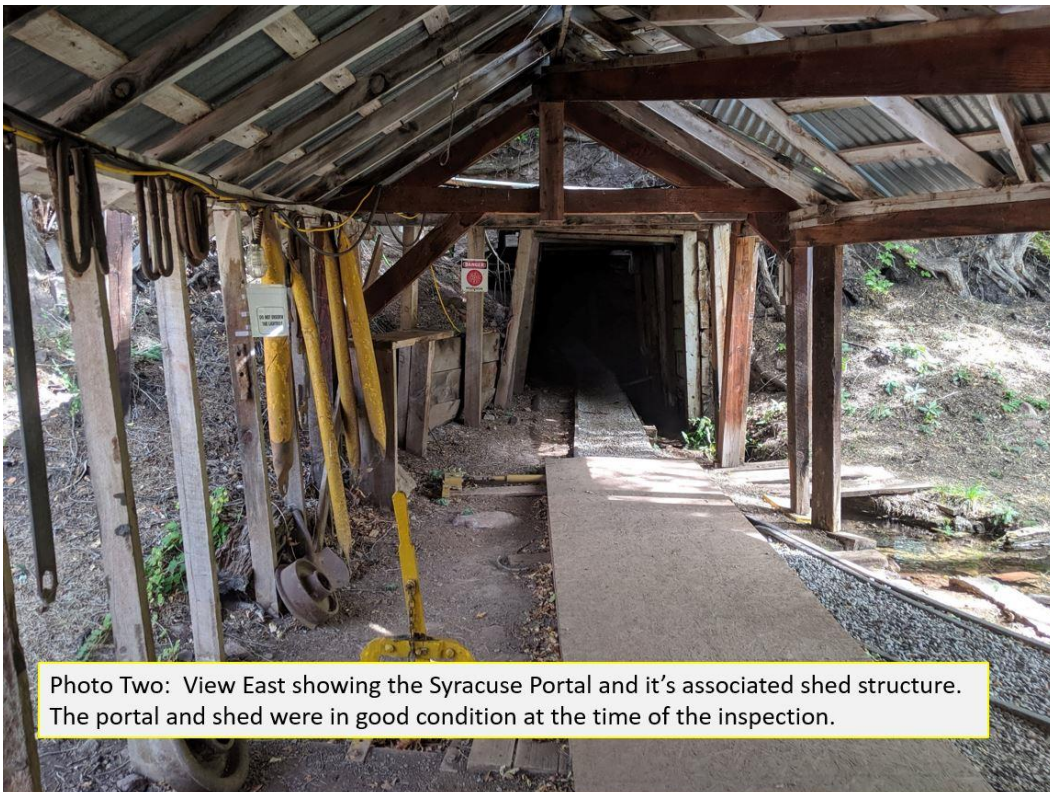
Photo Two: View East showing the Syracuse Portal and it's associated shed structure. The portal and shed were in good condition at the time of the inspection.

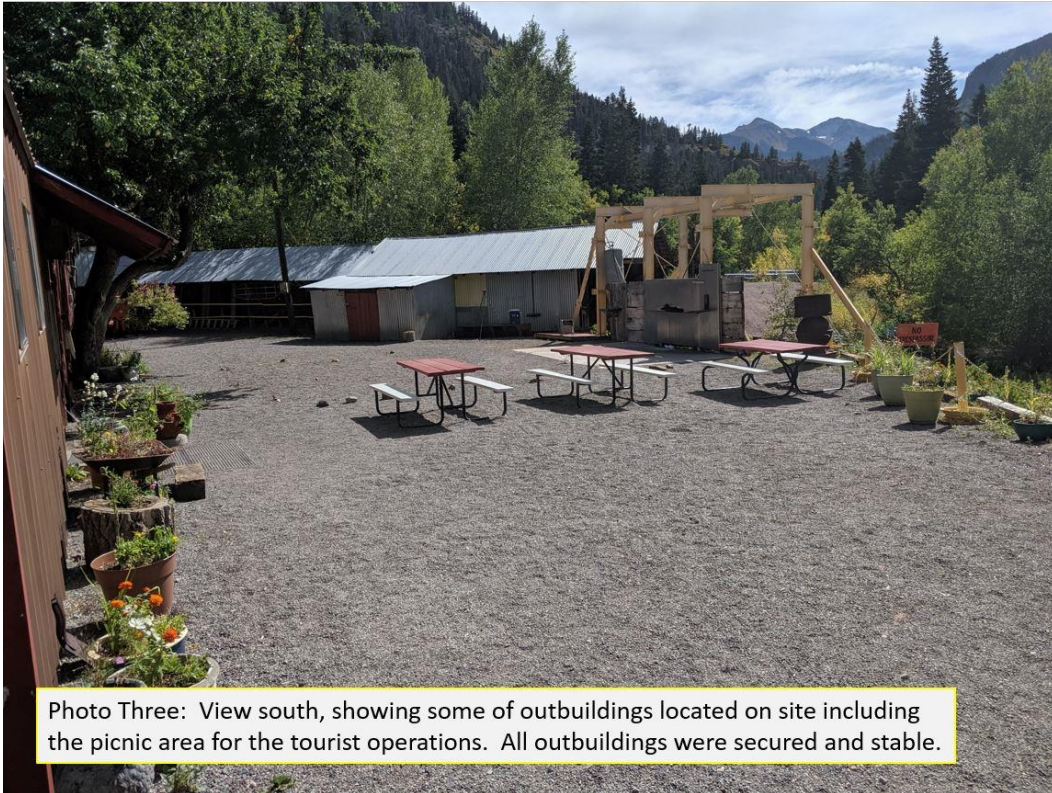
Along with the portal shed and loadout structure several outbuildings including a maintenance shop, gift shop and other facilities are located within the permit area. All outbuildings are in good condition and stable at the time of the inspection. Examples of the outbuildings can be seen in Photos Three and Four. Throughout the site no evidence of state listed noxious weeds were observed. No signs of significant erosion, settling or slumping was noted during the inspection

Photo Three: View south, showing some of outbuildings located on site including the picnic area for the tourist operations. All outbuildings were secured and stable.

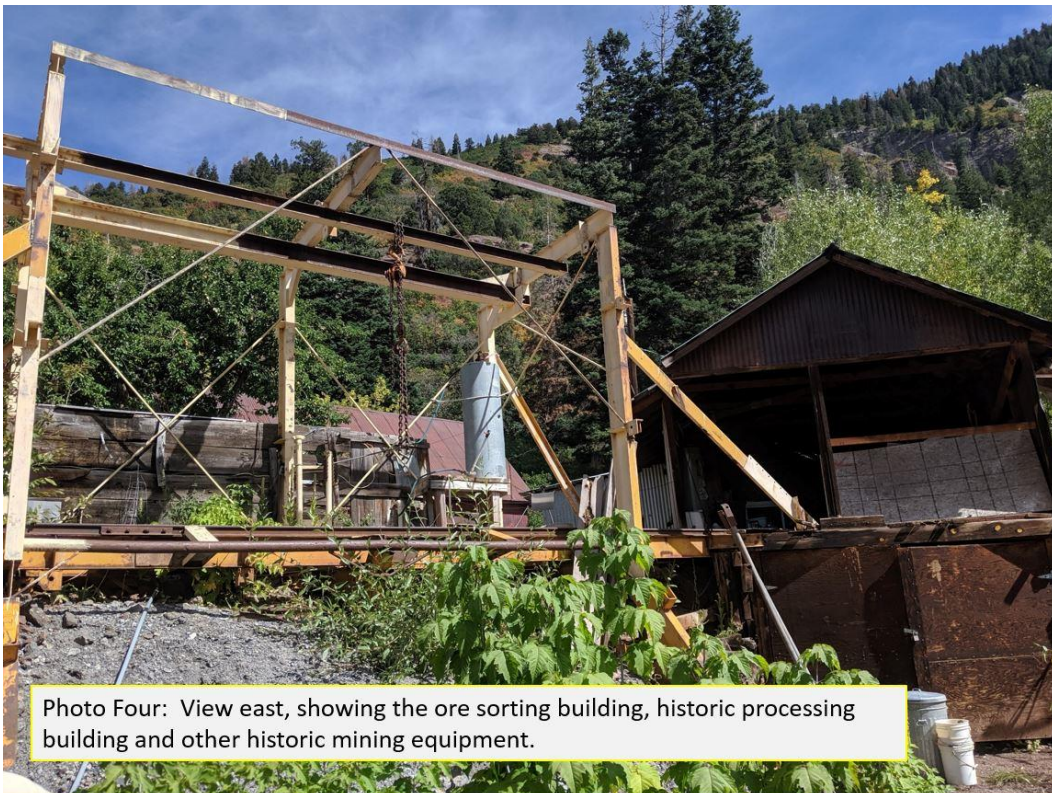
Photo Four: View east, showing the ore sorting building, historic processing building and other historic mining equipment.
