**MINERALS PROGRAM INSPECTION REPORT**  
**PHONE: (303) 866-3567**

<b>MINE NAME:</b> Bachelor Syracuse Mn	<b>MINE/PROSPECTING ID#:</b> M-1980-171	<b>MINERAL:</b> Silver and gold	<b>COUNTY:</b> Ouray
<b>INSPECTION TYPE:</b> Monitoring	<b>INSPECTOR(S):</b> Lucas J. West	<b>INSP. DATE:</b> September 25, 2019	<b>INSP. TIME:</b> 14:00
<b>OPERATOR:</b> Bachelor Silver Mines Company	<b>OPERATOR REPRESENTATIVE:</b> Carl Dismant	<b>TYPE OF OPERATION:</b> 110(2) - Hard Rock Limited Impact	
<b>REASON FOR INSPECTION:</b> High Priority	<b>BOND CALCULATION TYPE:</b> Complete Bond	<b>BOND AMOUNT:</b> \$6,536.00	
<b>DATE OF COMPLAINT:</b> NA	<b>POST INSP. CONTACTS:</b> None	<b>JOINT INSP. AGENCY:</b> None	
<b>WEATHER:</b> Clear	<b>INSPECTOR'S SIGNATURE:</b>

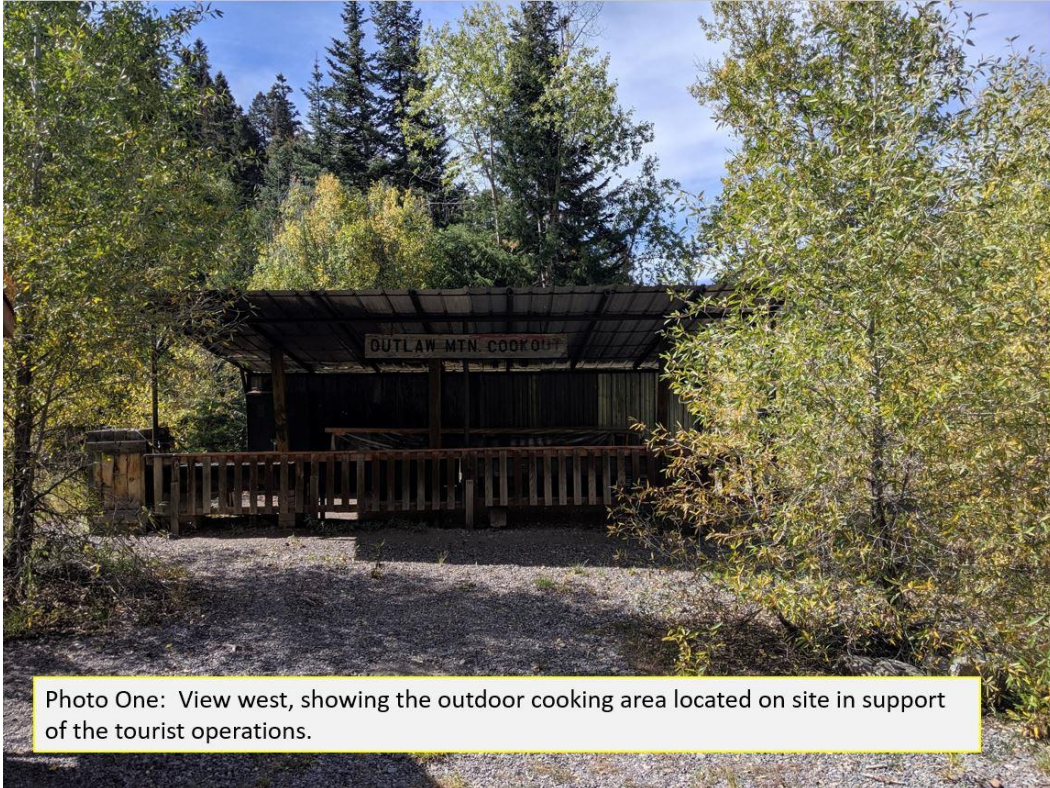
The tourist related structures on site include a covered picnic area, cooking area and camp fire pit used as a meal site for the tourist operations. All structures and items located in this area are in good condition and were stable at the time of the inspection. The structures can be seen in Photos One and Two. Adjacent to the meal area is a pre-law waste rock pile that borders Dexter Creek. The waste rock pile was stable during the inspection and has begun to revegetate itself with volunteer species.

Photo One: View west, showing the outdoor cooking area located on site in support of the tourist operations.

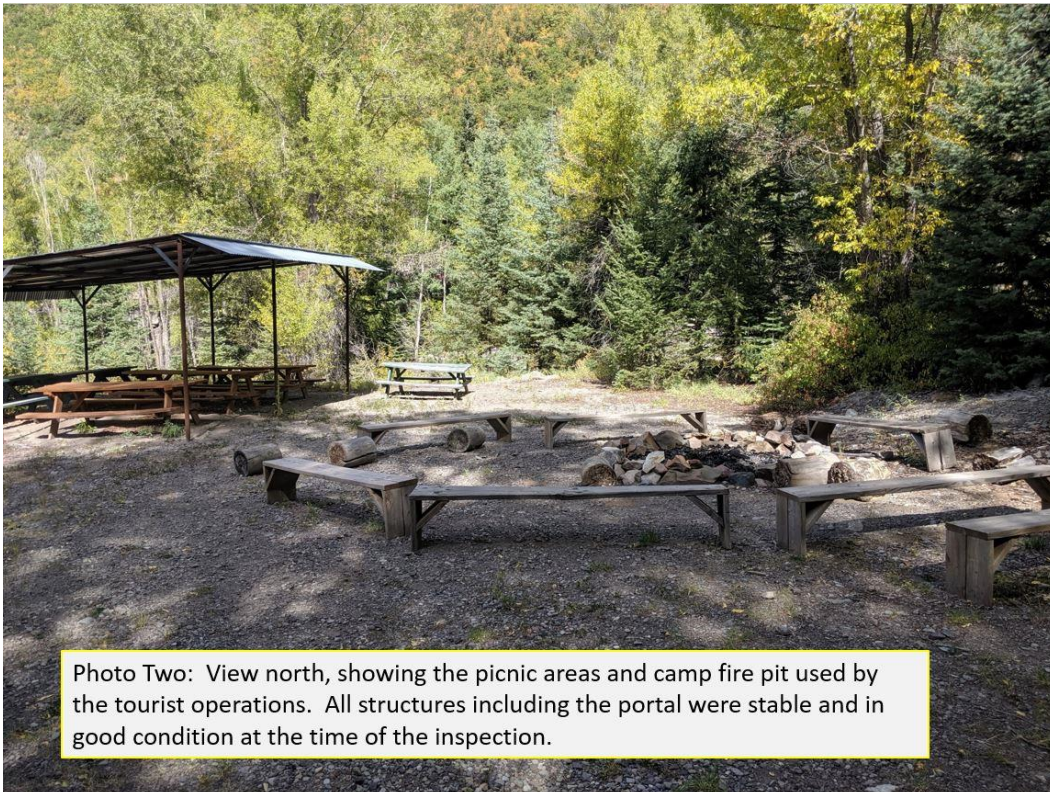
Photo Two: View north, showing the picnic areas and camp fire pit used by the tourist operations. All structures including the portal were stable and in good condition at the time of the inspection.
