MINERALS PROGRAM INSPECTION REPORT
PHONE: (303) 866-3567

MINE NAME: The Pride of America Mine	MINE/PROSPECTING ID#: M-1999-058	MINERAL: Marble	COUNTY: Gunnison
INSPECTION TYPE: Monitoring	INSPECTOR(S): Dustin Czapla	INSP. DATE: October 22, 2019	INSP. TIME: 12:00
OPERATOR: Colorado Stone Quarries, Inc.	OPERATOR REPRESENTATIVE: Daniele Treves	TYPE OF OPERATION: 112c - Construction Regular Operation

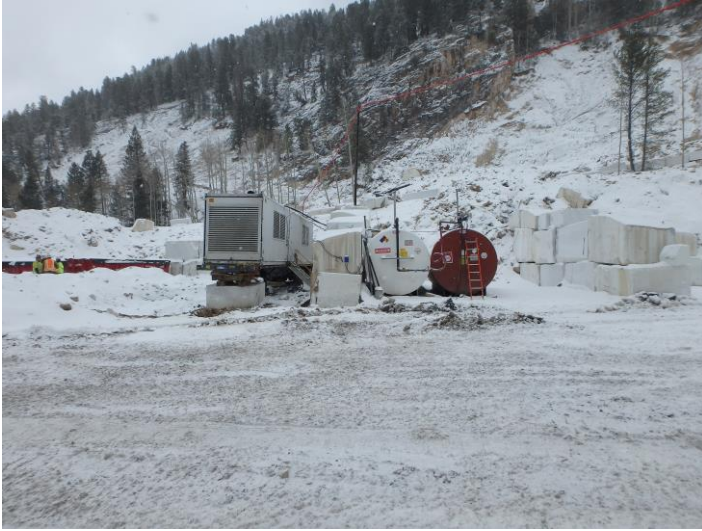
A generator and associated diesel fuel storage tanks were recently moved from their previous location within the 110c permit area near the Lincoln Gallery, to a location on Franklin Ridge. The new location was not proposed in CN-1, and therefore has not been approved by the Division. Currently, two double-wall fuel tanks feed a fuel tank located within the generator unit. During the relocation, a vent pipe was installed incorrectly on the generator tank, which led to the fuel pump running continuously and overflowing through the vent. This situation went undiscovered for several days resulting in a diesel spill estimated at 5,500 gallons. Fuel was spilled onto unlined ground and seeped into the unconsolidated material beneath the generator. Although the diesel storage tanks are double walled, which is generally appropriate secondary containment, their connection to each other and the generator create potential for spills. Therefore, the fuel tanks and generator need to be contained within a single secondary containment structure of adequate capacity. The containment structure and fuel storage location shall be addressed through a technical revision to the permit.

Figure 1: Generator unit and two associated fuel tanks

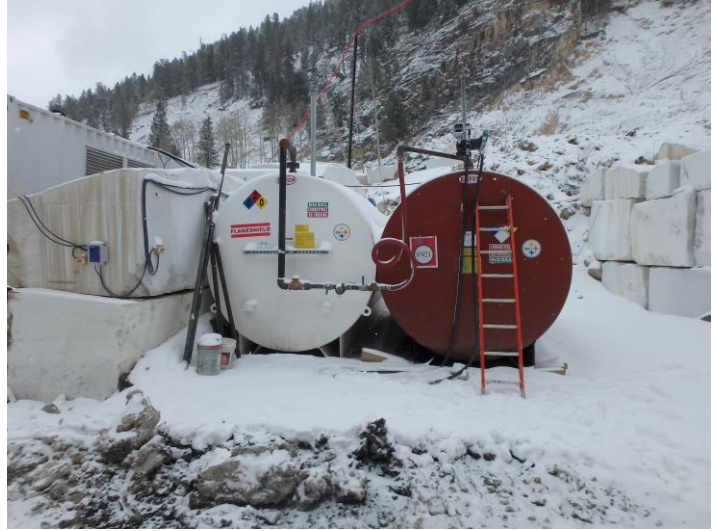
Figure 2: Fuel tanks for generator

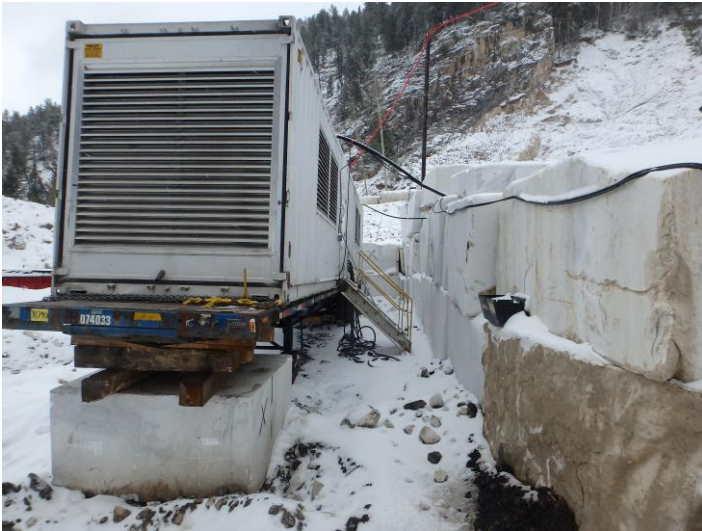
POSSIBLE VIOLATION: Fuel storage associated with the generator unit was not placed in adequate secondary containment structures, resulting in a fuel spill which has impacted soils, and potentially surface and groundwater.

Figure 3: Generator unit in which leak occurred

CORRECTIVE ACTIONS: The operator shall immediately remediate the spill and submit a final report to the Division containing at least the following information:

All storage tanks, petroleum and any hazardous materials on site for any period of time shall have appropriate secondary containment. The site will also have to comply with all applicable SPCC requirements. Note that secondary containment structures shall consist of an impermeable containment which could contain all contents of the tanks and various containers (when full) plus 10% of the total capacity.

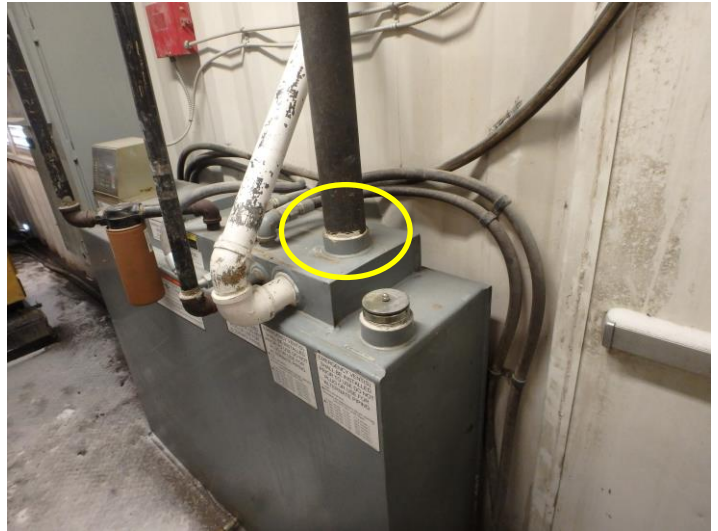
Figure 4: Fuel tank with pump located inside generator unit. Vent was initially installed without the extension pipe causing the system to fail

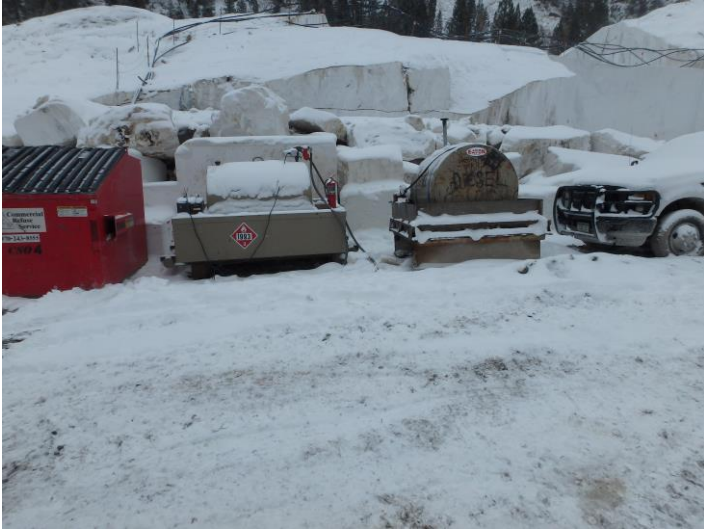
Figure 5: Fuel storage near trailers. Tank on right has been decommissioned due to inadequate secondary containment.

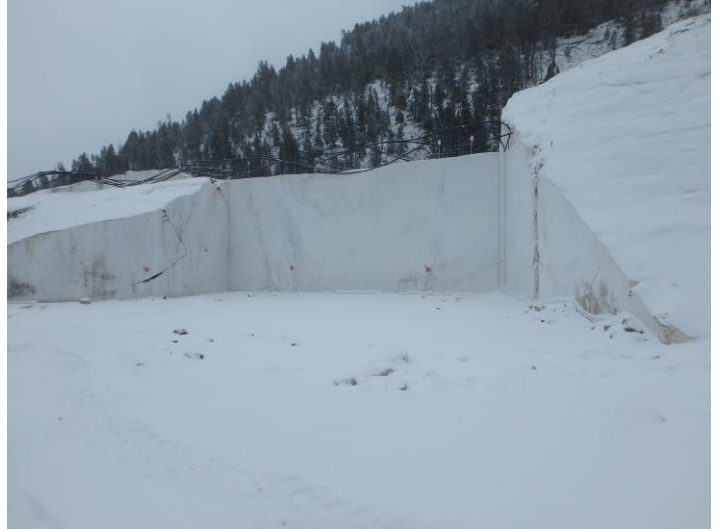
Due to the temporary diversion of Yule Creek, Franklin Ridge lies between the spill location and the creek. The ridge is composed of marble and is for the most part impermeable, creating a barrier between the spill and creek. There is potential, however, that diesel can move downhill through unconsolidated material following the abandoned channel of Yule Creek, joining the diverted Yule Creek at the north end of Franklin Ridge. The operator has placed absorbent booms in a sump located at the end of the channel. At the time of this inspection water in the sump appeared clear and did not appear to have the oily sheen typically associated with diesel spills. It is unknown though whether or not diesel has reached the creek. Water samples are to be collected by a third party group, Terracon, and lab analyzed for hydrocarbons. The operator has initiated cleanup efforts to be conducted by Clean Harbors Environmental Services.

Figure 6: Current cut into Franklin Ridge mining area. Franklin Ridge lies between spill location and diverted Yule Creek

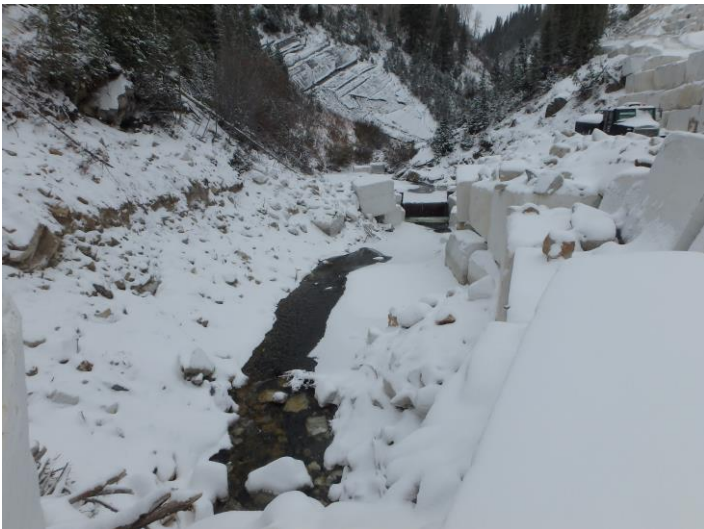
Figure 7: Looking upstream from Yule Creek diversion point

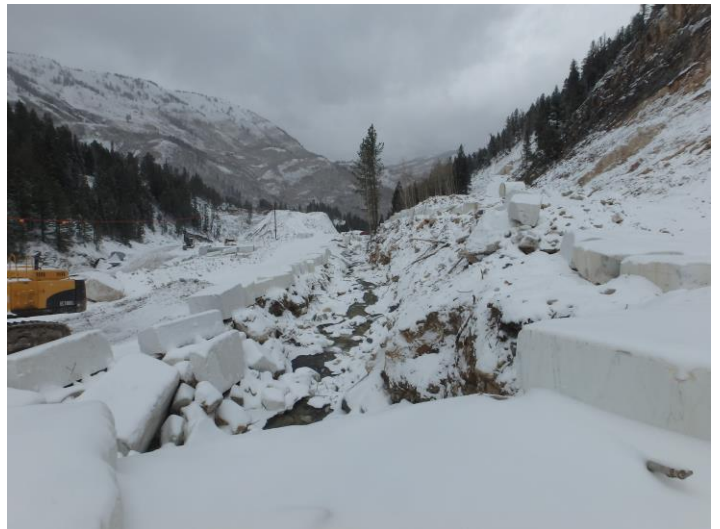
Figure 8: Looking downstream from Yule Creek diversion point

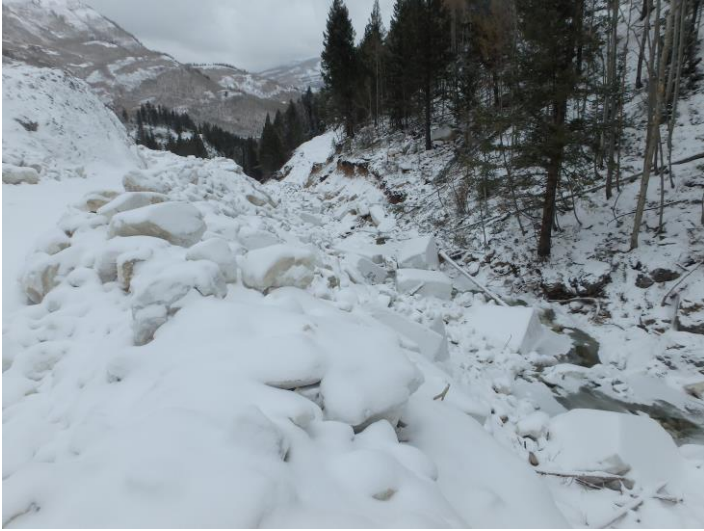
Figure 9: Yule Creek diversion channel

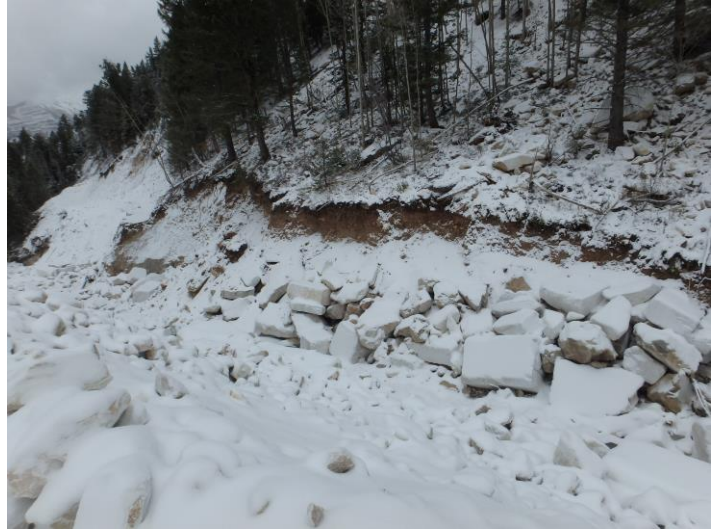
Figure 10: Yule Creek diversion channel

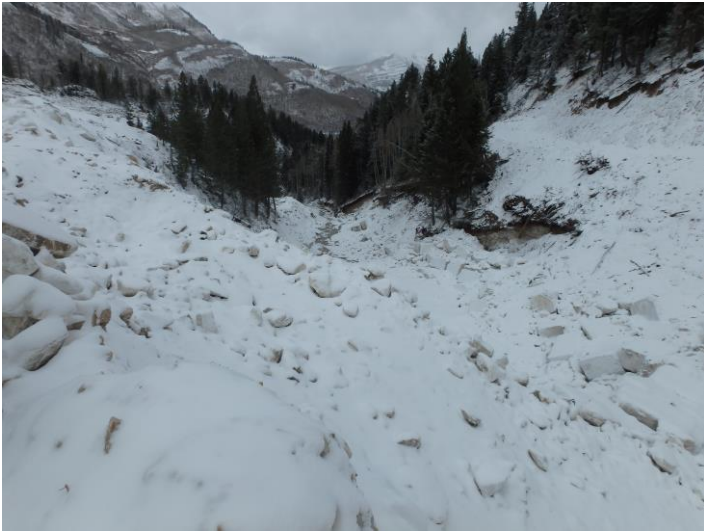
Figure 11: Yule Creek diversion channel

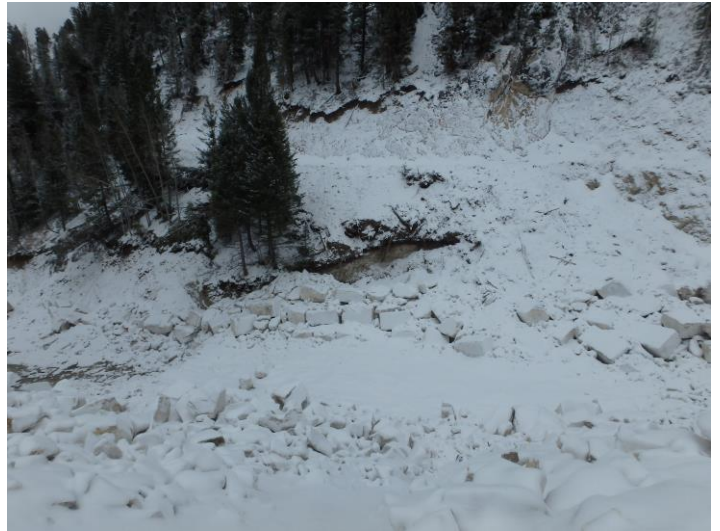
Figure 12: Yule Creek diversion channel
