MINERALS PROGRAM INSPECTION REPORT
PHONE: (303) 866-3567

MINE NAME: Crystal Falls #1 and #2	MINE/PROSPECTING ID#: M-2019-045	MINERAL: GEM	COUNTY: El Paso
INSPECTION TYPE: Illegal(Unpermitted Operation)	INSPECTOR(S): Timothy A. Cazier	INSP. DATE: September 26, 2019	INSP. TIME: 10:15
OPERATOR: James Thomas	OPERATOR REPRESENTATIVE: James Thomas	TYPE OF OPERATION: ILL - Illegal	
REASON FOR INSPECTION: Citizen Complaint	BOND CALCULATION TYPE: IT.Bondcalculationtype.CD.Desc	BOND AMOUNT: No Bond Held	
DATE OF COMPLAINT: August 8, 2019	POST INSP. CONTACTS: None	JOINT INSP. AGENCY: U.S.Forest Service	
WEATHER: Clear	INSPECTOR'S SIGNATURE:

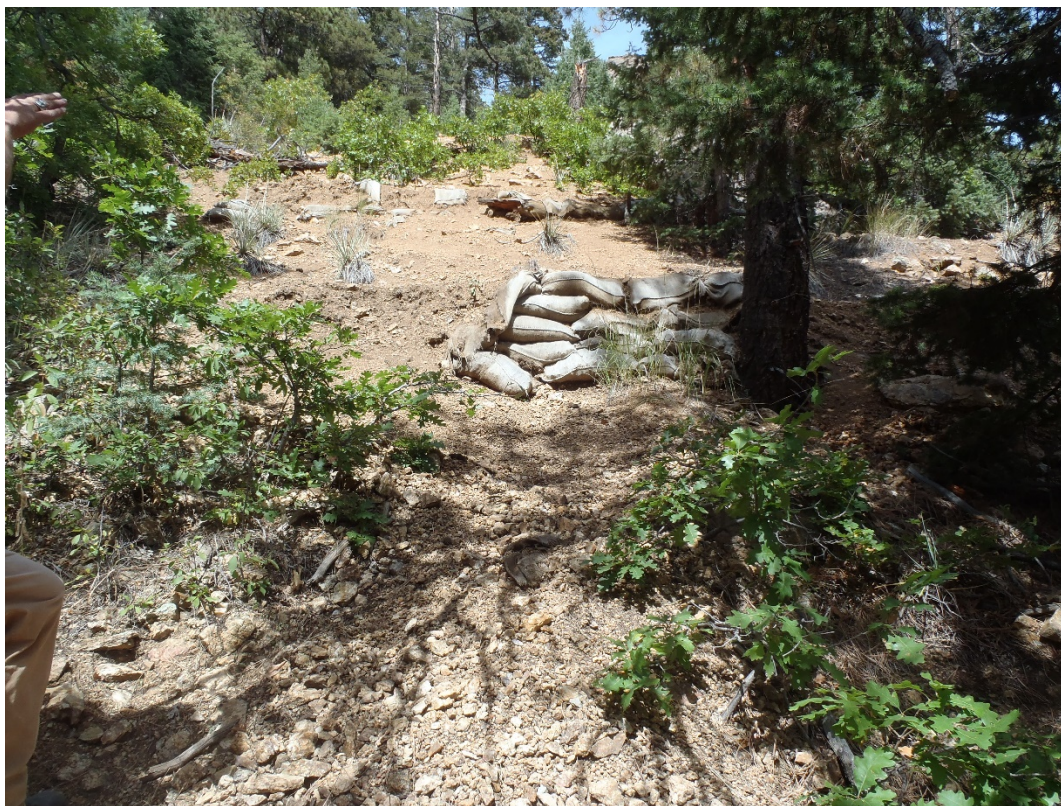
Backfilling and Grading: Mr. Thomas pointed out where he had initiated consolidation and stabilization of cast-off material (see **Photos 1 & 2**) from digs in the vicinity of his discovery pits (see **Photos 3 & 4**), shown as markers on attached **Post Inspection Map** as Discovery post no 1 and no 2 that had occurred before he discovered the area. Backfill material was available for the larger dig sites (labeled as "Mathew's dig", "Facebook dig", and Mathew & Scott's dig" on the attached **Post Inspection Map**) observed within his two claims, but above the discovery pits on flatter ground (see **Photos 5, 6 & 7**).

Photo 1. Stabilization of cast-off material (looking west from downhill & east of Discovery Pit #2).

Sediment Control: Mr. Thomas explained he has professional experience and training in the construction industry for implementing erosion control measures. His efforts to stabilize the cast off material on the steep slope near the discovery posts appeared to be adequate at the time of this inspection. No erosion problems were observed as a result of the larger disturbances (attributed to others above, in Backfilling and Grading), therefore no immediate need for erosion control best management practices (BMPs) was deemed necessary. The DRMS encourages Mr. Thomas to continue his efforts in stabilizing the disturbed areas related to his claims.

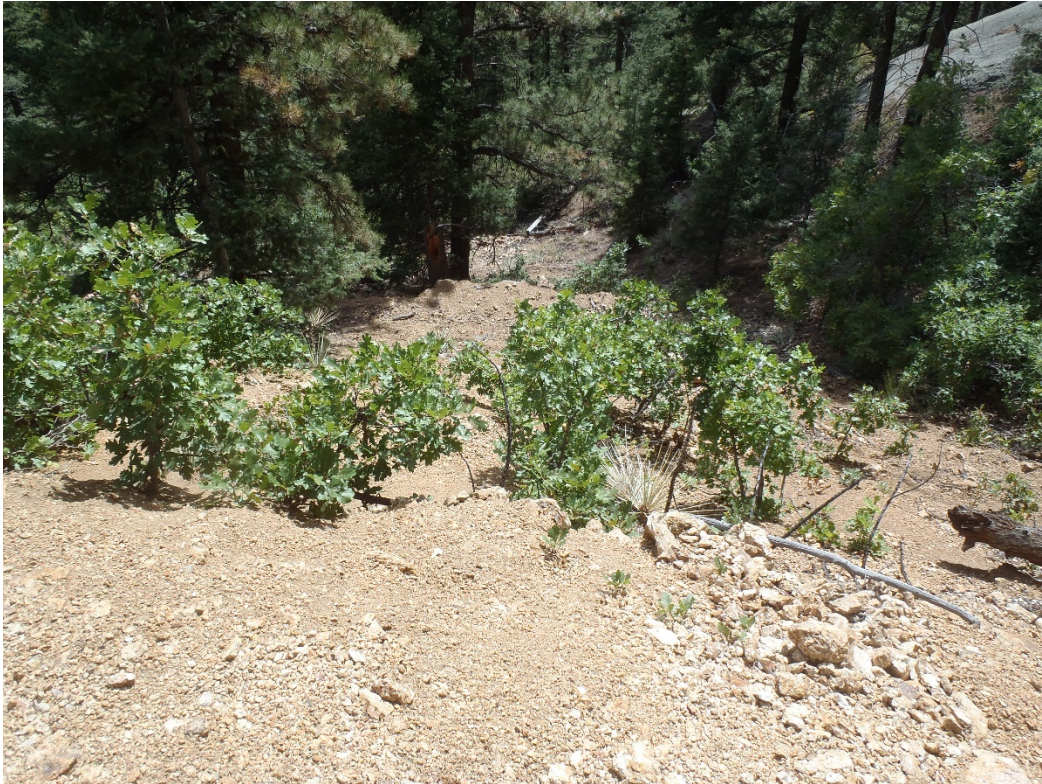
Photo 2. Stabilization of cast-off material (looking east from downhill & east of Discovery Pit #2)

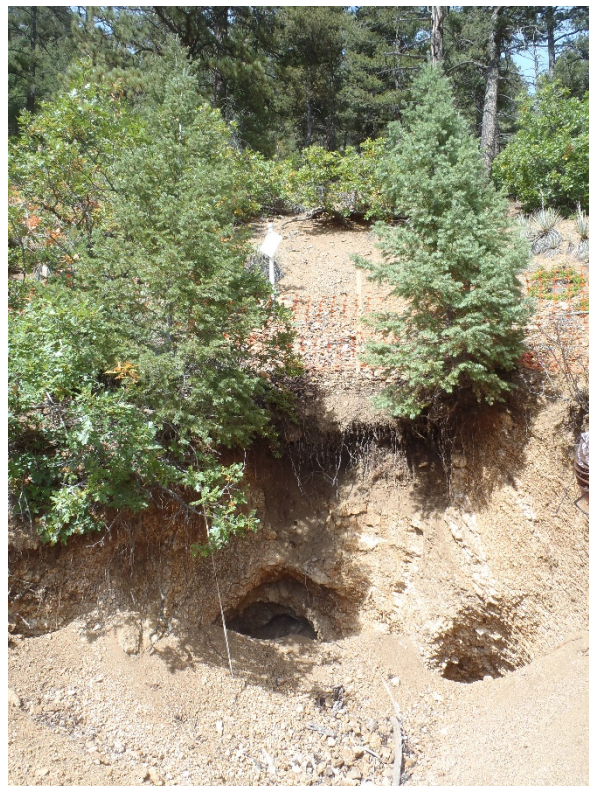
Photo 3. Discovery Pit #2 (looking west from downhill side).

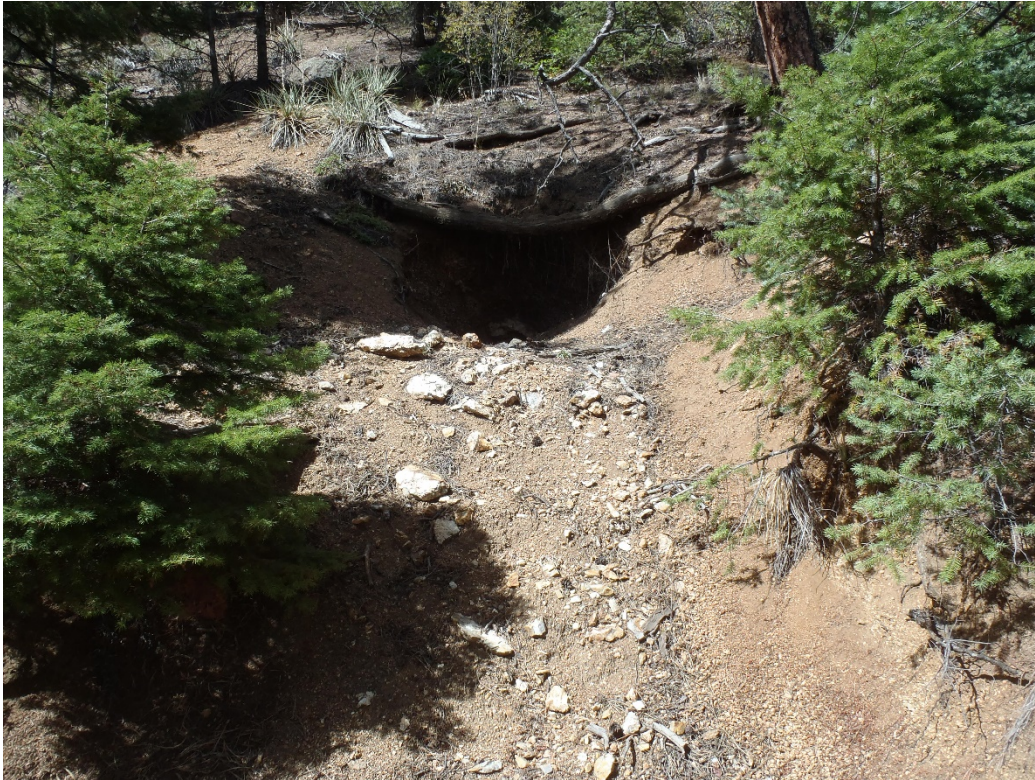
Photo 4. Discovery Pit #1 (looking west from downhill side).

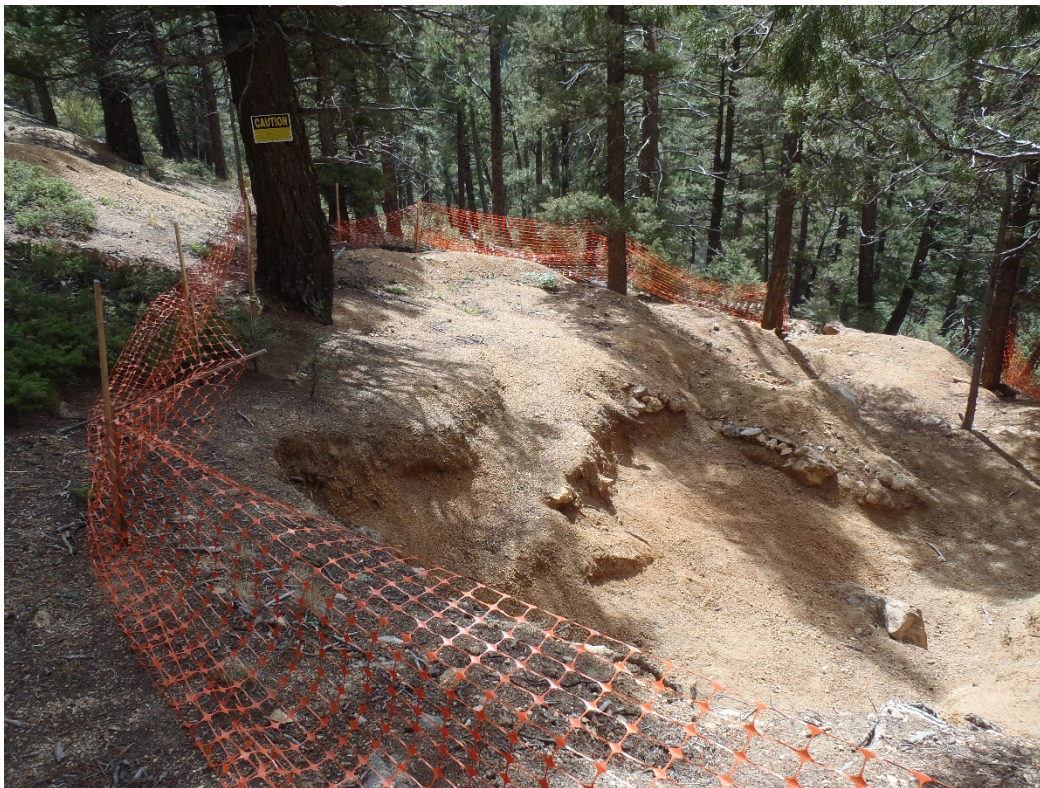
Excess Spoil and Dev. Waste: Development waste or cast-off material surrounded all five notable dig sites. As noted above Mr. Thomas had initiated consolidation and stabilization of the cast-off material associated with the discovery pits. The cast-off material from both the Mathew's dig and the Mathew & Scott's dig had been scattered as far as 50 feet from the dig sites. The cast-off material from the Facebook dig site appeared to be primarily left in place, essentially turned over from where it was disturbed. Mr. Thomas committed to include reclamation costs for all three excavations by others in his financial warranty.

Photo 5. "Mathew's dig" (looking east from west side of highwall crest).

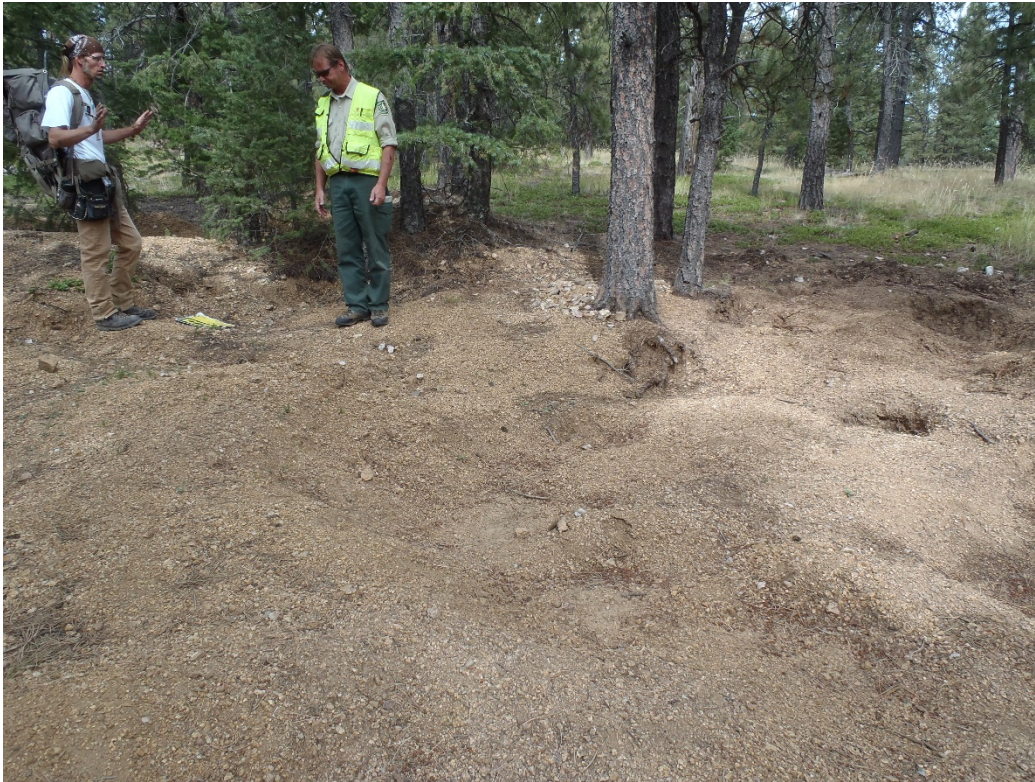
Photo 6. "Facebook dig" (looking north from south end of disturbance).

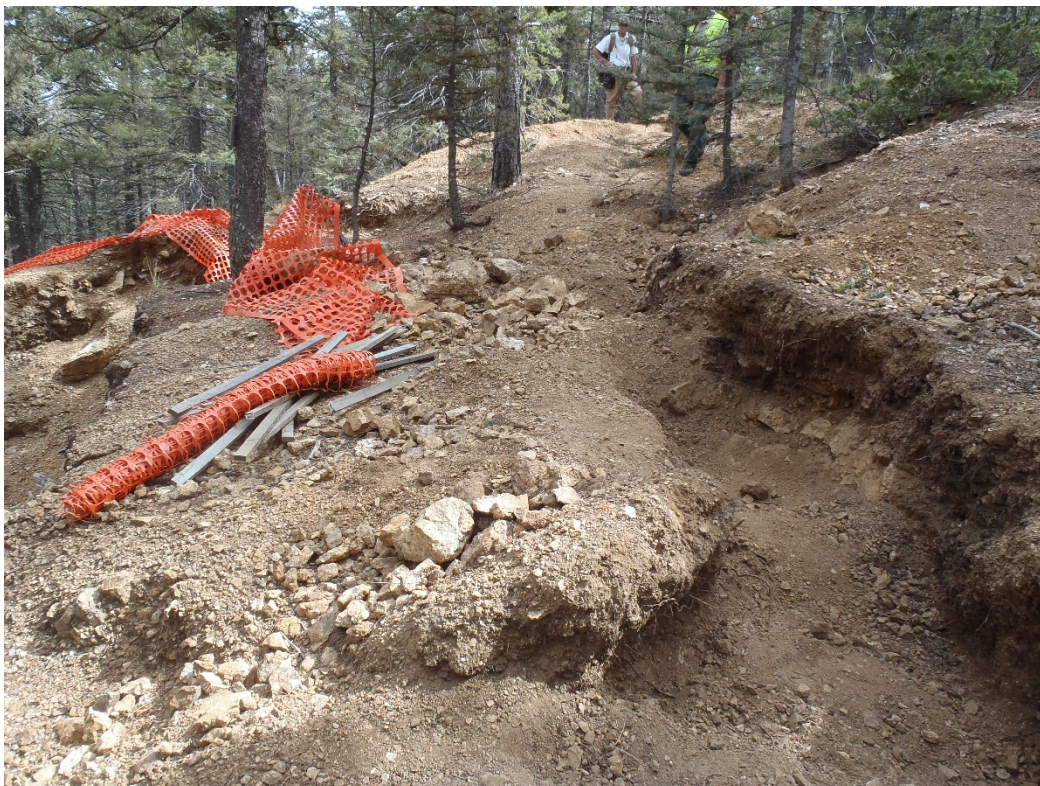
Photo 7. "Mathew & Scott's dig" (looking east from west side of highwall crest).

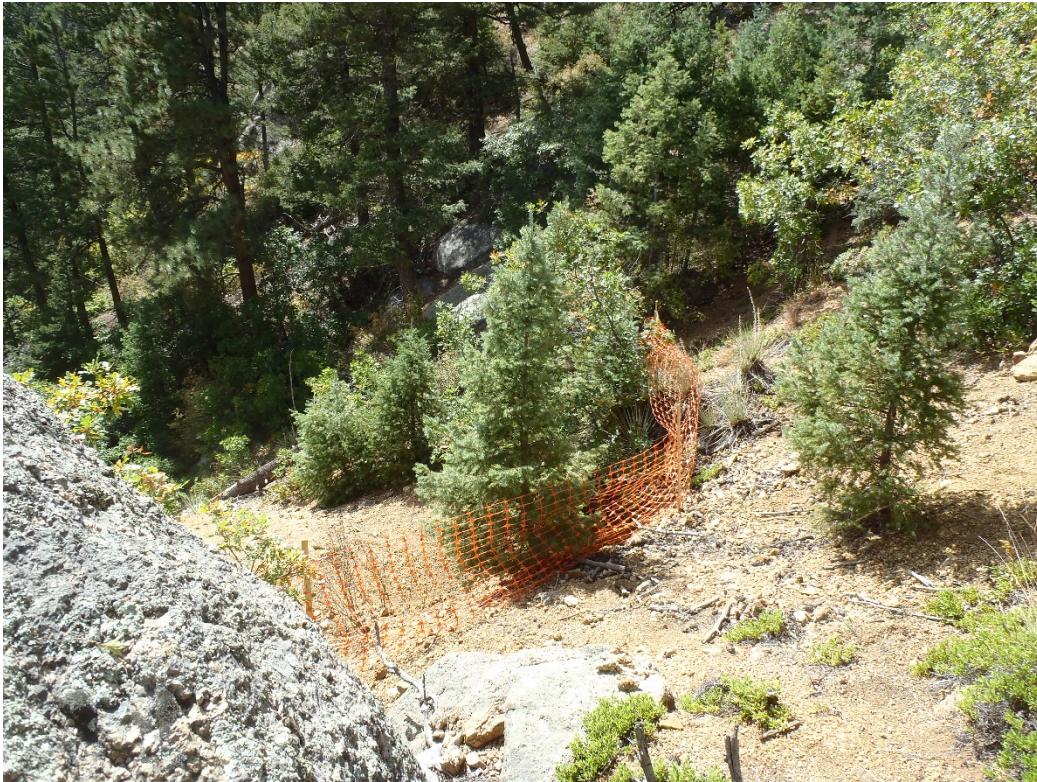
Fish and Wildlife: No discernable impact to wildlife was observed. Construction fencing provided a short barrier to steep highwall drop offs in each case (see **Photos 8 & 9**).

Photo 8. Construction fencing barrier above Discovery pit #2 (looking SE from above pit).

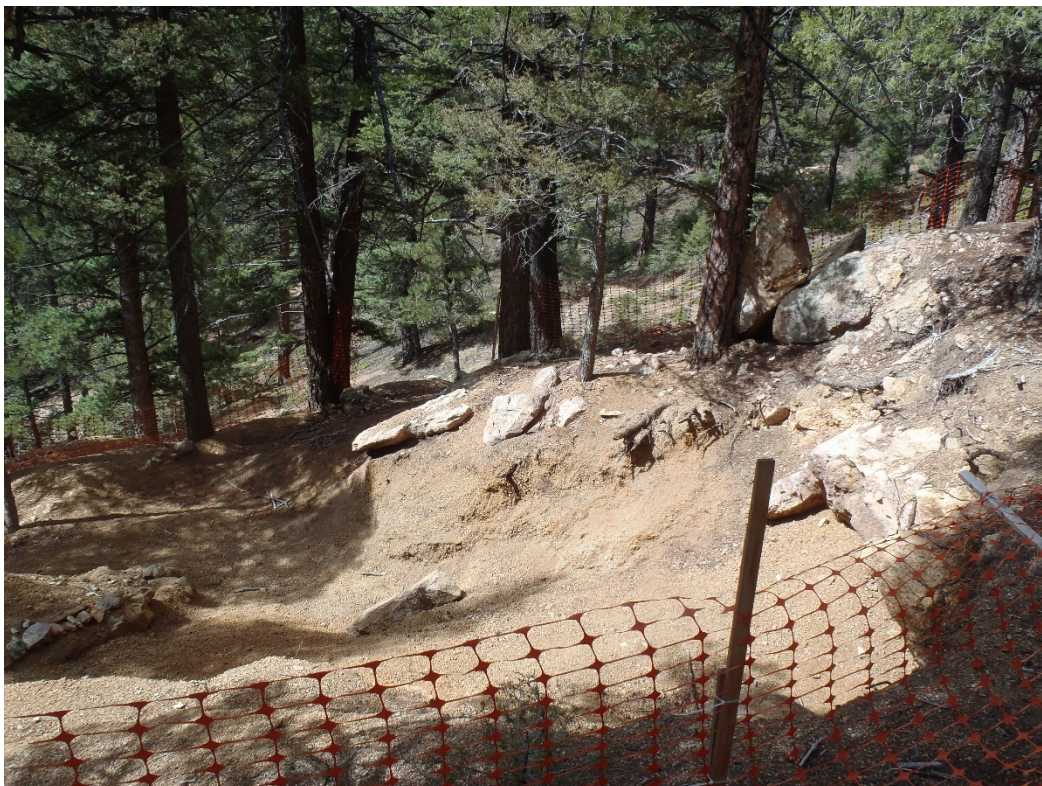
Photo 9. Construction fencing barrier above "Mathew's dig" (looking SW from highwall crest).
