MINERALS PROGRAM INSPECTION REPORT
PHONE: (303) 866-3567

MINE NAME: Camp Bird Mine	MINE/PROSPECTING ID#: M-1982-090	MINERAL: Gold, silver, lead, zinc	COUNTY: Ouray
INSPECTION TYPE: Monitoring	INSPECTOR(S): Lucas West	INSP. DATE: October 2, 2019	INSP. TIME: 09:00
OPERATOR: Caldera Mineral Resources, LLC	OPERATOR REPRESENTATIVE: Mike Thompson	TYPE OF OPERATION: 112 - Hard Rock Regular Operation	
REASON FOR INSPECTION: Normal I&E Program	BOND CALCULATION TYPE: None	BOND AMOUNT: \$157,680.00	
DATE OF COMPLAINT: NA	POST INSP. CONTACTS: None	JOINT INSP. AGENCY: None	
WEATHER: Clear	INSPECTOR'S SIGNATURE:

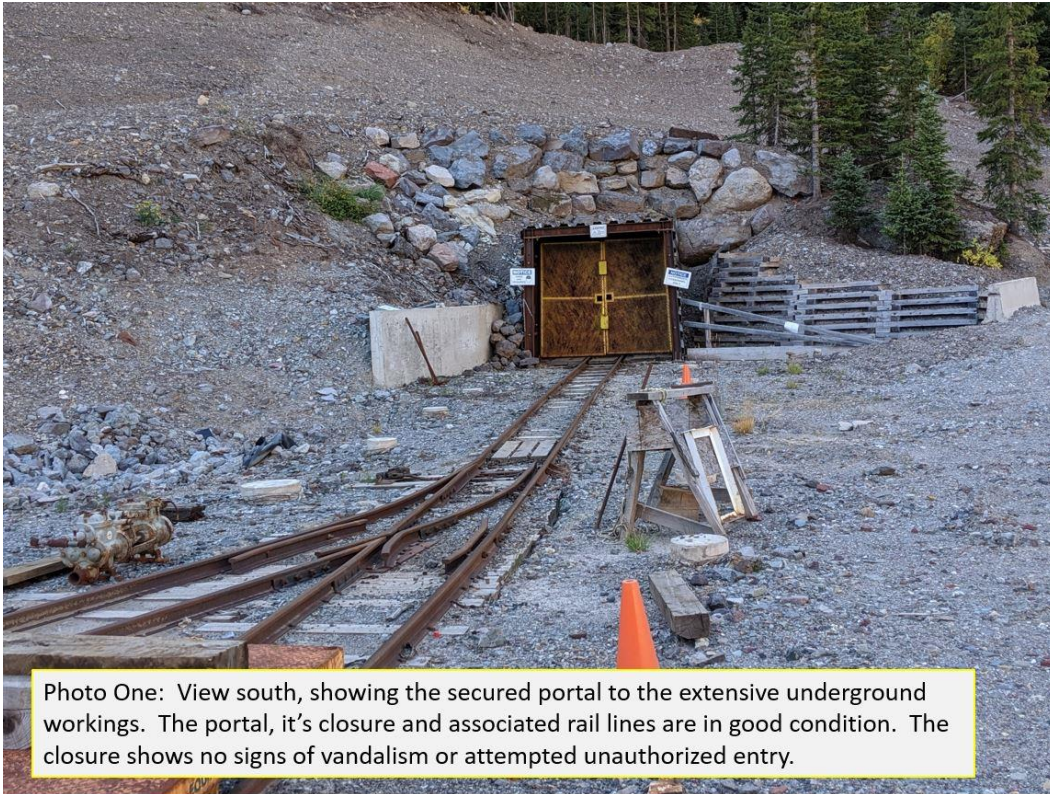
Photo One: View south, showing the secured portal to the extensive underground workings. The portal, its closure and associated rail lines are in good condition. The closure shows no signs of vandalism or attempted unauthorized entry.
