MINERALS PROGRAM INSPECTION REPORT
PHONE: (303) 866-3567

MINE NAME: Revenue Mine	MINE/PROSPECTING ID#: M-2012-032	MINERAL: Lead, silver and gold	COUNTY: Ouray
INSPECTION TYPE: Monitoring	INSPECTOR(S): Lucas West	INSP. DATE: October 2, 2019	INSP. TIME: 11:00
OPERATOR: Ouray Silver Mines Inc.	OPERATOR REPRESENTATIVE: Brian Briggs, Brianna Greer	TYPE OF OPERATION: 112d-1 - Designated Mining Operation	
REASON FOR INSPECTION: Normal I&E Program	BOND CALCULATION TYPE: None	BOND AMOUNT: \$476,269.41	
DATE OF COMPLAINT: NA	POST INSP. CONTACTS: None	JOINT INSP. AGENCY: None	
WEATHER: Clear	INSPECTOR'S SIGNATURE:

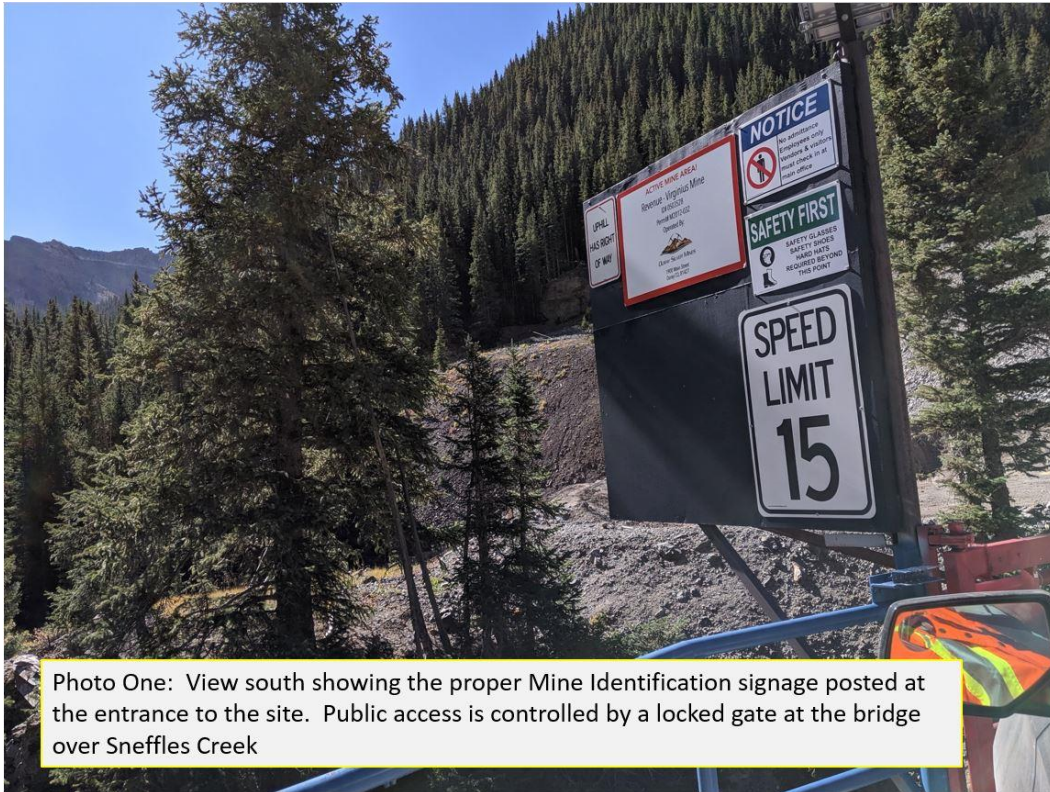
Proper mine identification signage was observed at the entrance to the mine site and can be seen in Photo One and permit boundary markers in the form of tall white PVC posts were observed around the perimeter of the permitted area. The site was active during the inspection, however it was only minor construction and site maintenance. No mining or milling was taking place at the time of the inspection. Various maintenance and construction activities were taking place on site during the inspection. The underground facilities were inspected starting with the Coarse Ore Bin, leading through the Crusher Gallery, Mill Room and filter building. All underground facilities were in excellent condition and free from trash and debris. The mill remains in an idle status awaiting more pieces of equipment to begin final configuration. A view of the mill area can be seen in Photo Two.

Photo One: View south showing the proper Mine Identification signage posted at the entrance to the site. Public access is controlled by a locked gate at the bridge over Sneffles Creek

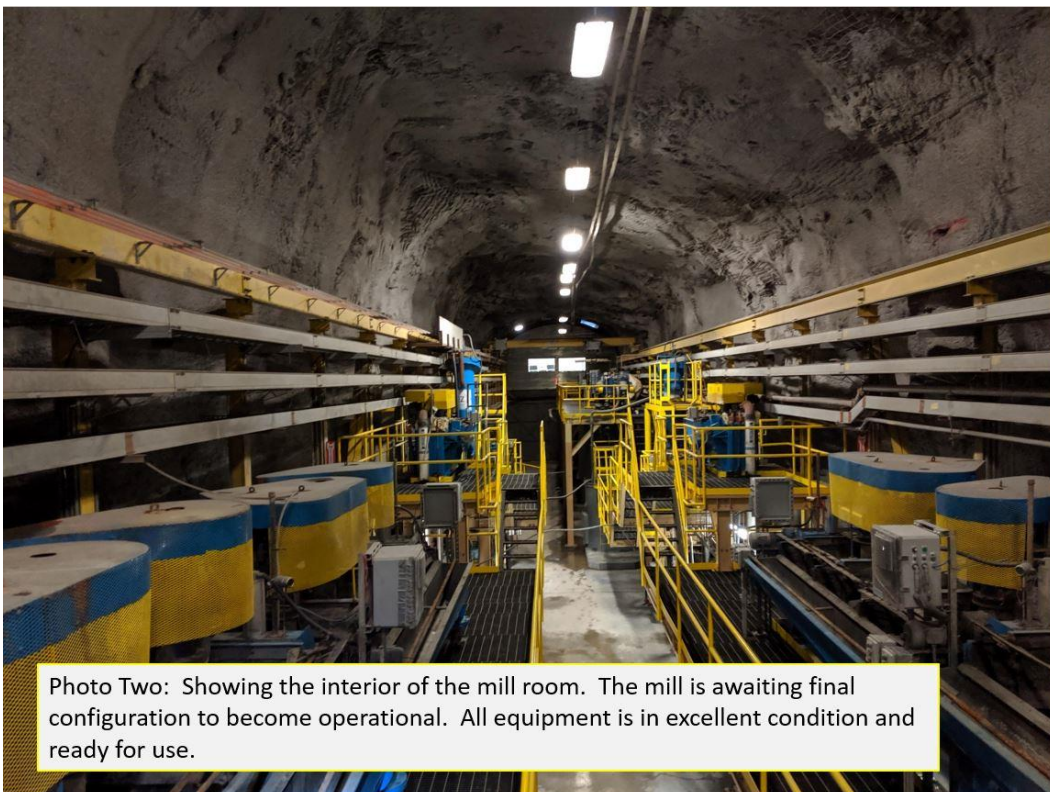
Photo Two: Showing the interior of the mill room. The mill is awaiting final configuration to become operational. All equipment is in excellent condition and ready for use.

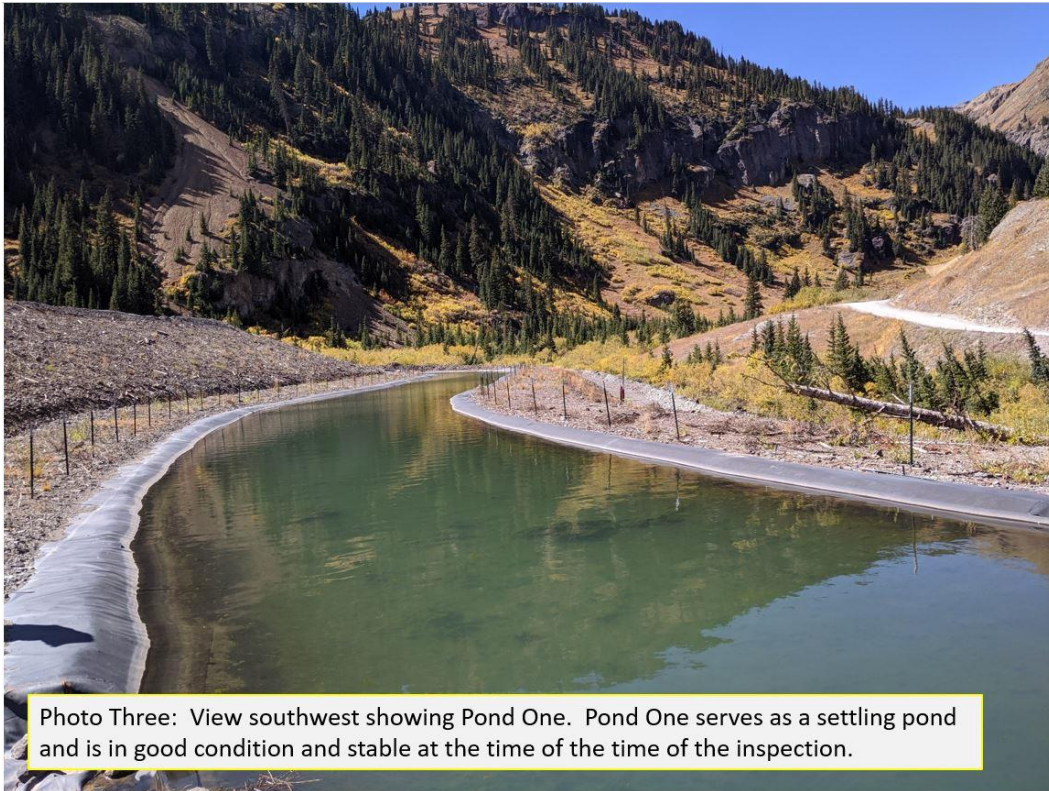
The water management system was observed. Water that leaves the portal from its associated discharge flows into the settling pond. The settling pond can be seen in Photo Three. From there the water is conveyed into Pond Two which currently allows for infiltration to the ground water. Pond Two can be seen in Photo Four. Construction of the final conveyance to Pond Three and ultimately to a surface discharge into Sneffles Creek has been initiated and will be completed in the coming weeks. All ponds and conveyances appear meet the construction designs and currently the system is functioning properly.

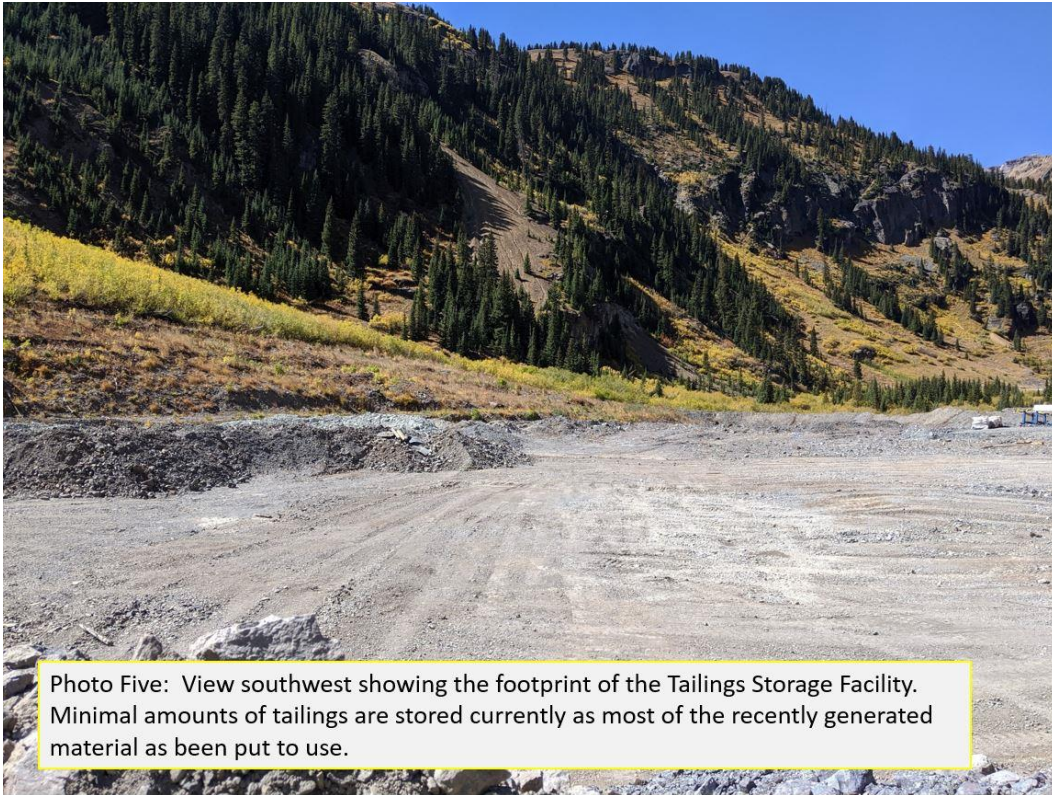
The tailings storage facility was also observed in the southwest portion of the site. The facility has minimal tailings being stored in it currently as what little tailings have been produces have been blended with waste rock for road base as approved through TR-09. The tailings facility is in good condition and was stable at the time of the inspection, it can be seen in Photo Five. All other surface facilities including the waste rock crusher and stockpiles, rail line, fuel storage area were all in good condition at the time of the inspection.
