MINERALS PROGRAM INSPECTION REPORT
PHONE: (303) 866-3567

MINE NAME: Sunnyside Gold Mine	MINE/PROSPECTING ID#: M-1977-378	MINERAL: Lead, zinc, copper, iron	COUNTY: San Juan
INSPECTION TYPE: Monitoring	INSPECTOR(S): Lucas West	INSP. DATE: October 17, 2019	INSP. TIME: 13:05
OPERATOR: Sunnyside Gold Corp	OPERATOR REPRESENTATIVE: Pat Maley	TYPE OF OPERATION: 112 - Hard Rock Regular Operation	
REASON FOR INSPECTION: Normal I&E Program	BOND CALCULATION TYPE: None	BOND AMOUNT: \$60,534.00	
DATE OF COMPLAINT: NA	POST INSP. CONTACTS: None	JOINT INSP. AGENCY: None	
WEATHER: Clear	INSPECTOR'S SIGNATURE:

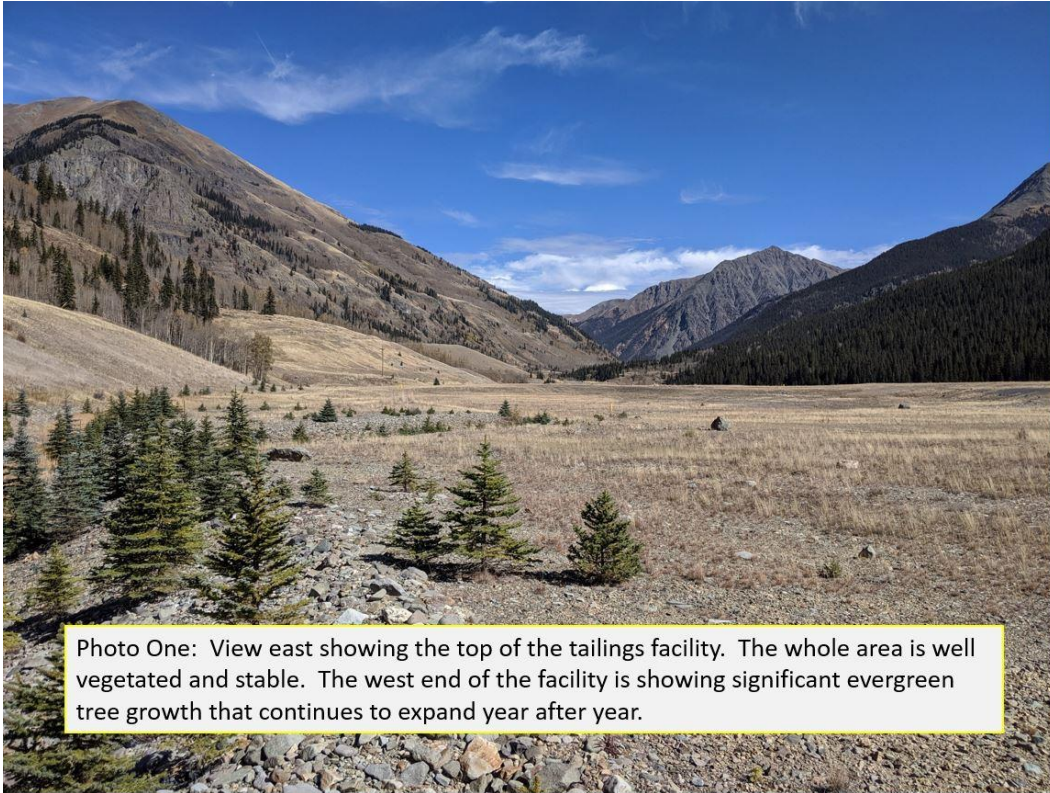
Photo One: View east showing the top of the tailings facility. The whole area is well vegetated and stable. The west end of the facility is showing significant evergreen tree growth that continues to expand year after year.

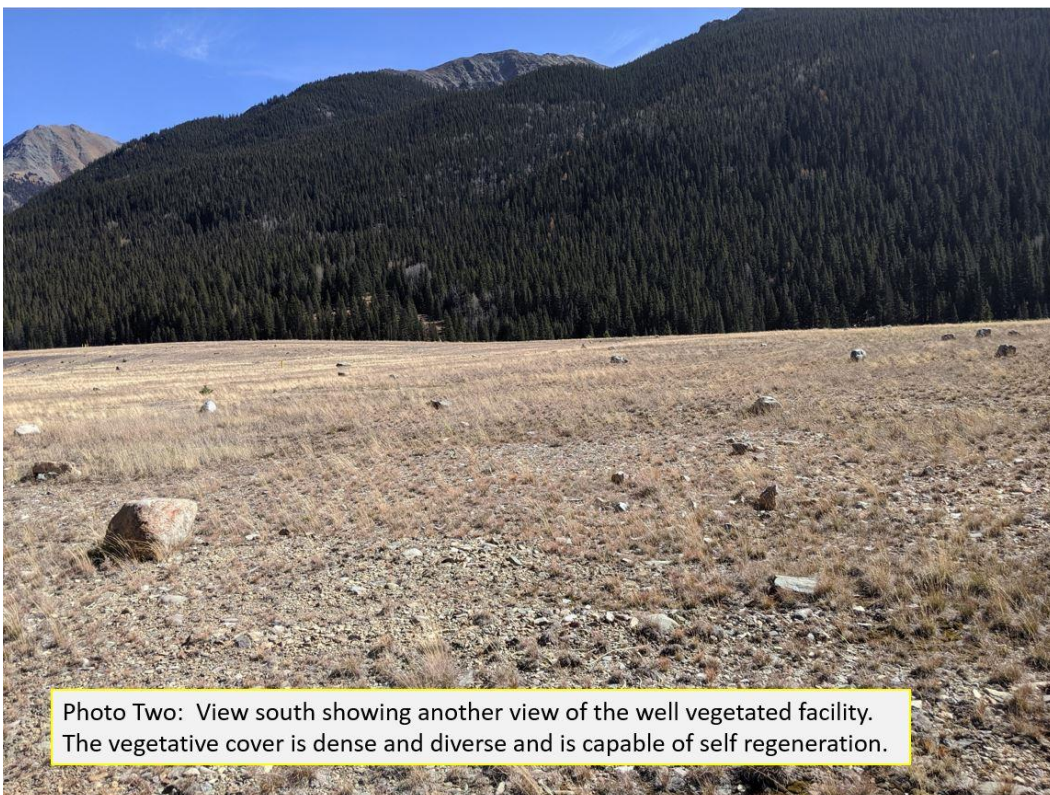
Photo Two: View south showing another view of the well vegetated facility. The vegetative cover is dense and diverse and is capable of self regeneration.
