COLORADO
Division of Reclamation,
Mining and Safety
Department of Natural Resources

Permit Number: C-1996-083 Mine Name: Bowie No. 2 Mine Operator: Bowie Resources, LLC Operator Address: Mr. Basil A Bear P.O. Box 1488 Paonia, CO 81428	County: Delta Operation Type: Underground Permit Status: Active Ownership: Private
	Operator Representative Present: None
Operator Representative Signature: (Field Issuance Only)

Inspection Start Date: October 24, 2019 Inspection Start Time: 13:00 Inspection End Date: October 24, 2019 Inspection End Time: 16:20		Inspection Type: Coal Partial Inspection Inspection Reason: Normal I&E Program Weather: Clear	
Joint Inspection Agency: None		Joint Inspection Contacts: 	
Post Inspection Agency: None		Post Inspection Contacts: 	
Inspector(s): Robert Zuber, P.E. Michael Cunningham	Inspector's Signature: <i>Robert D. Zuber</i>		Signature Date: 10/29/2019

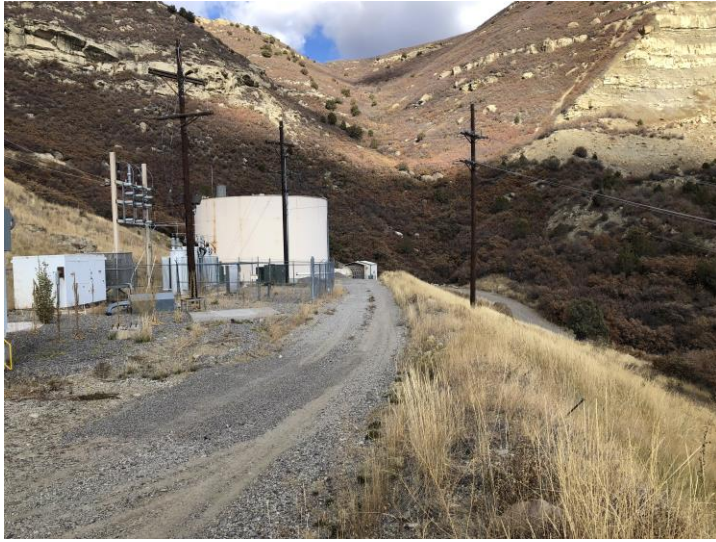
Utility Bench

Knapweed was seen at the Utility Bench, near Pond C, and below Gob Pile #3.

Berms were found to be functional at several pads, including the Utility Bench, the D Portal Bench, the storage pad east of the D Portal, the B Portal bench, and the Coal Stockpile Pad.

The dirt piles by the Hubbard Creek Coal Gas facility (next to the Utility Bench) should be moved or protected from erosion. Coal residue under the conveyor should be moved to a gob pile.

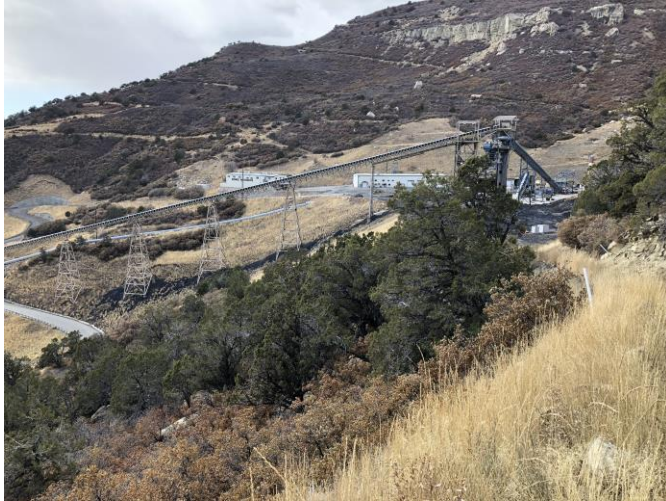
Coal residue under conveyor

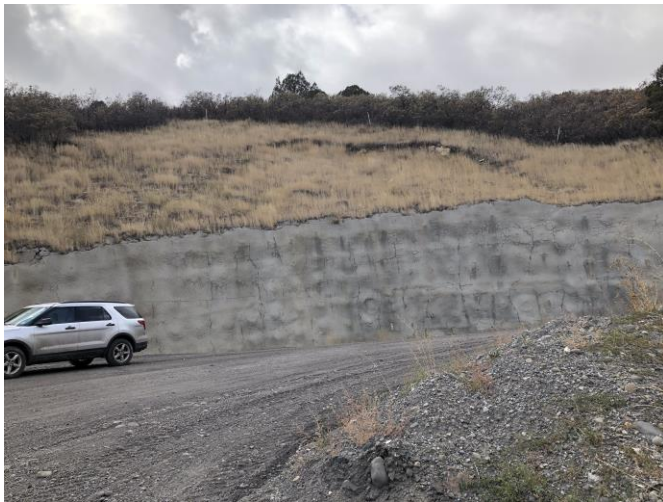
It appears that slumps have not moved significantly in the recent past. These include slumps by the B Portal and by Curve Number 11 along the Haul Road.

Curve Number 11 slump and retaining wall

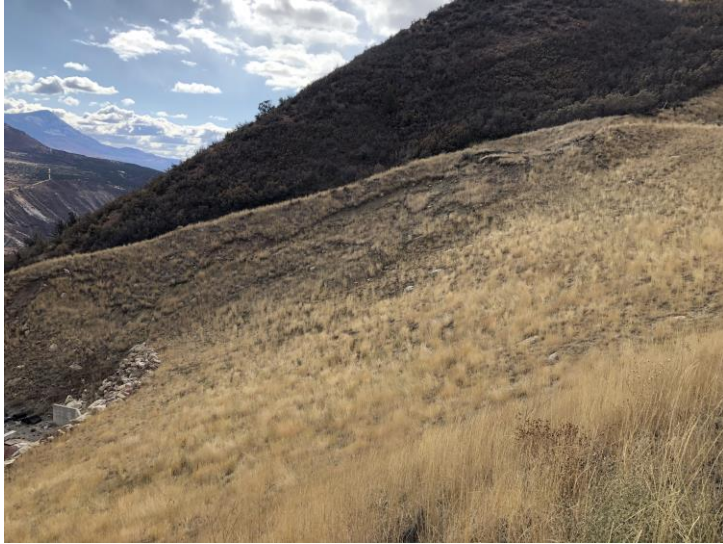
Slump above B Portal

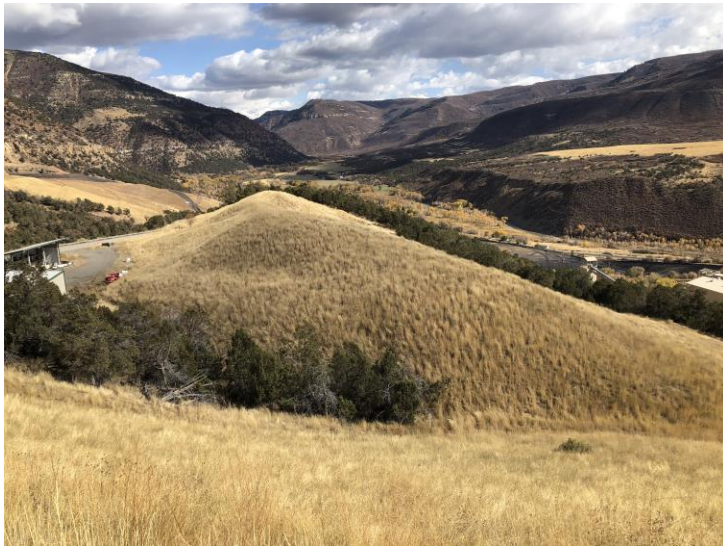
Topsoil Stockpile "A"

Topsoil piles were found to be in good shape, with excellent vegetative cover and signs in place.

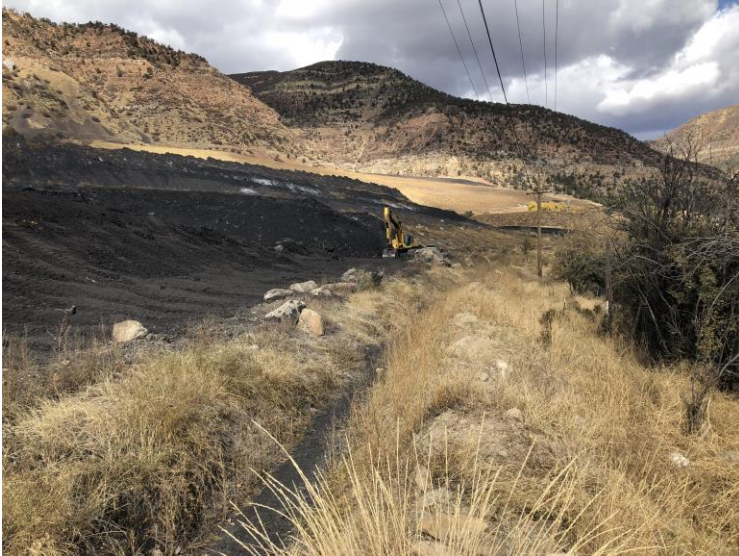
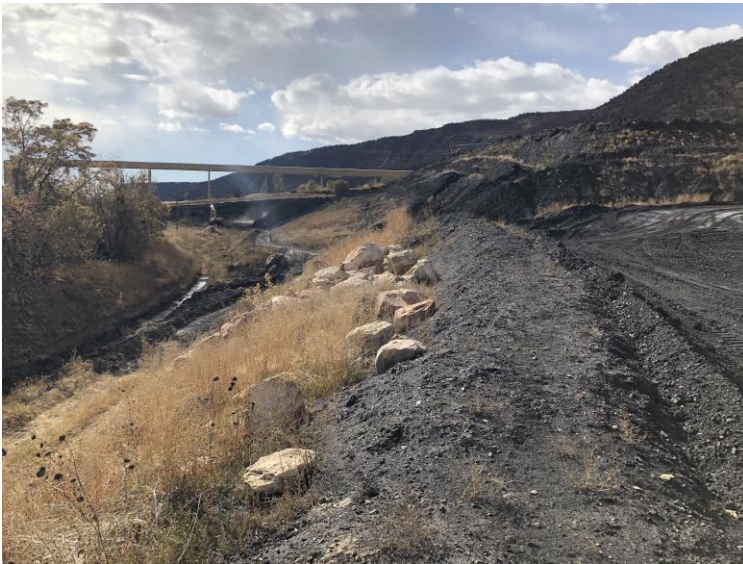
Water was not seeping out of the Fire Mountain Canal near Gob Pile #3, and there was little water in the canal. There was some standing water in the ditch below the pile, indicating that there had been recent flow through the underdrain.

Area below Gob Pile #3, looking east

Area below Gob Pile #3, looking west

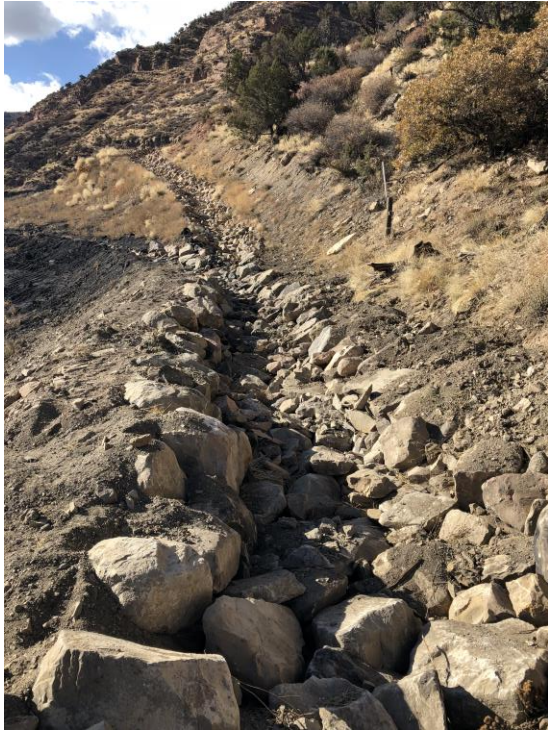
No problems were identified with any ditches, including the two from the Coal Stockpile Pad to Pond B (D30 and D34) and the one above Pond F (F4). The ditch east of Gob Pile #2 (above Ditch F4) has been improved with riprap lining. It appears that the riprap was well placed and should remain stable. The dimensions are approximately six feet wide and three to four feet deep.

Reconstructed ditch beside Gob Pile #2

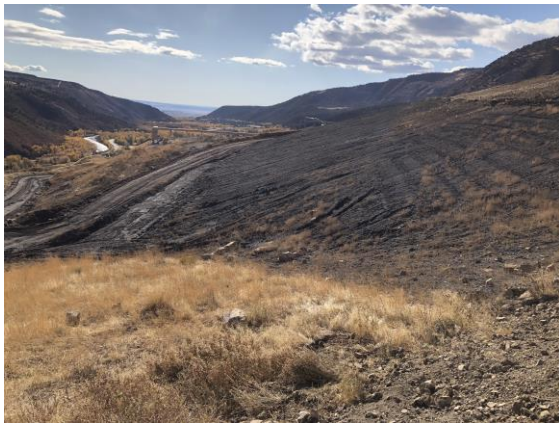
BRL is trying to address erosion near the east end of Gob Pile #2. Water bars and wattles appear to be functioning. The seeps below Gob Pile #2 had only white precipitate; no rust or other colors indicate iron or other metals.
