MINERALS PROGRAM INSPECTION REPORT

MINE NAME: Marrs Memorials	MINE/PROSPECTING ID#: M-1977-168	MINERAL: Aggregate	COUNTY: Fremont
INSPECTION TYPE: Monitoring	INSPECTOR(S): Timothy Cazier	INSP. DATE: July 24, 2019	INSP. TIME: 11:30
OPERATOR: Colorado Quarries Inc	OPERATOR REPRESENTATIVE: None	TYPE OF OPERATION: 110c - Construction Limited Impact

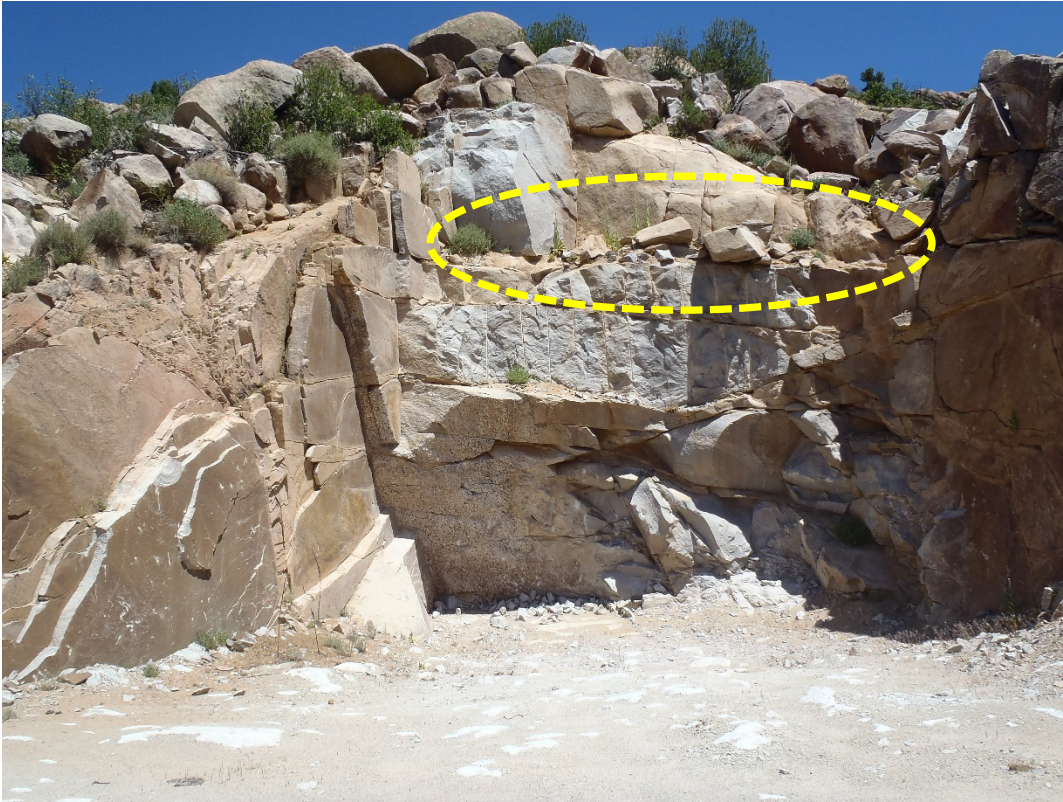
to be approximately one acre, based on 2016 imagery. Highwalls were estimated to vary between 30 and 40 feet in height. Loose, potentially unstable rock was observed at the top of the vertical highwall near the east end of the operating area (see **Photo 1**). This rock should be removed to stabilize the highwall. This is considered a potential safety problem, and not a problem that could lead to offsite damage. Therefore it is not cited as a problem.

Photo 1. Loose, unstable rock observed on top of vertical highwall near east end of pit (looking north).

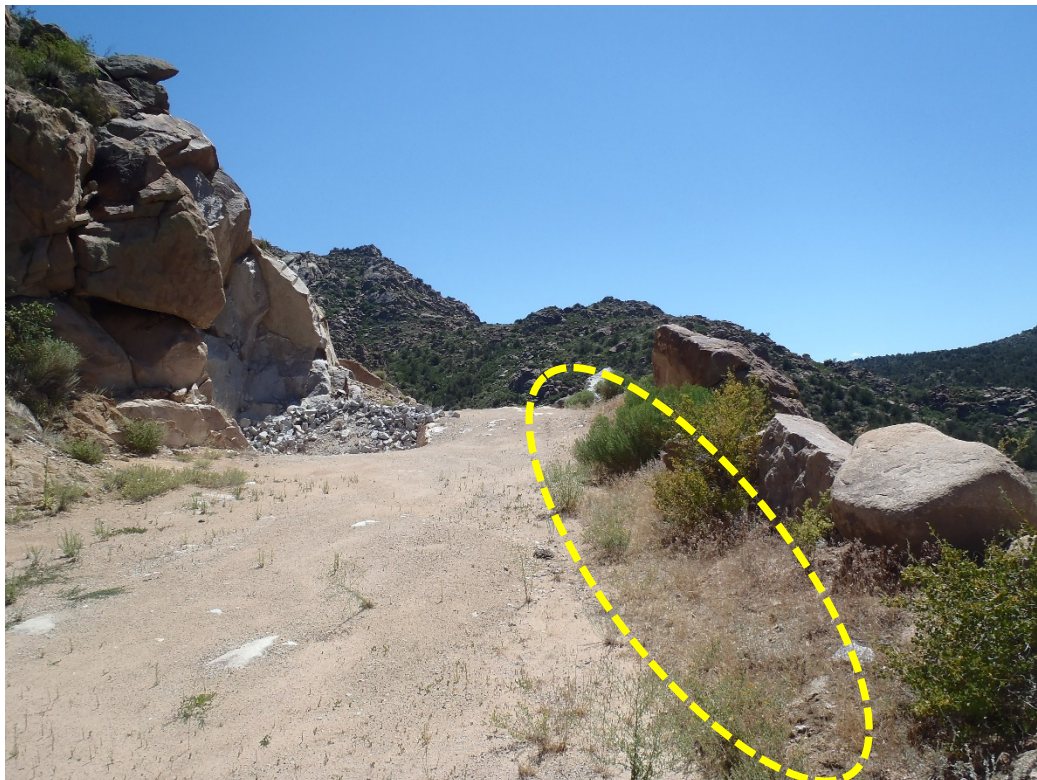
PROBLEM/POSSIBLE VIOLATION: Problem No. 2: There are state-listed noxious weeds present on site. This is a problem for failure to employ weed control methods for state listed noxious weed species within the permitted area, and to reduce the spread of weeds to nearby areas as required by Section 3.1.10 (6) of the rule.

Revegetation: Knapweed, both spotted and diffuse (see **Photos 2 and 3**) were observed in the pit floor/access road area. **The presence of these List B noxious weeds is cited as Problem 2 on page 1 of this report.**

Photo 2. Knapweed on right.

CORRECTIVE ACTIONS: Implement approved weed control plan and provide proof to the Division that this has been done. If a weed control plan is not already in place, the operator shall develop a weed control and management plan in accordance with Section 3.1.10 (6) of the Rule. This plan should be developed in consultation with the county extension agency, or weed control district office and should include specific control measures to be applied, a schedule for when control measures will be applied and a post-treatment monitoring plan. This weed control plan shall be submitted to the Division as a Technical Revision to the approved plan with the appropriate Technical Revision fee of \$216.00 by the corrective action date.

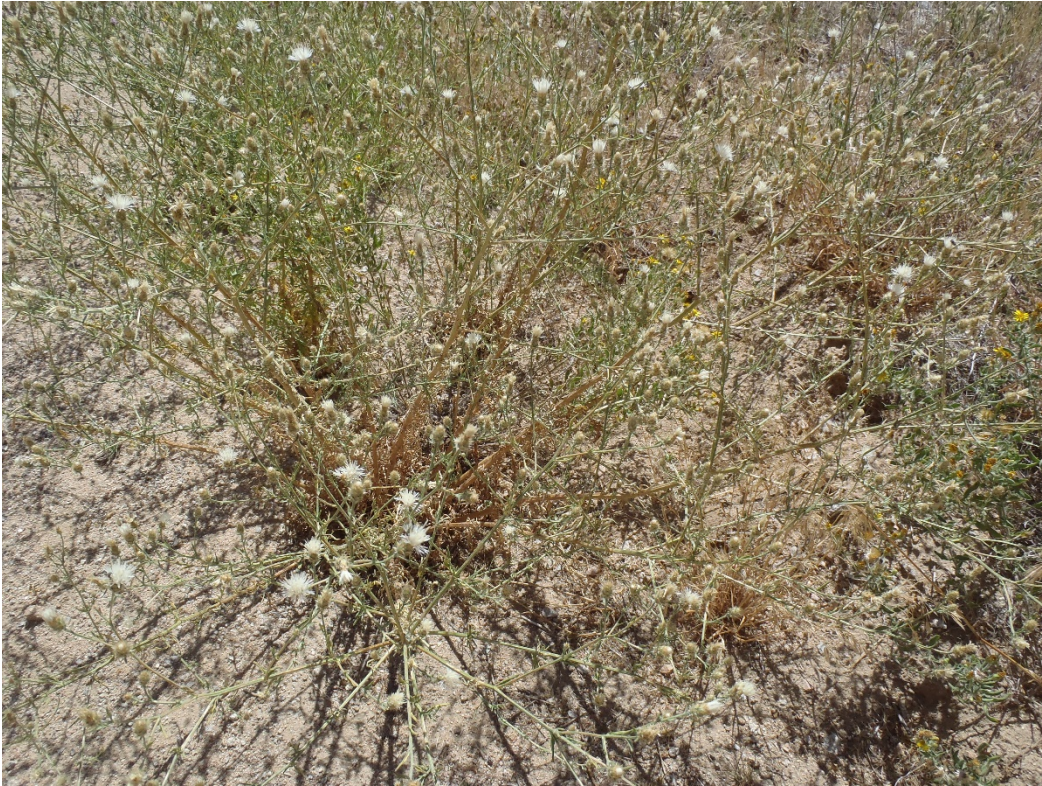
Photo 3. Knapweed observed.

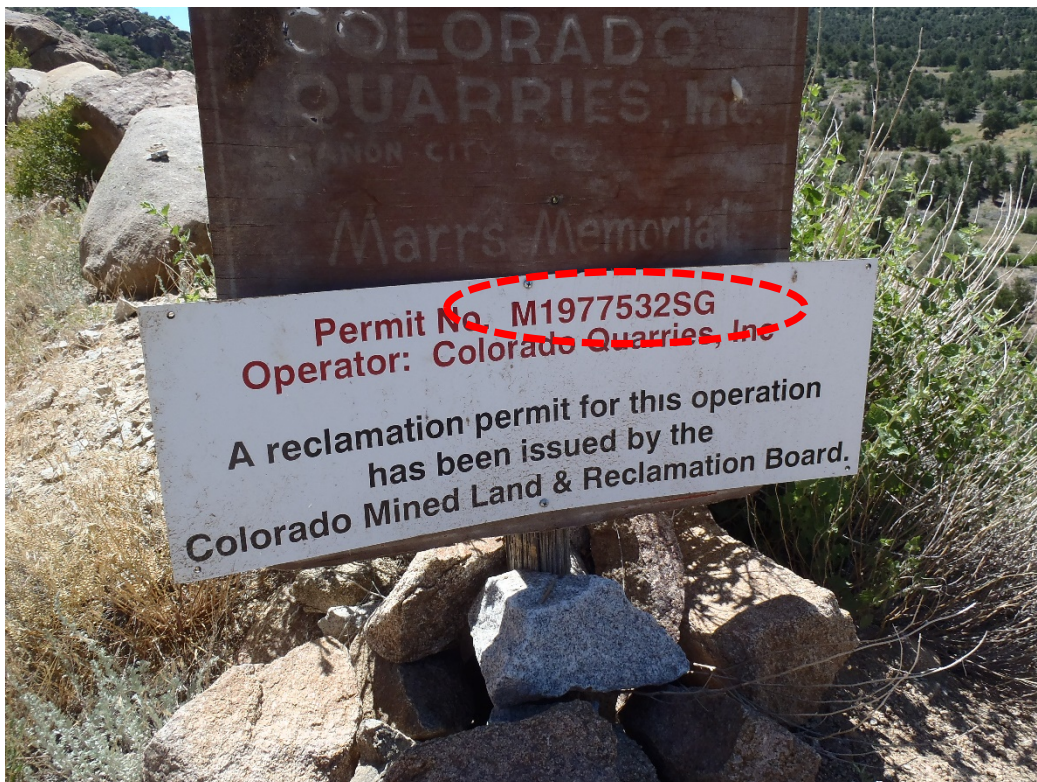
PROBLEM/POSSIBLE VIOLATION: Problem No. 3: The mine identification sign posted at the entrance of the mine site is for another permit. This is a problem for failure to post a mine identification sign as required by Section 3.1.12(1) of the rule.

Signs and Markers: A permit sign was displayed at the site entrance (see **Photo 4**). This appeared to be the same incorrect sign displaying the wrong permit number (M1977532SG, that should be M1977168) the DRMS requested be changed after the July 22, 2015 inspection. **The fact that the required permit sign has not been corrected in four years is cited as Problem No. 3 on page 2 of this report.** The permit boundary markers appeared to be in place, but were not practical to access, given the terrain.

Photo 4. Permit sign with incorrect permit number (near pit entrance).

CORRECTIVE ACTIONS: The operator shall, at the entrance of the mine site, post a sign which shall be clearly visible from the access road with the following: the name of the operator, a statement that a reclamation permit for the operation has been issued by the Colorado Mined Land Reclamation Board; and the permit number for this site (M-1977-168). The operator shall submit photo documentation that a proper sign has been posted by the corrective action date.

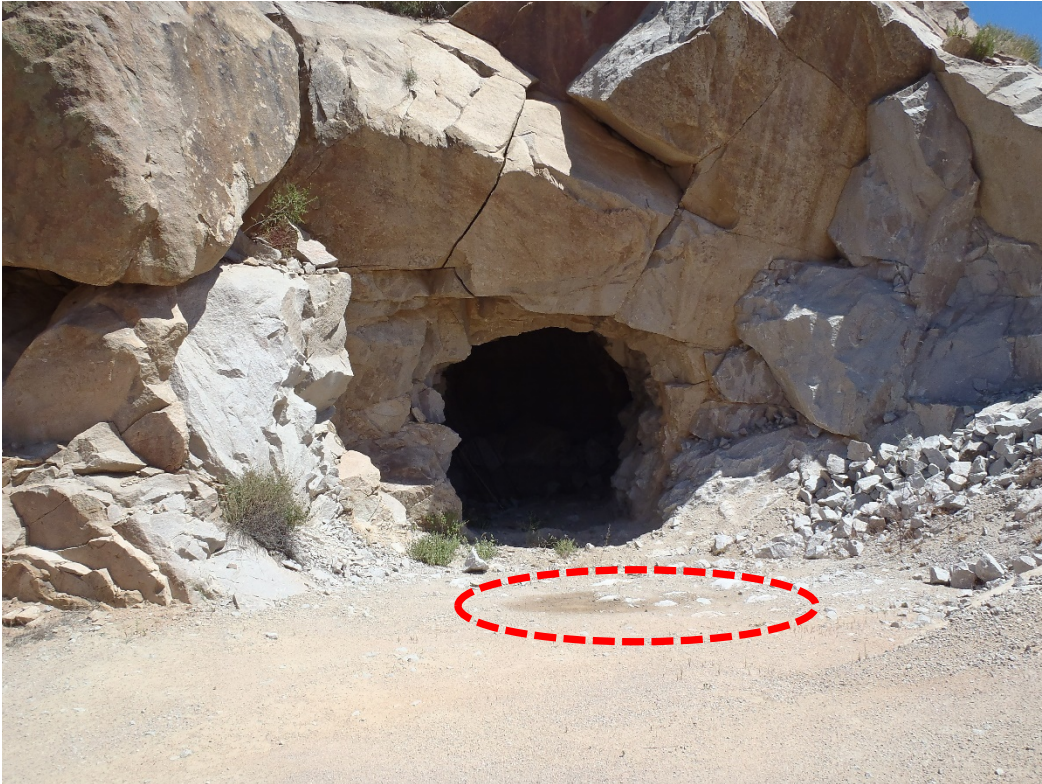
PROBLEM/POSSIBLE VIOLATION: Problem No. 1: A fuel spill has occurred at the site which has impacted soils, surface water or groundwater.

Storm Water MGT Plan: What appeared to be a petroleum product spill was observed in the pit floor/access road area (see **Photos 5 and 6**). **The presence of this petroleum product spill is cited as Problem No. 1 on page 1 of this report.**

Photo 5. Petroleum product spill (looking north).

CORRECTIVE ACTIONS: The operator shall immediately remediate the spill and submit a final report to the Division containing at least the following information:

- 1.) A description of how the spill was cleaned up containing at a minimum - the appropriate maps, volumes removed, sample locations, analytical data, and photo documentation.
- 2.) Evidence in the form of a receipt that the contaminated soil was disposed of by an approved method (such as sent to an approved landfill, land farming, recycling center, etc.).

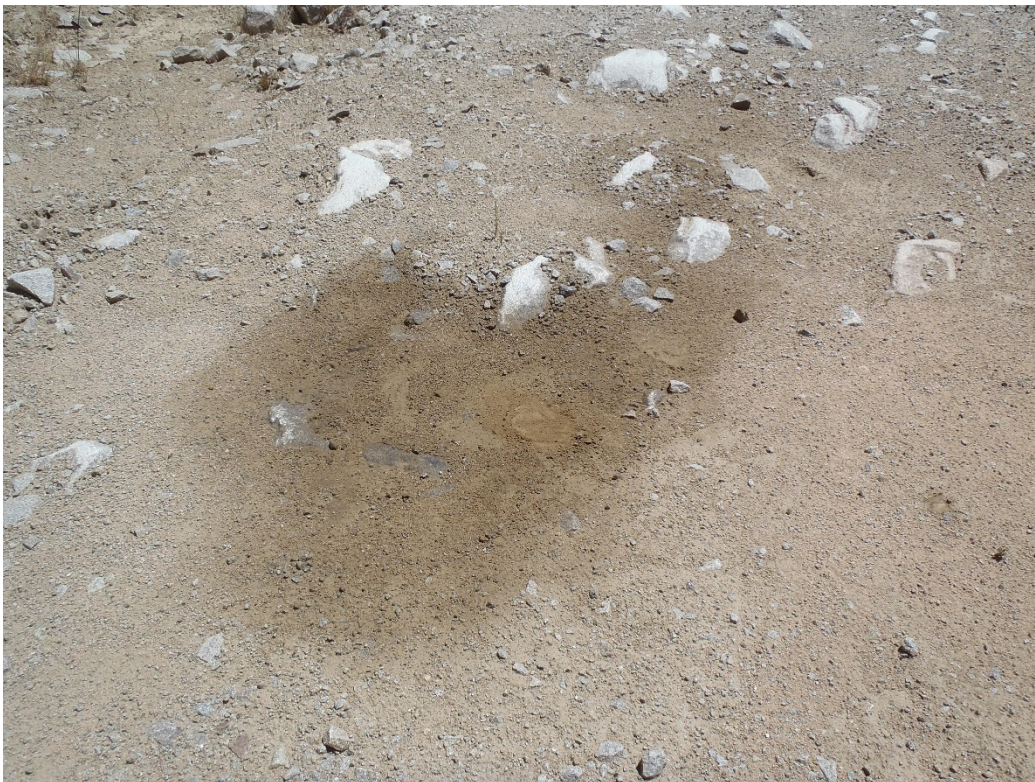
Photo 6. Petroleum product spill.
