**MINERALS PROGRAM INSPECTION REPORT**  
**PHONE: (303) 866-3567**

<b>MINE NAME:</b> Climax Mine	<b>MINE/PROSPECTING ID#:</b> M-1977-493	<b>MINERAL:</b> Molybdenum	<b>COUNTY:</b> Summit
<b>INSPECTION TYPE:</b> Monitoring	<b>INSPECTOR(S):</b> Lucas West	<b>INSP. DATE:</b> October 23, 2019	<b>INSP. TIME:</b> 10:00
<b>OPERATOR:</b> Climax Molybdenum Company	<b>OPERATOR REPRESENTATIVE:</b> Dianna Kelts	<b>TYPE OF OPERATION:</b> 112d-3 - Designated Mining Operation	
<b>REASON FOR INSPECTION:</b> Normal I&E Program	<b>BOND CALCULATION TYPE:</b> None	<b>BOND AMOUNT:</b> \$91,011,850.00	
<b>DATE OF COMPLAINT:</b> NA	<b>POST INSP. CONTACTS:</b> None	<b>JOINT INSP. AGENCY:</b> None	
<b>WEATHER:</b> Clear	<b>INSPECTOR'S SIGNATURE:</b>

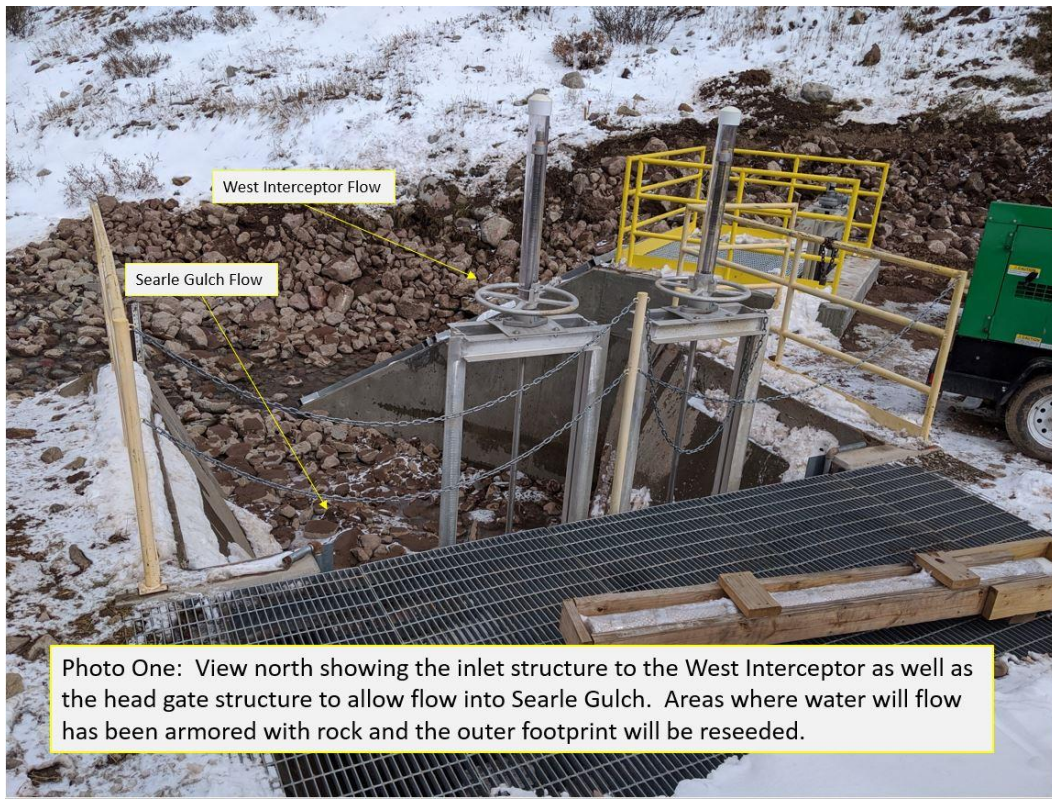
**West Interceptor:** In accordance with TR-28 the West Interceptor, a listed Environmental Protection Facility, is being upgraded. The work is being done in sections to achieve replacing the entire ditch line. The upgrade replaces the old 50 inch line with 60 inch HDPE ditch with a series of inlet structures. At the start of this phase of the project is the inlet to the line from Searle Gulch. The inlet structure allows for water to be turned into the West Interceptor to bypass the site or allow it to flow down the gulch and enter the process water system for use. The inlet structure has received substantial upgrades and can be seen in Photo One. The current section contains 6 inlet structures with grated steel closures and concrete reinforcement. An example of one of the inlet structures can be seen in Photo Two. Where this phase of the project terminates and transitions from the new 60" line back to the original 50" line an overflow structure has been installed. This structure will allow any excess flow to return to Searle Gulch without overwhelming the system. The outlet of the overflow structure has been armored with rip rap and the outer areas will be seeded. It can be seen in Photo Three. All work being conducted in this area is in compliance with the designs and plans contained in TR-28.

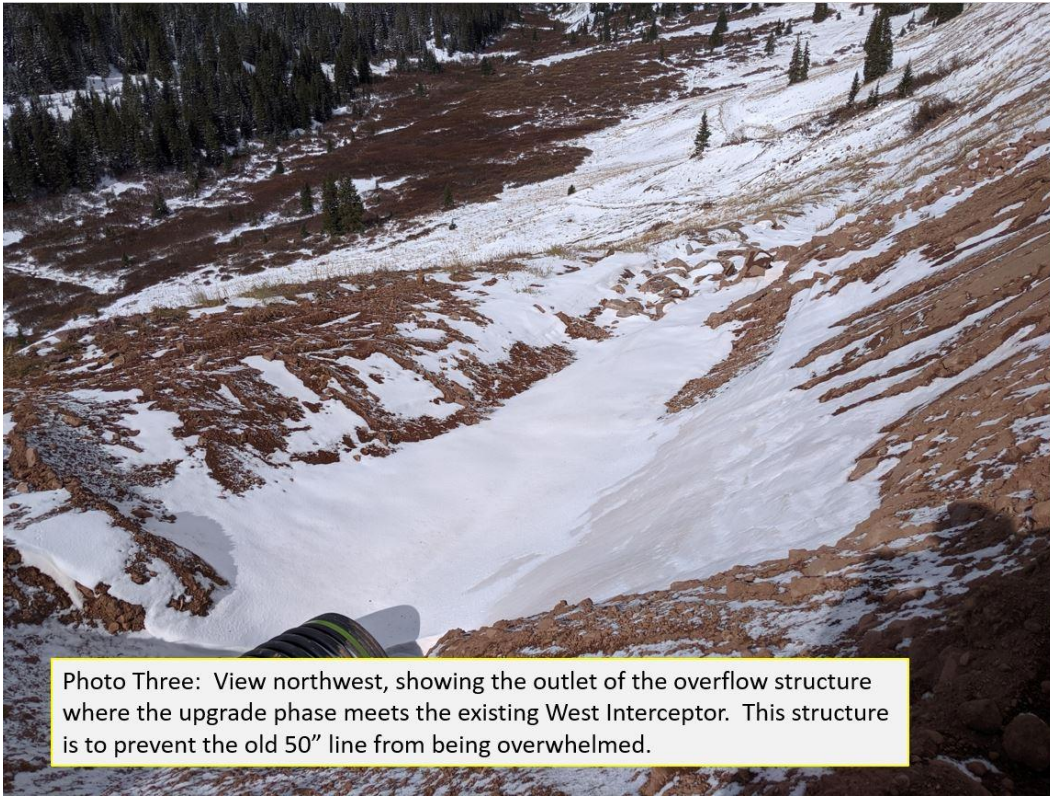
Photo Three: View northwest, showing the outlet of the overflow structure where the upgrade phase meets the existing West Interceptor. This structure is to prevent the old 50" line from being overwhelmed.

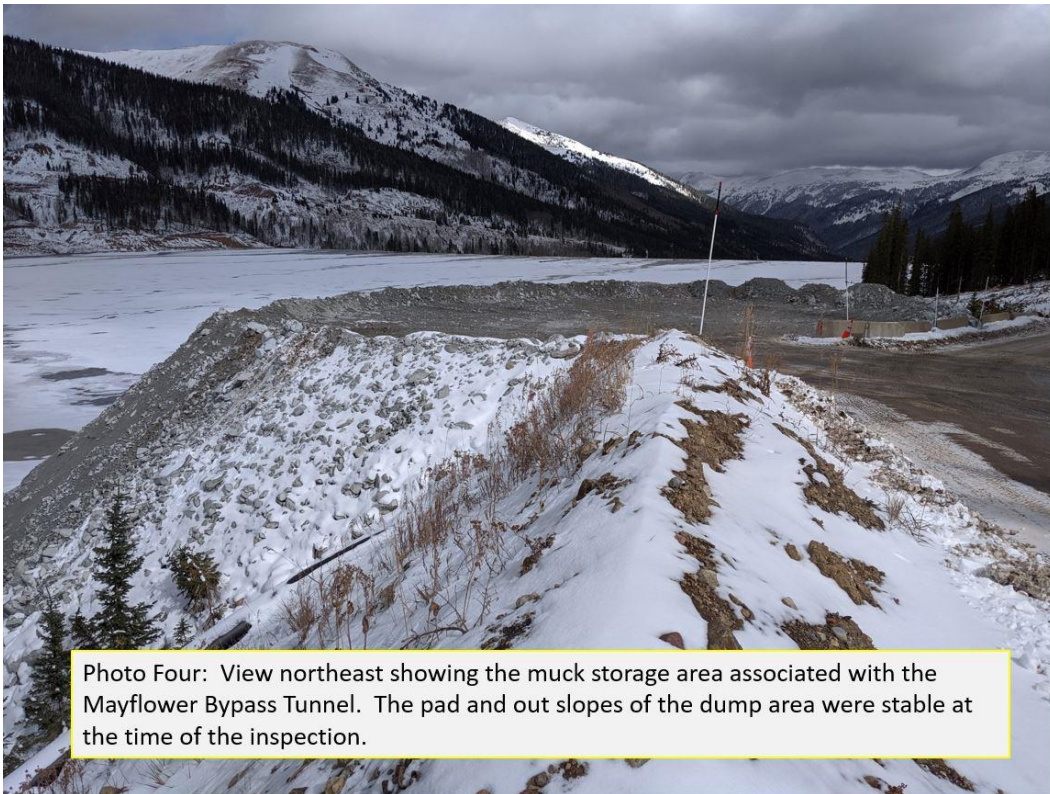
**Muck Storage Area:** The muck storage area associated with the Mayflower Bypass Tunnel has been constructed and is currently being used. The material is being generated from driving the approved Mayflower Bypass Tunnel and being deposited within the footprint of the Mayflower Tailings Storage Facility. A small pad has been created to allow for equipment to deposit the material on the out slope of the pad. The pad and it's out slope was stable at the time of the inspection and no signs of settling, slumping or significant erosion was observed. The pad and dump can be seen in Photo Four.

Photo Four: View northeast showing the muck storage area associated with the Mayflower Bypass Tunnel. The pad and out slopes of the dump area were stable at the time of the inspection.
