MINERALS PROGRAM INSPECTION REPORT
PHONE: (303) 866-3567

MINE NAME: Iron Mountain Road Gravel Pit	MINE/PROSPECTING ID#: M-1994-092	MINERAL: Gravel	COUNTY: Fremont
INSPECTION TYPE: Monitoring	INSPECTOR(S): Timothy Cazier	INSP. DATE: July 24, 2019	INSP. TIME: 09:00
OPERATOR: Rocky Mountain Excavating, LLC	OPERATOR REPRESENTATIVE: Bennie & Shawnie Koch	TYPE OF OPERATION: 110c - Construction Limited Impact

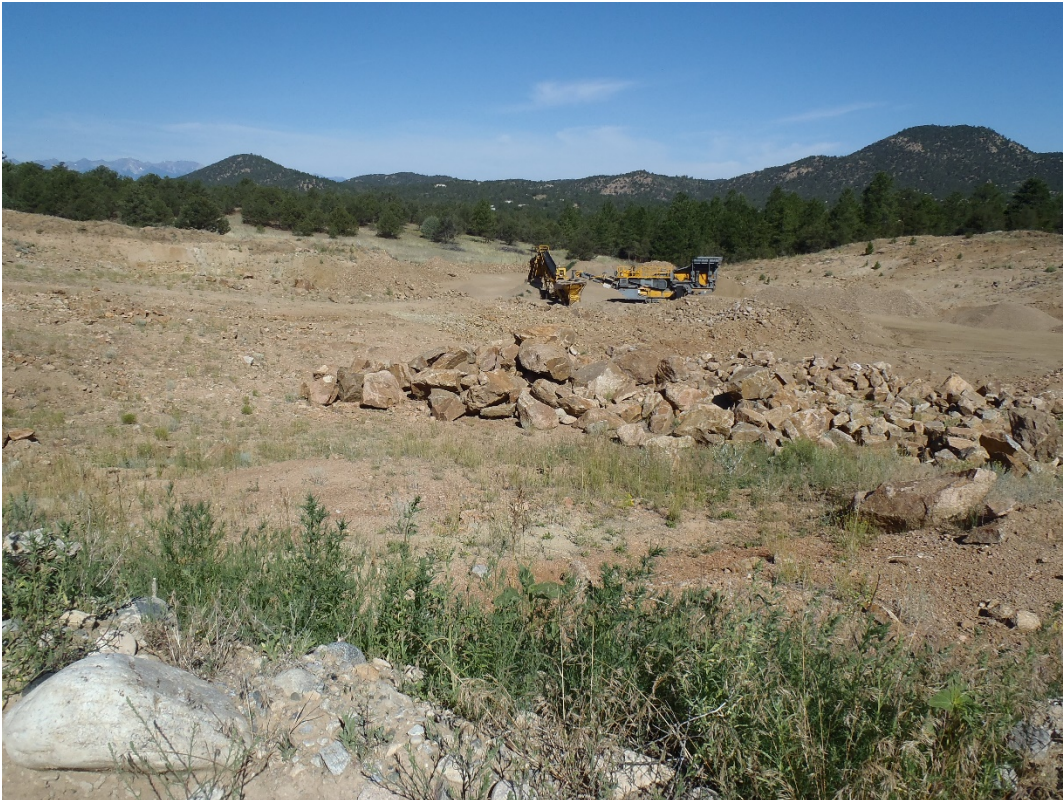
Excess Spoil and Dev. Waste: Mr. Koch explained he processes all overburden. The observed piles (see **Photo 1**) will be converted to product.

Support Facilities On-site: A screen plant, crusher, and loader were observed on site (see **Photo 1**).

Photo 1. Overburden piles to be processed & equipment (looking NW across active pit area).

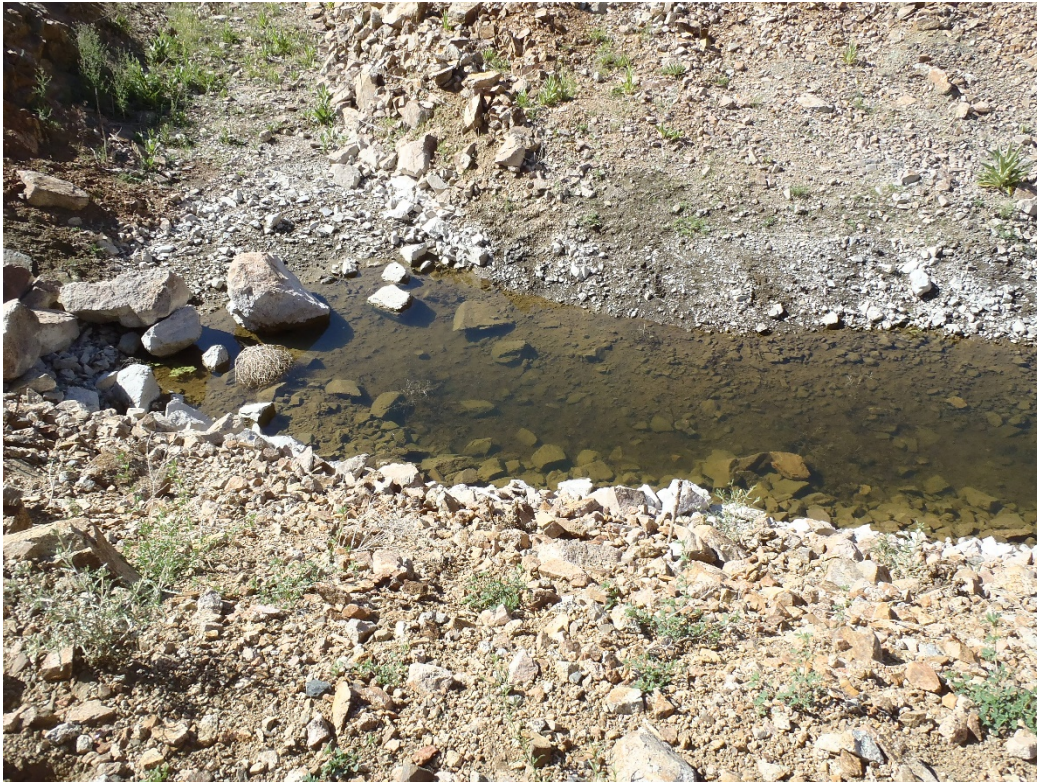
PROBLEM/POSSIBLE VIOLATION: Problem: The site is improperly impounding surface drainage/runoff.

Hydrologic Balance: Standing water was observed in the pit, but determined not to be exposed groundwater. Discussions with Mr. Koch determined the ponded water was from captured stormwater runoff. Mr. Koch explained the pit floor is competent rock and very tight, not allowing infiltration of captured runoff. This assertion is supported by the white residue from evaporation observed along the edge of the ponded water (see **Photos 2 and 3**) and the observation that this small portion of the pit floor is below the elevation of the adjacent stormwater pond. Pursuant to Colorado Division of Water Resources regulations, this stormwater runoff must be pumped out and allowed to infiltrate or returned to the local drainage. **The presence of the trapped stormwater runoff is cited as a problem on Page 1 of this report.**

Photo 2. East end of trapped pit stormwater.

CORRECTIVE ACTIONS: Submit documentation from the State Engineer's Office demonstrating that the impoundment of water in this pit is authorized by that office. Operator could also remove impediments to proper surface drainage.

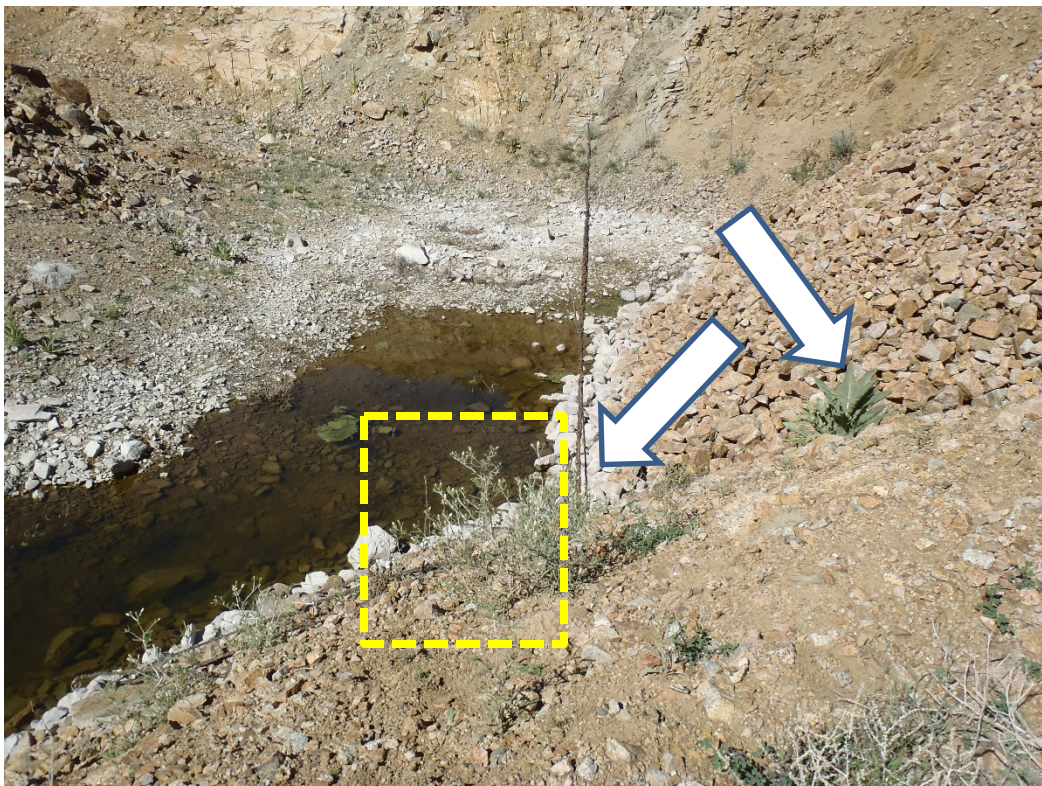
Revegetation: Some Common Mullein was observed and a few plants of what appeared to be knapweed (see **Photo 3**). The mullein is a noxious weed List C species, so it was not cited as a problem, but the DRMS advises implementing a weed control plan. The knapweed is a list B noxious weed species but was not yet prevalent to

be cited as a problem. However, the Operator should implement the knapweed weed control program included in the original permit application to control the knapweed before it becomes problematic.

Photo 3. Knapweed [box], mullein [arrows] (near west end of trapped pit water).

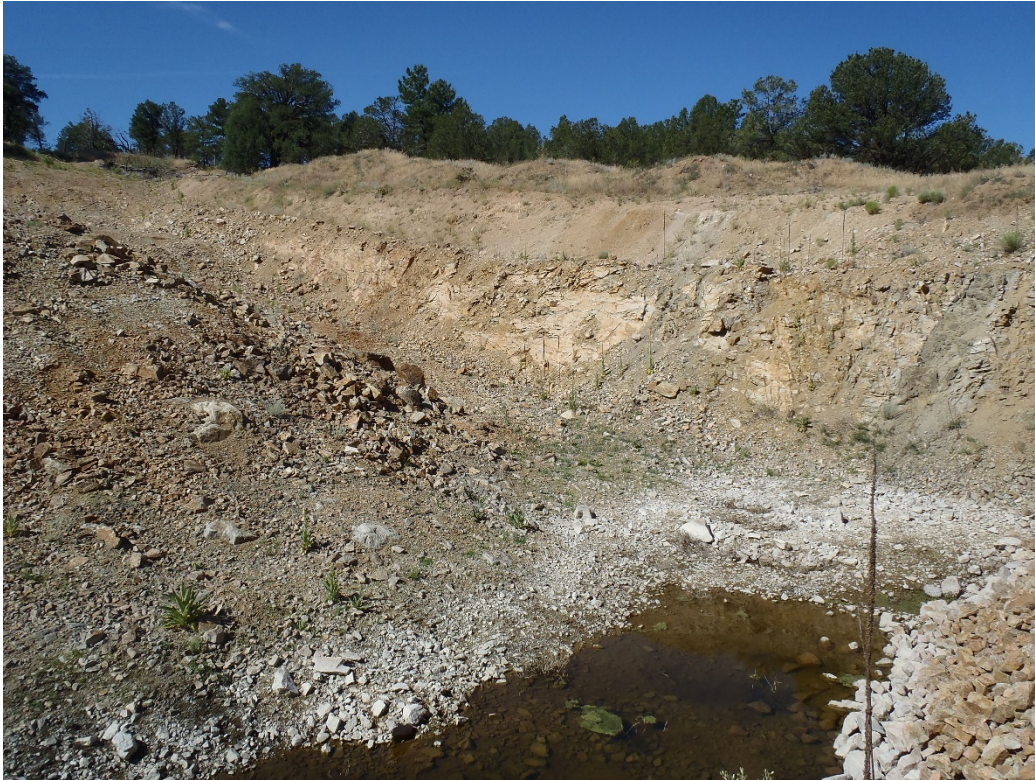
Gen. Compliance with Mine Plan: Google Earth was used to measure the disturbed area, which was estimated to be approximately 7.9 acres (including the access road), based on 2016 imagery. Highwalls on the west side (see **Photo 4**) were estimated to vary between 12 and 15 feet in height at approximately a 1H:1V overall slope and appeared stable.

Photo 4. West side highwall & west end of trapped pit stormwater (looking SW).

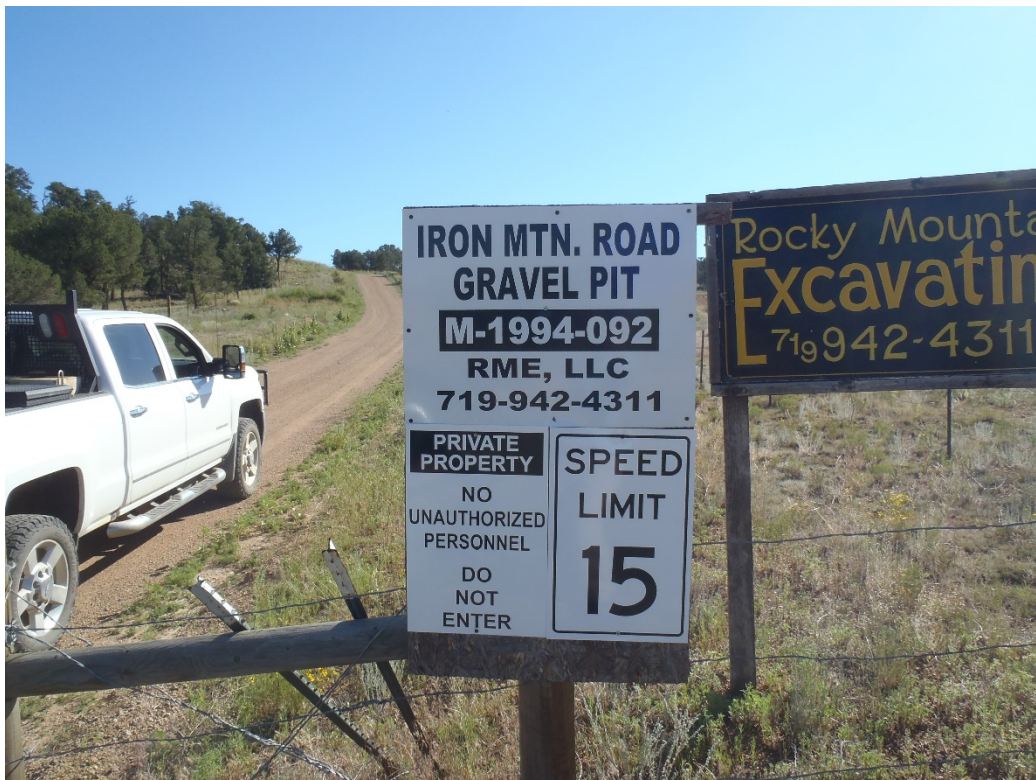
Signs and Markers: The permit sign was properly posted (see **Photo 5**) and the boundary is marked with three strand fencing (see **Photo 6**).

Photo 5. Permit sign at entrance.

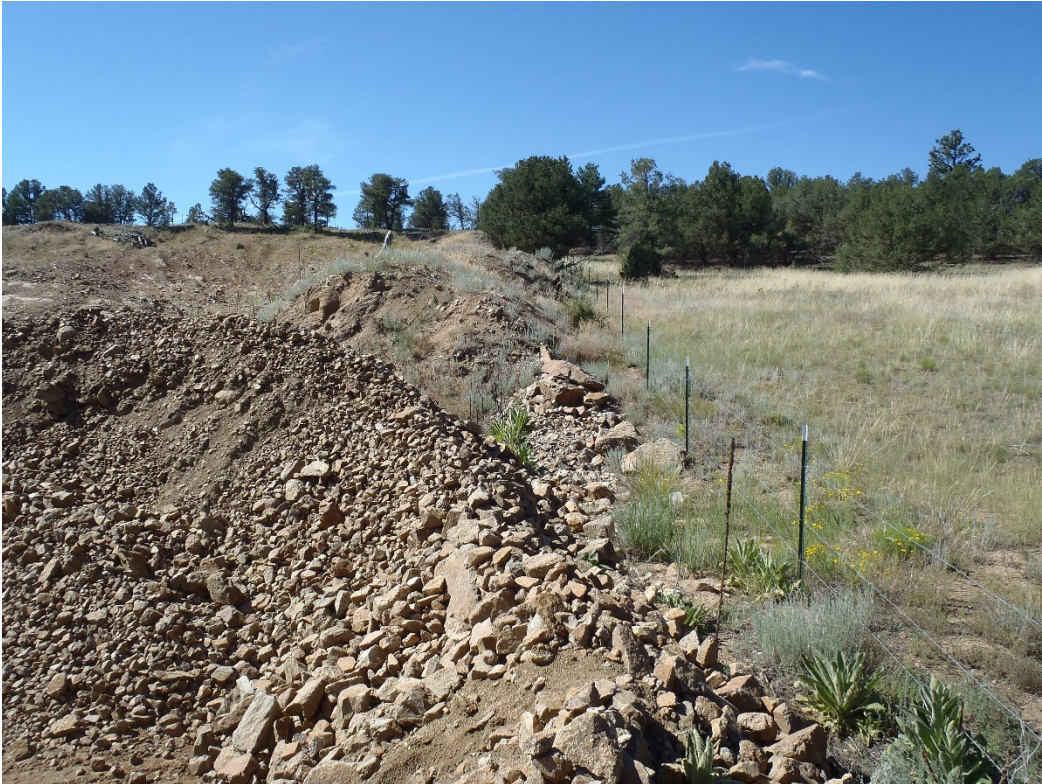
Storm Water MGT Plan: No oil or fuel spills observed. The site has a sediment pond in the NW corner (see **Photo 7**), but it is cutoff from most of the site runoff by berms between it and the pit floor (see **Photo 6**) and the problem cited above under Hydrologic Balance with the pit floor being lower than the sediment pond.

Photo 6. West boundary fence, berms and topsoil stockpile (looking south).
PHOTOGRAPHS (cont.)

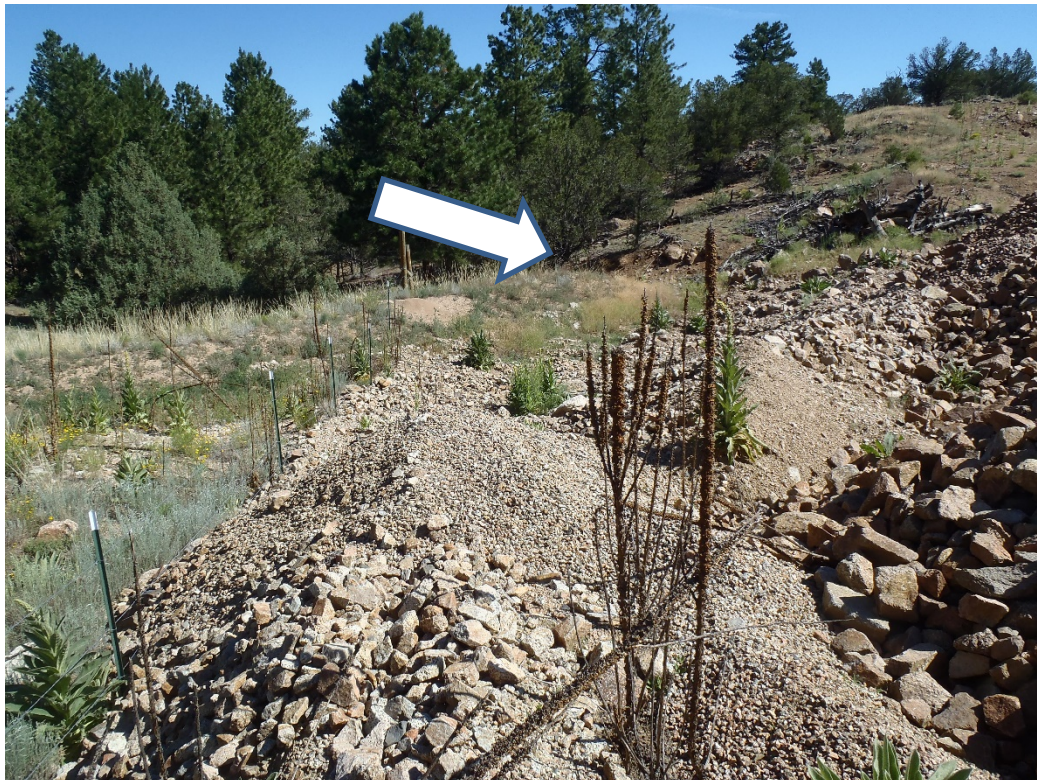
Photo 7. Sediment pond, west boundary fence and berms (looking north).
