MINERALS PROGRAM INSPECTION REPORT

MINE NAME: South Pit	MINE/PROSPECTING ID#: M-1994-114	MINERAL: Gravel	COUNTY: Custer
INSPECTION TYPE: Monitoring	INSPECTOR(S): Timothy Cazier	INSP. DATE: June 18, 2019	INSP. TIME: 15:25
OPERATOR: Kagan & Son, L.L.C.	OPERATOR REPRESENTATIVE: Andy & Becky Kagan	TYPE OF OPERATION: 112c - Construction Regular Operation	
REASON FOR INSPECTION: Normal I&E Program	BOND CALCULATION TYPE: Partial Bond	BOND AMOUNT: \$36,250.00	
DATE OF COMPLAINT: NA	POST INSP. CONTACTS: None	JOINT INSP. AGENCY: None	
WEATHER: Cloudy	INSPECTOR'S SIGNATURE:

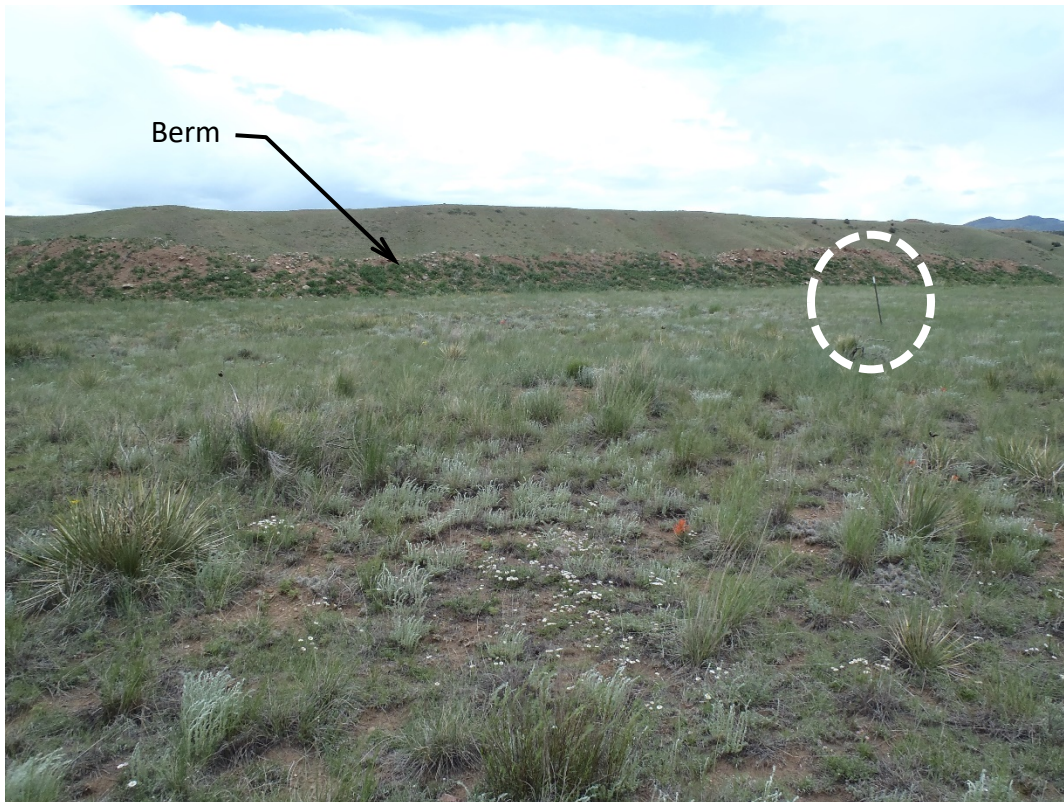
Backfilling and Grading: Sufficient backfill material appeared to be available as the plan is to push down material (as planned) to achieve the required 3H:1V reclamation slopes and sufficient buffer area is marked (see **Photo 1**).

Photo 1. Current buffer area between marker and working slope denoted by short berm (looking NE).

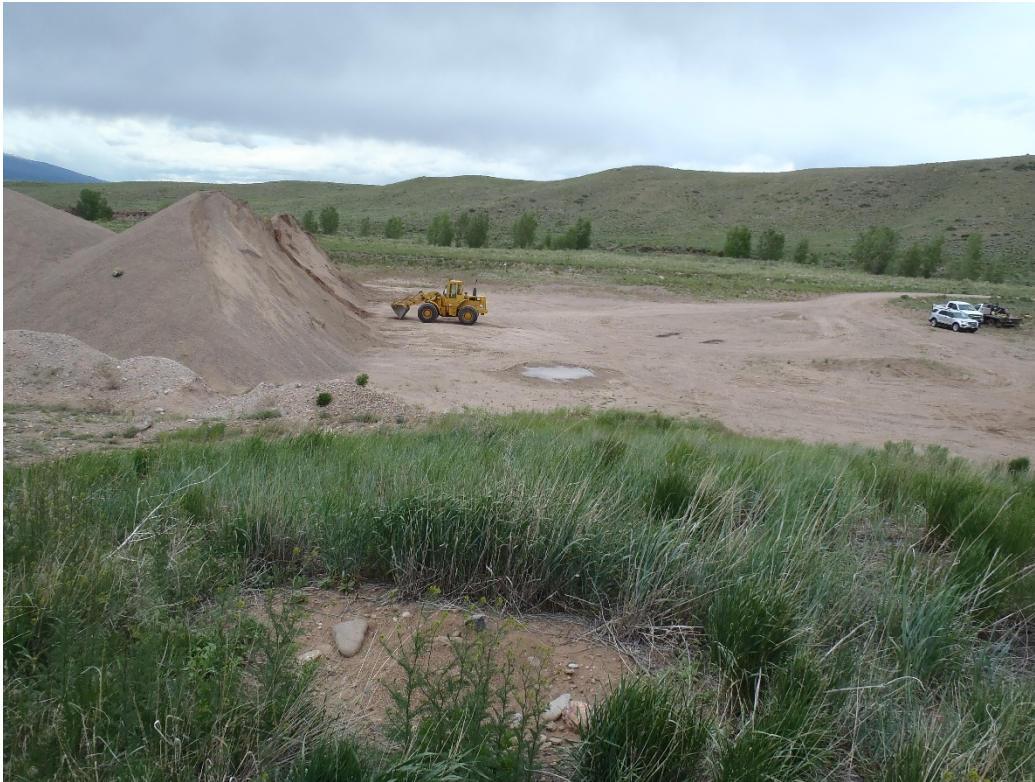
Support Facilities On-site: A loader was observed on site (see **Photo 2**) near the product stockpile.

Photo 2. Loader and product stockpile on pit floor (looking NW).

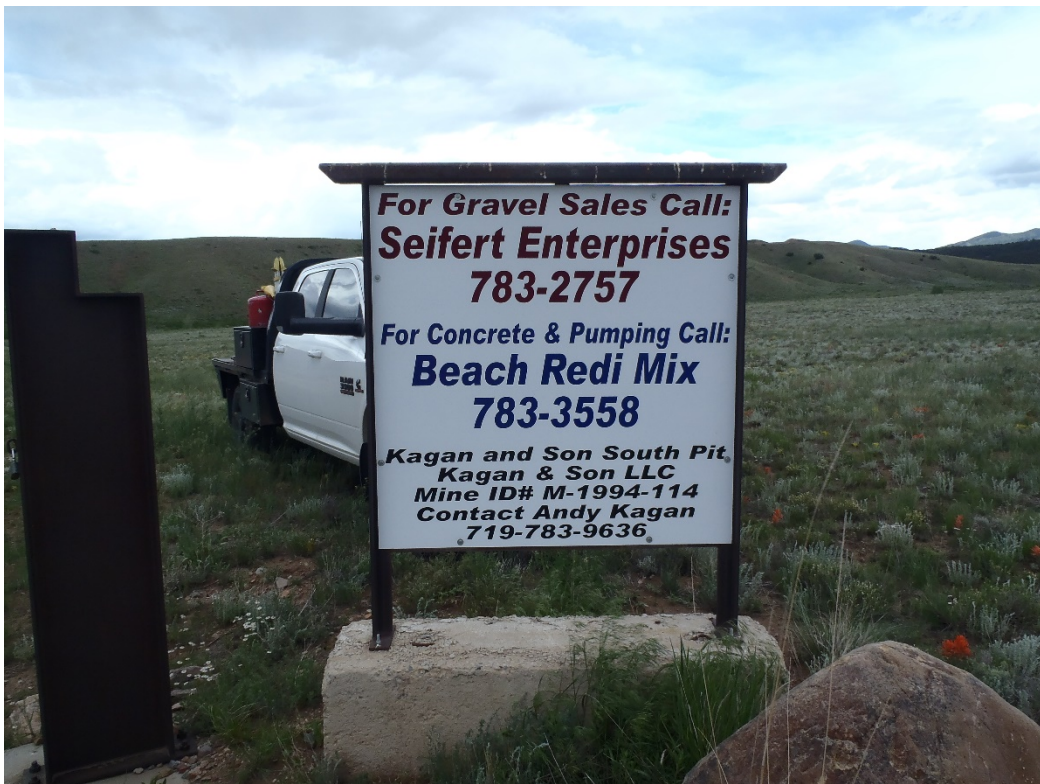
Signs and Markers: The permit sign was properly posted (see **Photo 3**) and boundary markers were observed

Photo 3. Permit sign (at entrance).

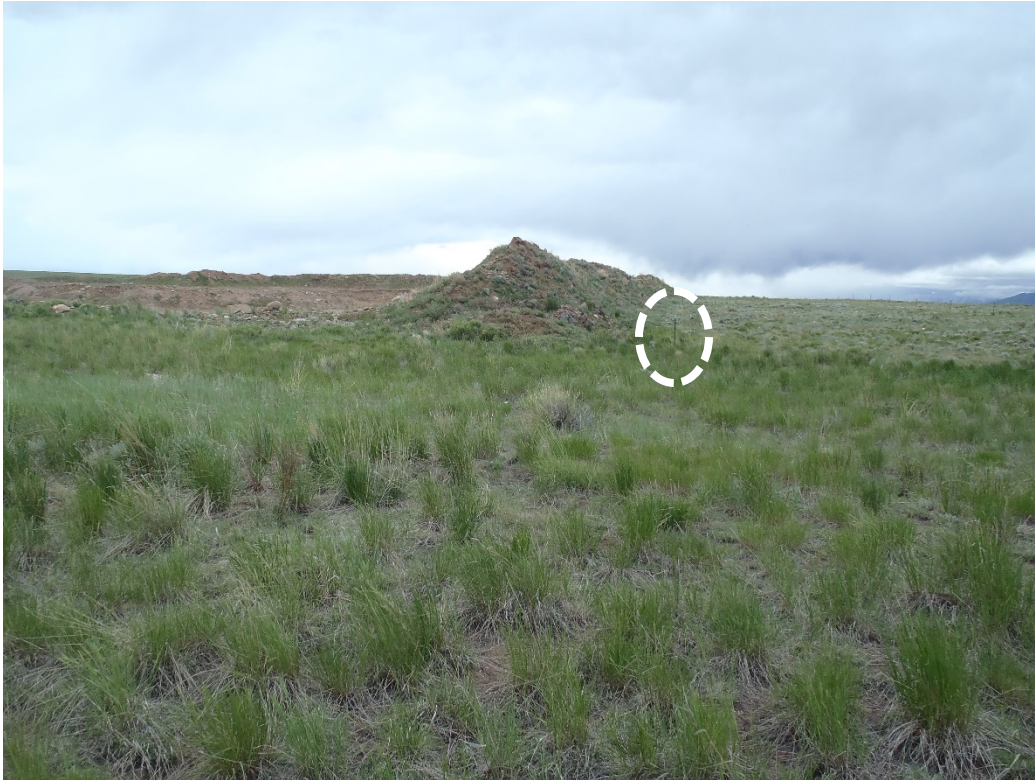
to delineate the affected area boundary (see **Photos 4** and **5**).

Photo 4. Boundary marker on west side of active pit (looking south).

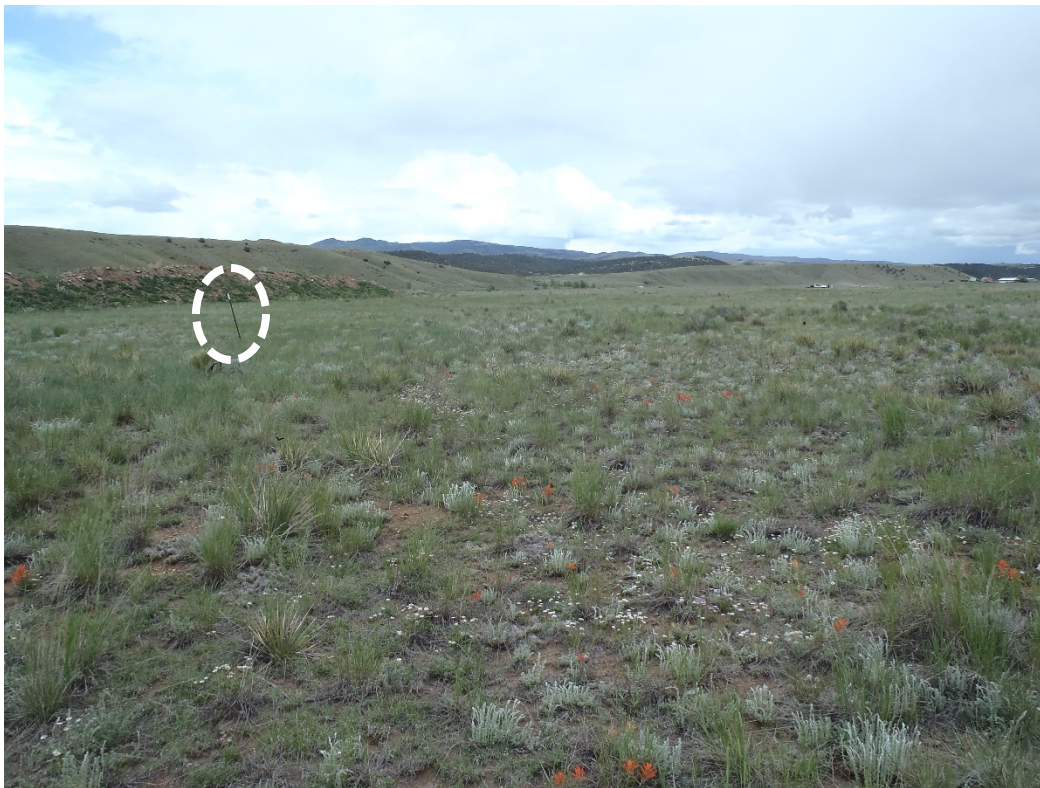
Photo 5. Boundary marker SW corner of active pit (looking NE).

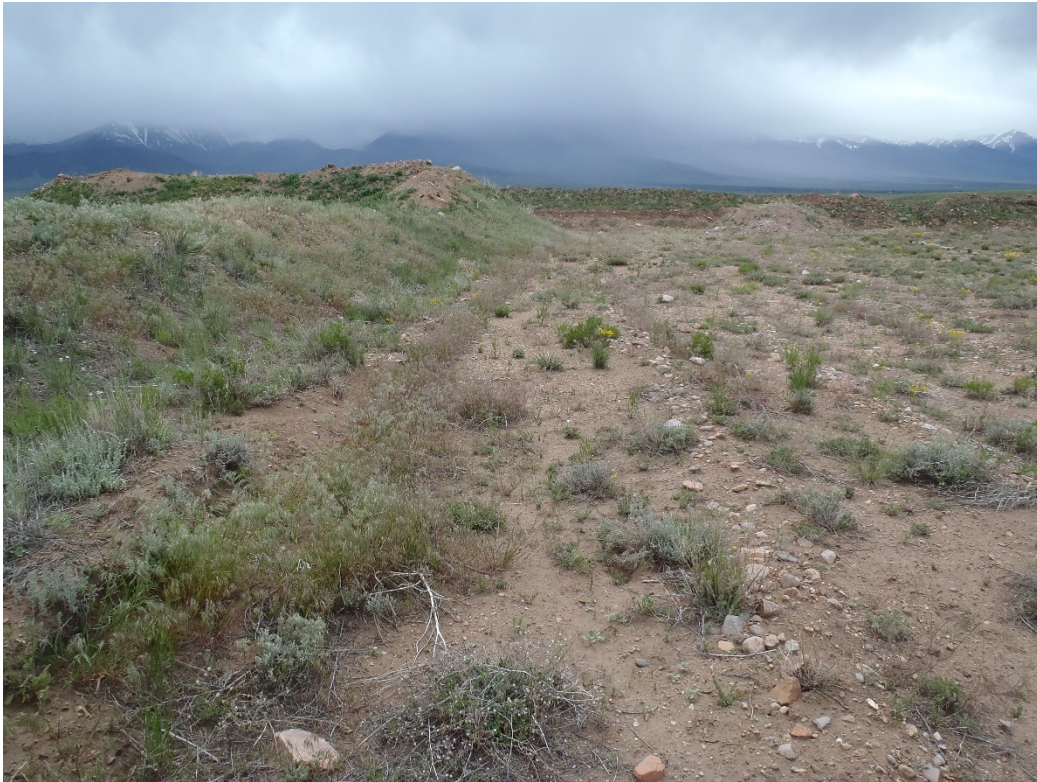
Topsoil: Topsoil had been stripped ahead of mining (see **Photo 6**) and stockpiled on the edge of the pit (see **Photo 7**).

Photo 6. Stripped topsoil on right (south of pit, looking north).

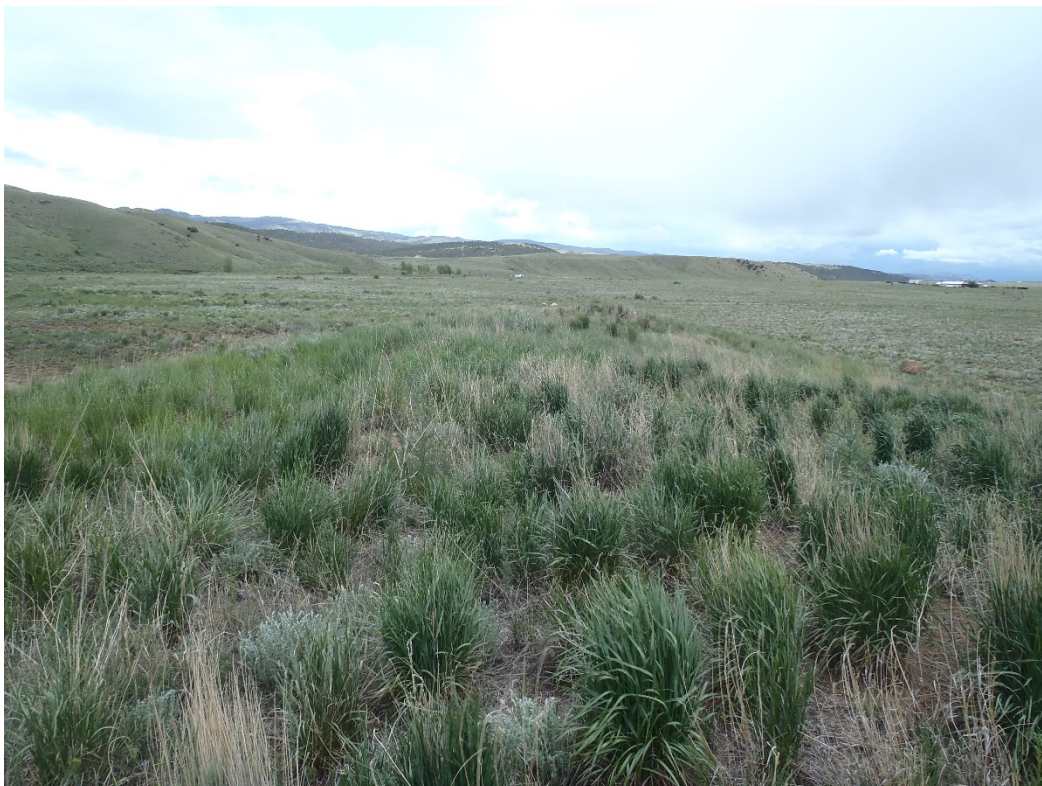
Photo 7. Topsoil stockpile (south side, looking east).
