**COLORADO DIVISION OF RECLAMATION, MINING AND SAFETY
MINERALS PROGRAM INSPECTION REPORT****PHONE: (303) 866-3567**

MINE NAME: Liberty Project	MINE/PROSPECTING ID#: P-2007-058	MINERAL: Gold	COUNTY: Ouray
INSPECTION TYPE: Monitoring	INSPECTOR(S): Lucas West	INSP. DATE: October 2, 2019	INSP. TIME: 10:30
OPERATOR: The Mining Company, Inc.	OPERATOR REPRESENTATIVE: None	TYPE OF OPERATION: MP - Mineral Prospecting

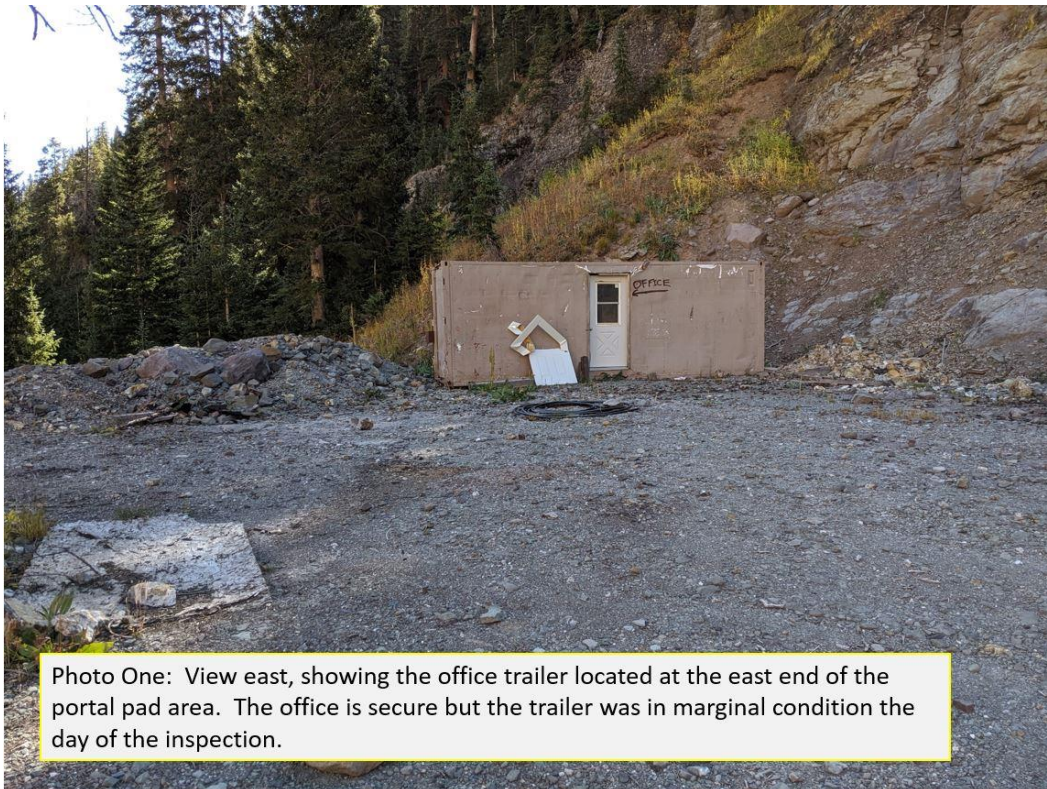
Photo One: View east, showing the office trailer located at the east end of the portal pad area. The office is secure but the trailer was in marginal condition the day of the inspection.

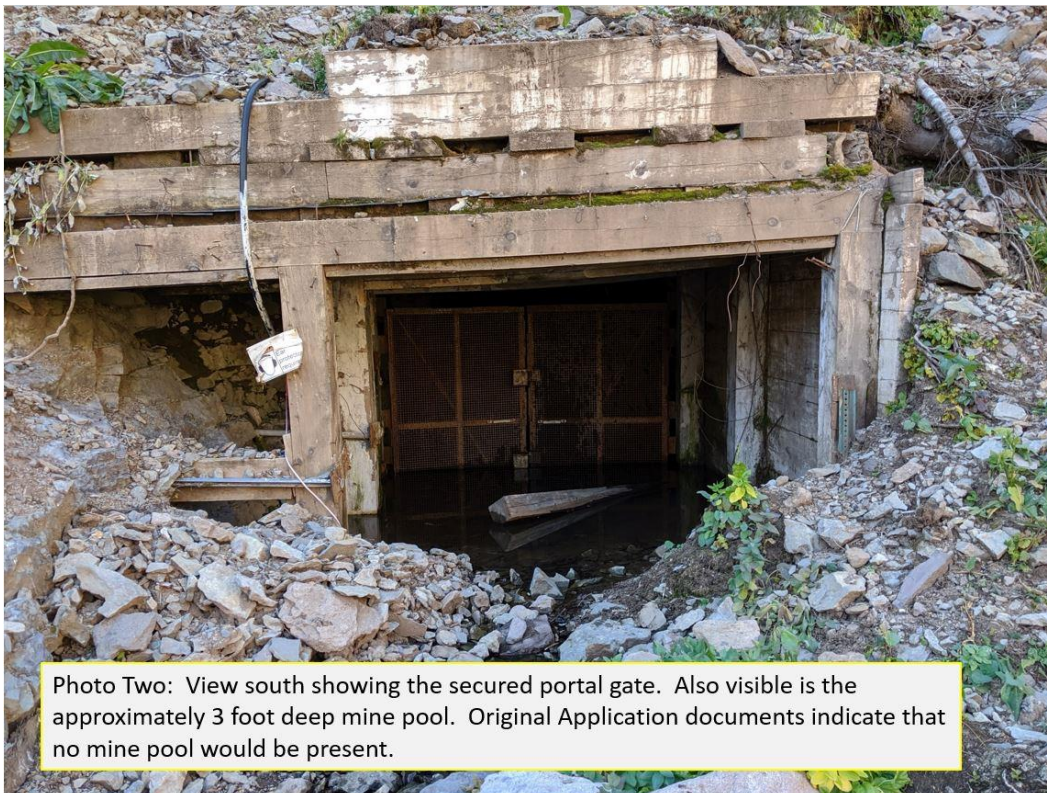
PROBLEM/POSSIBLE VIOLATION: Problem: Unauthorized portal discharge. During the site inspection on 9/11/2019 and 10/2/2019 water was observed discharging the portal. The Mining and Reclamation plan outline that the mine does not have a mine pool and there is no discharge associated with the Notice.

Photo Two: View south showing the secured portal gate. Also visible is the approximately 3 foot deep mine pool. Original Application documents indicate that no mine pool would be present.

CORRECTIVE ACTIONS: Within 30 days of the date of this report, The Operator shall submit an explanation of the presence of water in the mine. The explanation should be received no later than Friday November 29, 2019. Also the Operator shall conduct a study to investigate the source and perform a basic water quality analysis, submitting the results to the Division after the runoff season no later than June 1, 2020.

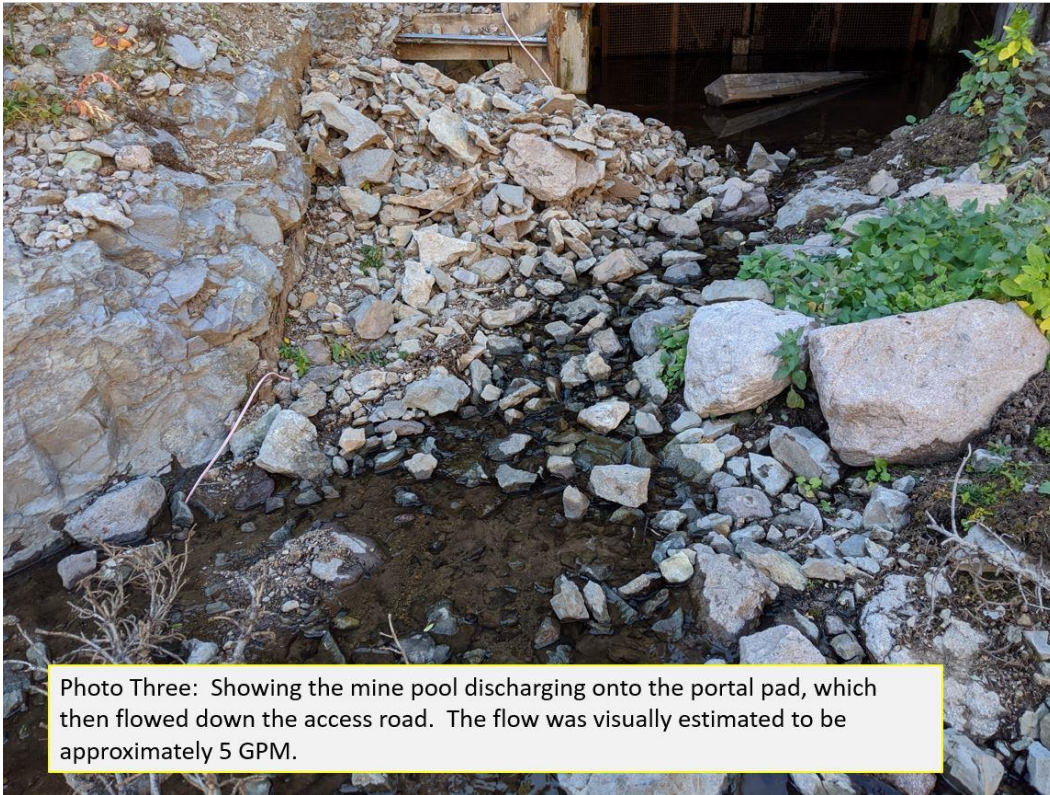
Unauthorized portal discharge. During the site inspection September 11, 2019 and October 2, 2019 water was observed discharging the portal, traveling down the access road. The Mining and Reclamation plan outline that the mine does not have a mine pool and there is no discharge associated with the Notice. Within 30 days of the date of this report, the Operator shall submit a written explanation of the presence of water in the mine. The Explanation should be submitted no later than Friday November 29, 2019. The Operator shall also conduct a study to investigate the source and perform a basic water quality analysis, submitting the results to the Division. Due to winter conditions the results of the study should be submitted after the 2020 run off season, no later than Monday June 1, 2020. The discharge can be seen in Photo Three. The results of the corrective actions may result in further action being necessary.
