#### Minerals Plan of Operations Inspection U.S. Department of the Interior Bureau of Land Management Royal Gorge Field Office

Date: Mar 7, 2019	Operation Name: 1st Bentonite			
<b>Time:</b> 11:03	Case Number: COC-051303			
Weather: Cloudy, Precipitation	CDRMS Number: M-1977-231			
Attendees	General			
BLM: A. Sanderson & J. Rambo	<b>Operation</b> (s) are in compliance with documentation on file			
	$\square$ Yes $\square$ No $\square$ N/A			
<b>Operator</b> (s): None present	<b>Operation(s) and disturbance on-site coincide with the</b>			
	operations and access on file			
Other(s): None	$\square$ Yes $\square$ No $\square$ N/A

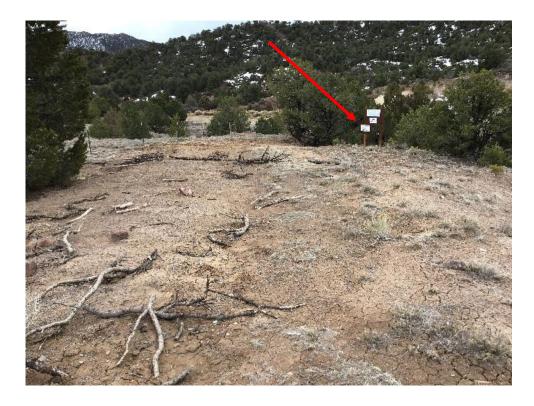
## Image 1:

Comment: Final reclamation sign at entrance and the access road into the reclamation site.

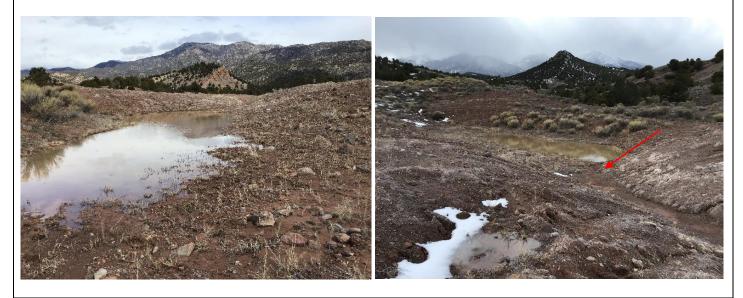
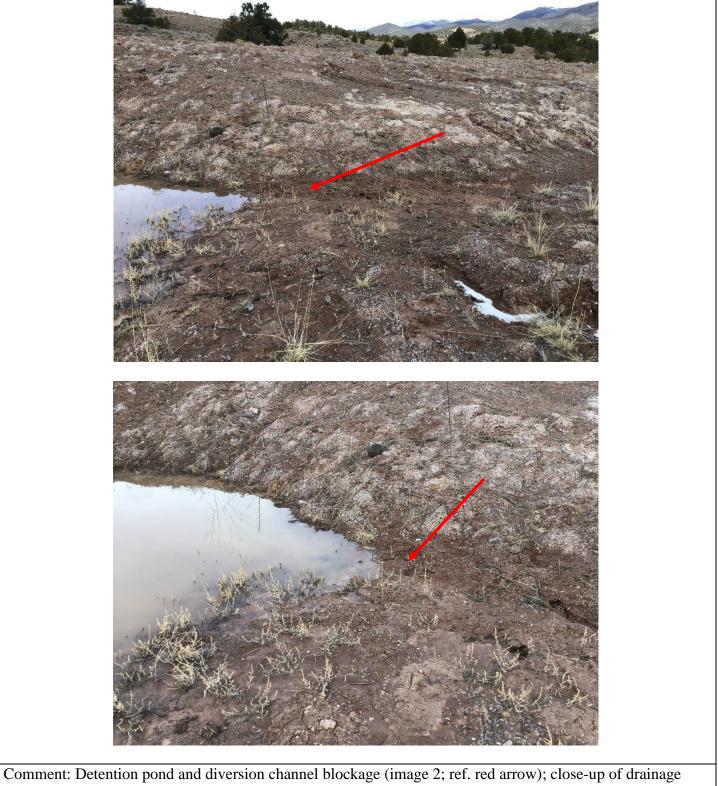
### Image 2-5:

- **6.b & 6.d** Reseeding was conducted during the fall (October). A lack of vegetation remains an issue along the access/haul road, N/NE staging area and southern detention pond. The minimal vegetation is causing soil instability in these areas.
- **6.e** approximately 6'' of standing water was observed in the detention pond located along the SW boundary. Storm/melt water flow was blocked as a result of sediment buildup along the diversion channel entrance (ref. images 2-5). BLM suggests to remove the sediment in order to stimulate drainage flow. The primary type of geological material is bentonite (ref. image 7) which could act as an impermeable boundary, therefore causing the standing water. BLM will continue to monitor this during routine site visits/inspections.

Comment: Detention pond and diversion channel blockage (image 2; ref. red arrow); close-up of drainage channel sediment blockage.

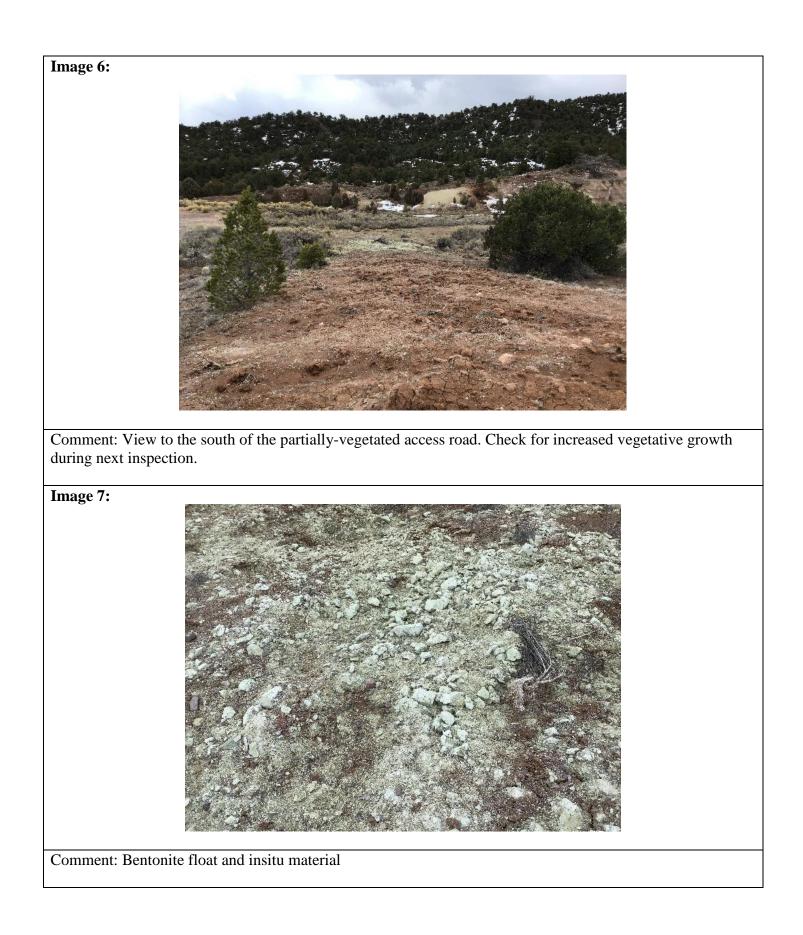
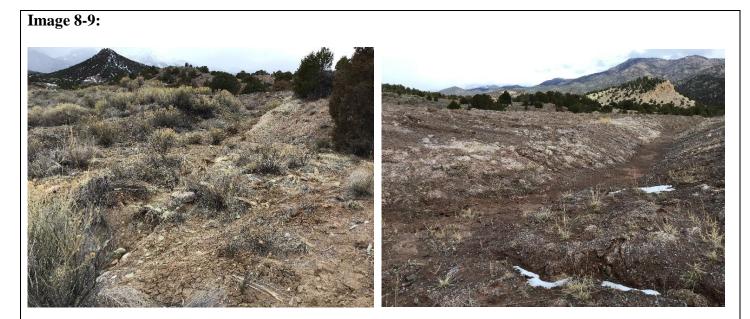
Comment: Eastern flowing drainage channel trending down gradient toward Arkansas River.

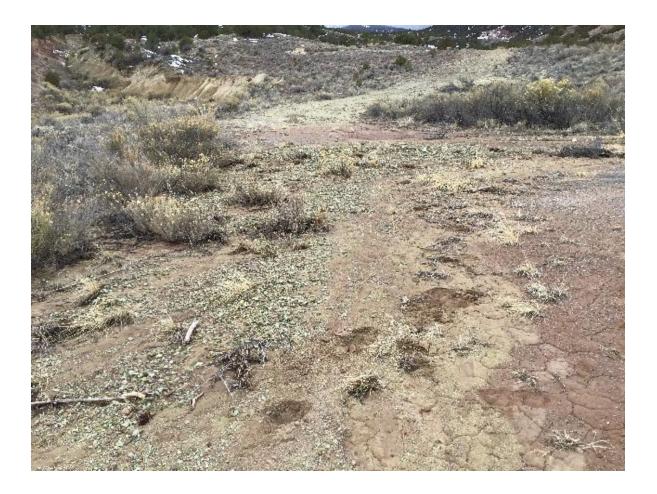
## Image 10:

Comment: Dominant natural vegetation and grasses

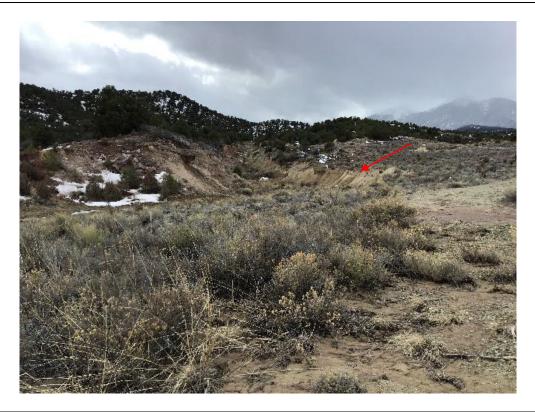
# Image 11:

- 1' wide gullies located along the edges of the detention pond. After referencing the surrounding geology, this was determined to be naturally occurring (ref. image 11).
- Tentative inspection scheduled for 07/23/19 to inspect vegetation growth, soil stability and ponding water.

Comment: Natural erosion (ref. red arrow) located around south boundary

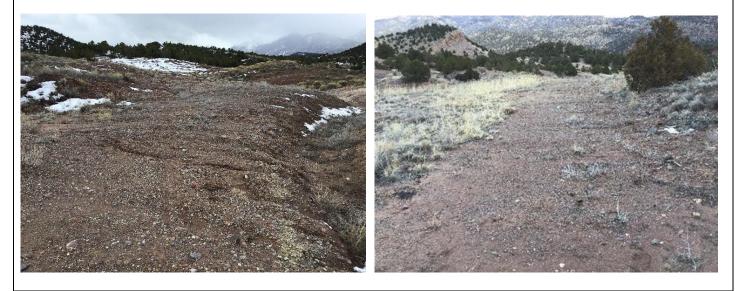
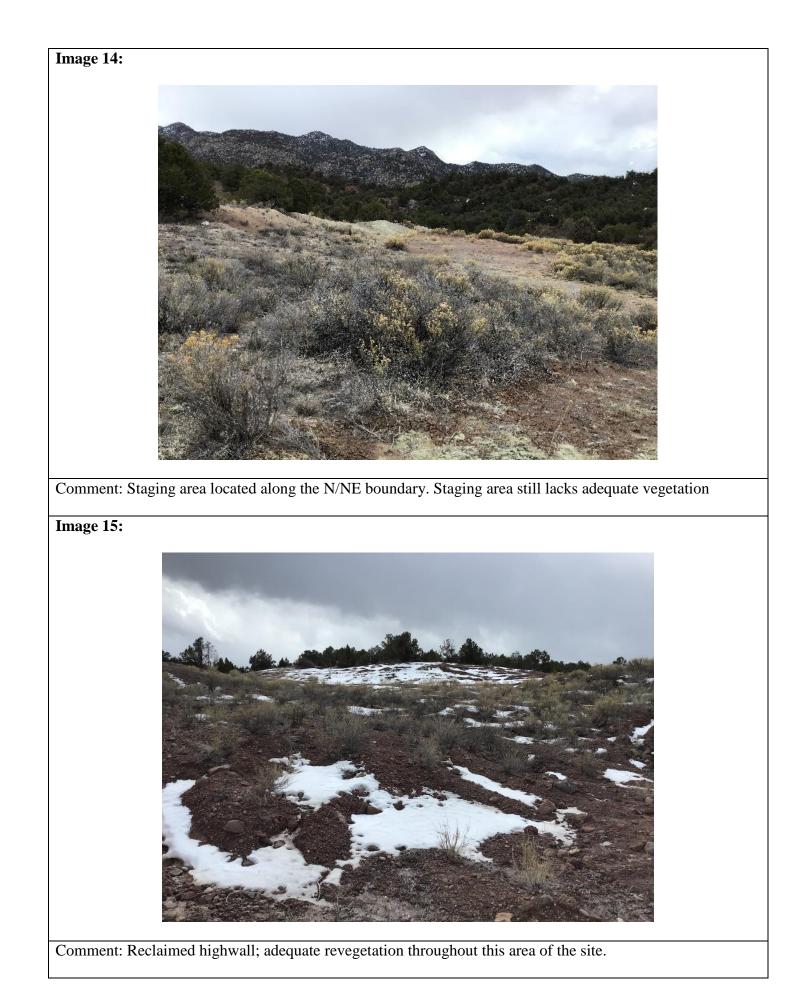
## Image 12-13:

Comment: Access/Haul road trending east-west down-gradient. Dependent on vegetation growth during spring/summer, road and staging area may need to be ripped and reseeded again.
