# Minerals 3600 Mine and Reclamation Inspection

U.S. Department of the Interior  
Bureau of Land Management  
Royal Gorge Field Office

| <b>Date:</b> Jul 20, 2018<br><b>Time:</b> 10:45<br><b>Weather:</b> Sunny | <b>Operation Name:</b> CO-Quarries: Mica White<br><b>Case Number:</b> COC78191<br><b>CDRMS #:</b> M1992058 |

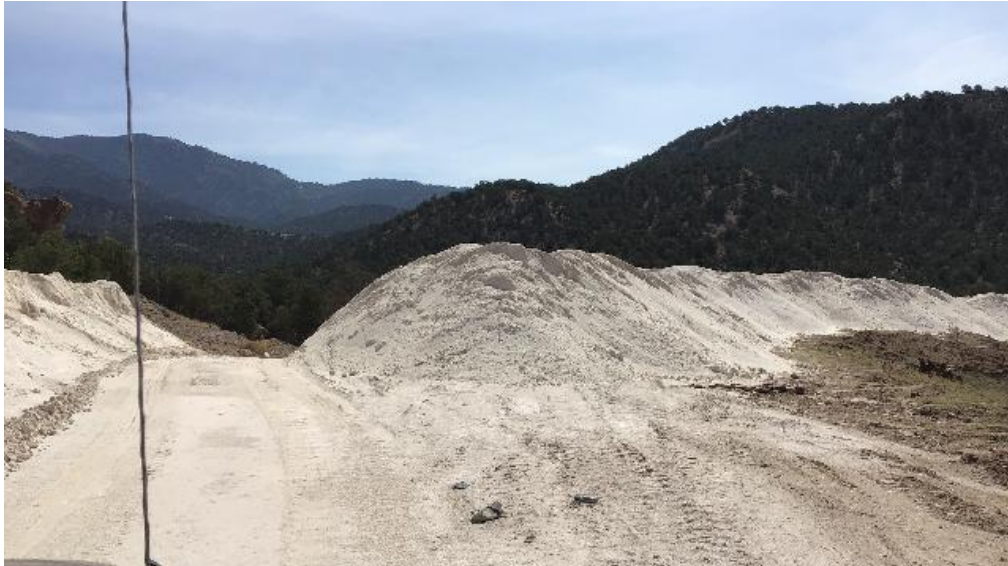
**Image 1:**

Comment: Fines stockpiles located south of active operations. Adequate ingress/egress and angle of repose on stockpiles.

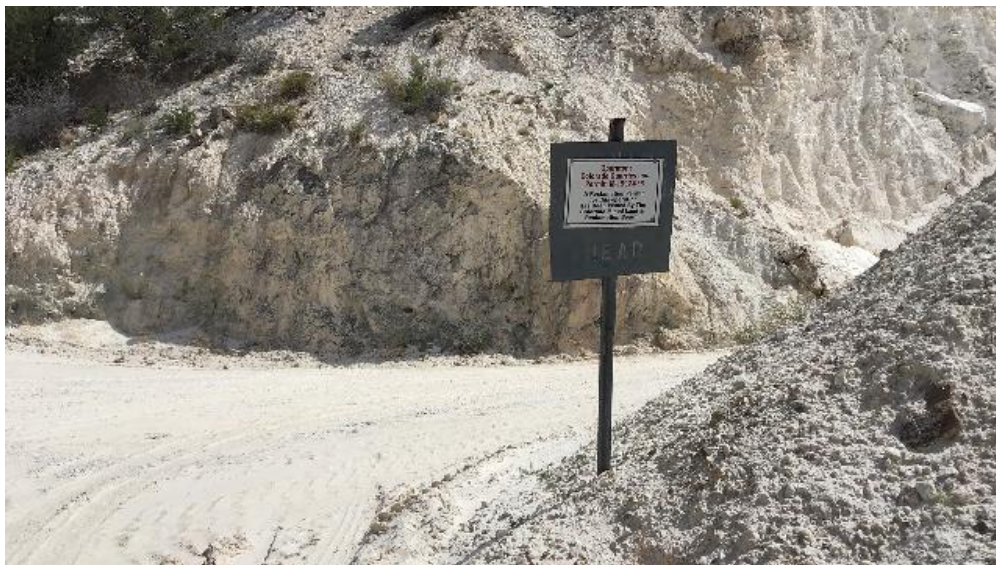
**Image 2:**

Comment: Signage upon entrance to active operational site

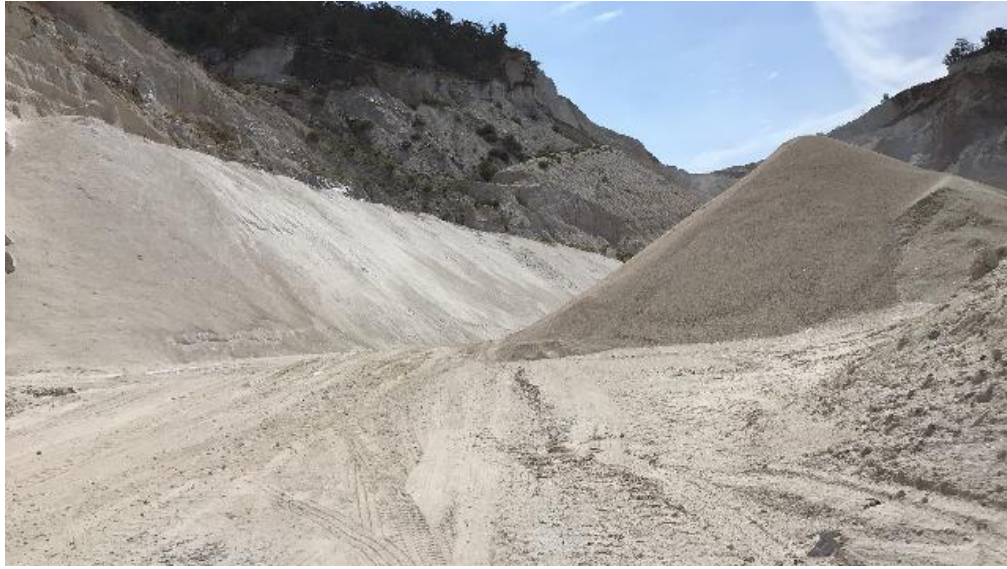
**Image 3:**

Comment: Fines stockpiles located on staging floor south of the N/ NE working floor

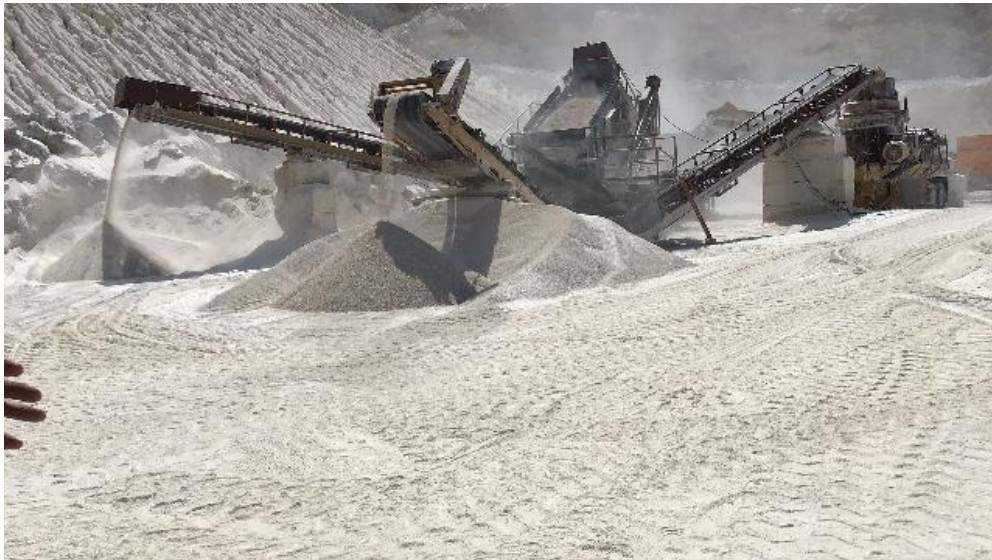
**Image 4:**

Operator monitors dust from crushing/screening of processed material. Water trucks are used to minimize fugitive dust, however due to the lack of precipitation throughout the area, the site was dusty during the inspection. No offsite migration was observed nor migration into/toward any surficial water. Operator was spraying water at the time of the inspection. Site has never had an issue with dust in past inspections.

Comment: Crusher and screener of 1/4" aquarium material. Fines screened separately from processed material. Dust was an issue on-site. Operator had water trucks spraying, however due to the minimal precipitation in the general area, the site was extremely dusty.

1. Include dust control mitigation into your Storm Water Management Plan (SWMP) to mitigate fugitive dust from crushing/screening processes and for the off-site transport of raw, final or fines materials.
2. Operator should reference their CDPHE 2014 APEN and 2017 Storm Water Permit (COG500000-Sand and gravel) which states the appropriate control measures in order to minimize the generation of fugitive dust.

1. Suggestive Dust Control Measures: Attach a water sprayer along the conveyor belt of the crusher/screener to minimize fugitive dust? This may help decrease dust during processing, however water saturation can interfere with the product by swelling the material if the material expands when wet. This could affect the weight of the final product.
2. Watch berm height on access road. Berms should be  $\geq \frac{1}{2}$  the height of the largest vehicle/equipment's axle. Material (Fines) can be added to the berms if erosion from drought/wind continues.
3. Check both of these inspection items during the next inspection.

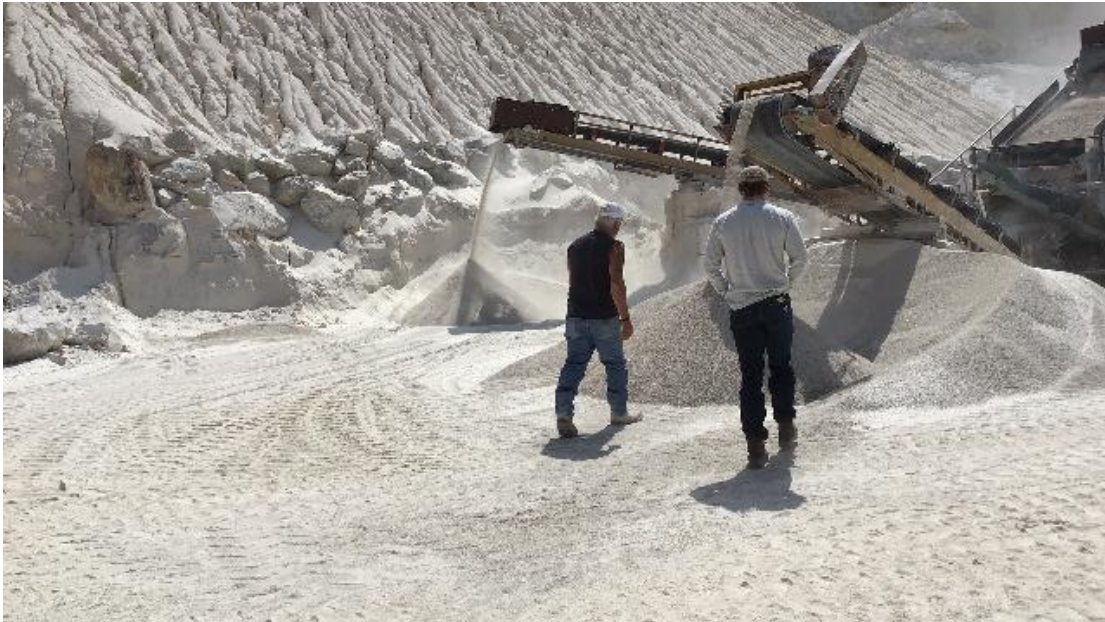
**Image 5:**

Comment: Fines on the left and 1/4" aquarium rock on the right

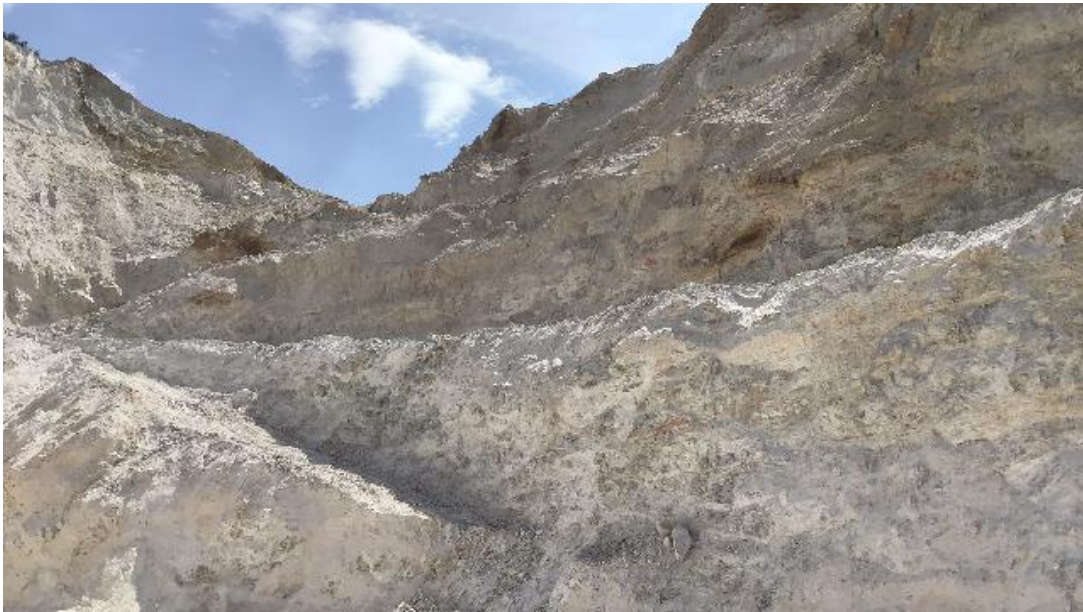
**Image 6:**

Comment: Active highwall containing minimal black contaminant material. Depending on a client's needs will depend where on the highwall mining will occur

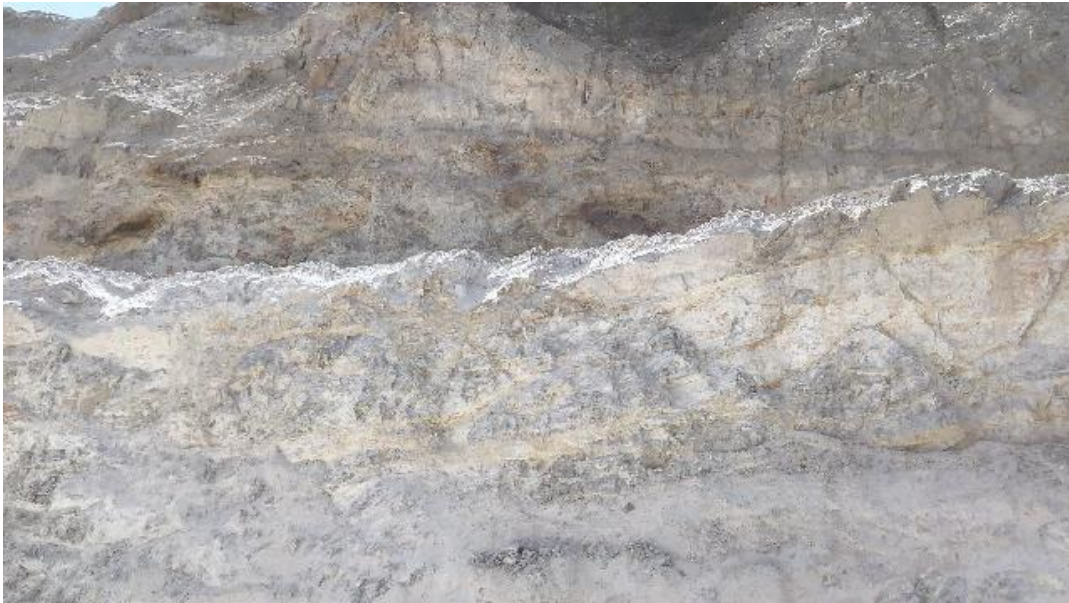
**Image 7:**

Comment: Active highwall of pure white material. This material is most desired by clients since material is dyed following processing.

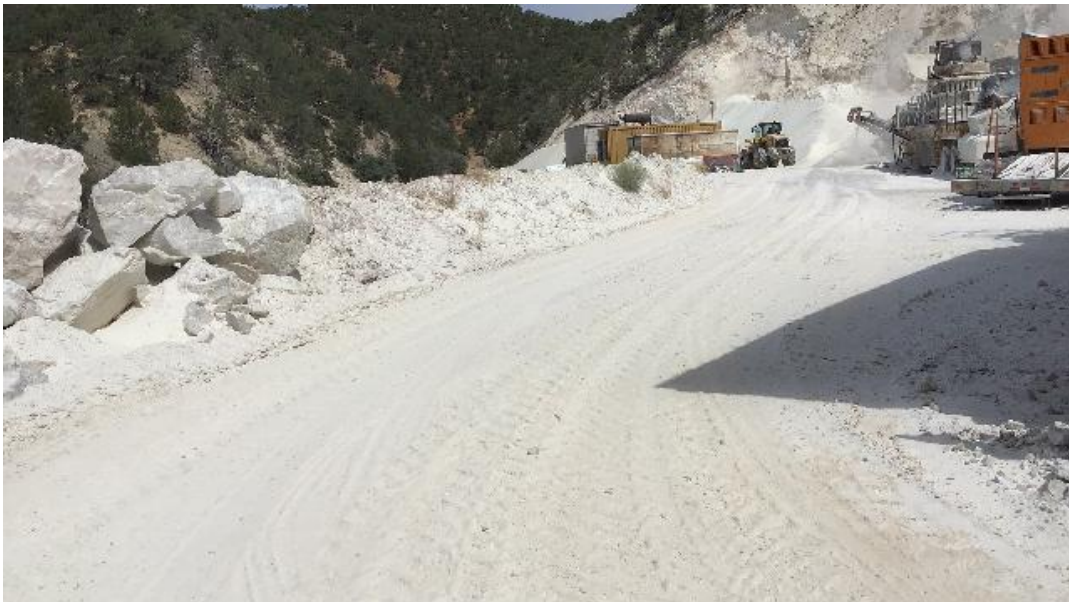
**Image 8:**

Comment: Haul road looking down from highwall. Berms are adequate for the type of equipment utilized.

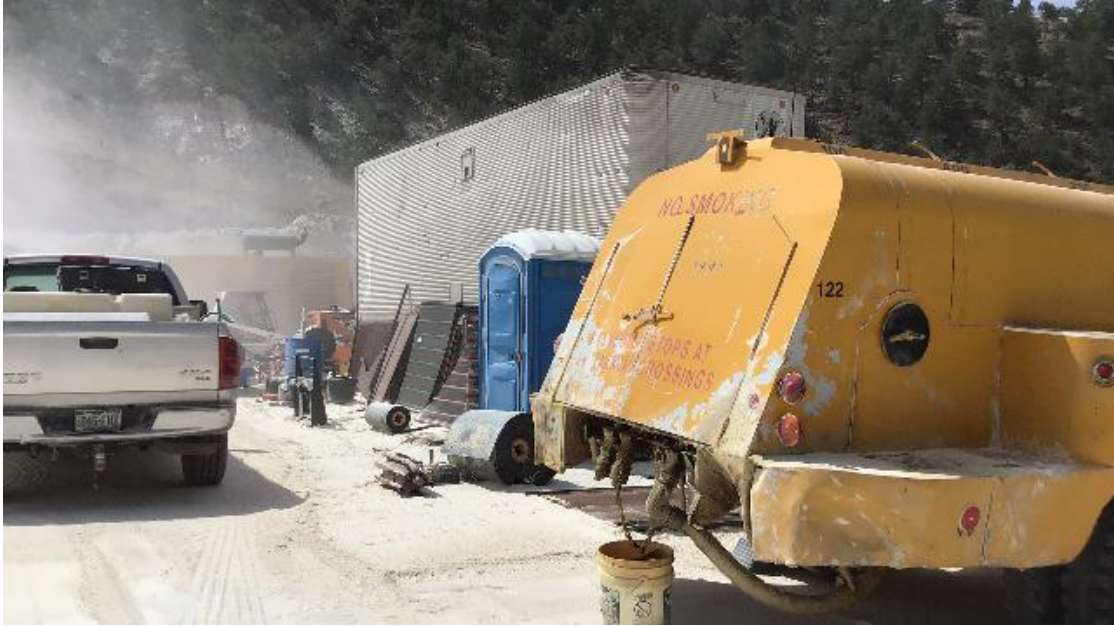
**Image 9:**

Comment: Water truck in parking area. Area where fuels and oils stored.

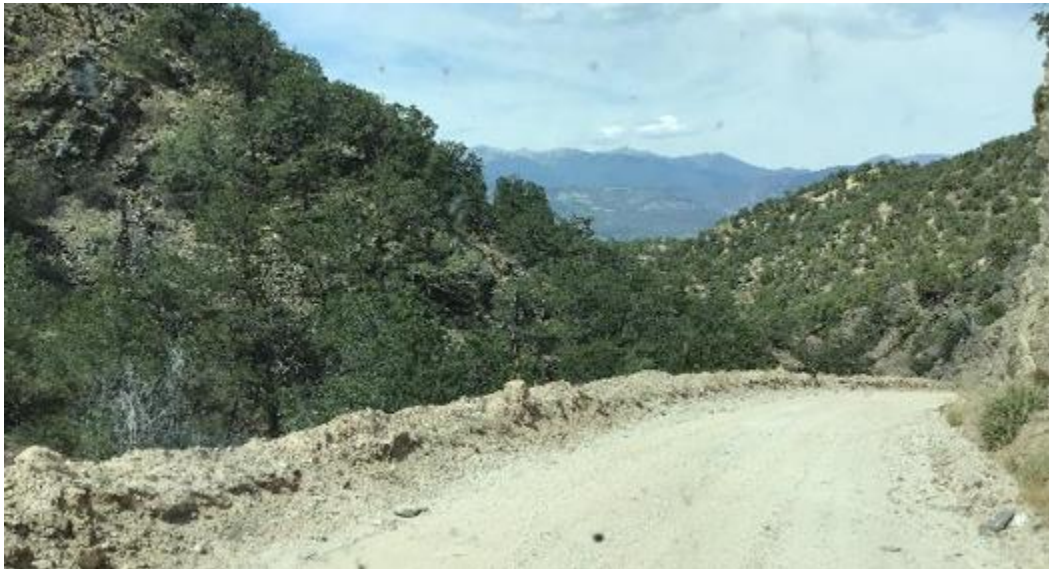
**Image 10:**

Comment: Access road to northern site. Berms need to be watched for erosion. Material will need to be added to increase berm size to the axle size of the largest piece of equipment using the access road.
