Minerals 3600 Mine and Reclamation Inspection
U.S. Department of the Interior
Bureau of Land Management
Royal Gorge Field Office

Date: Mar 7, 2019 Time: 10:10 Weather: Precipitation , Cloudy	Operation Name: CO-Quarries: Mica White Case Number: COC-078191 CDRMS #: M1992058
<u>Attendees</u> BLM: A Sanderson & J. Rambo Operator(s): Greg Cleeves Other(s): None	<u>General</u> Operation(s) are in compliance with documentation on file <input checked="" type="checkbox"/> Yes <input type="checkbox"/> No <input type="checkbox"/> N/A Operation(s) and disturbance on-site coincide with the operations and access on file <input checked="" type="checkbox"/> Yes <input type="checkbox"/> No <input type="checkbox"/> N/A

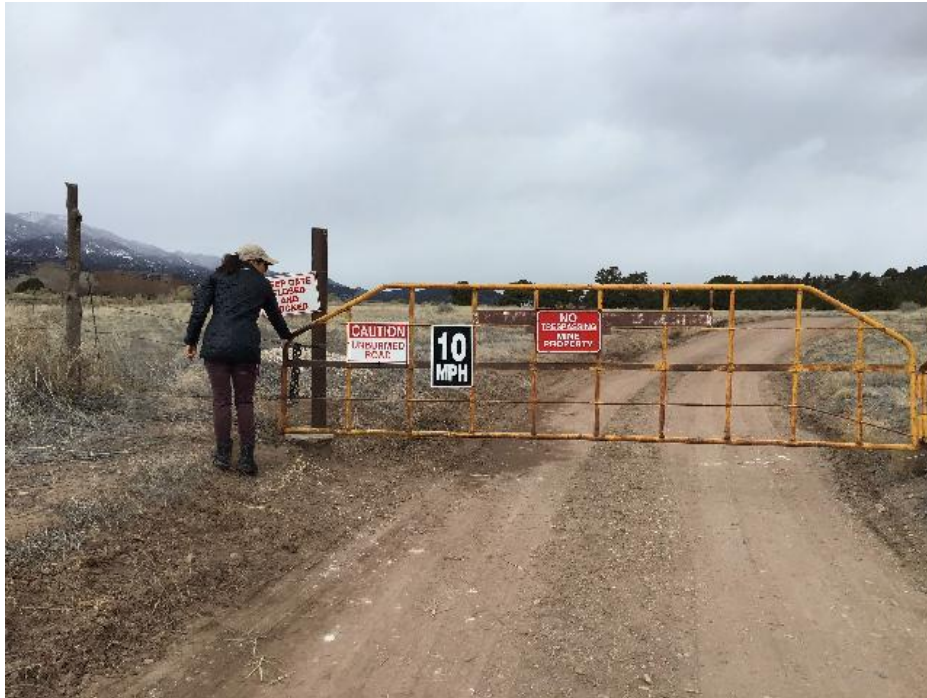
Image 1:

Comment: Entrance is through a locked gate along C.R. 45

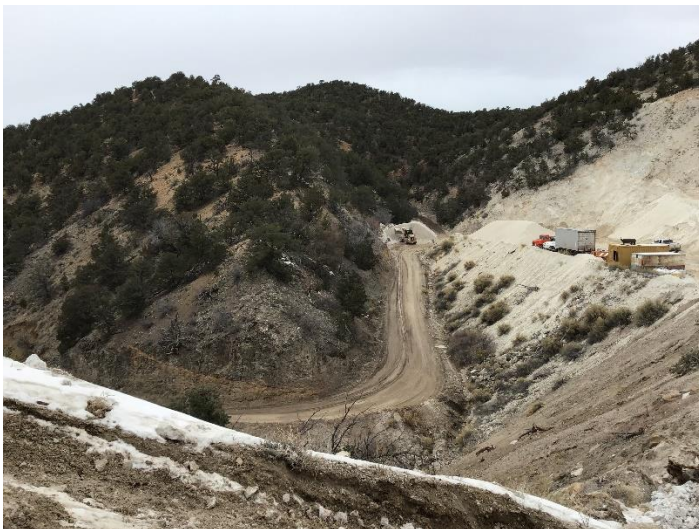
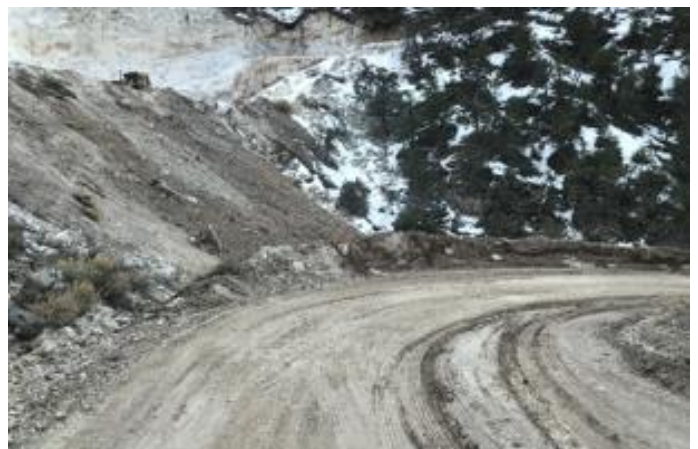
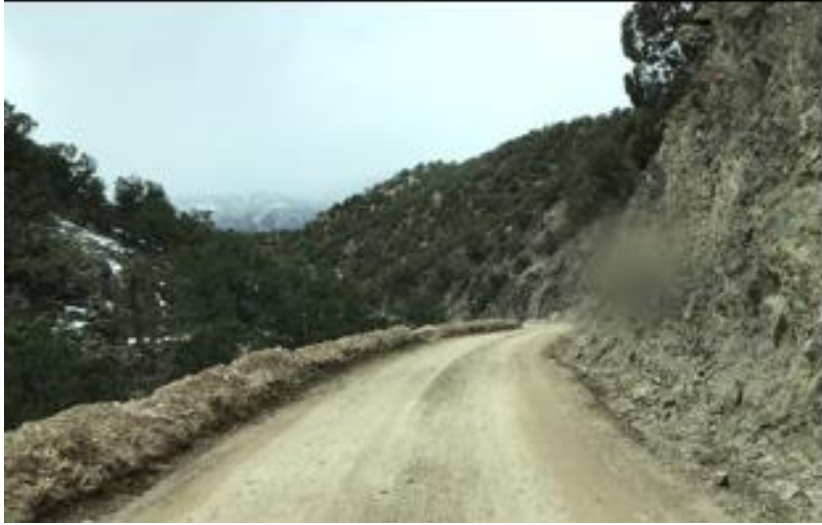
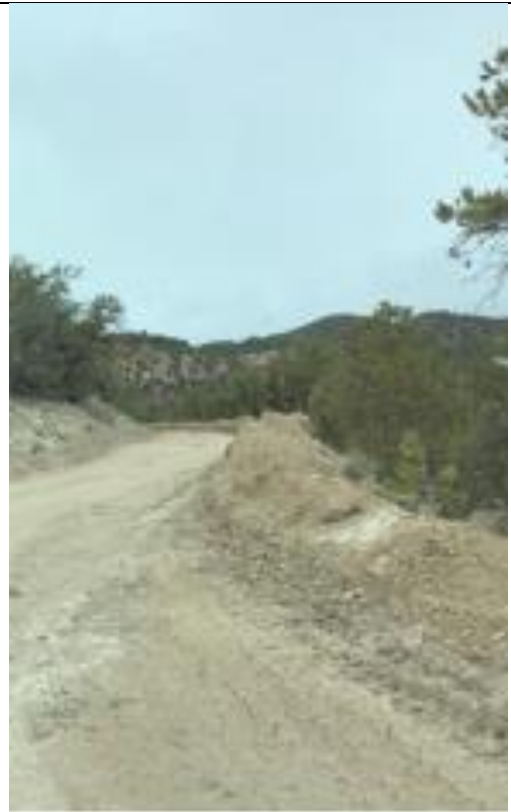
Image 2-5:

Comment: Bermed access/haul road leading to both the active mine site and lower fines staging area. No evidence of significant erosion or abundant sediment accumulation. Drainage channels appear to be adequately diverting all storm/melt water from the access/haul road.

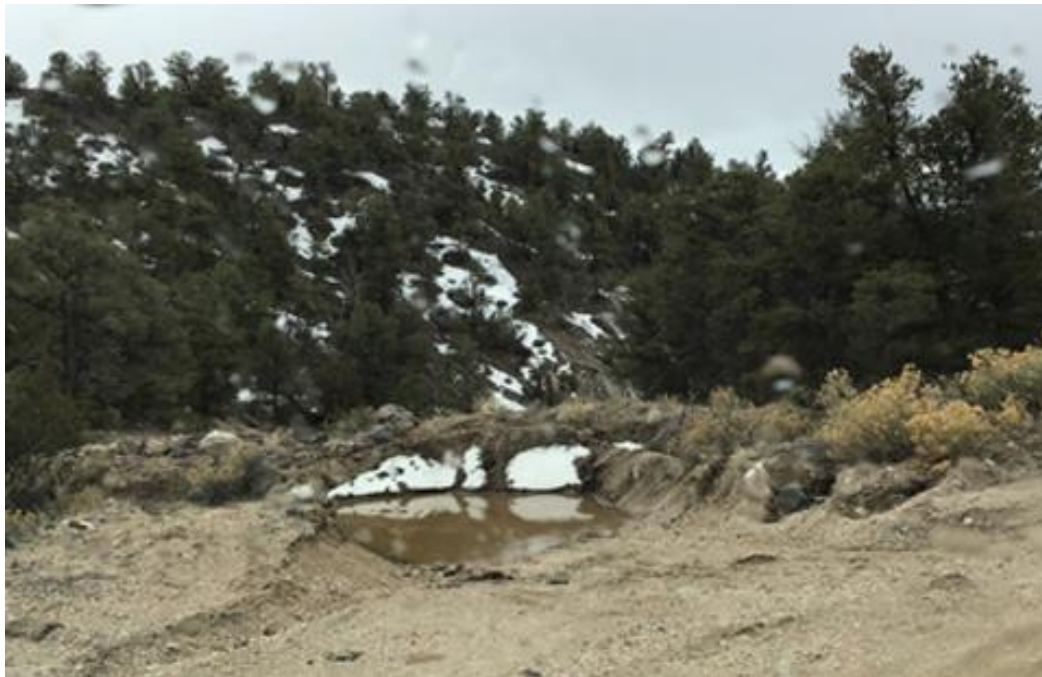
Image 6:

Comment: Catchment pond along the access road emplaced for storm/meltwater management

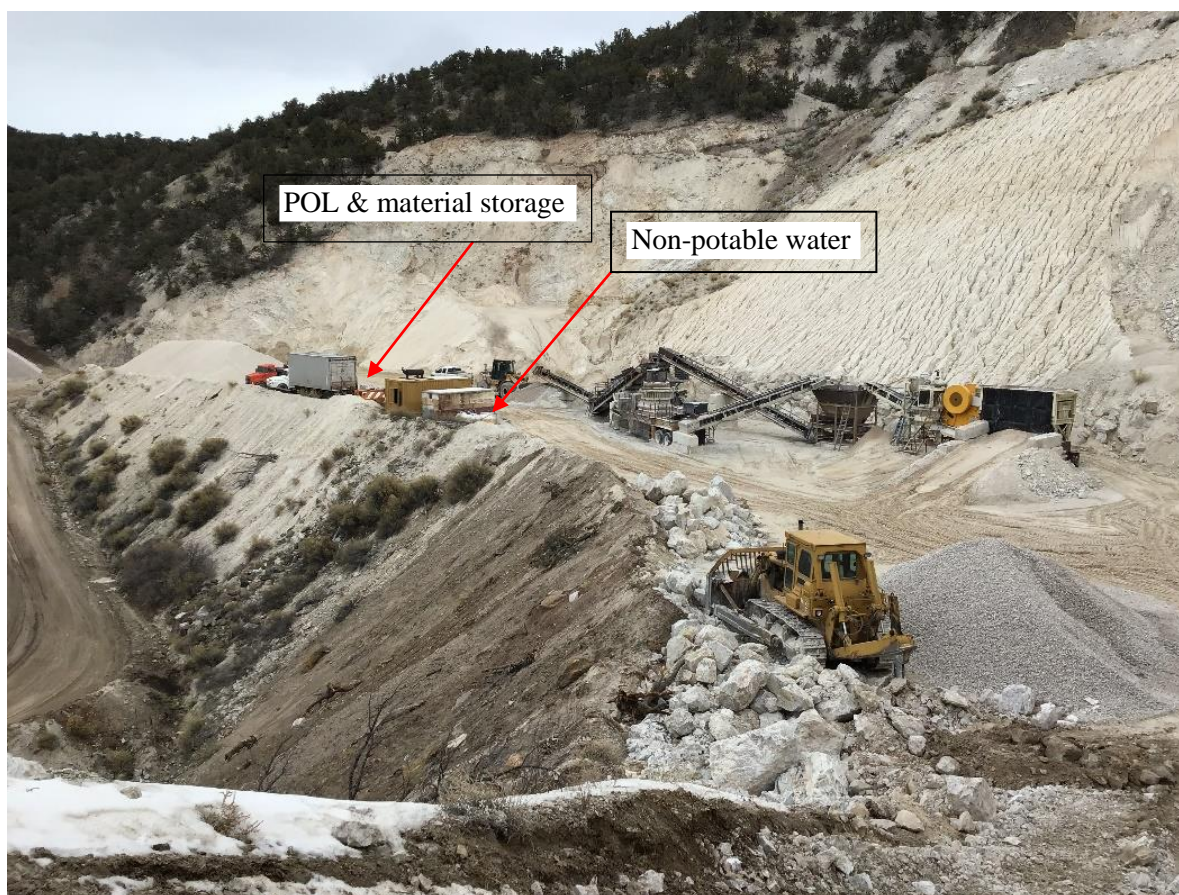
Image 7:

Comment: Western view from bench 1 of the working floor, various types of equipment, materials storage and parking area

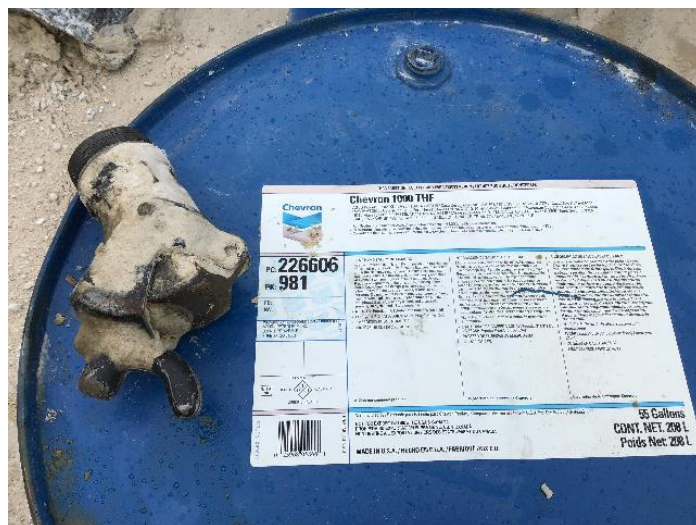
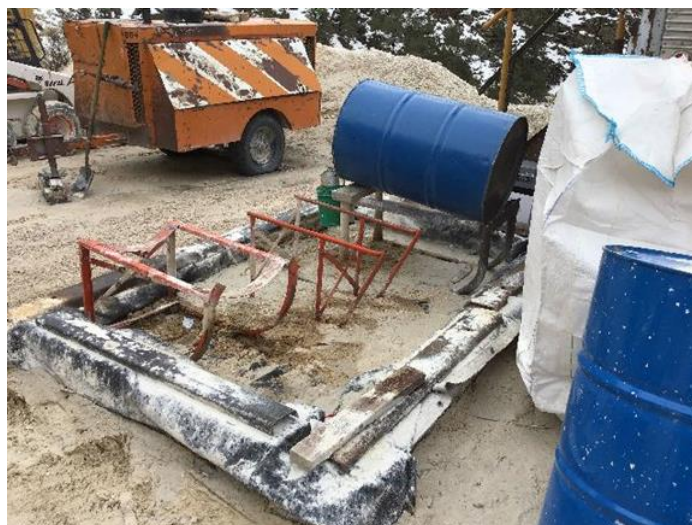
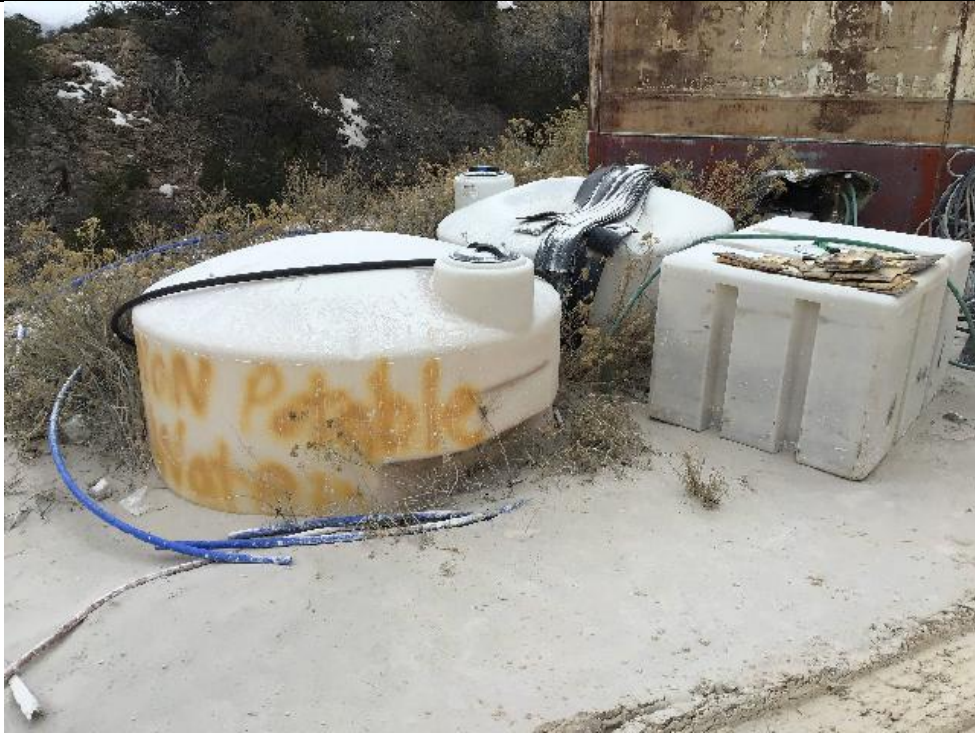
Image 8-10:

Comment: Non-portable water and mining related material stored along the southern boundary of the working floor. All storage containers are labeled. Rubber-lined POL secondary containment is in use.

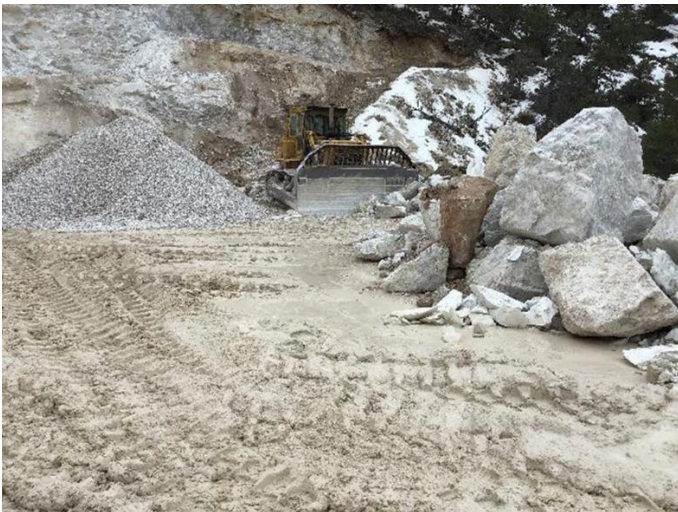
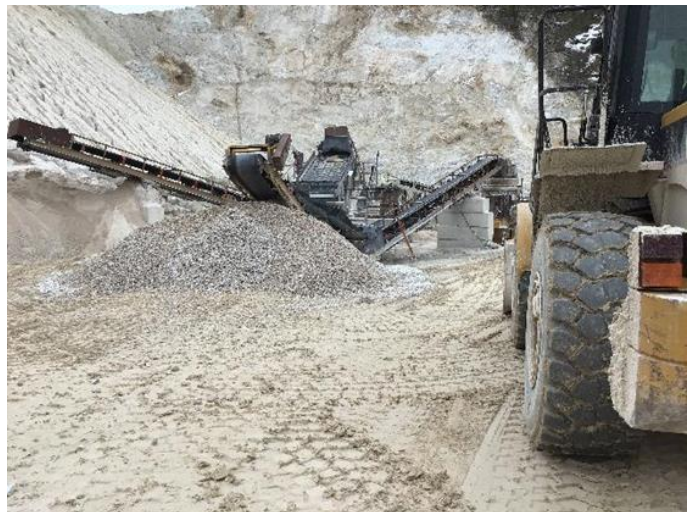
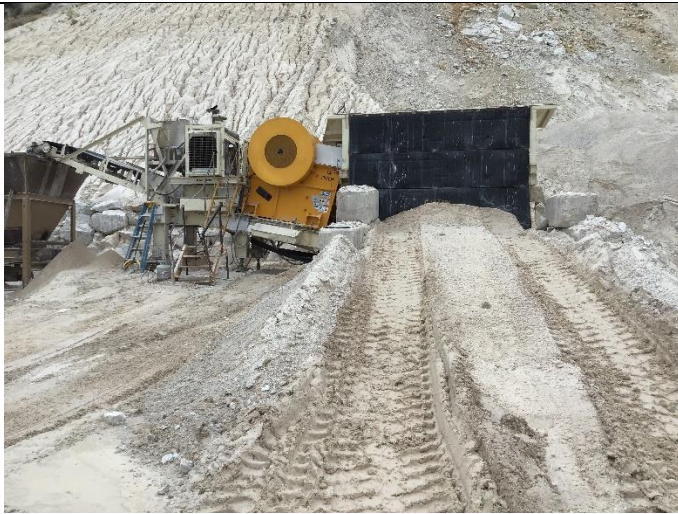
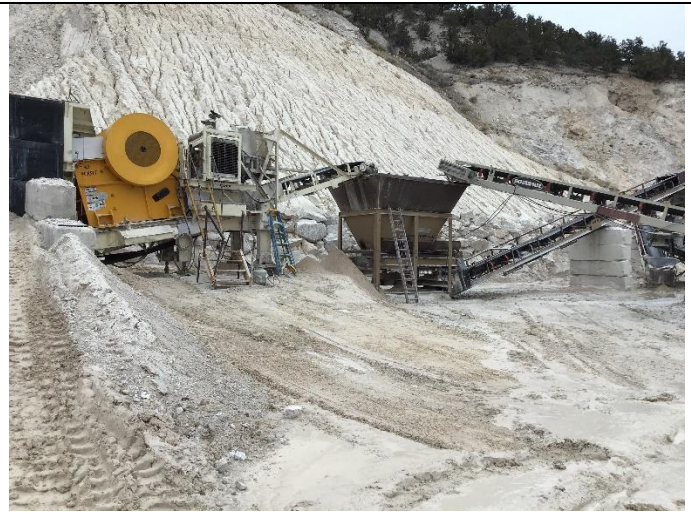
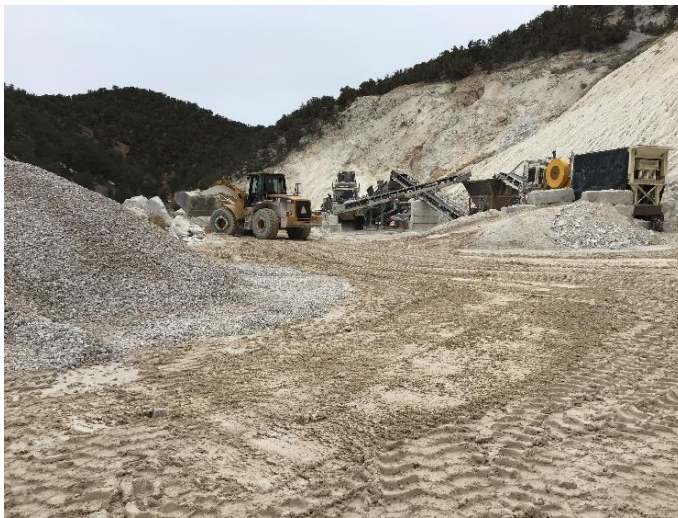
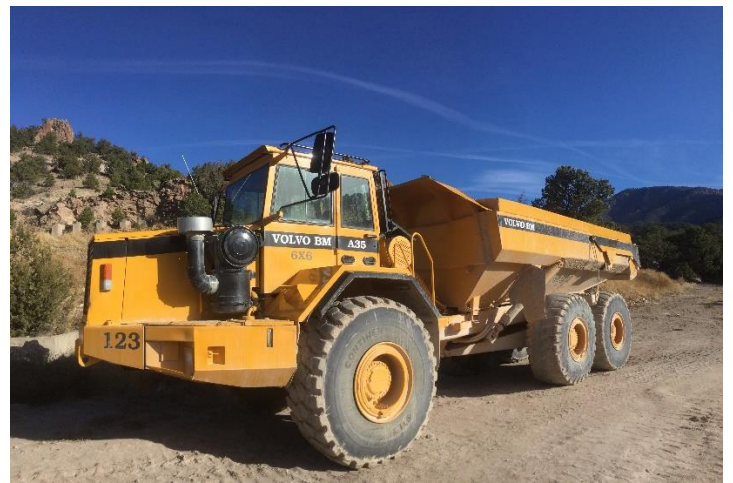
Image 11-16:

Comment: Equipment – Crusher/Screener with grizzly and 2 conveyor belt system, front-end wheel loader, track dozer and articulated haul truck (located along access road).

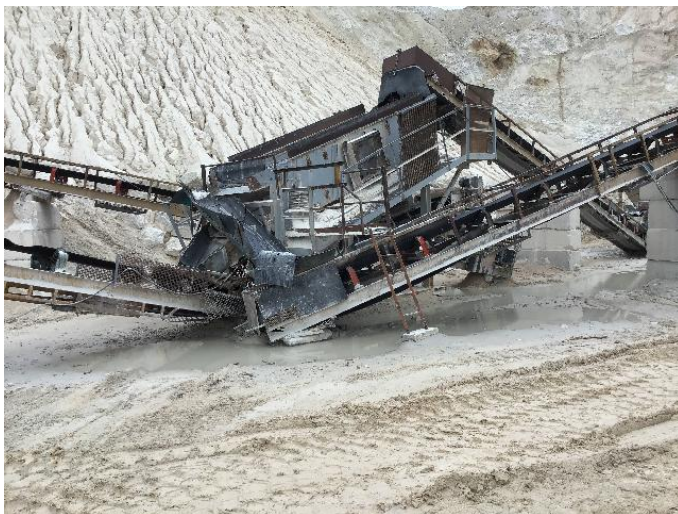
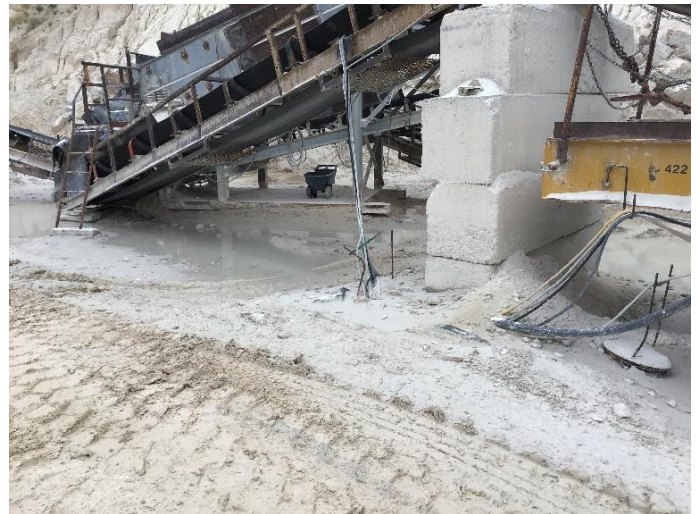
Image 17-18:

- POLs and other chemicals are adequately stored approximately 75' from the working floor (ref. images 16-17). No spills/leaks were observed. Follow-up conversation with the operator, indicated that the ponding water had dissipated within 48-hours.

Comment: 2-3" of standing water beneath the crusher/screener

Additional Actions Necessary
<ul style="list-style-type: none"> If standing water continues to pond on the working floor for extended periods of time, the operator should consider augmenting the on-site conditions to coincide with the Stormwater Management Plan (SWMP) or adjust the SWMP to reflect on-the-ground conditions. All federal, state and county permits and corresponding management plans should be available on-site for reference.
Final Notes
<p>General Comments:</p> <ul style="list-style-type: none"> Operations were active during inspection. Previous Inspection "Watch" Items addressed: <ul style="list-style-type: none"> Earthwork was completed to heighten the berms located along the haul/access road. Fugitive dust was not present and mitigation measures are being taken to control fugitive dust Catchment ponds along the access/haul road were adequate (ref. image 6). Storm/melt water are being adequately diverted from the access/haul road. Approximately 2-3" of standing water was observed on the working floor beneath the crusher/screener. Due to an abundant amount of precipitation/snow in the general area, the site was experiencing abnormal wet conditions.

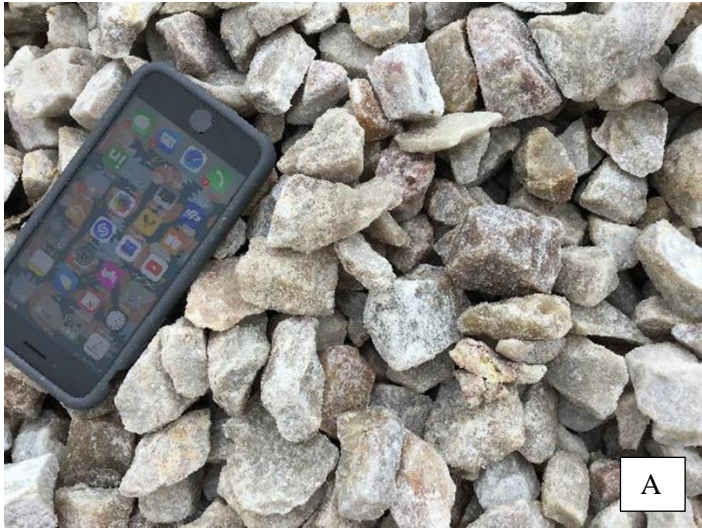
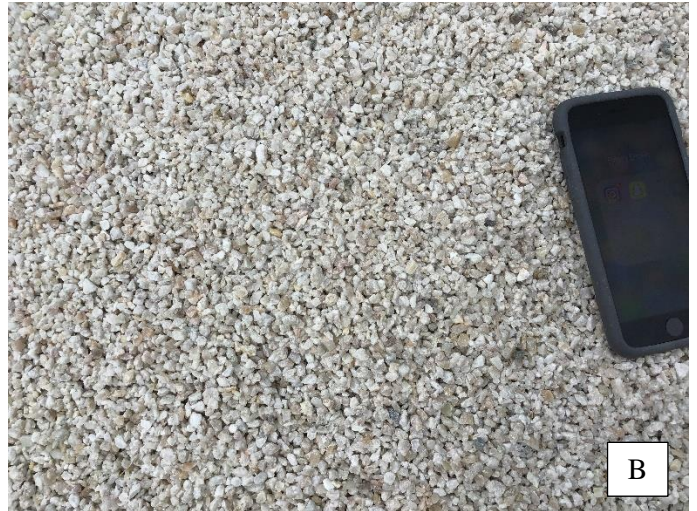
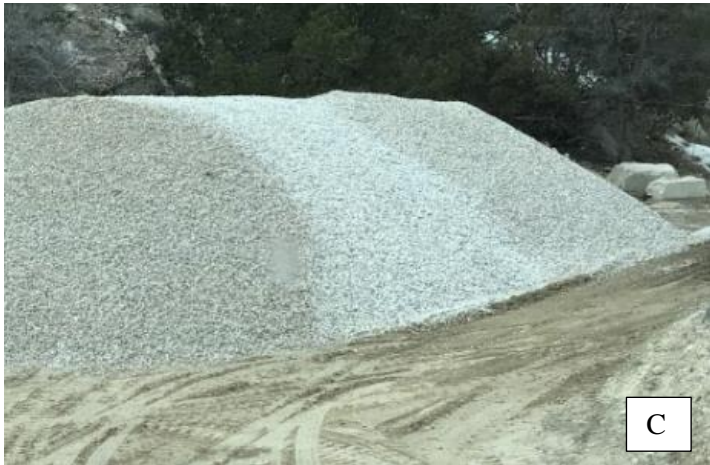
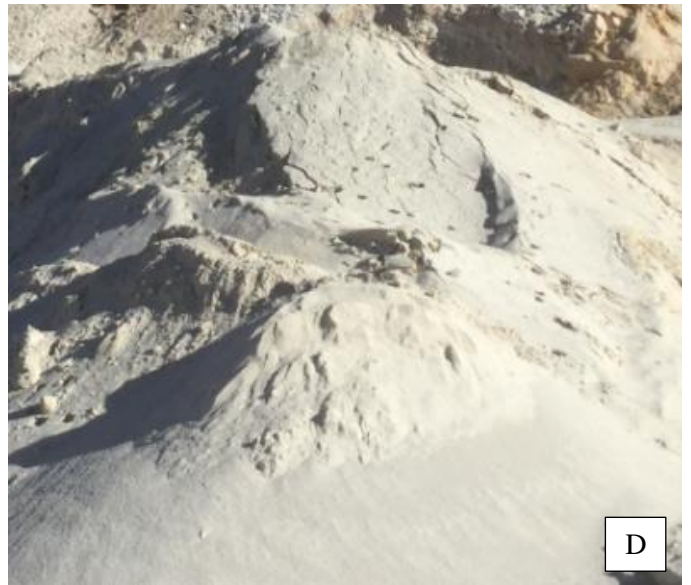
Image 19-22:

Comment: Various sized processed materials – (A) 1 ½“, (B) ¼ to ⅛”, (C) roadbase ¾“and (D) fines stockpiles.

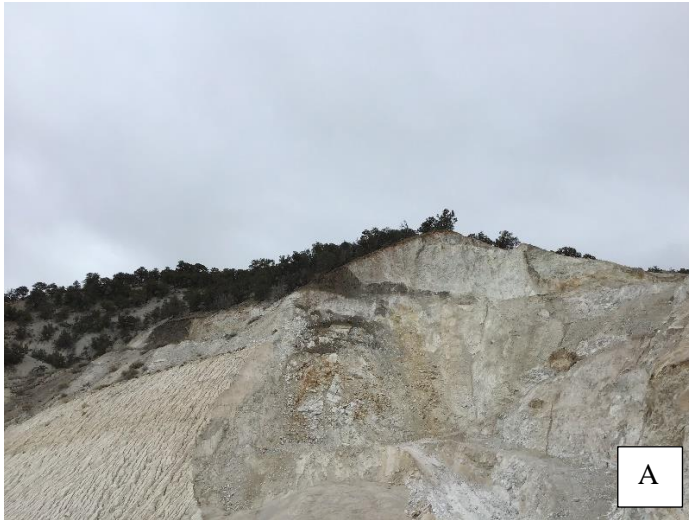
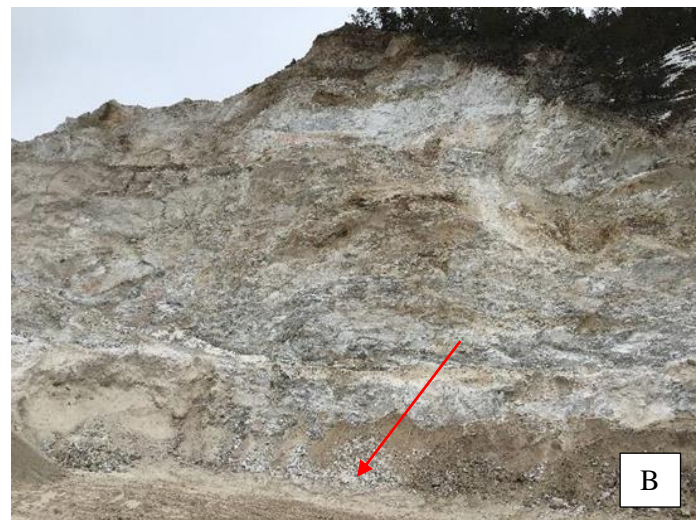
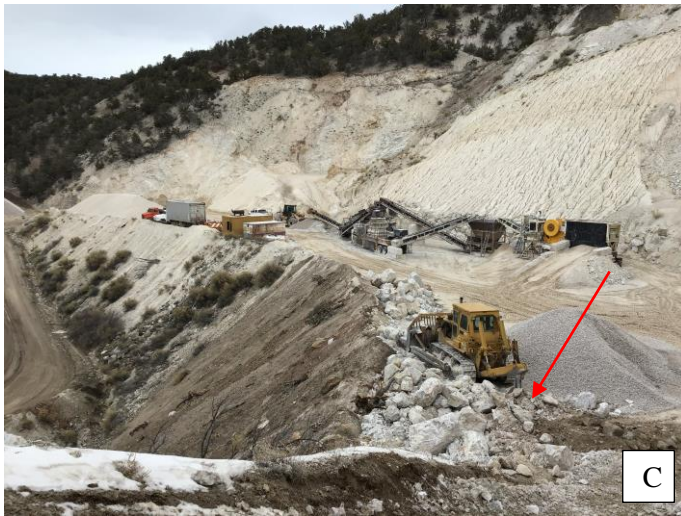
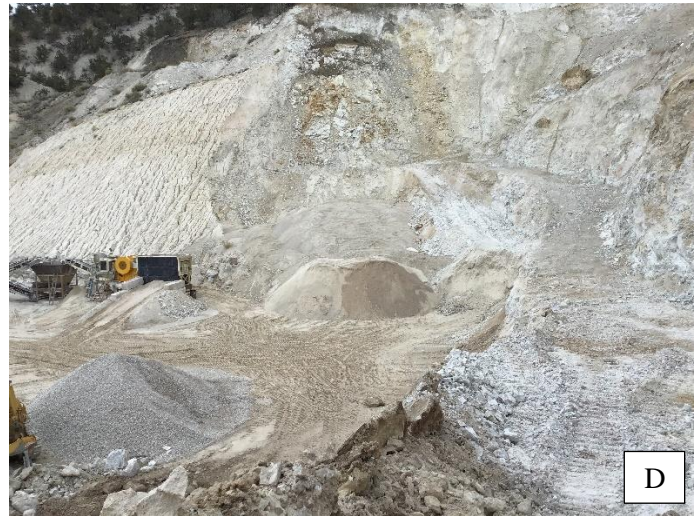
Image 23-26:

Comment: Active highwall – highwall appears to be stable given the type of geologic material. The highwall has been re-enforced with large boulders to prevent sloughing (image C). Multiple benches are in place to access various sections of the highwall. A new bench along the northern face is currently being constructed (image B).

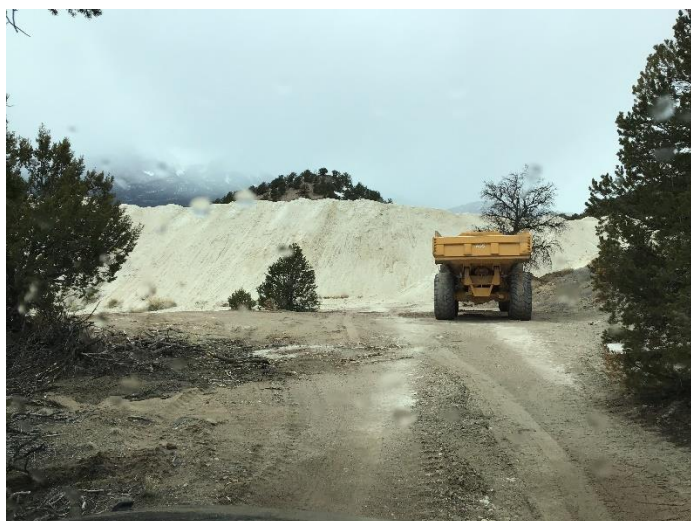
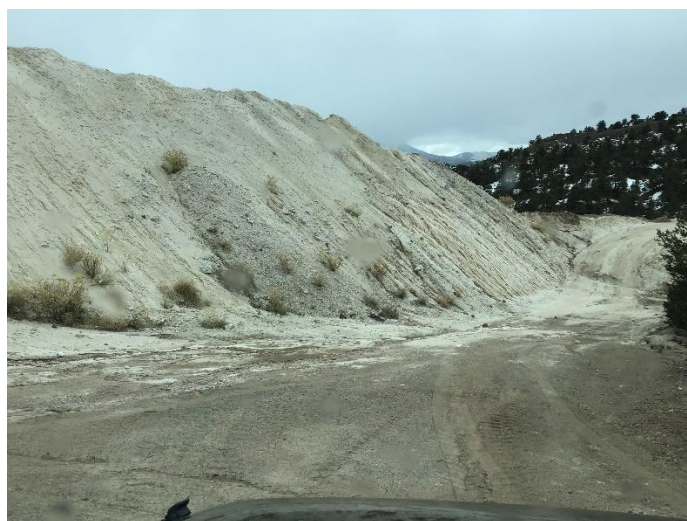
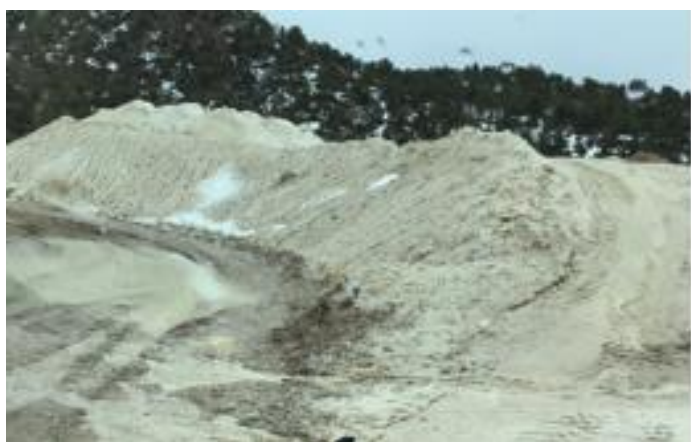
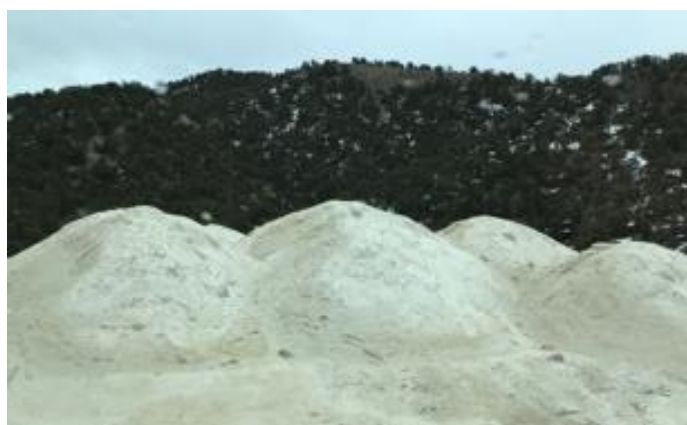
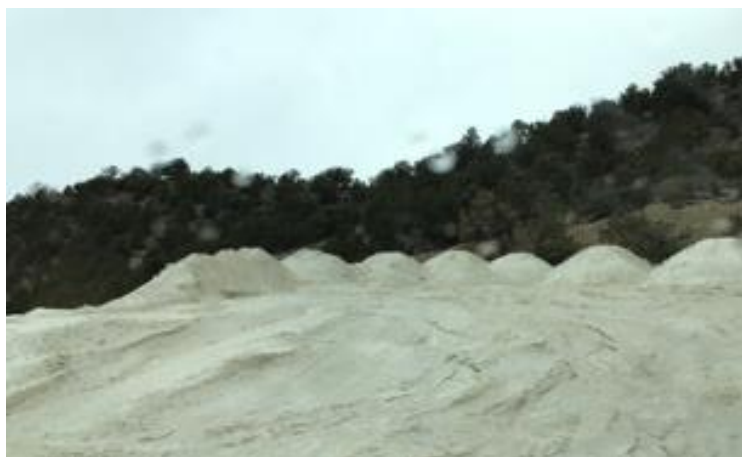
Image 27-32:

Comment: Lower staging area for all fines material. All fines are stockpiled for later use during final reclamation. Stockpiles have adequate angle of repose.
