**MINERALS PROGRAM INSPECTION REPORT**  
**PHONE: (303) 866-3567**

<b>MINE NAME:</b> San Luis Project	<b>MINE/PROSPECTING ID#:</b> M-1988-112	<b>MINERAL:</b> Gold and silver	<b>COUNTY:</b> Costilla
<b>INSPECTION TYPE:</b> Monitoring	<b>INSPECTOR(S):</b> Lucas West	<b>INSP. DATE:</b> October 14, 2019	<b>INSP. TIME:</b> 11:40
<b>OPERATOR:</b> Battle Mountain Resources, Inc.	<b>OPERATOR REPRESENTATIVE:</b> Julio Madrid, Steve Carino	<b>TYPE OF OPERATION:</b> 112d-3 - Designated Mining Operation	
<b>REASON FOR INSPECTION:</b> Normal I&E Program	<b>BOND CALCULATION TYPE:</b> None	<b>BOND AMOUNT:</b> \$7,400,000.00	
<b>DATE OF COMPLAINT:</b> NA	<b>POST INSP. CONTACTS:</b> None	<b>JOINT INSP. AGENCY:</b> None	
<b>WEATHER:</b> Clear	<b>INSPECTOR'S SIGNATURE:</b>

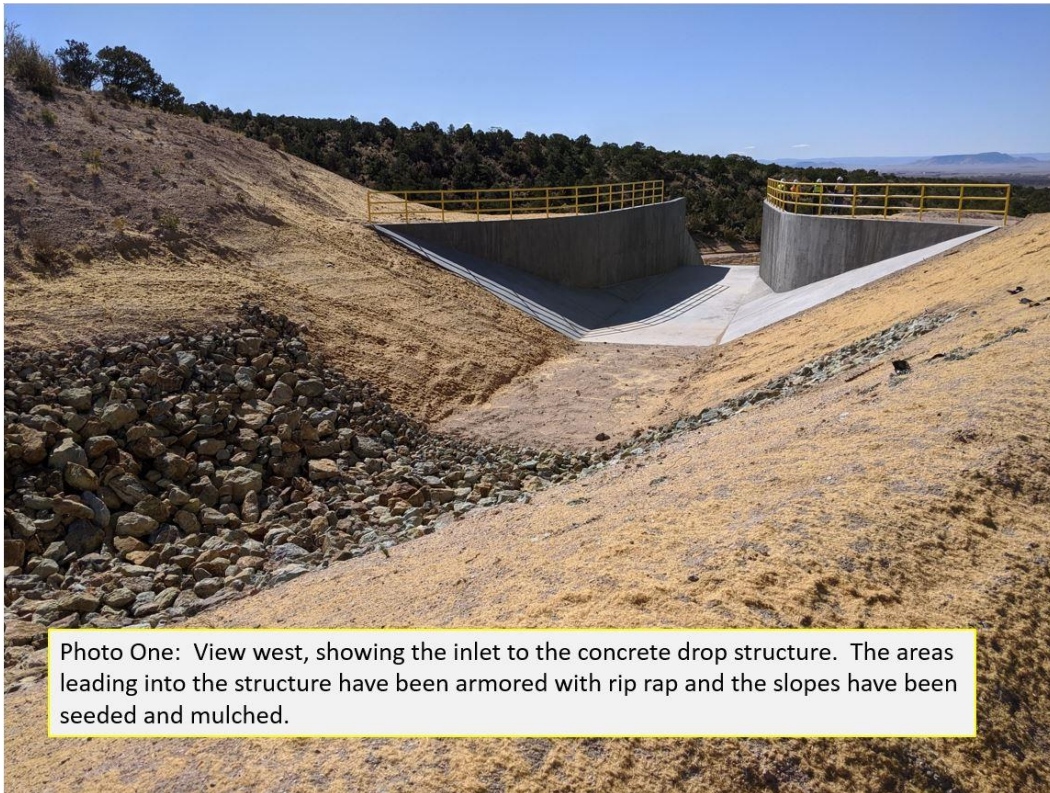
The main focus of this inspection was to observe the completed concrete drop structure adjacent to the tailings dam. The spillway can be seen in Photos One through Three. The construction of the spillway is now 100% complete. All final grading and seeding of the fringe areas have been completed. Small amounts of growth in the revegetated areas were observed. The inlet and outlet areas have all been lined with rip rap to prevent erosion. All poured concrete areas are in excellent condition. The emergency overflow structure was observed and has been completed. In the Arroyo, downstream of the spillway, all culverts have been upgraded, lined with rip rap and seeded. All culverts observed are in excellent condition. The drop structure, its out slopes, inlet structure, outlet structure and downstream culverts have all been completed as designed in Technical Revision 34. The only remaining item to close out the file will be submitting the Certified As Built Reports for the construction of the structure.

Photo One: View west, showing the inlet to the concrete drop structure. The areas leading into the structure have been armored with rip rap and the slopes have been seeded and mulched.

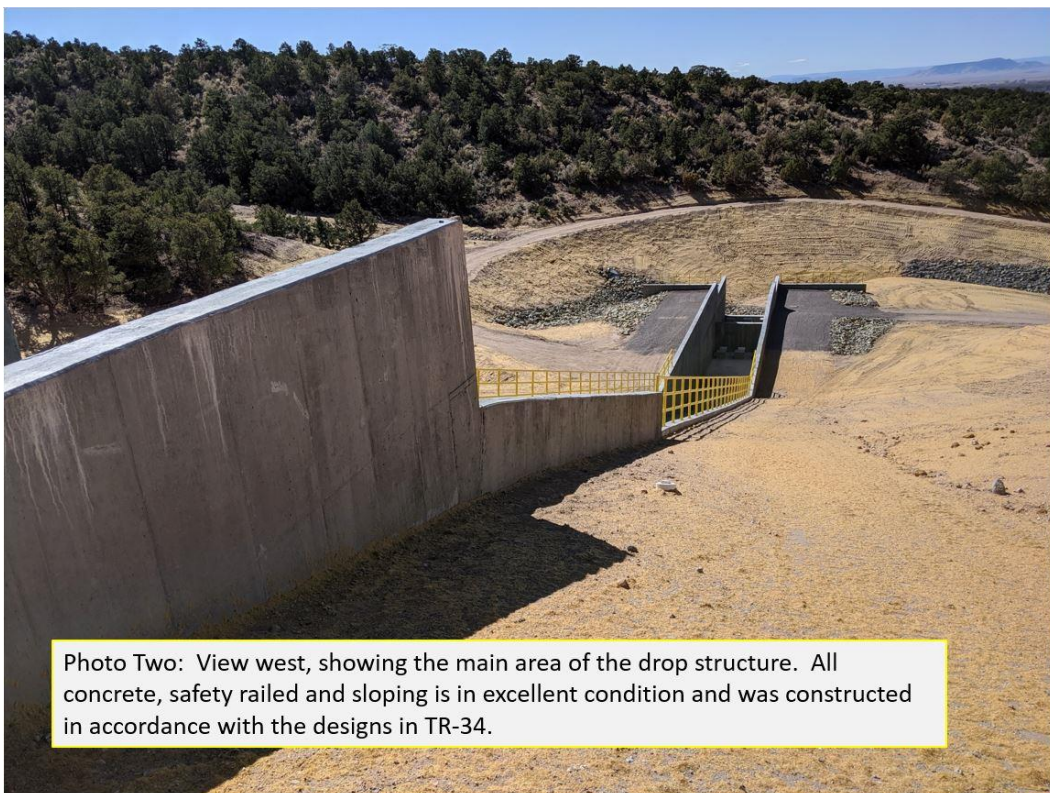
Photo Two: View west, showing the main area of the drop structure. All concrete, safety railed and sloping is in excellent condition and was constructed in accordance with the designs in TR-34.

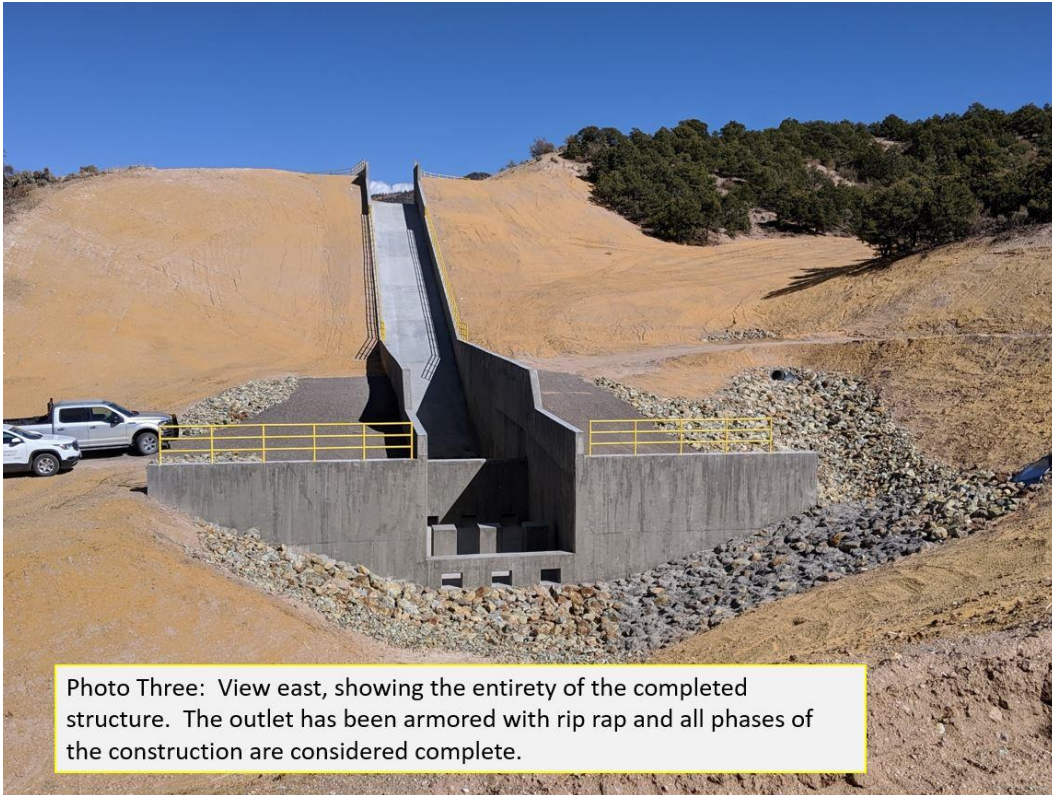
Photo Three: View east, showing the entirety of the completed structure. The outlet has been armored with rip rap and all phases of the construction are considered complete.

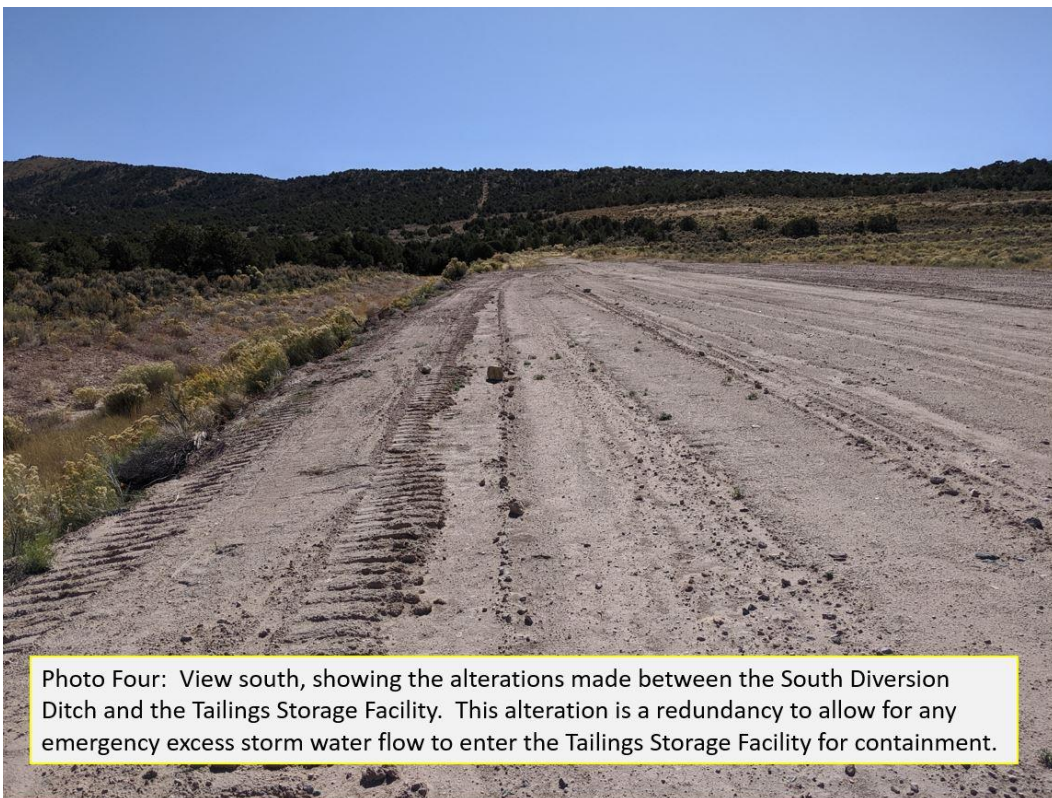
In addition to the concrete drop structure the alteration to the South Diversion Ditch was completed as approved through Technical Revision 34. The alteration was done to lower the road and its associated berm between the South Diversion Ditch and the Tailings Storage Facility to allow excessive storm water flows to overflow into the Tailings Storage Facility for containment. All grading and earthwork has been completed and so signs of settling slumping or erosion was observed. The out slopes leading into the Tailings Storage Facility and into the South Diversion Ditch have been seeded with the reclamation seed mix. No growth was observed as the seeding was recently completed. Photos Four and Five show the overflow area. In addition to the as built designs for the drop structure, the final constructed designs for the overflow area need to be submitted to the Division in accordance with TR-34.

Photo Four: View south, showing the alterations made between the South Diversion Ditch and the Tailings Storage Facility. This alteration is a redundancy to allow for any emergency excess storm water flow to enter the Tailings Storage Facility for containment.

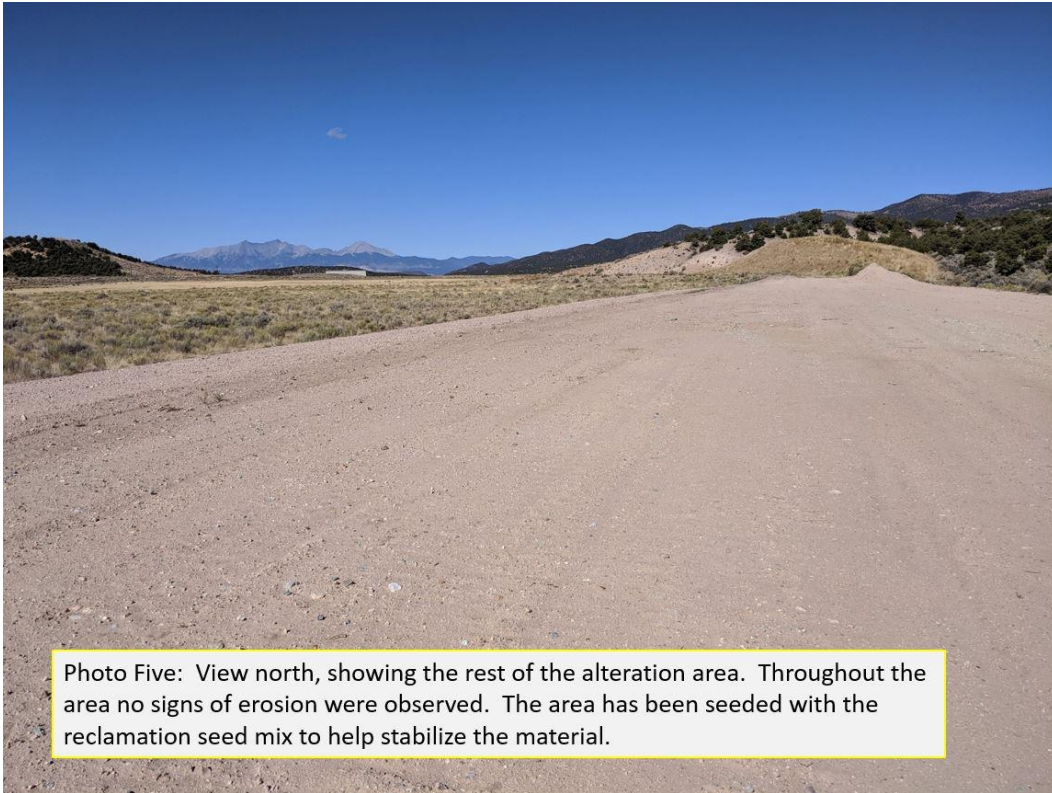
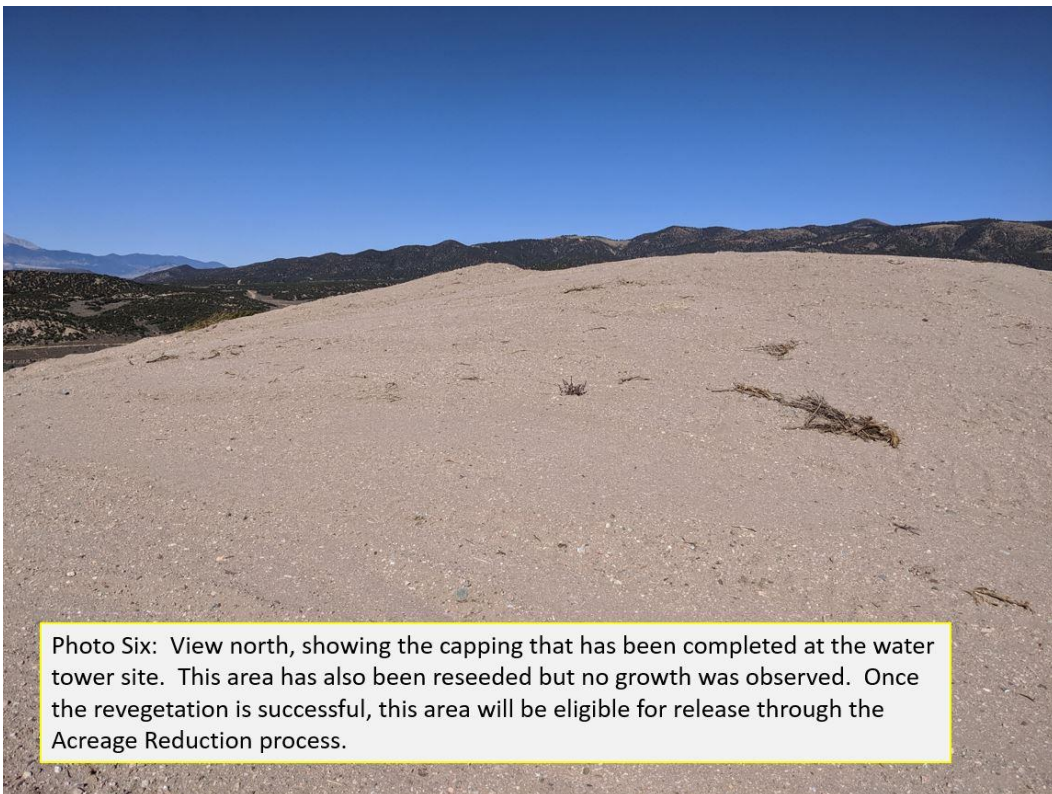
Final reclamation of certain areas have also been completed and inspected. These areas include the old water tower site, mill area and the West Pit. The old water tower site has been adequately capped and seeded. No evidence of settling slumping or erosion was observed and small berms have been installed to control erosion. The water tower site can be seen in Photo Six. Adjacent to the water tower is the mill area. Reclamation of this area was completed some time ago. The area seen in Photo Seven, was stable at the time of the inspection and has excellent vegetative growth. The vegetative cover is dense, diverse and shows signs of self-regeneration. No evidence that the mill ever existed was observed. Final reclamation of this area is considered complete at this time and could be released through the Acreage Reduction process.

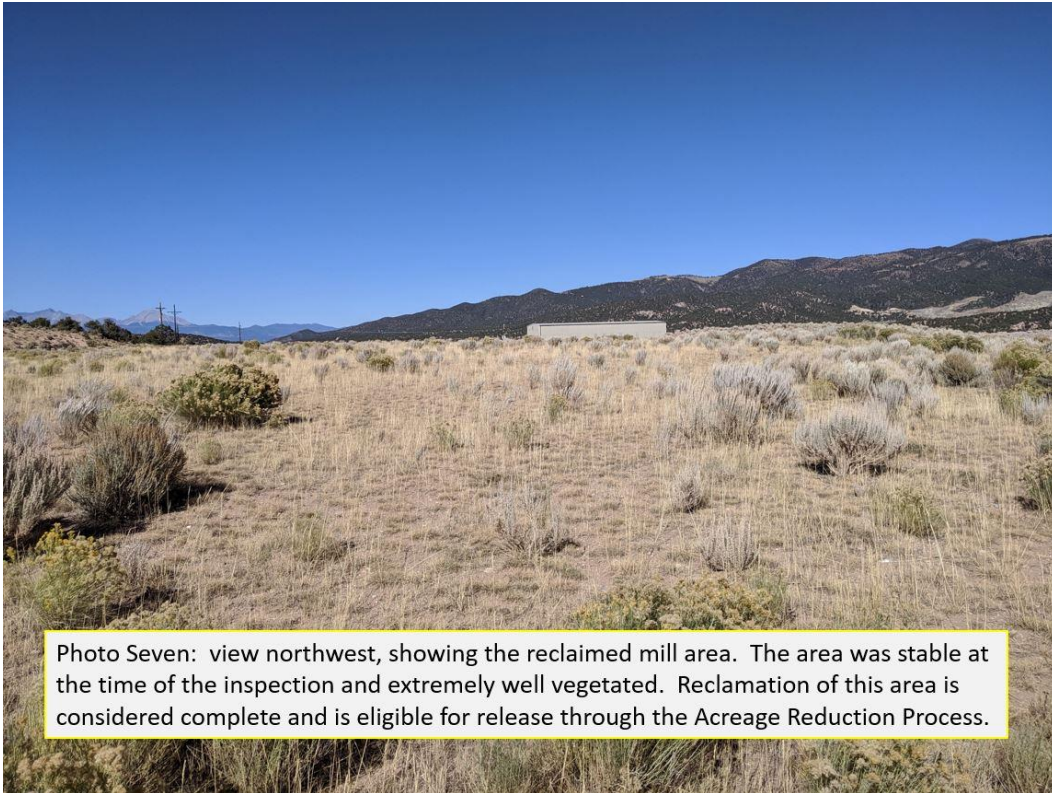
Photo Seven: view northwest, showing the reclaimed mill area. The area was stable at the time of the inspection and extremely well vegetated. Reclamation of this area is considered complete and is eligible for release through the Acreage Reduction Process.

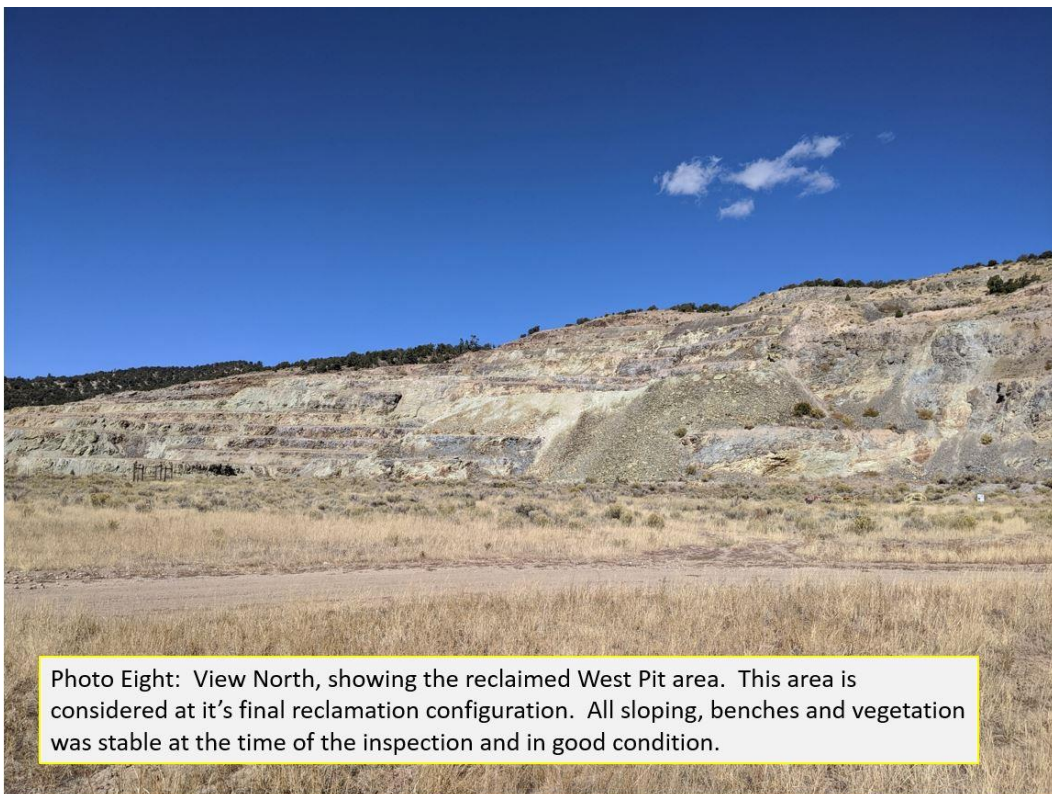
The area of the West Pit was also inspected for its final reclamation configuration. The West Pit, seen in Photo Eight, was contemporaneously reclaimed at the time of mining. The approved reclamation allows for benching, adding topsoil, and revegetation of the bench areas. Talus sloping was also approved to be placed throughout the reclaimed benches to allow for wildlife access. The benches and sloping was stable at the time of the inspection and in good condition. The areas where topsoil has been replaced and revegetation was completed were also in good condition. The West Pit has been reclaimed in accordance with the approved Reclamation Plan and at this time is considered at its final reclamation configuration. This area is not eligible for release through the Acreage Reduction because of the current water management operations being conducted on site. Discussions with the Operator indicate that an alternative solution to water management operations is being discussed and could be perused. Any changes to the water management and treatment systems will be addressed through the Amendment Process.

Photo Eight: View North, showing the reclaimed West Pit area. This area is considered at it's final reclamation configuration. All sloping, benches and vegetation was stable at the time of the inspection and in good condition.
