MINERALS PROGRAM INSPECTION REPORT
PHONE: (303) 866-3567

MINE NAME: Gillette Pit	MINE/PROSPECTING ID#: M-1992-009	MINERAL: Gravel	COUNTY: Teller
INSPECTION TYPE: Monitoring	INSPECTOR(S): Elliott Russell	INSP. DATE: October 16, 2019	INSP. TIME: 15:00
OPERATOR: Gillette Sand and Gravel, Inc.	OPERATOR REPRESENTATIVE: Chris Pyles	TYPE OF OPERATION: 112c - Construction Regular Operation	
REASON FOR INSPECTION: Priority	BOND CALCULATION TYPE: CDPHE, DWR, CPW	BOND AMOUNT: \$37,613.00	
DATE OF COMPLAINT: NA	POST INSP. CONTACTS: None	JOINT INSP. AGENCY: None	
WEATHER: Clear	INSPECTOR'S SIGNATURE:

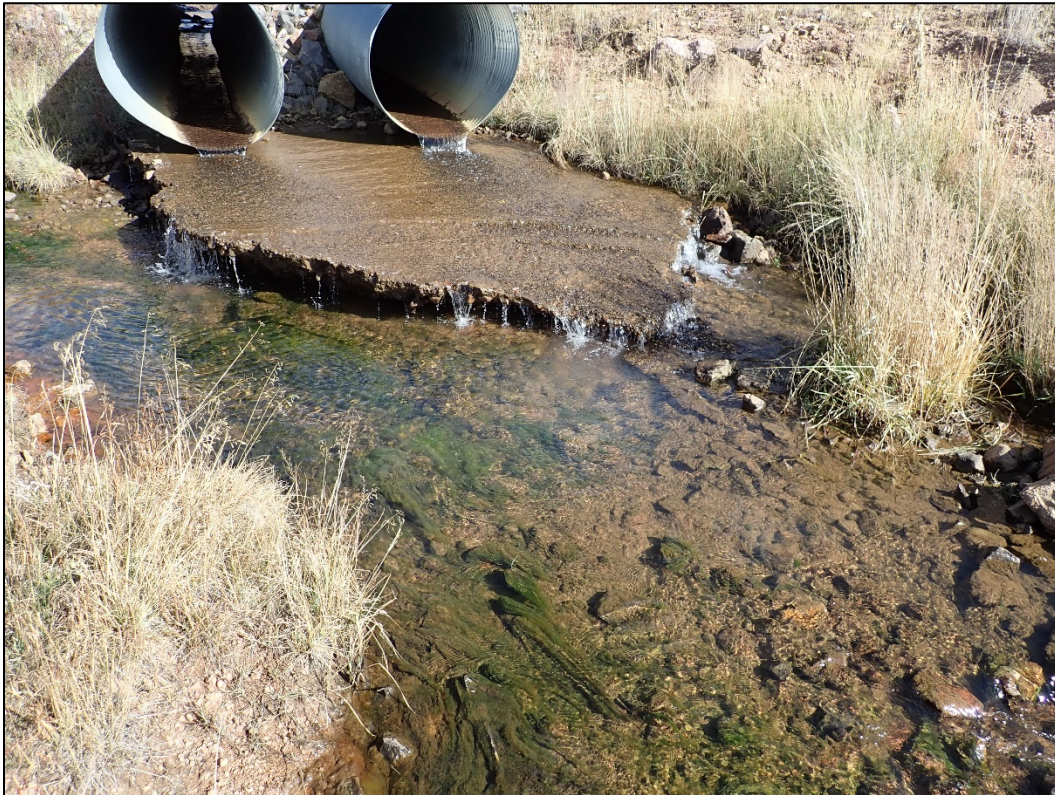
The Division met Chris Pyles at the mine site entrance located 900 feet east of County Road 81, approximately ¼ mile south of State Highway 67. Near the turn off to the site, Beaver Creek flows through a culvert under CR 81. The Division observed that the milky discoloration previously observed in Beaver Creek on October 4, 2019 was no longer present. The Division inspected Beaver Creek from CR 81 up to the site and observed clear water and numerous brook trout.

Photo 1. Downstream side of CR 81 culvert; looking east.

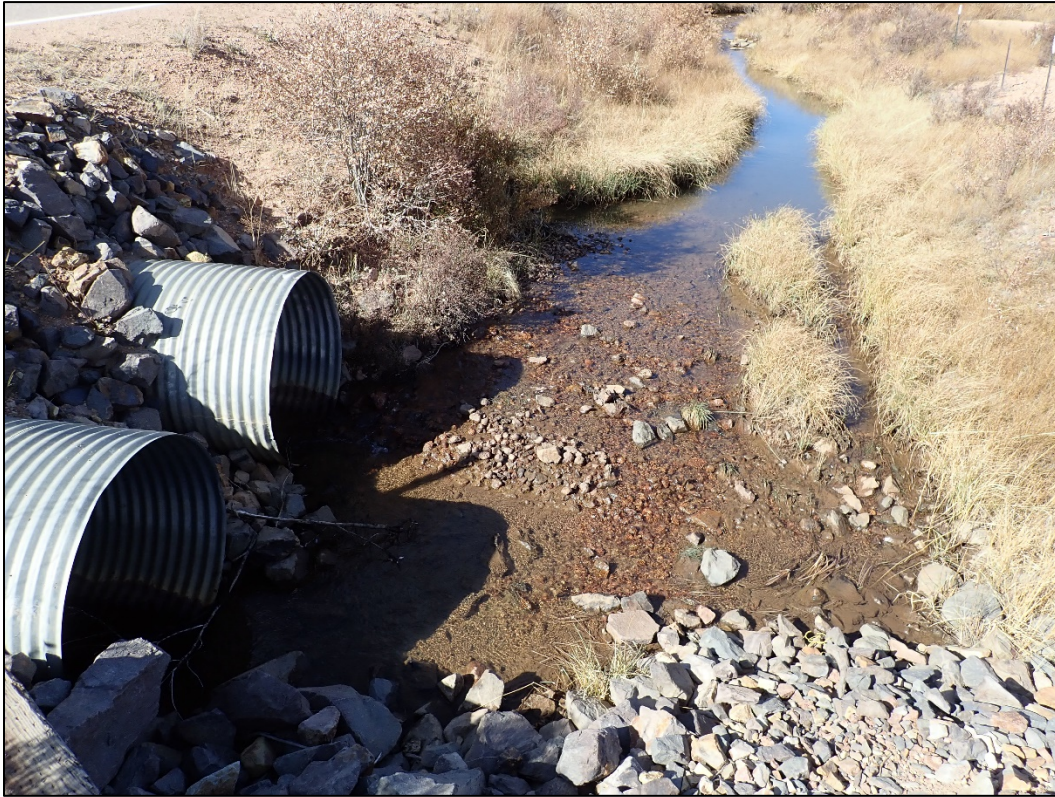
Photo 2. Upstream side of CR 81 culvert; looking north.

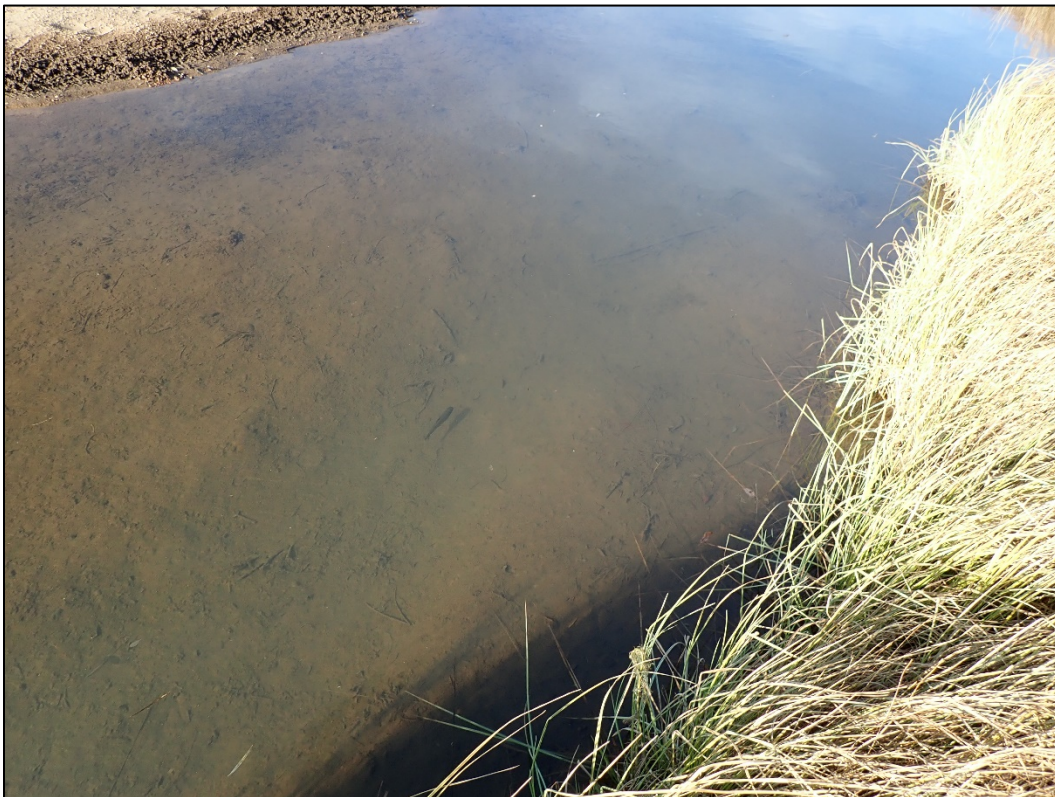
Photo 3. Brook trout and clear water in Beaver Creek downstream of site; looking northwest.

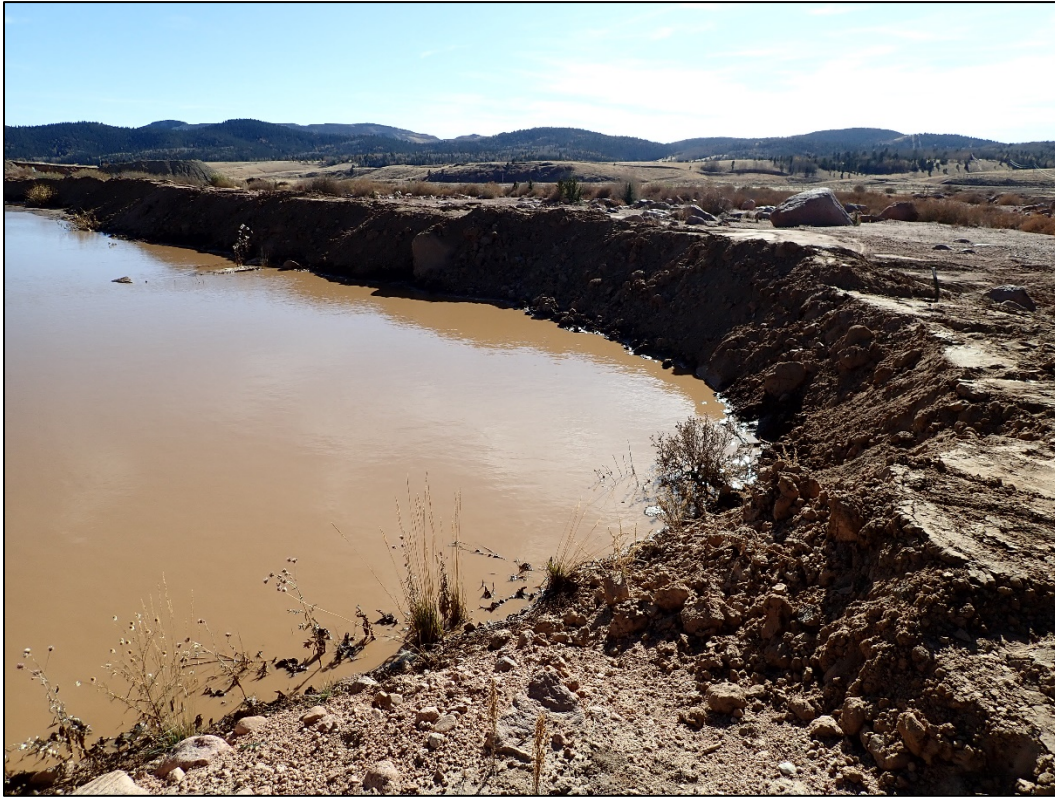
Mr. Pyles showed the Division the work that was done to the process pond embankment prior to receiving the Cease and Desist Order. The embankment has been reinforced and is now higher than the water level. The lowest point in the embankment where water had left the ponds during the October 3, 2019 event has been backfilled and raised. The Operator stated that he wants to eventually make the embankment wider so that an excavator can drive down it to clean out the sediment fines. The embankment will likely need to be wrapped around the northern side of the northern process pond, however, the Operator stated he will likely backfill and abandon the northern portion of the northern pond to create a larger buffer from Beaver Creek. The revisions to the process ponds, including but not limited to location, size, capacity, and sediment handling, will need to be proposed and discussed in further detail in the forthcoming revision to the permit.

Photo 4. Raised embankment in northwest corner of northern process pond; looking southeast.

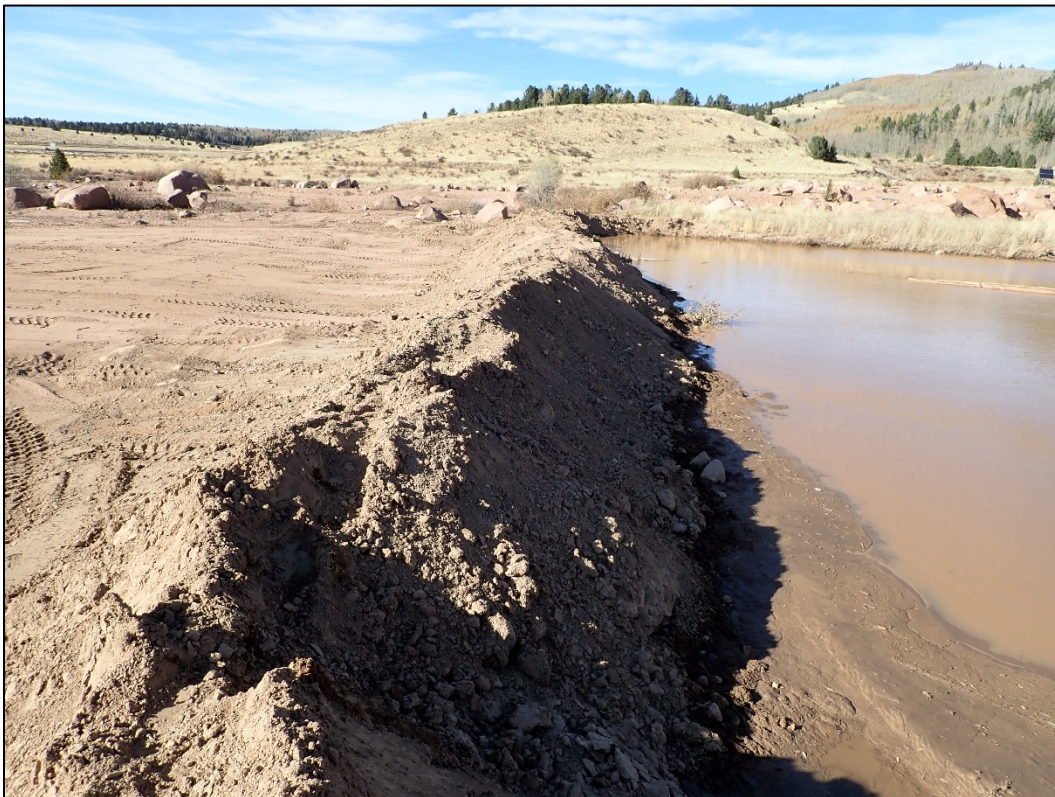
Photo 5. Raised embankment along western side of the northern process pond; looking north.

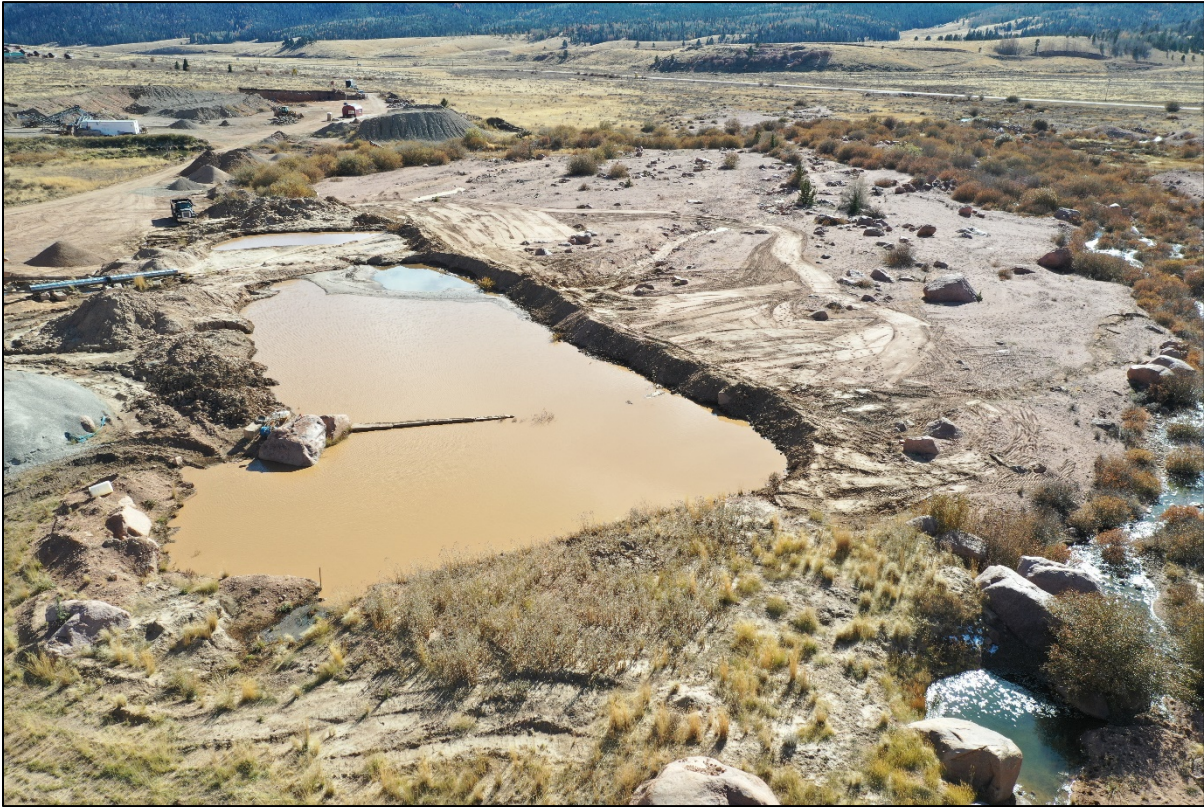
Photo 6. Aerial overview of process ponds; looking southwest.

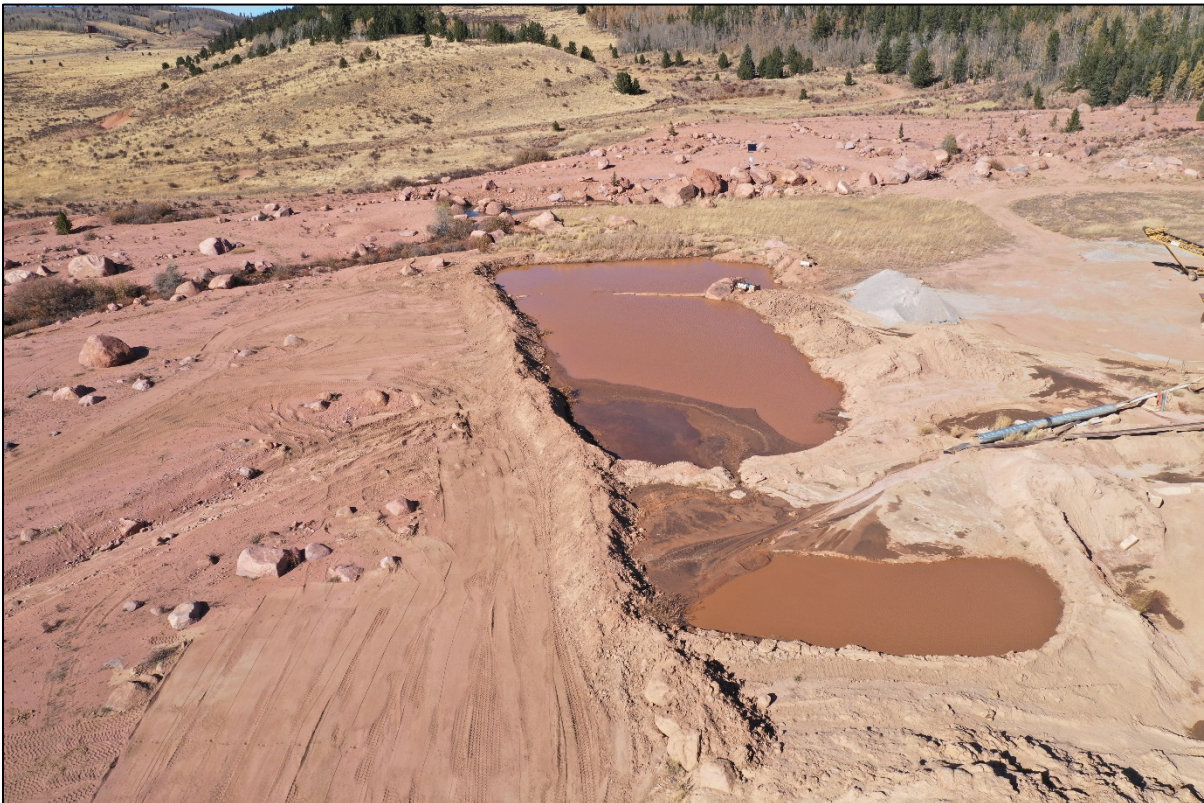
Photo 7. Aerial overview of process ponds; looking north.

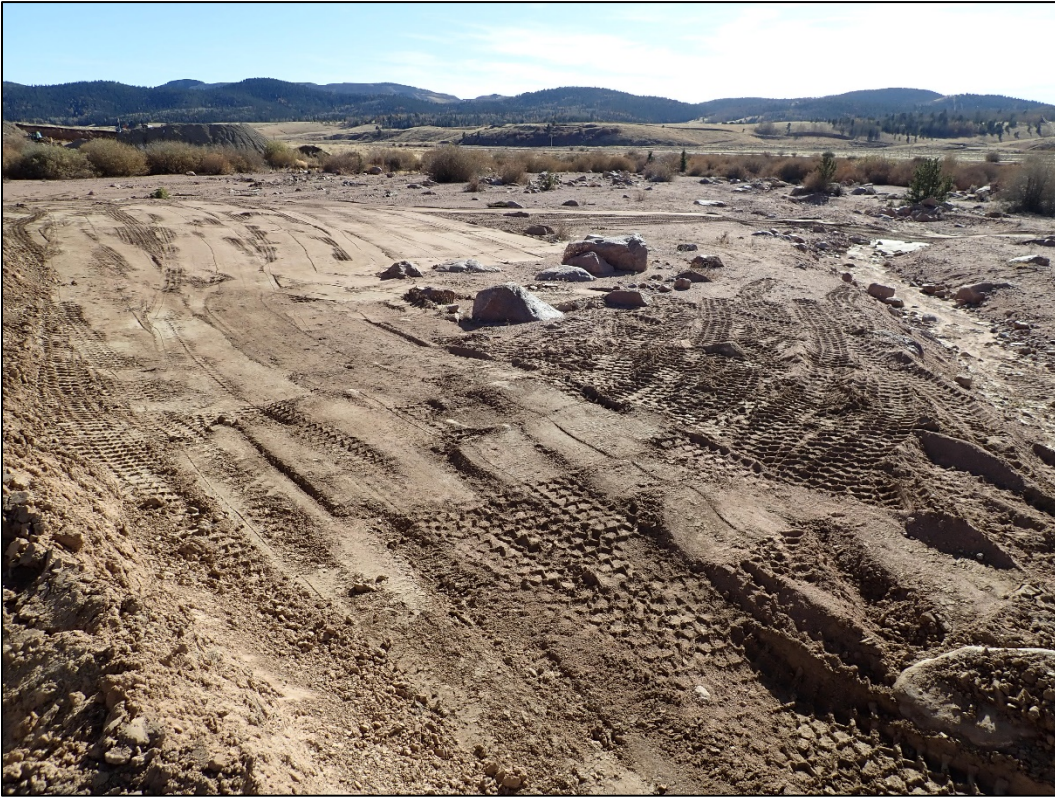
Photo 8. Graded off-site disturbance area to the west of the permit boundary; looking southwest.

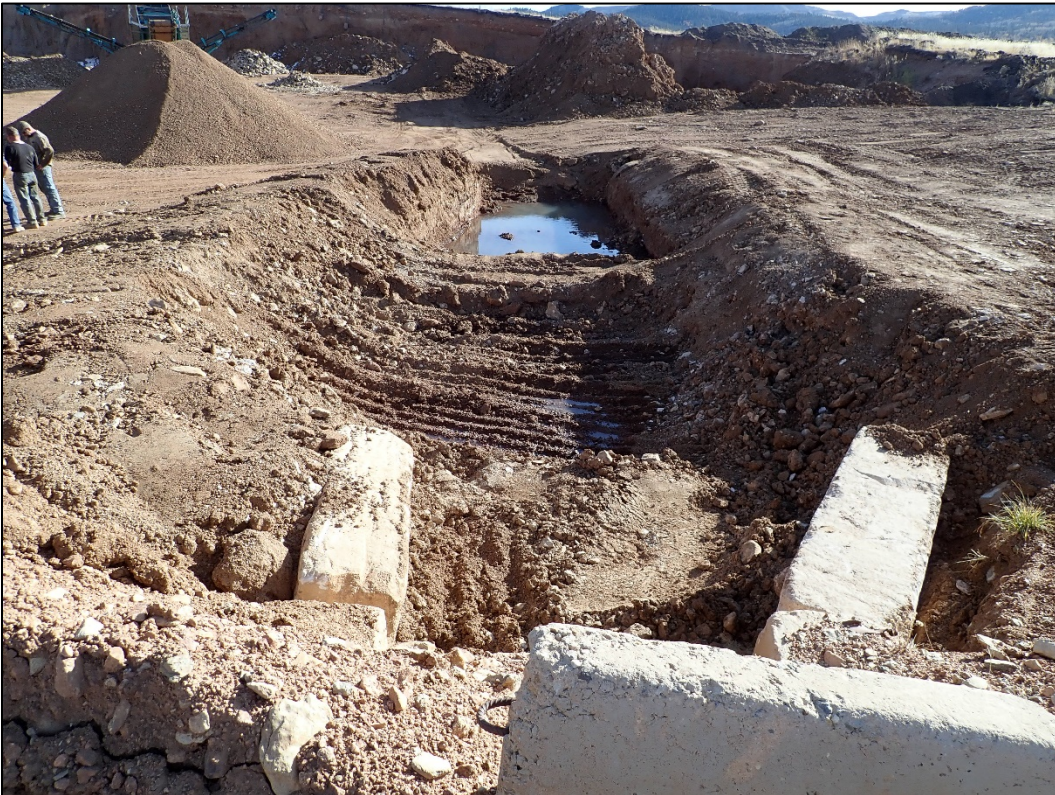
The Division also observed several stormwater control measures which have been installed since the October 4, 2019 inspection. The Operator had created a berm along the western edge of a large crusher fines stockpile located north of the scale house. The Operator was also installing a two-stage detention basin in the southern pit before the culvert which leads the Wetlands Area. The Operator stated they would purchase straw or hay bales and utilize them as sediment check dams.

Photo 9. Storm water detention basins being constructed in the Southern Pit; looking south.

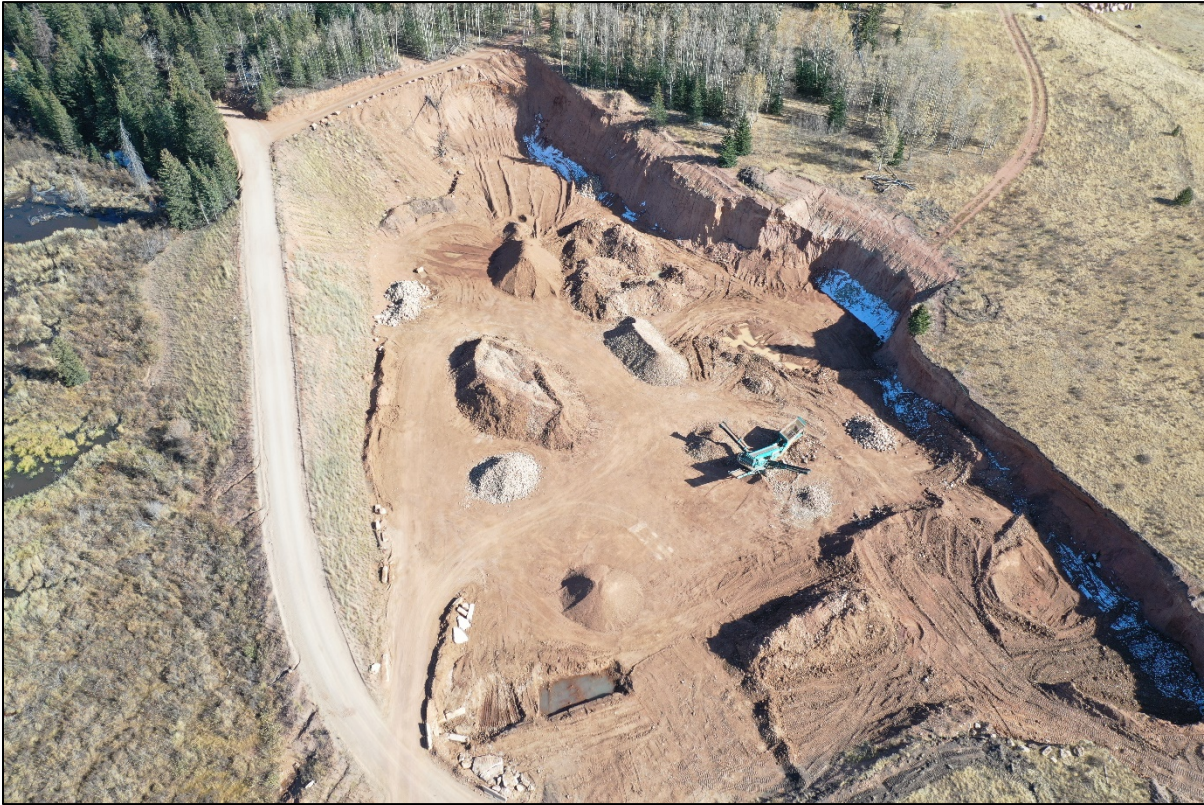
Photo 10. Aerial overview of Southern Pit; looking southeast.

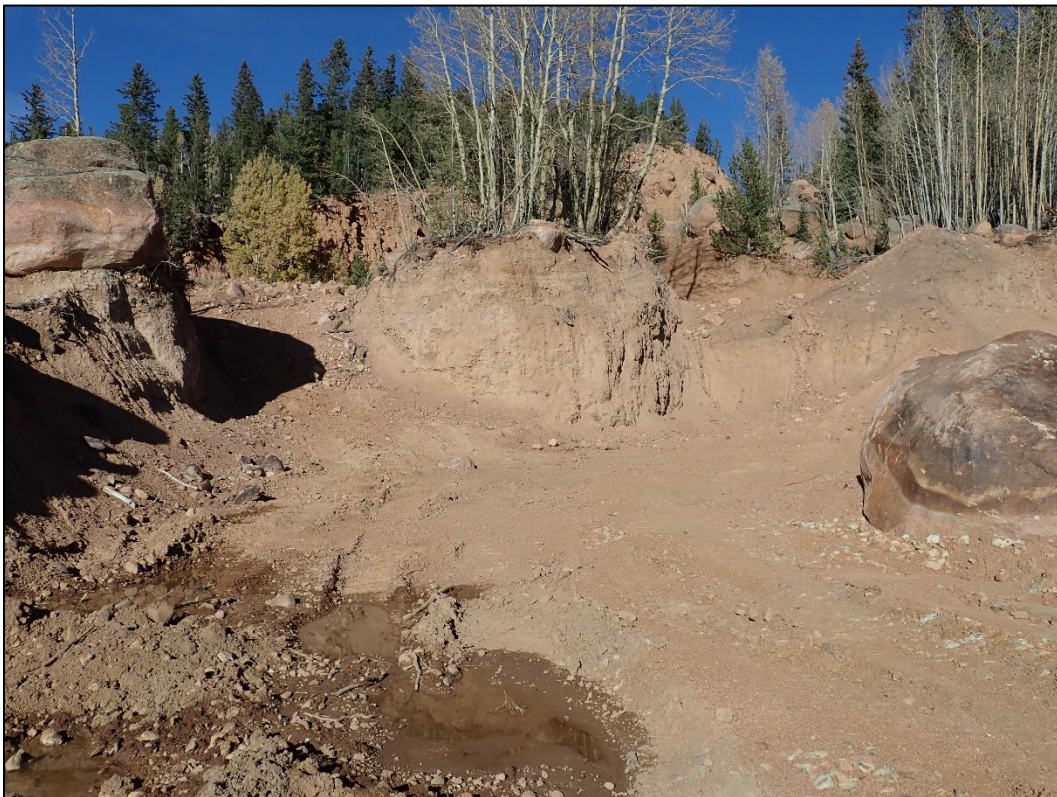
Photo 11. Northern highwall in the Northern Pit which operator is requesting to reclaim; looking northwest.

The Operator also showed the Division two areas which he would like to reclaim while working on permitting to bring the site back into compliance. The first area is the northern highwall of the Northern Pit and the second area is the eastern highwall of the Southern Pit. The Division stated this could be proposed under a request to partially lift the Cease and Desist Order. After the inspection, the Division received a formal request from the Operator to lift portions of the Cease and Desist Order to continue working on corrective actions, reclaim the areas discussed during the inspection, and to allow the haulage of already stockpile product, but to keep excavation and processing of material shut-down until further notice and the site is back in compliance. The Division approved this request on October 18, 2019.

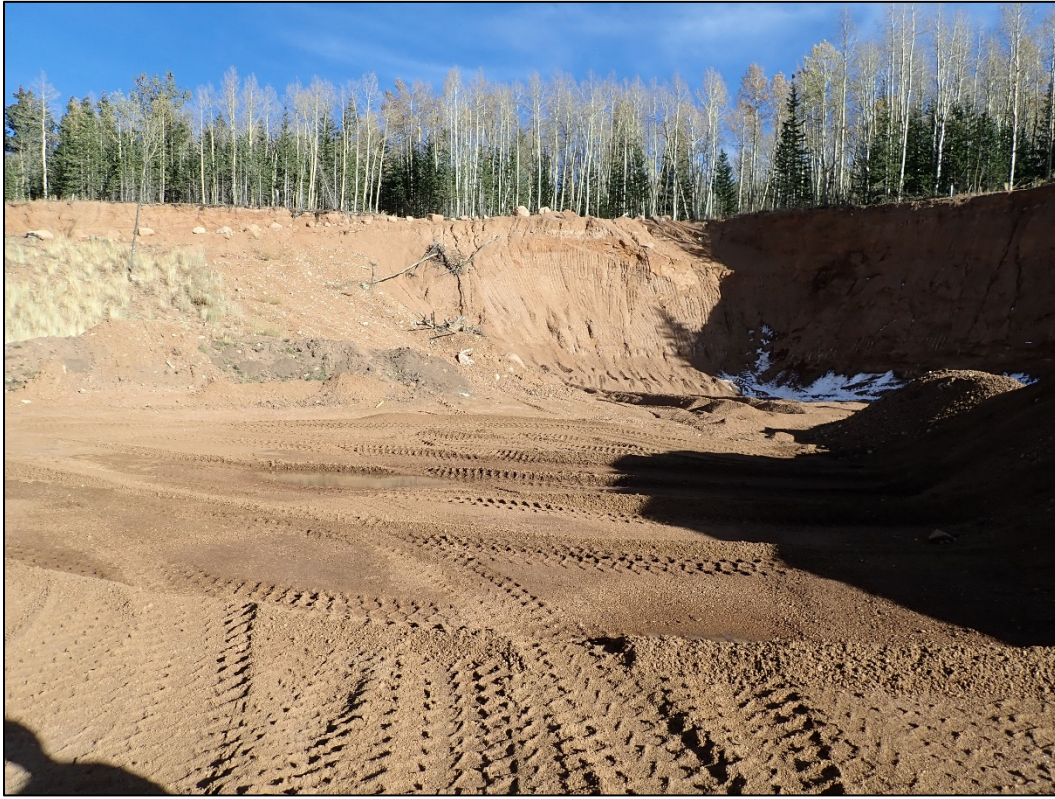
Photo 12. Eastern highwall in the Southern Pit which operator is requesting to reclaim; looking east.
