MINERALS PROGRAM INSPECTION REPORT
PHONE: (303) 866-3567

MINE NAME: Geroux Gravel	MINE/PROSPECTING ID#: M-2000-059	MINERAL: Sand and gravel and borrow material for construction	COUNTY: Custer
INSPECTION TYPE: Monitoring	INSPECTOR(S): Timothy Cazier	INSP. DATE: June 18, 2019	INSP. TIME: 16:15
OPERATOR: Geroux Gravel	OPERATOR REPRESENTATIVE: Andy & Becky Kagan	TYPE OF OPERATION: 110c - Construction Limited Impact	
REASON FOR INSPECTION: Normal I&E Program	BOND CALCULATION TYPE:	BOND AMOUNT: \$24,500.00	
DATE OF COMPLAINT: NA	POST INSP. CONTACTS: None	JOINT INSP. AGENCY: None	
WEATHER: Cloudy	INSPECTOR'S SIGNATURE:

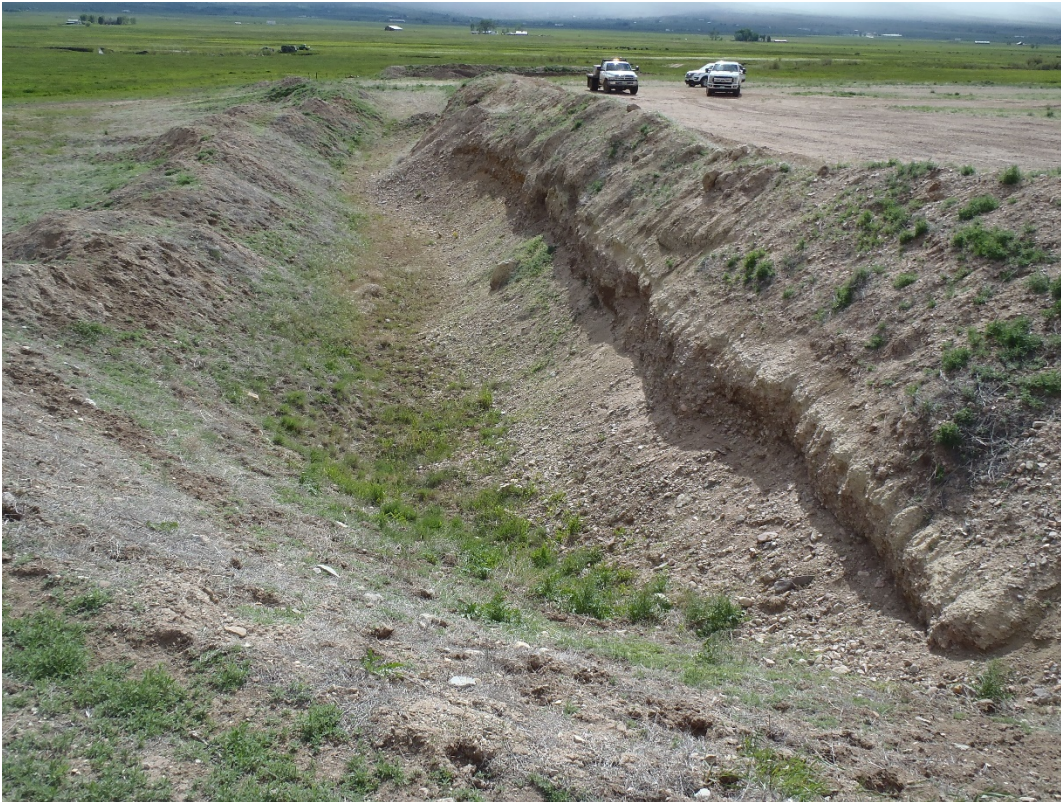
Backfilling and Grading: Sufficient backfill material appeared to be available for the open trench (see **Photo 1**). Other disturbed areas appeared to be near the required 3H:1V final slopes (see **Photo 2**).

Gen. Compliance with Mine Plan: The operation appeared to be in compliance with the approved mine plan. The maximum allowed disturbed area is 8.9 acres. Google Earth was used to measure the disturbed area, which was estimated to be approximately 6.6 acres, based on 2016 imagery. The aforementioned trench was estimated to be between 6 and 8 feet deep and appeared stable (see **Photo 1**).

Topsoil: Topsoil had been stripped from the trench and stockpiled on the south side of the trench (see **Photo 1**).

Photo 1. Active trench – topsoil on left, overburden on right (looking west).

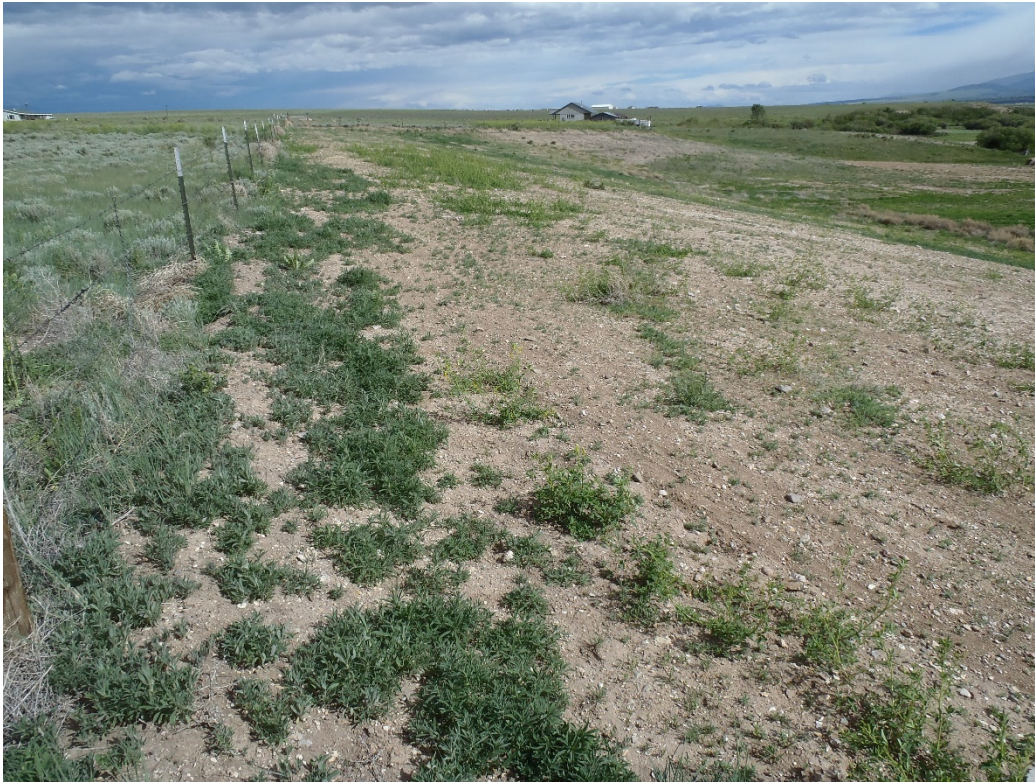
Signs and Markers: The permit sign was properly posted (see **Photo 5**) and the permit boundary is completely fenced (see **Photo 2**). Each fence corner post location was collected using a handheld Trimble Juno 3B GPS unit. Locations are shown on the attached **Post Inspection Map**.

Photo 2. Graded highwalls on south end of permit area & typical boundary fence (looking south).

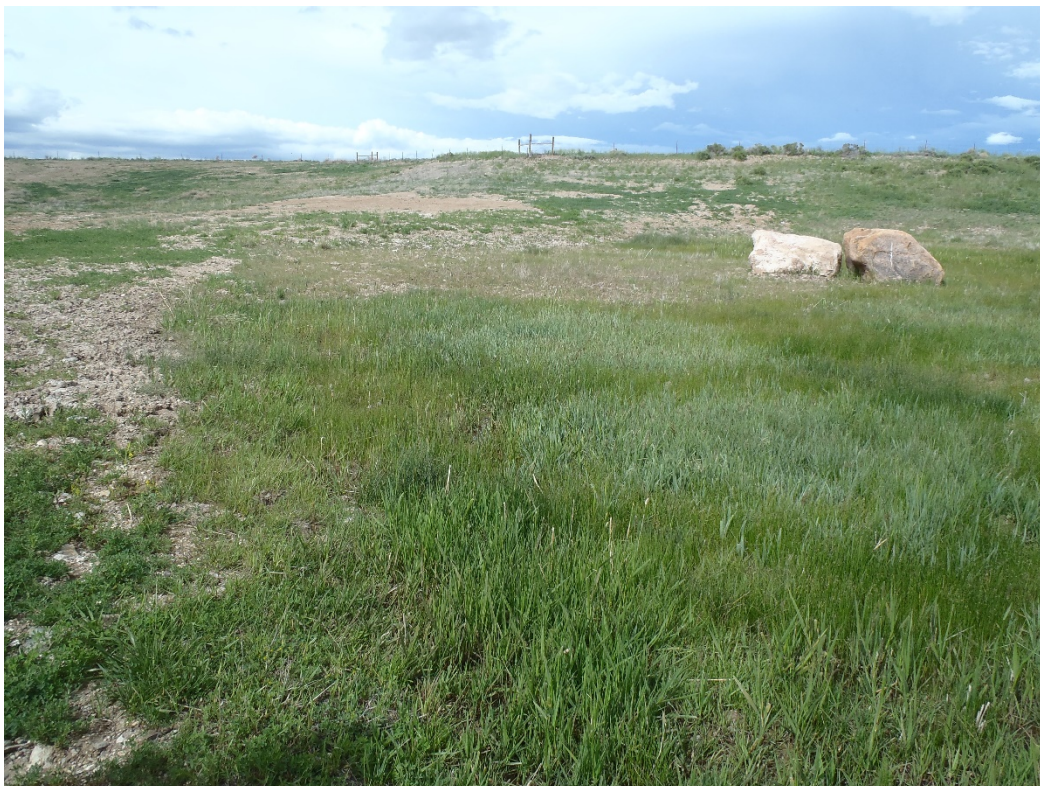
Hydrologic Balance: No standing water was observed in the pit. A small seep was observed about a third of the way from the south end of the permit boundary (see attached **Post Inspection Map**). The area downgradient of the seep was well vegetated with emergent plants (see **Photo 3**), but no ponding of water was observed.

Photo 3. Well vegetated area downgradient of seep (looking east).

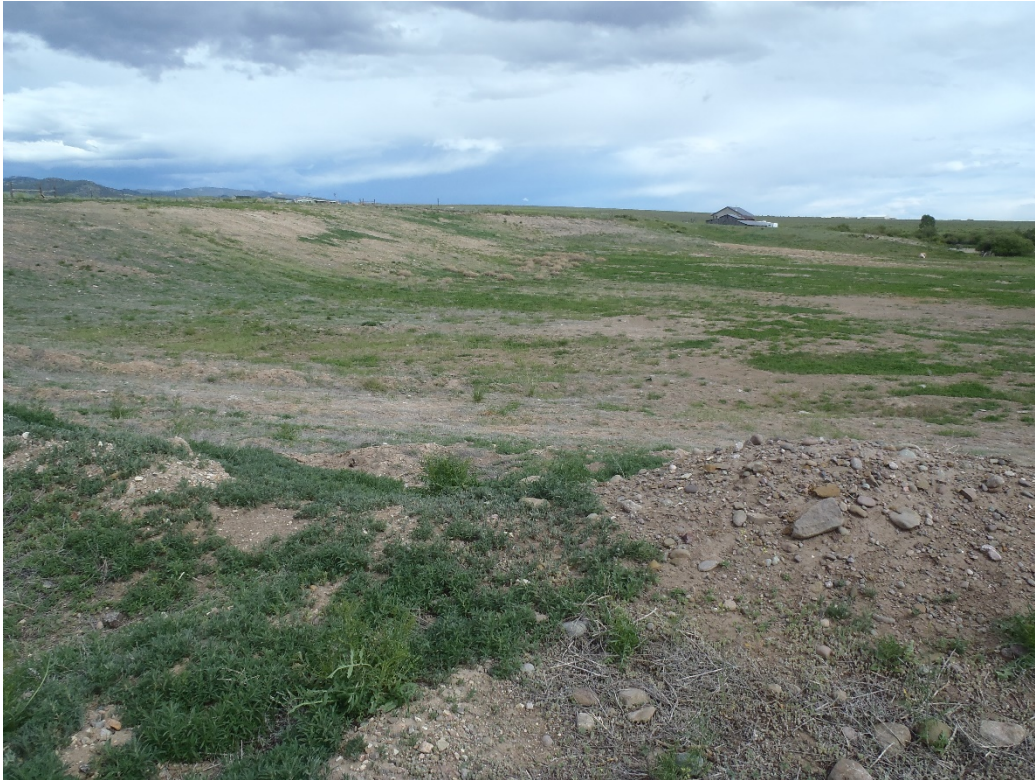
Reclamation Success: The roughly southern half of the pit is in final reclamation. The slopes had been graded to 3H:1V or flatter, topsoil replaced and seeded (see **Photo 4**).

Photo 4. Southern end of permit area – sloped and seeded (looking south).

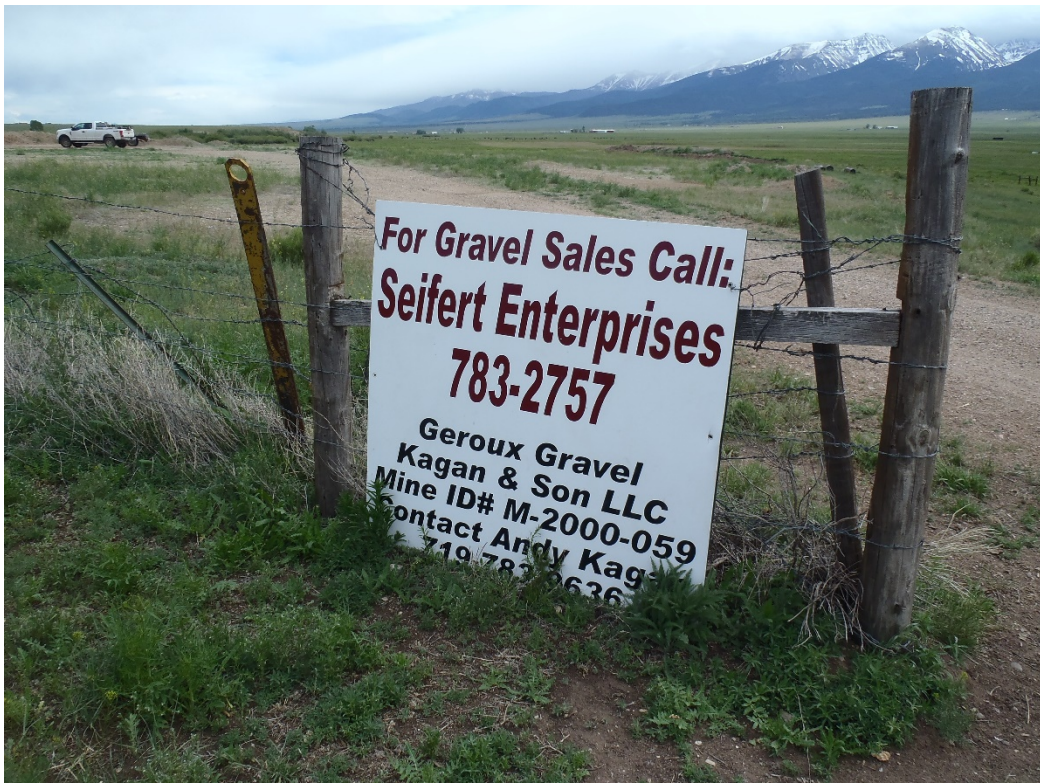
Photo 5. Permit sign.
