MINERALS PROGRAM INSPECTION REPORT

MINE NAME: Cañon Dolomite Quarry	MINE/PROSPECTING ID#: M-1977-376	MINERAL: Dolomite	COUNTY: Fremont
INSPECTION TYPE: Surety-Related Inspection	INSPECTOR(S): Timothy A. Cazier	INSP. DATE: August 6, 2019	INSP. TIME: 09:30
OPERATOR: Continental Materials Corporation	OPERATOR REPRESENTATIVE: None	TYPE OF OPERATION: 112c - Construction Regular Operation	
REASON FOR INSPECTION: Surety Related	BOND CALCULATION TYPE: Partial Bond	BOND AMOUNT: \$232,000.00	
DATE OF COMPLAINT: NA	POST INSP. CONTACTS: None	JOINT INSP. AGENCY:	
WEATHER: Clear	INSPECTOR'S SIGNATURE:

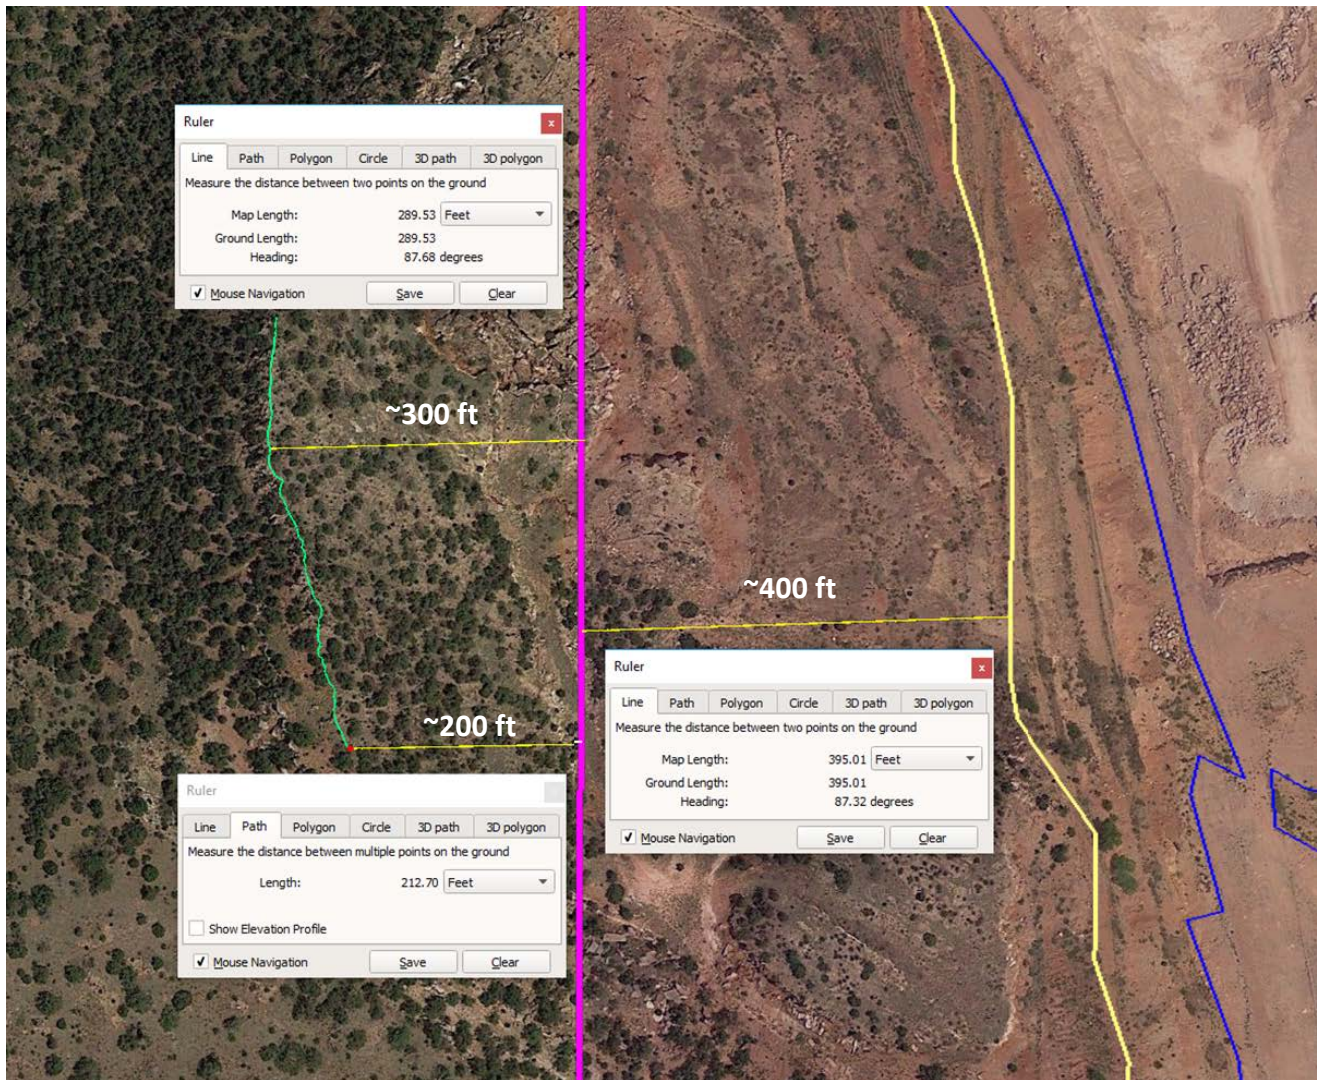
Figure 1. Relative Distances to Permit Boundary

Off-site Damage: The current operation appeared to be confined to the permit boundary, based on Google Earth review and site observations. Some discussion and site investigation was initiated to determine how far west the operation was permitted. The top of the ridge location was collected using a handheld Trimble Juno 3B GPS unit (see attached **Post Inspection Map**). It appears based on the GPS data, the top of the ridge is between 200 and 300 feet west of the permit boundary, which in turn is roughly 400 feet west of the affected area boundary. As such, an amendment to the permit would be required to mine not only most the material west of the current active disturbance (which requires increasing the current affected area boundary), but also extending the permit and affected area boundary to, or beyond the ridge to the west of the active area. Distances are shown below in **Figure 1**. The inspection led to the top of the west ridge where evidence of rock movement was observed between the permit boundary and the top of the ridge (see **Photos 1 and 2**), suggesting a potential for stability issues were this area to be mined. [This issue would need to be addressed in the Rule 6.5 Geotechnical Stability Exhibit.](#) It should be noted this movement may or may not be related to the pre-law mining activity at this site.

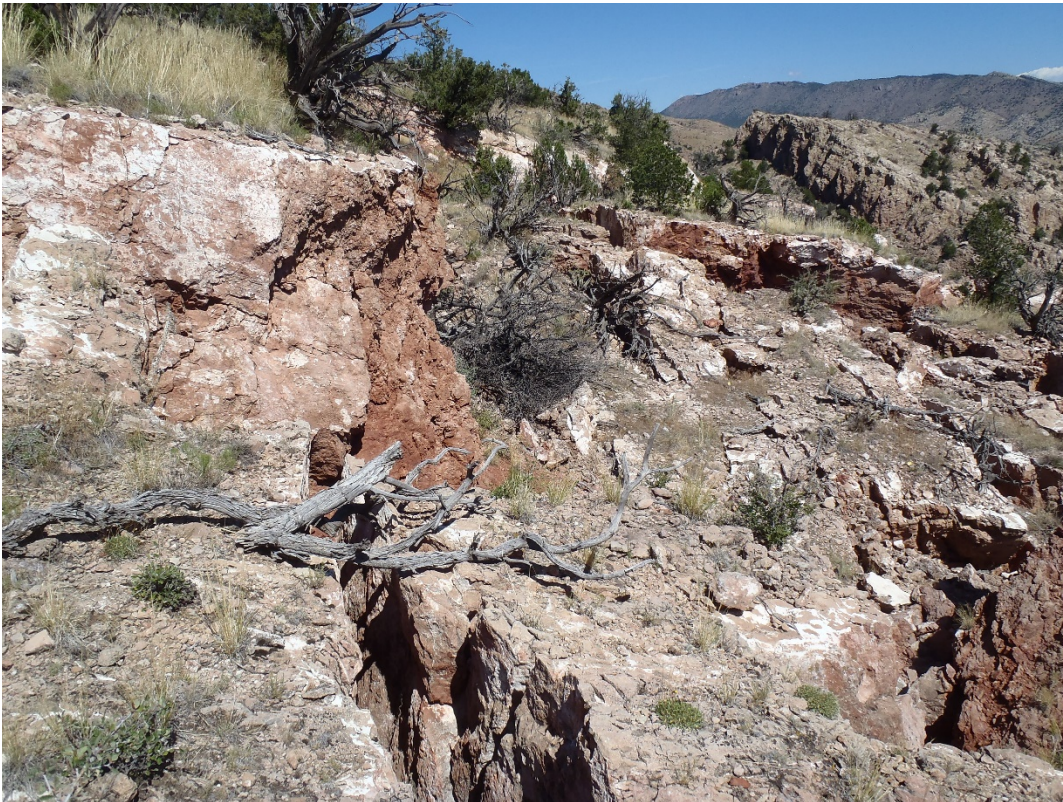
Photo 1. Tension cracks between ridge and permit boundary (outside permit area, looking north).

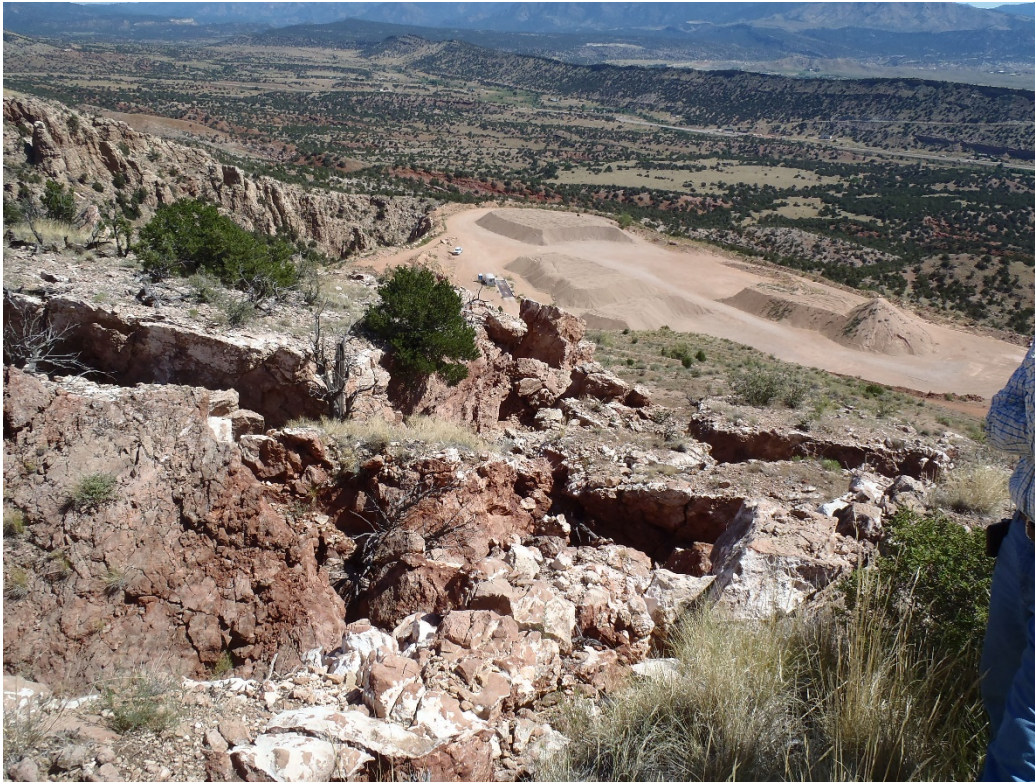
Photo 2. Evidence of rock movement between ridge and permit boundary (outside permit area, looking NE).

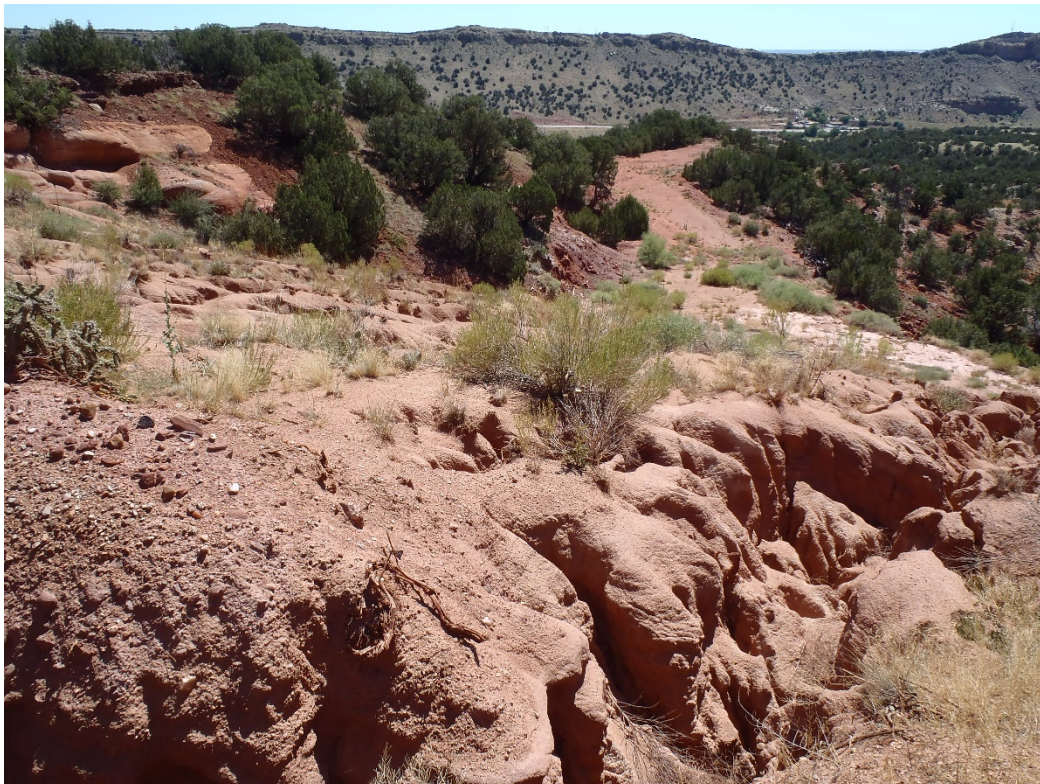
Reclamation Success: A technical revision (TR-03) was submitted and approved in 2018 to address the erosion problem in the fines disposal area. No reclamation in this area had been initiated at the time of the inspection (see **Photo 3**).

Photo 3. Erosion issue east of the fines disposal area (looking east).
