**MINERALS PROGRAM INSPECTION REPORT**  
**PHONE: (303) 866-3567**

<b>MINE NAME:</b> Hayden Gravel Pit	<b>MINE/PROSPECTING ID#:</b> M-1987-164	<b>MINERAL:</b> Sand and gravel	<b>COUNTY:</b> Routt
<b>INSPECTION TYPE:</b> Monitoring	<b>INSPECTOR(S):</b> Peter Hays	<b>INSP. DATE:</b> October 8, 2019	<b>INSP. TIME:</b> 11:30
<b>OPERATOR:</b> Oldcastle SW Group, Inc. dba United Comp	<b>OPERATOR REPRESENTATIVE:</b> Jason Burkey, Peter Siegmund	<b>TYPE OF OPERATION:</b> 112c - Construction Regular Operation	
<b>REASON FOR INSPECTION:</b> Normal I&E Program	<b>BOND CALCULATION TYPE:</b> Partial Bond	<b>BOND AMOUNT:</b> \$224,521.00	
<b>DATE OF COMPLAINT:</b> NA	<b>POST INSP. CONTACTS:</b> None	<b>JOINT INSP. AGENCY:</b> None	
<b>WEATHER:</b> Clear	<b>INSPECTOR'S SIGNATURE:</b>

## OBSERVATIONS

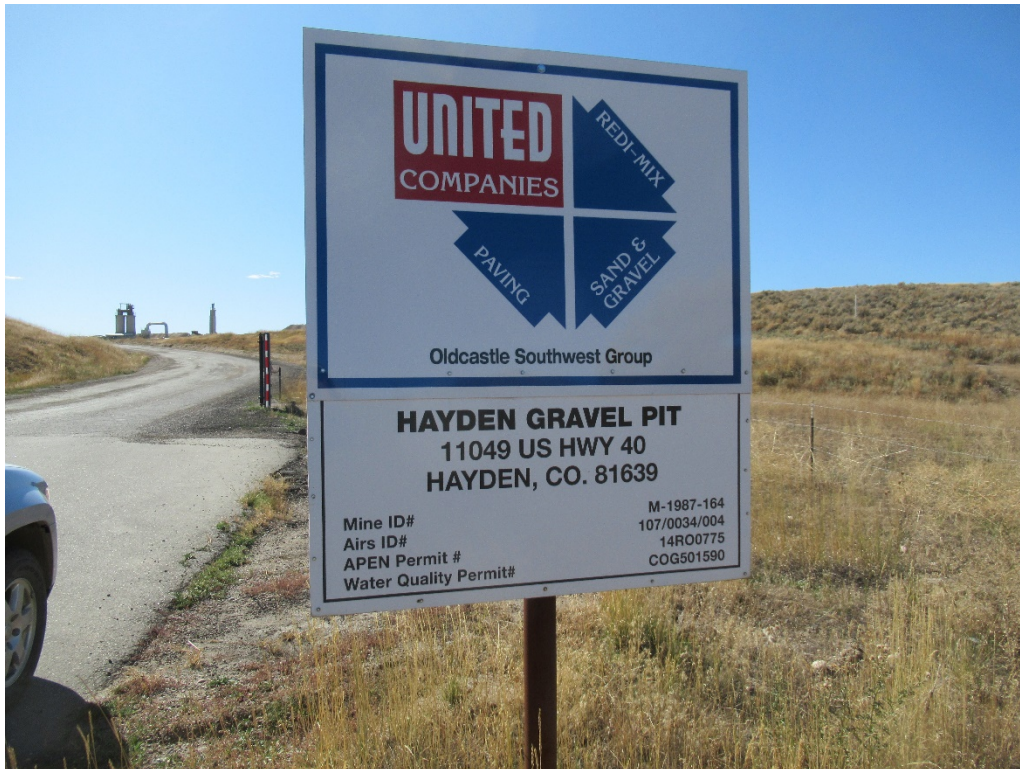
boundary markers were observed as required by Rule 3.1.12. The mine sign was located at the main entrance off of Highway 40. The boundary was delineated by tall white PVC pipes. The pit floor was dry and no erosion features were observed during the inspection. No noxious weeds were observed in the active portion of the site during the inspection.

Hayden Gravel Pit mine sign

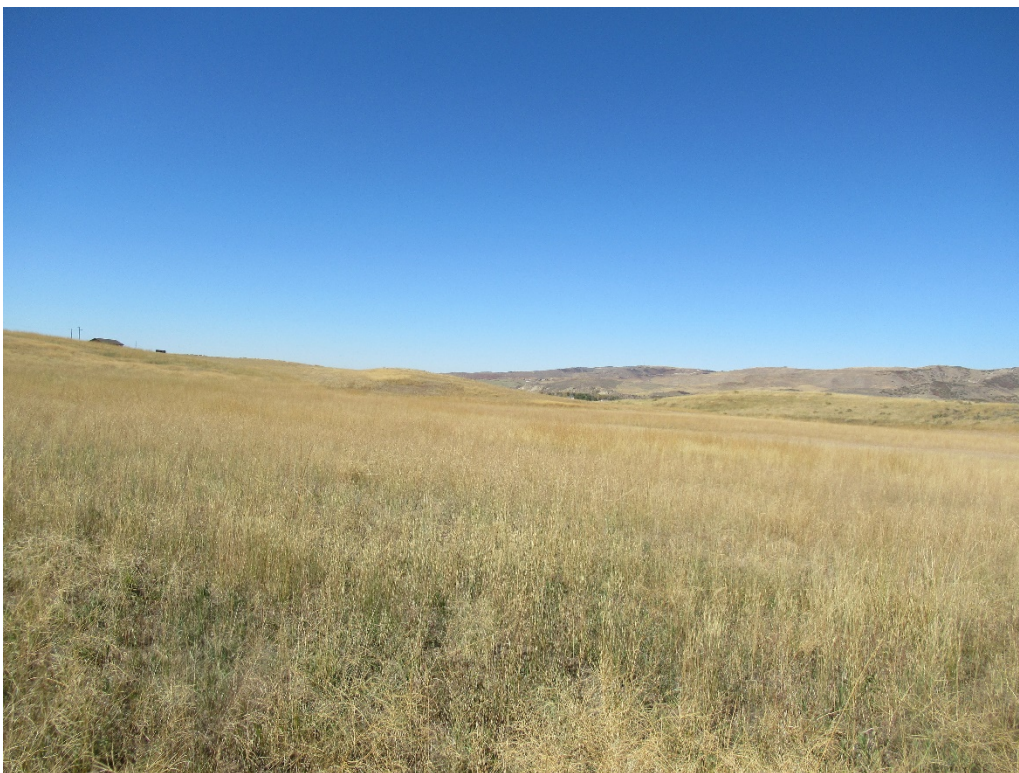
View of the AR-01 area from the east side looking west

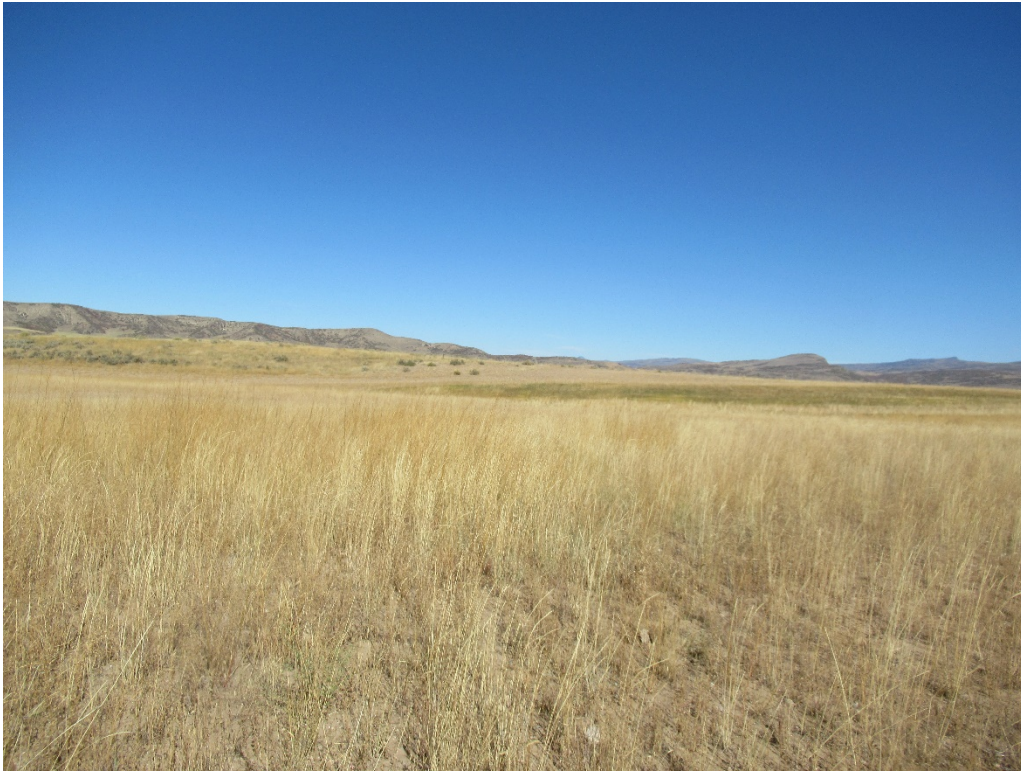
View of the AR-01 area from the east side looking north

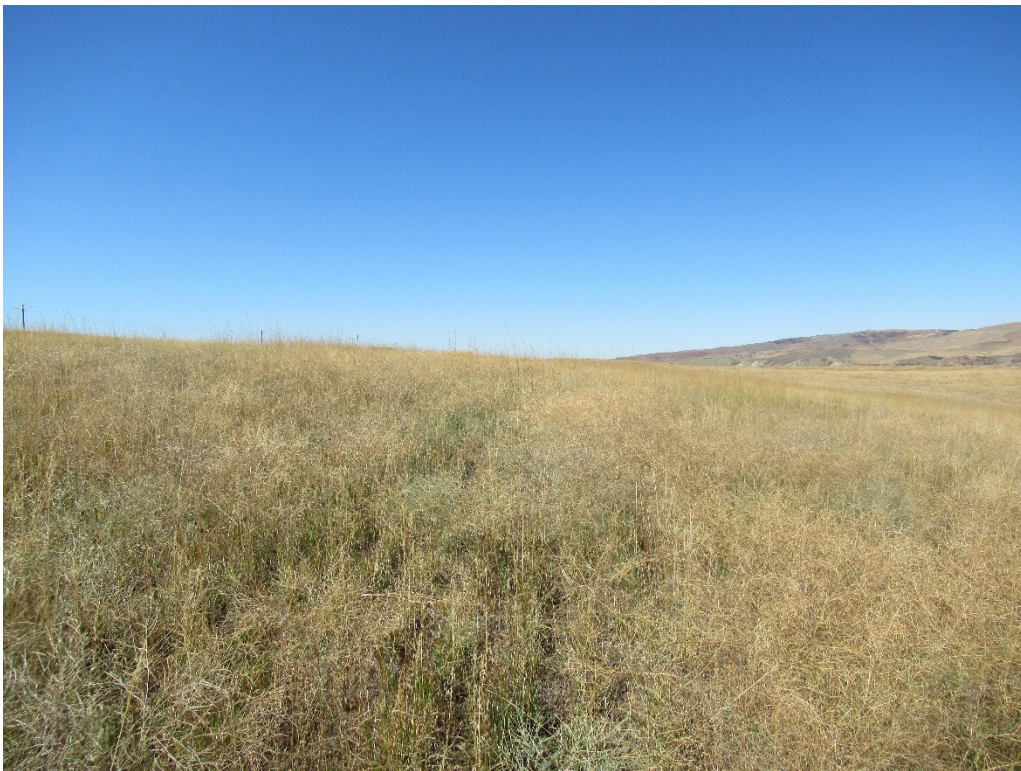
The acreage reduction request is for 44.7 acres and includes the original Camilletti Pit area and CR-51A access road. The Operator reported the final reclamation of the area was performed by Connell Resources, Inc. in 2017 prior to the permit transfer to Oldcastle Materials. The acreage reduction request would reduce the permitted acreage to 50.25 acres. The approved post-mining land use for the area is cropland. The approved Reclamation Plan states the maximum reclaimed slopes will not exceed 3H:1V and six (6) inches of topsoil will be replaced during reclamation. The reclaimed slopes were estimated at a 3H:1V or shallower during the inspection. The slopes were stable and no erosion features were observed during the inspection. The area vegetation consisted of grasses in the approved seed mixture including; pubescent wheatgrass, meadow brome, smooth brome and alfalfa. Chicory, a Class C noxious weed, and yellow sweet clover, an annual weed were observed in large patches in the release area. Reclamation grasses were observed intermixed and underneath the weed patches. Due to the dormant state of the grasses, it was difficult to determine if the grasses were out competing the annual and noxious weeds. Evidence of cattle grazing impacts were observed in areas of the pit floor.

**The Division will deny the acreage reduction request (AR-01) based on the observations from this inspection, due to the presence of large patches of weeds and the dormant status of the reclamation grasses. The Division encourages the Operator to control the weeds on-site and submit another acreage reduction request for the area next spring.**

View of reclamation grasses under and intermixed with annual weeds

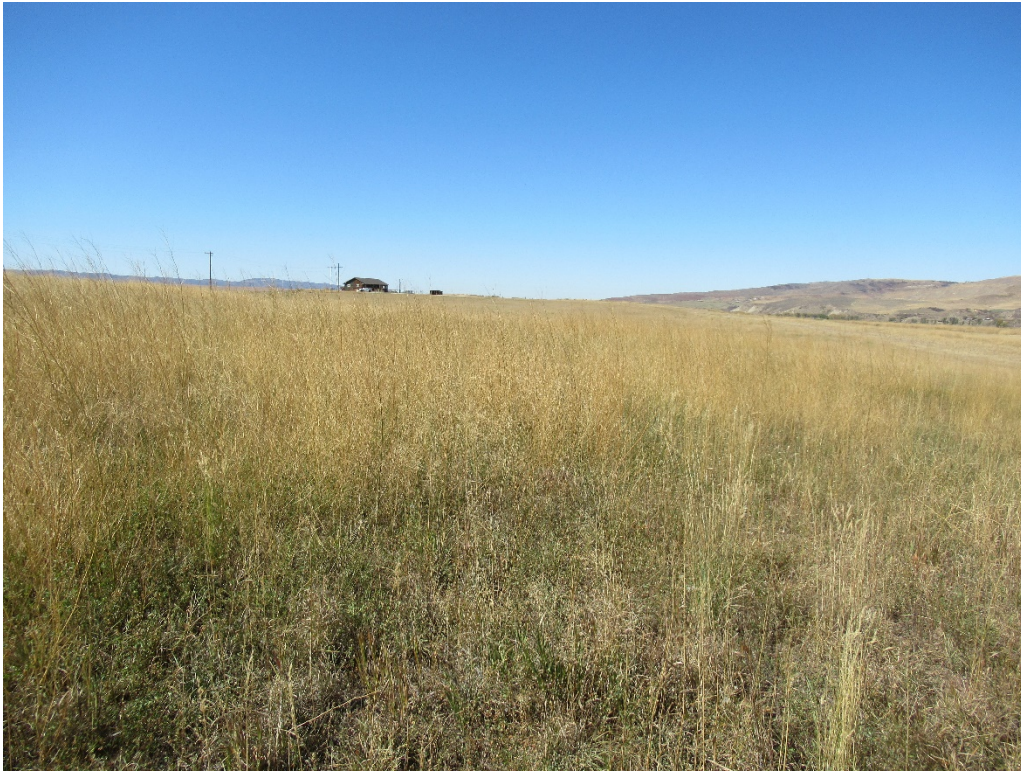
View of the southwest corner of the AR-01 area looking west

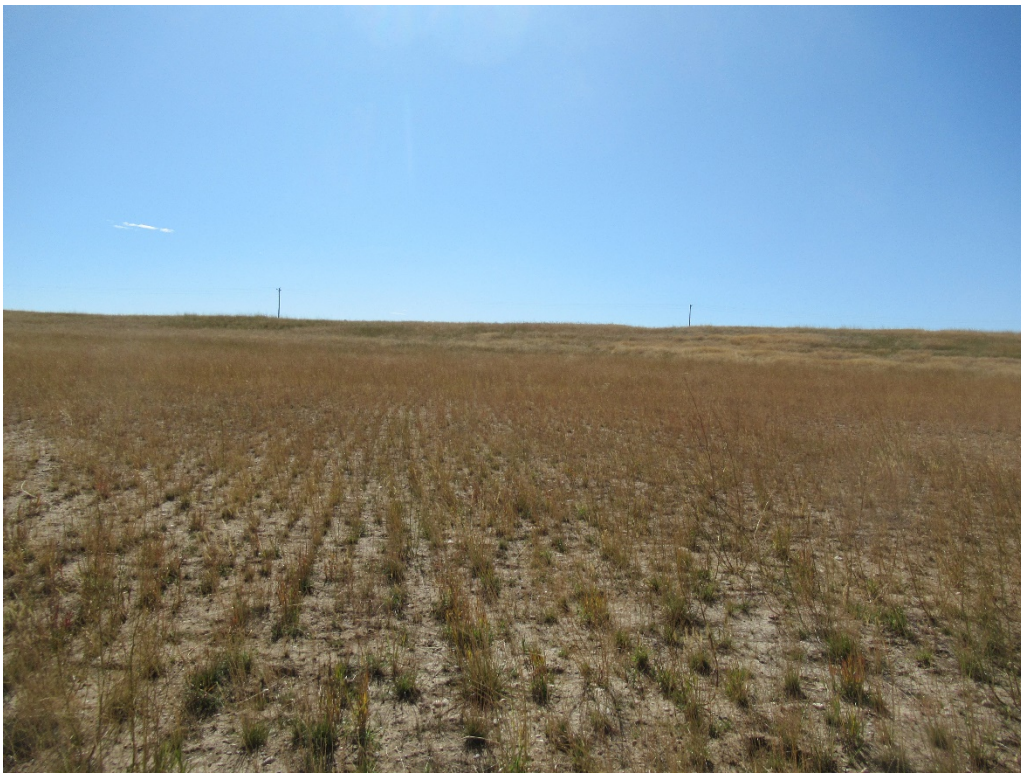
View of the AR-01 area pit floor looking north with evidence of grazing impacts

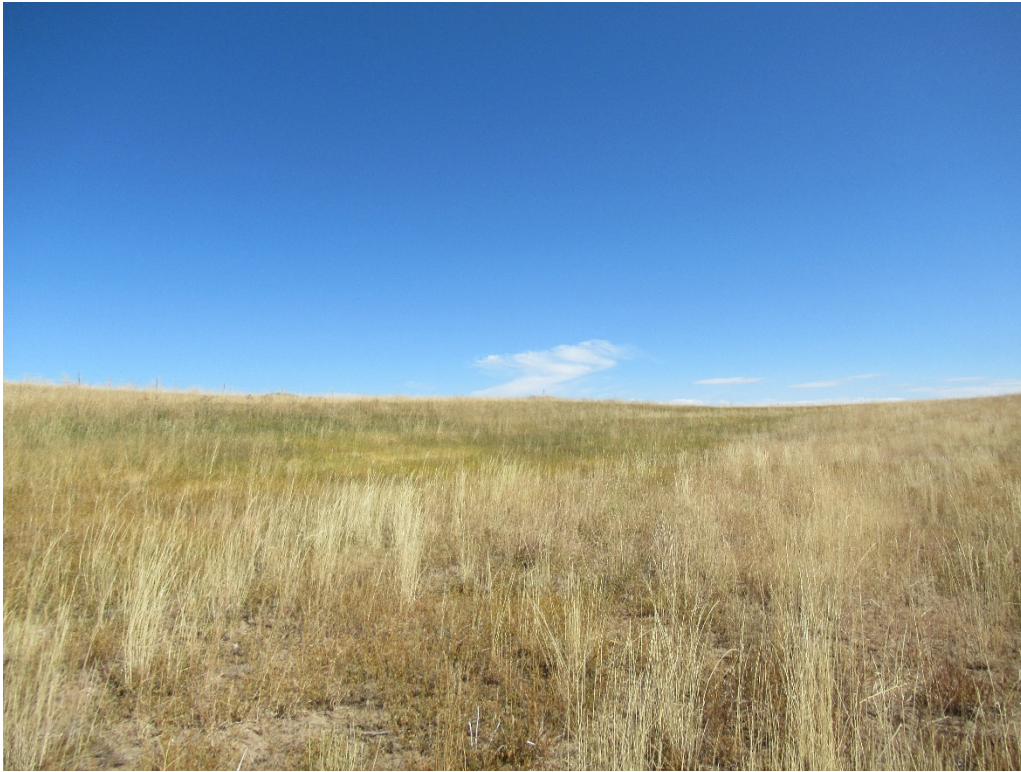
View of the northeast corner of the AR-01 area looking east

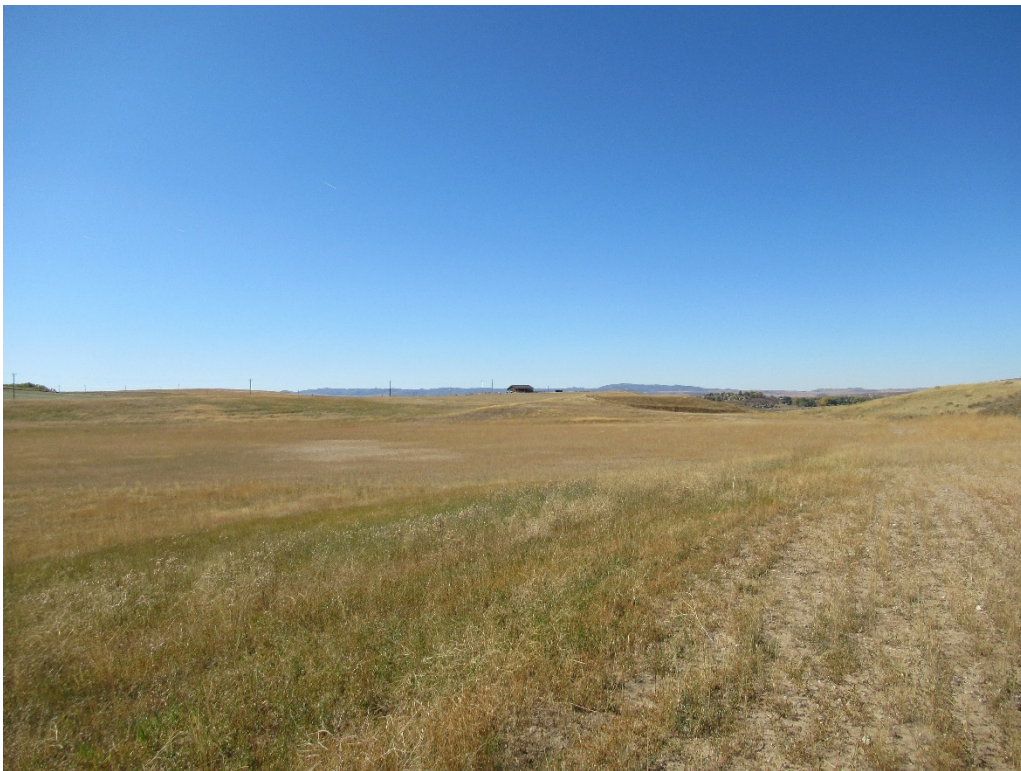
View of the AR-01 area from the northeast corner looking west

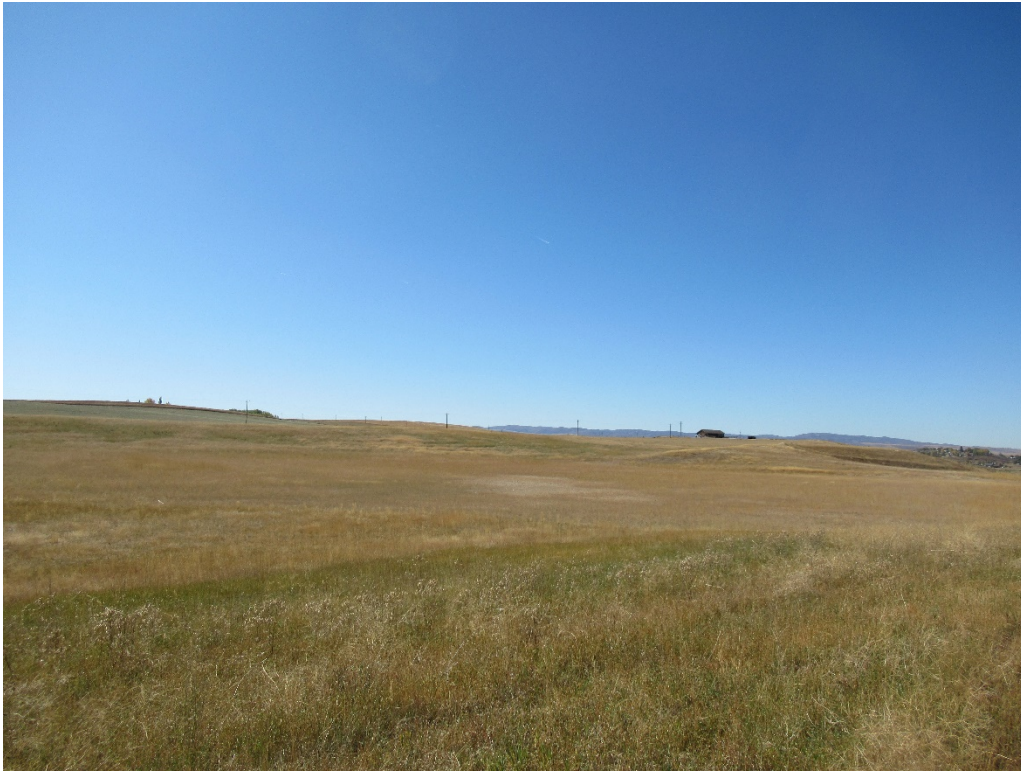
View of the AR-01 area from the northeast corner looking southwest

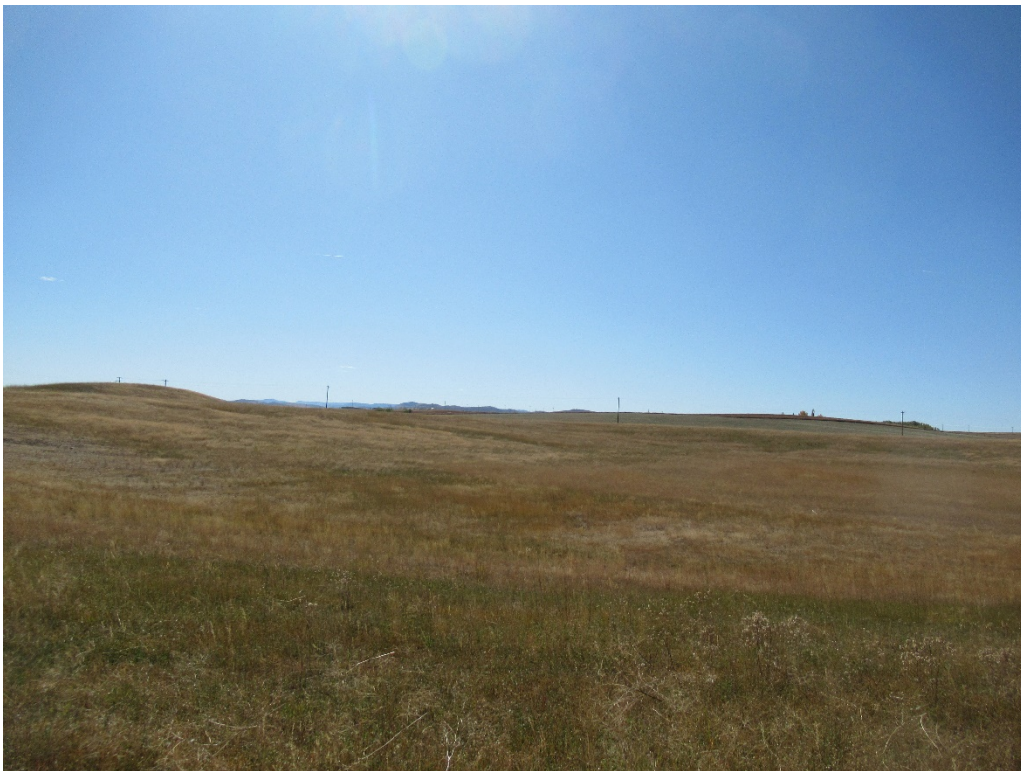
View of the AR-01 area from the northeast corner looking south

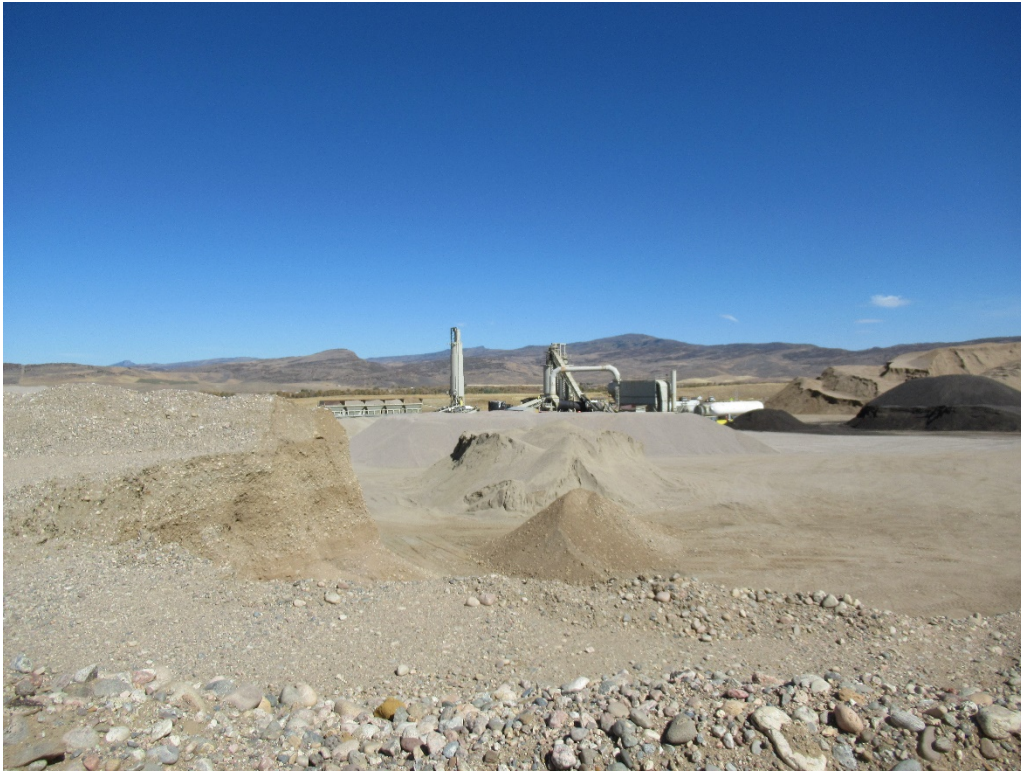
View of the mine site from the highwall looking north

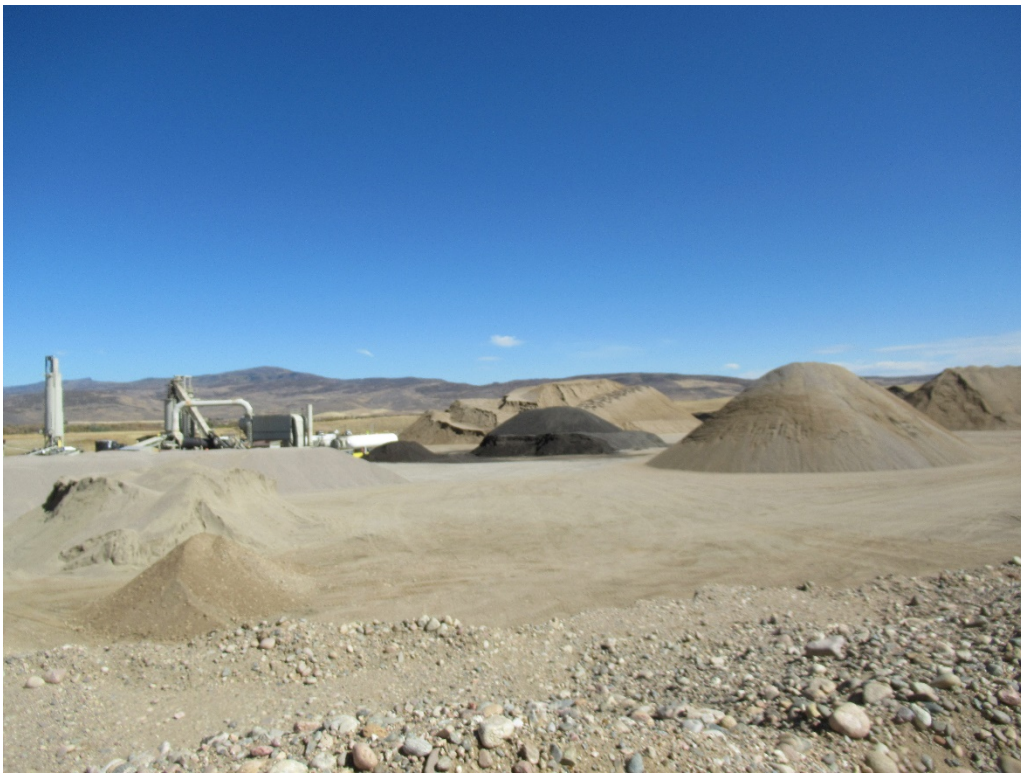
View of the mine site from the highwall looking northeast

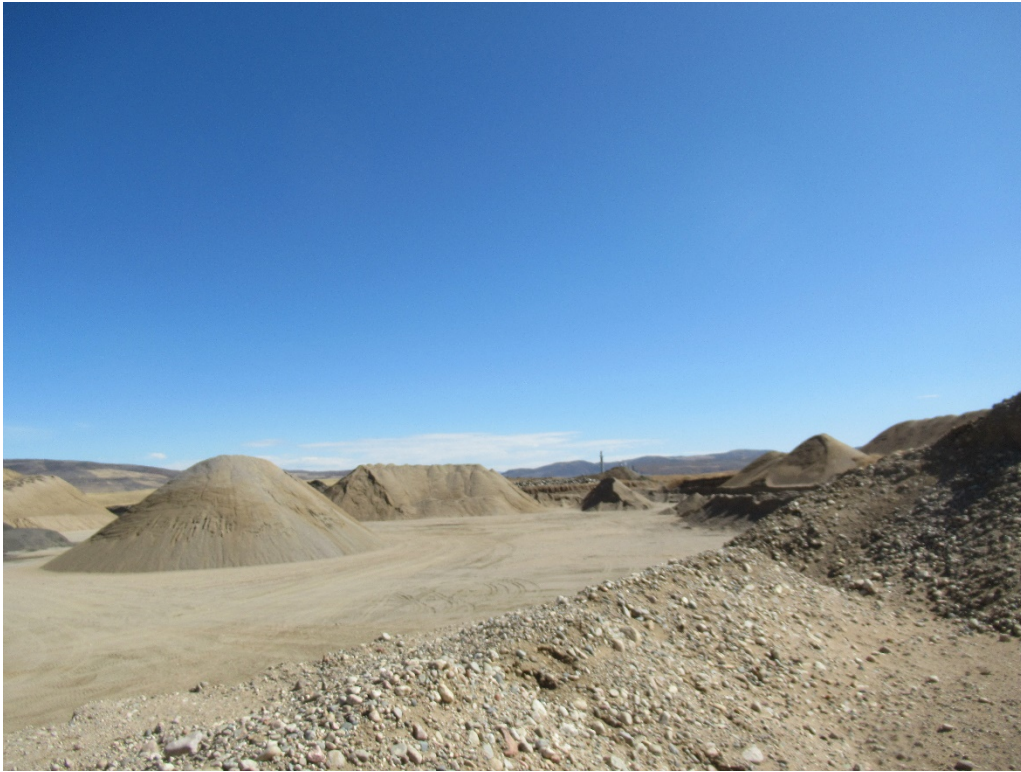
View of the mine site from the highwall looking east

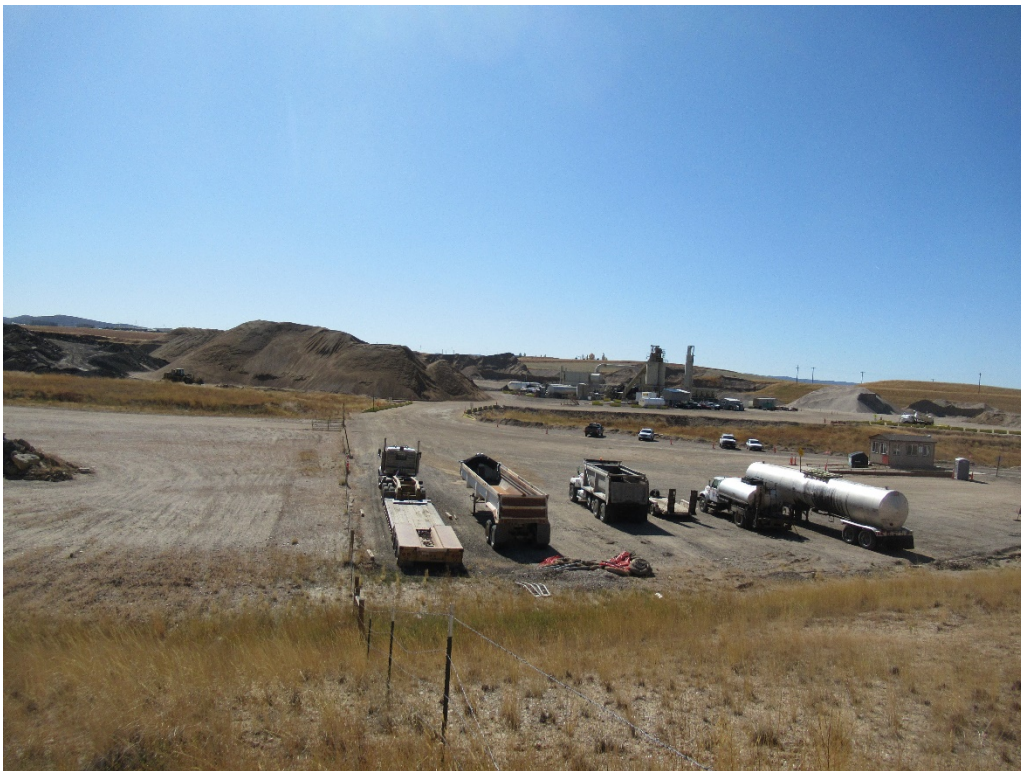
View of the mine site from the adjacent Routt County site looking southwest
