### MINERALS PROGRAM INSPECTION REPORT PHONE: (303) 866-3567

<b>MINE NAME:</b> Clear Spring Ranch Pit	<b>MINE/PROSPECTING ID#:</b> M-1992-074	<b>MINERAL:</b> Gravel	<b>COUNTY:</b> El Paso
<b>INSPECTION TYPE:</b> Monitoring	<b>INSPECTOR(S):</b> Timothy Cazier	<b>INSP. DATE:</b> October 15, 2019	<b>INSP. TIME:</b> 13:45
<b>OPERATOR:</b> City of Colorado Springs	<b>OPERATOR REPRESENTATIVE:</b> Ann Burdett & Patti Zietlow	<b>TYPE OF OPERATION:</b> 112c - Construction Regular Operation

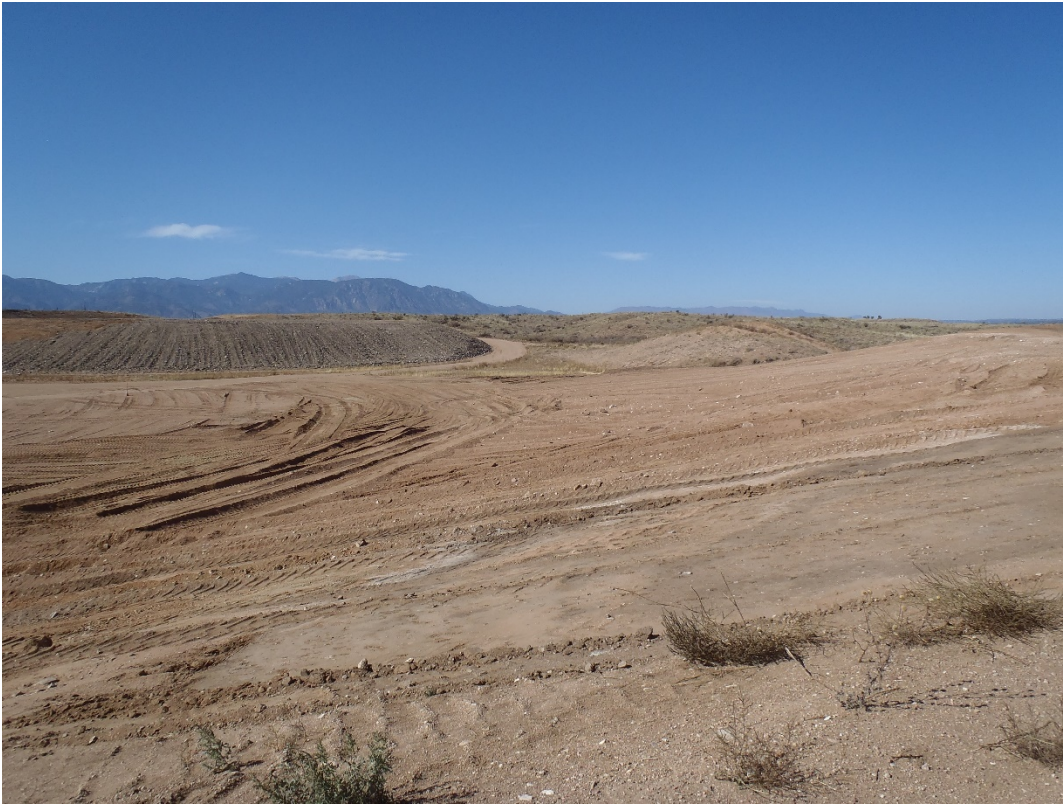
Gen. Compliance with Mine Plan: The maximum allowed disturbed area is 47.4 acres. Google Earth was used to measure the disturbed area, which was estimated to be approximately 34.5 acres, based on 2017 imagery. Highwalls were estimated to 25 feet in height and appeared stable at 2H:1V or flatter (see **Photo 1**).

Photo 1. Typical highwalls sloped to flatter than 2H:1V (looking west).

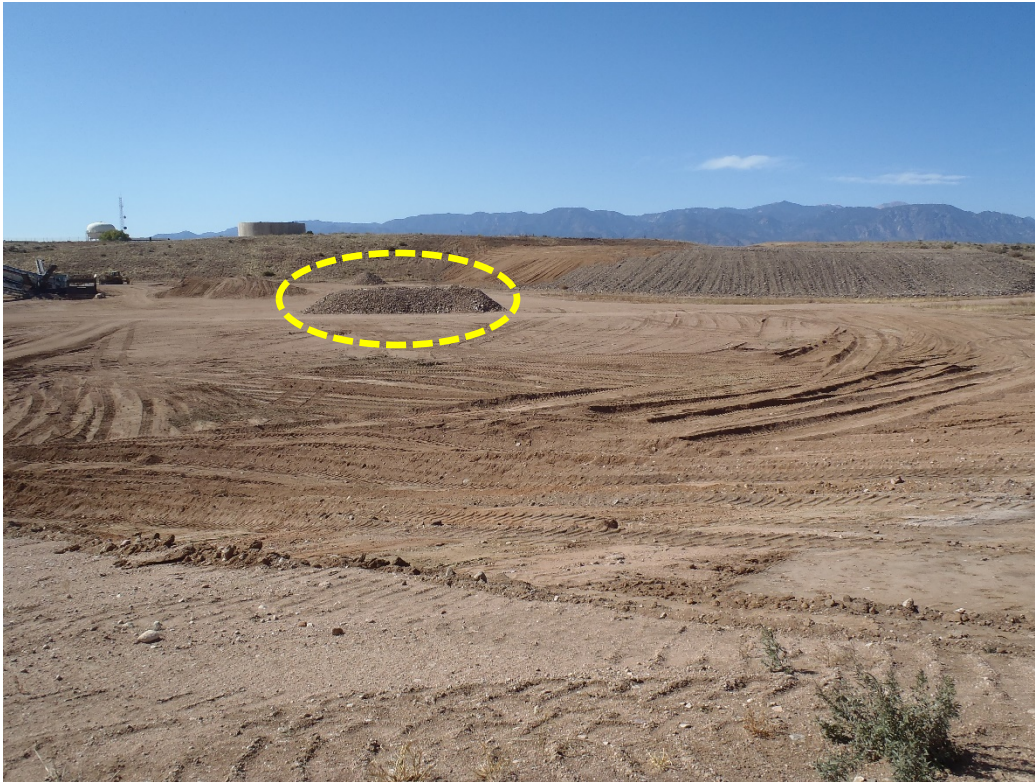
Processing Waste: A stockpile of oversized rock was observed on the pit floor (see **Photo 2**).

Photo 2. Stockpile of oversized rock.

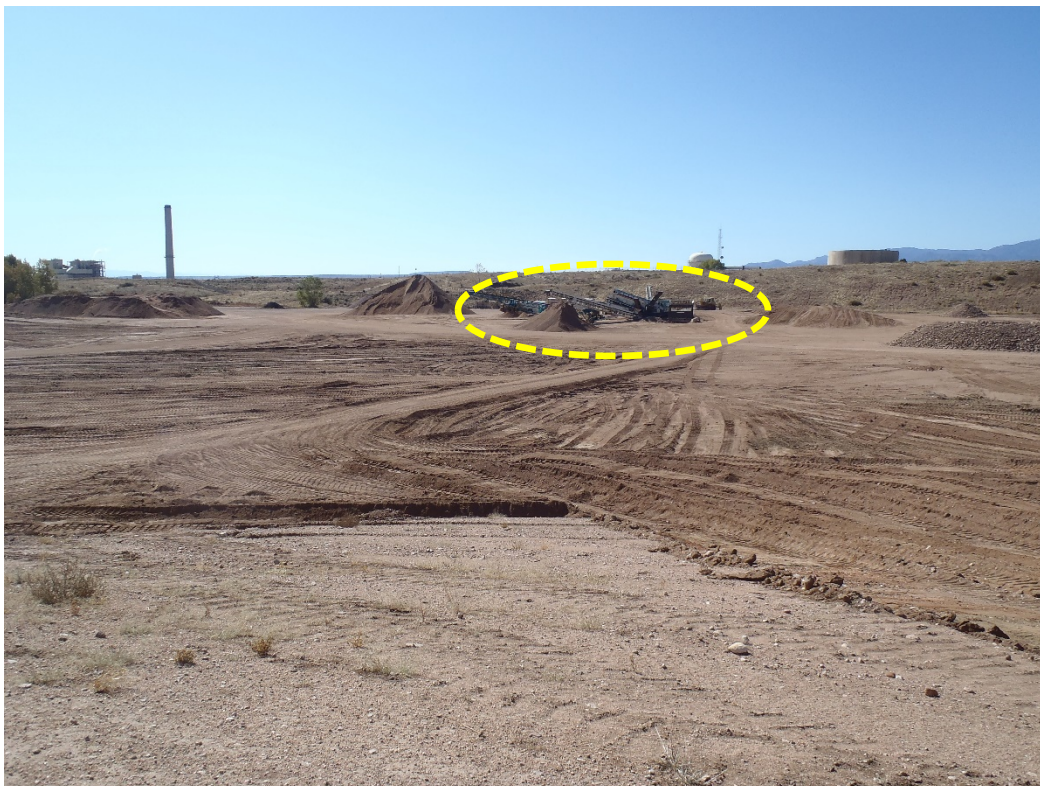
Support Facilities On-site: A screen plant and loader were observed on site (see **Photo 3**).

Photo 3. Screen plant (looking SW).

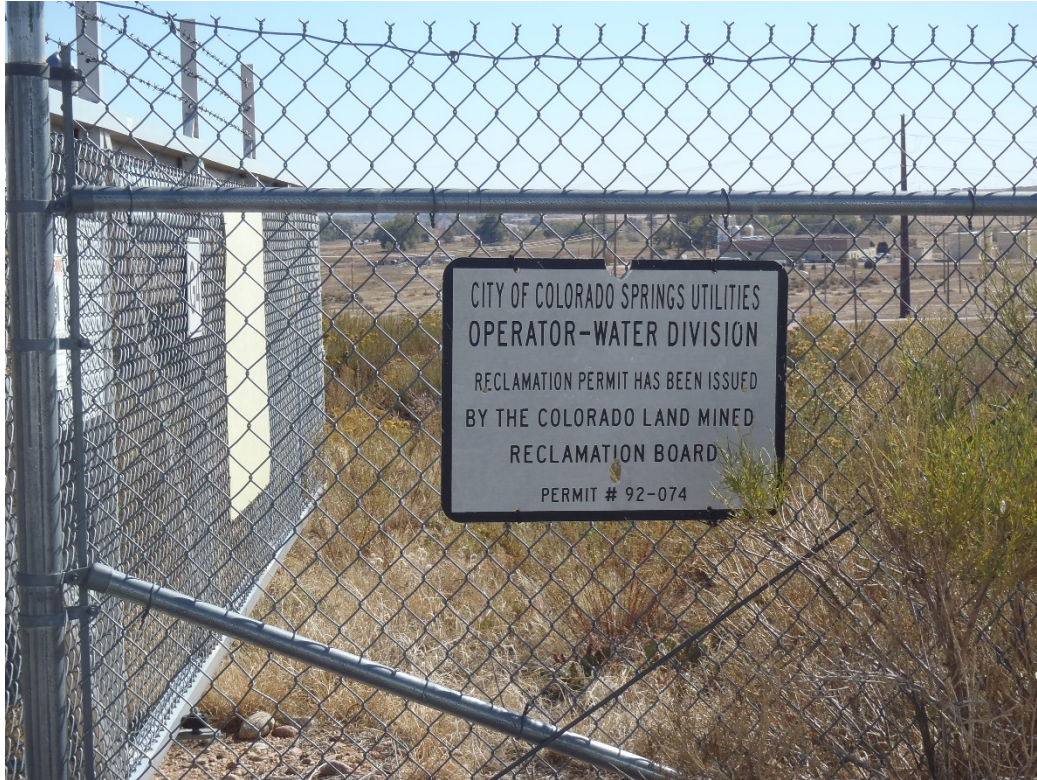
Signs and Markers: The permit sign was properly posted (see **Photo 4**) and boundary markers were observed to delineate the permit boundary (see **Photo 5**).

Photo 4. Permit sign (at mine entrance).

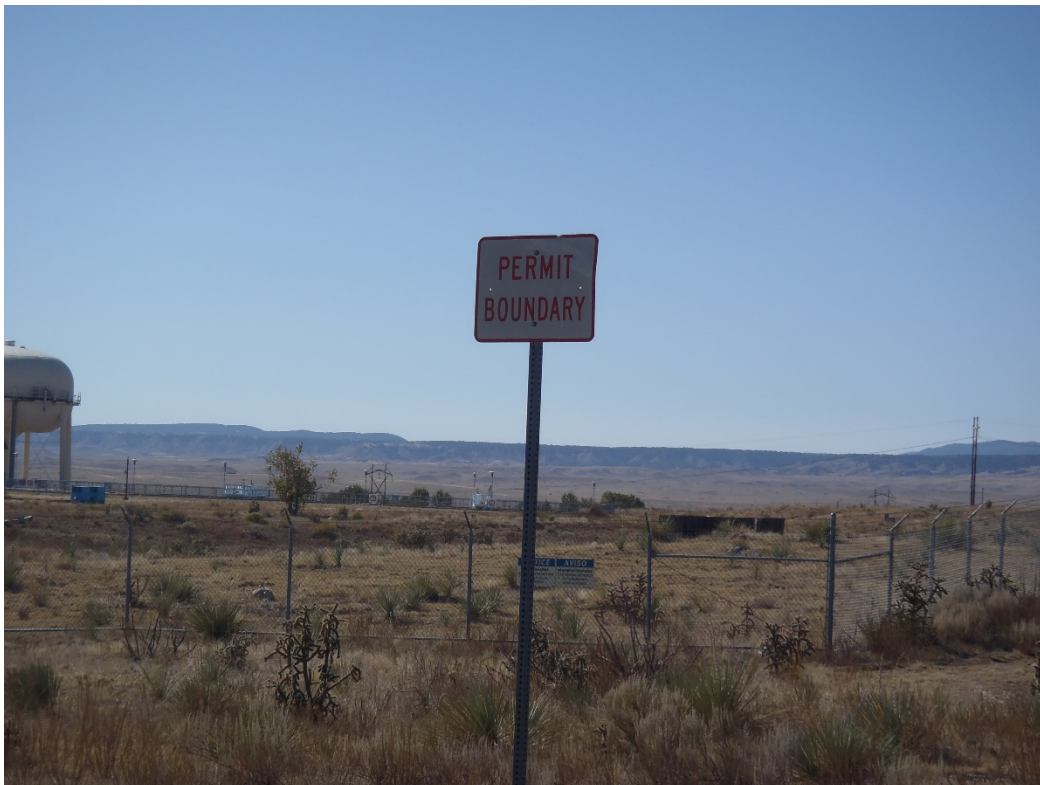
Photo 5. Typical permit boundary sign (west side).

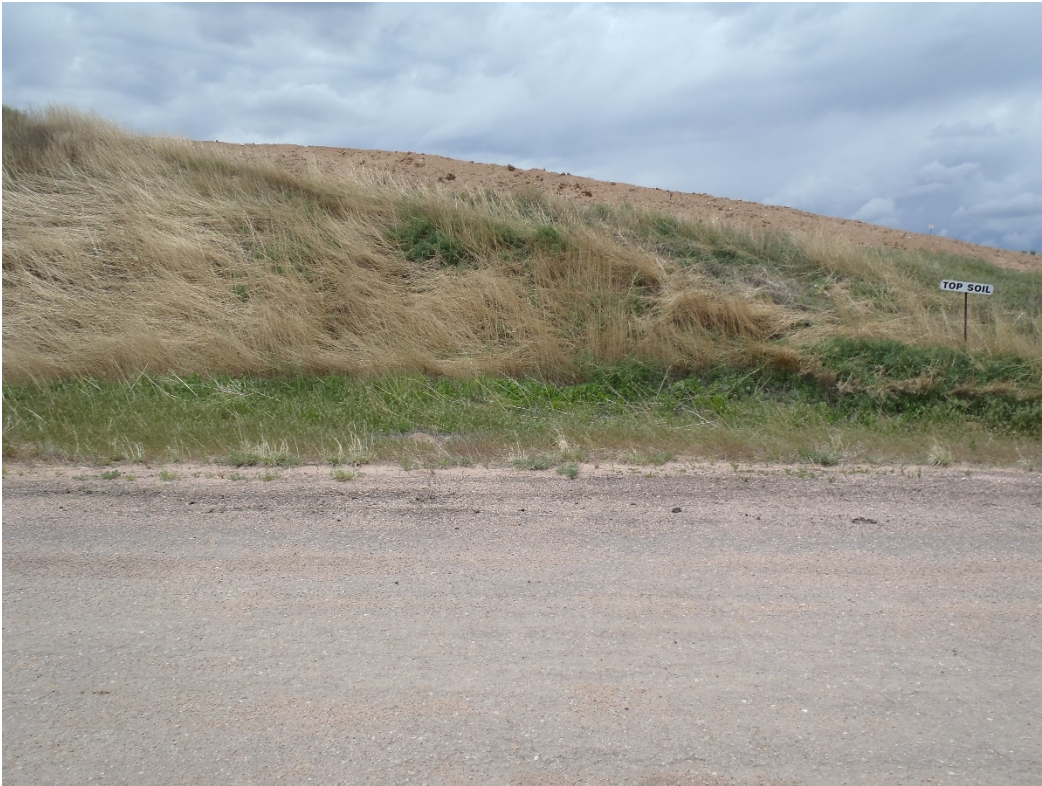
Topsoil: The large topsoil stockpile observed during the 2016 inspection (see **Photo 6**) had been removed and according to site representatives used elsewhere on the CSU property. The topsoil stockpile observed during this inspection was far too small to complete reclamation (see **Photo 7**). **The removal of the topsoil stockpile for purposes other than mine reclamation is cited as a problem on page 1 of this report.** CSU provided a plan to replace the topsoil stockpile by mid-2020 via email on November 1, 2019.

Photo 6. Topsoil stockpile with sign (SW corner) observed in 2016.

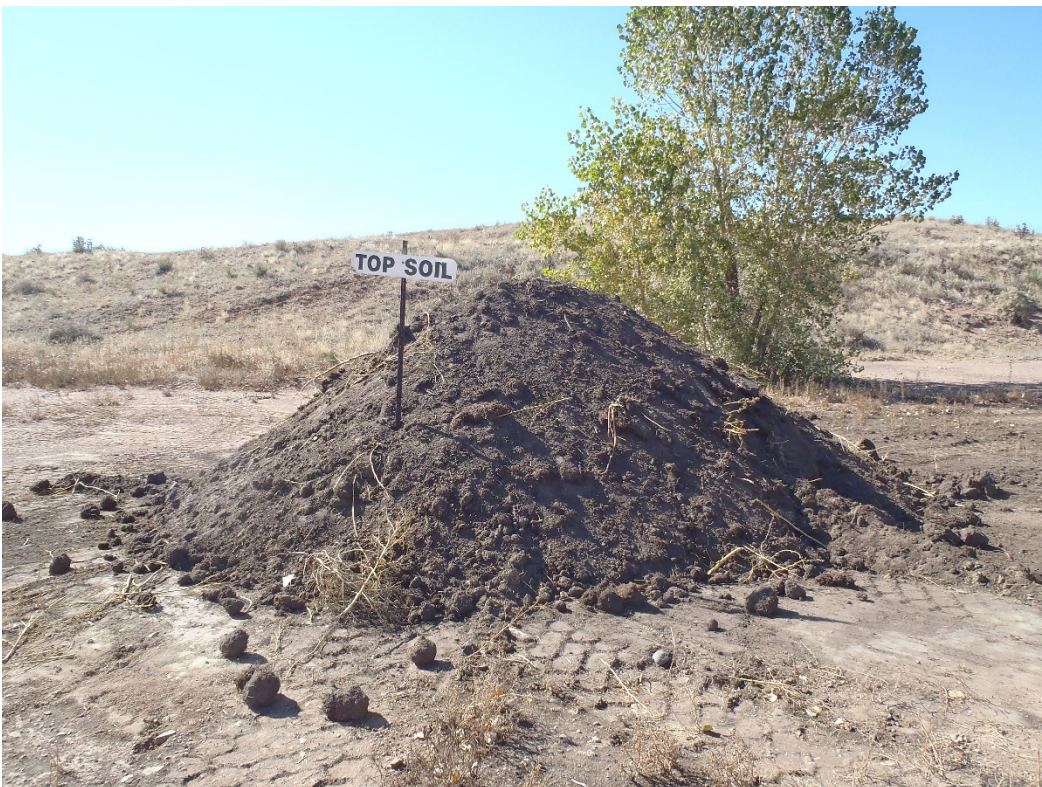
**PROBLEM/POSSIBLE VIOLATION:** Problem: During the inspection, it was discovered that there is inadequate topsoil to complete the approved reclamation at the site. This is a problem related to C.R.S. 34-32.5-116(4)(i) for failure to follow the reclamation plan prescribed in the permit.

Photo 7. Topsoil stockpile with sign (SW corner) current inspection.

**CORRECTIVE ACTIONS:** The operator submitted a plan on November 1, 2019 to replenish the topsoil stockpile from the surrounding City-owned property. Transportation of the required topsoil is to begin approximately November 4, 2019 and be complete by mid-2020.

**CORRECTIVE ACTION DUE DATE:** 6/30/20
