**MINERALS PROGRAM INSPECTION REPORT**  
**PHONE: (303) 866-3567**

<b>MINE NAME:</b> Gravel Pit M-093	<b>MINE/PROSPECTING ID#:</b> M-1995-026	<b>MINERAL:</b> Gravel	<b>COUNTY:</b> Custer
<b>INSPECTION TYPE:</b> Monitoring	<b>INSPECTOR(S):</b> Timothy Cazier	<b>INSP. DATE:</b> June 18, 2019	<b>INSP. TIME:</b> 14:00
<b>OPERATOR:</b> Custer County	<b>OPERATOR REPRESENTATIVE:</b> Gary Hyde	<b>TYPE OF OPERATION:</b> 112c - Construction Regular Operation	
<b>REASON FOR INSPECTION:</b> Normal I&E Program	<b>BOND CALCULATION TYPE:</b> None	<b>BOND AMOUNT:</b> \$0.00	
<b>DATE OF COMPLAINT:</b> NA	<b>POST INSP. CONTACTS:</b> None	<b>JOINT INSP. AGENCY:</b> None	
<b>WEATHER:</b> Cloudy	<b>INSPECTOR'S SIGNATURE:</b>

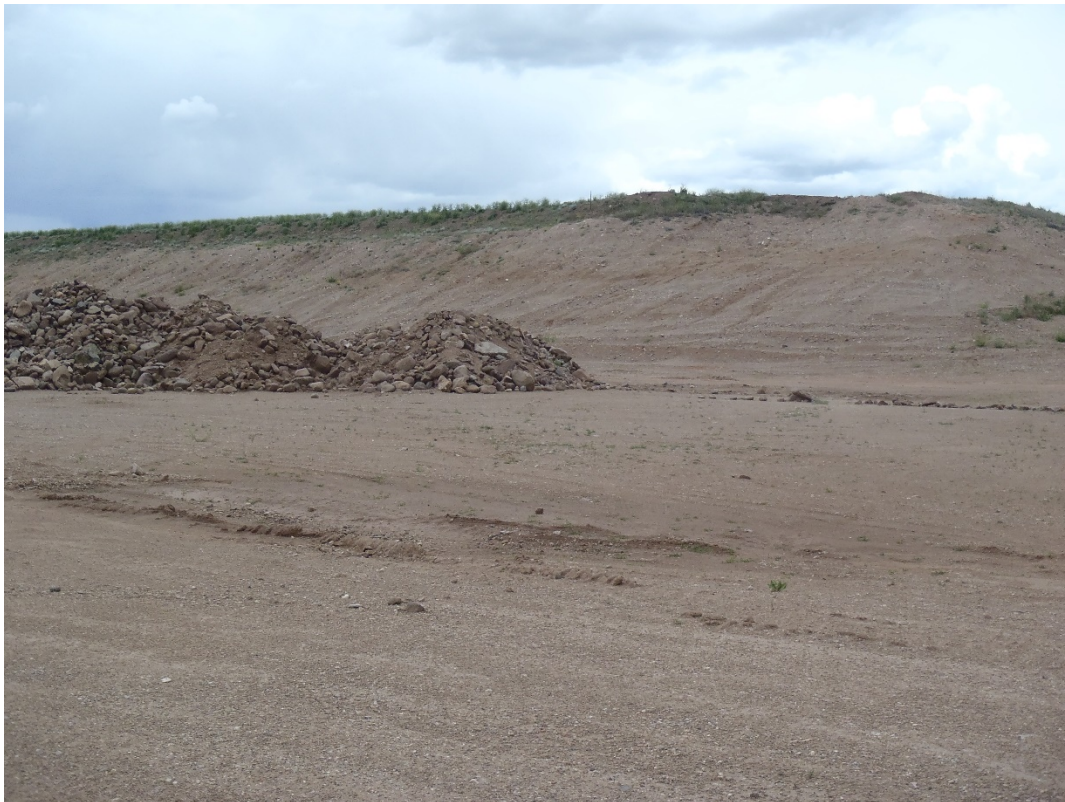
**Gen. Compliance with Mine Plan:** The operation appeared to be in compliance with the approved mine plan. The maximum allowed disturbed area is 40.3 acres. Google Earth was used to measure the disturbed area, which was estimated to be approximately 20 acres, based on 2016 imagery. Highwalls were estimated to be 25 feet in height and appeared stable as they were sloped at roughly 2H:1V (see **Photo 1**).

Photo 1. Highwalls (~25 feet high) appearing stable sloped at roughly 2H:1V (looking NE from pit floor).

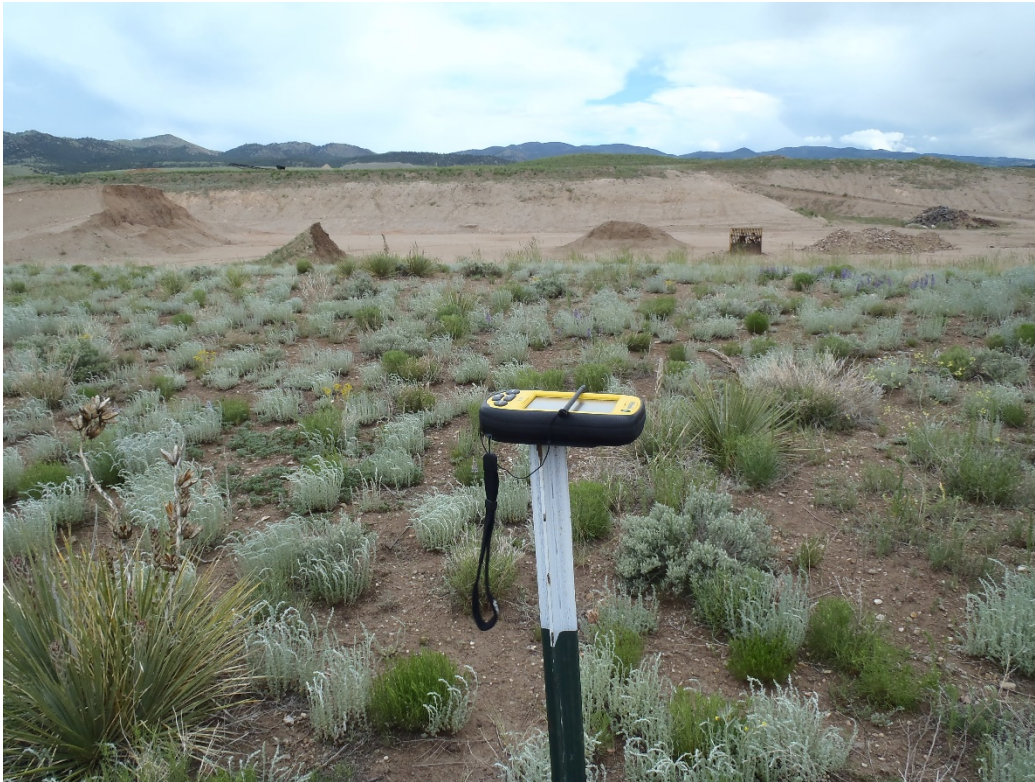
**Off-site Damage:** The operation appeared to be confined to the permit boundary, based on Google Earth review and site observations, which included collecting boundary marker locations using a handheld Trimble Juno 3B GPS unit (see **Photo 2**). A map of the collected locations is attached as the **Post Inspection Map**.

**Signs and Markers:** The permit sign was properly posted (see **Photo 7**) and T-post boundary markers were observed to delineate the permit boundary (see **Photos 2, 4 and 6**). Locations of the permit boundary markers were collected using a handheld Trimble Juno 3B GPS unit. Locations are shown on the attached **Post Inspection Map**.

Photo 2. Typical permit boundary marker, highwall beyond (looking east, note GPS unit on top of T-post).

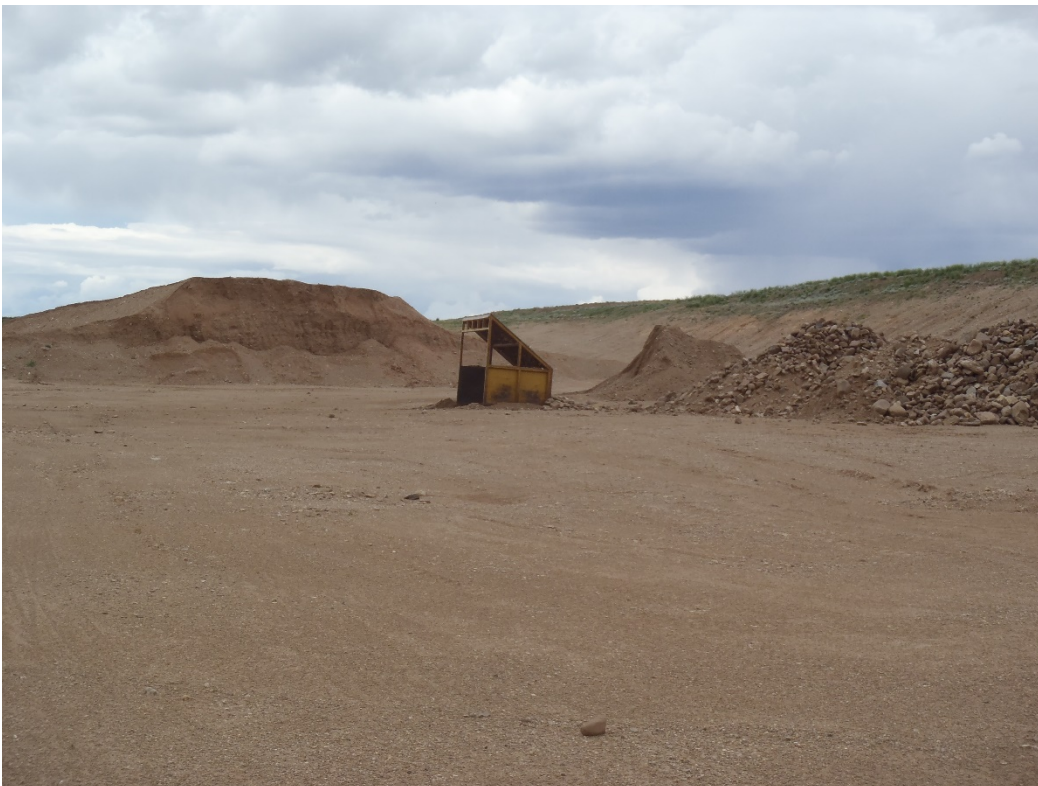
**Processing Waste:** A stockpile of oversized rock was observed on the pit floor (see **Photo 3**).

**Support Facilities On-site:** A grizzly screen and loader were observed on site (see **Photos 3 and 6**).

Photo 3. Grizzly screen, product stockpile and oversize rock stockpile (looking NE from pit floor).

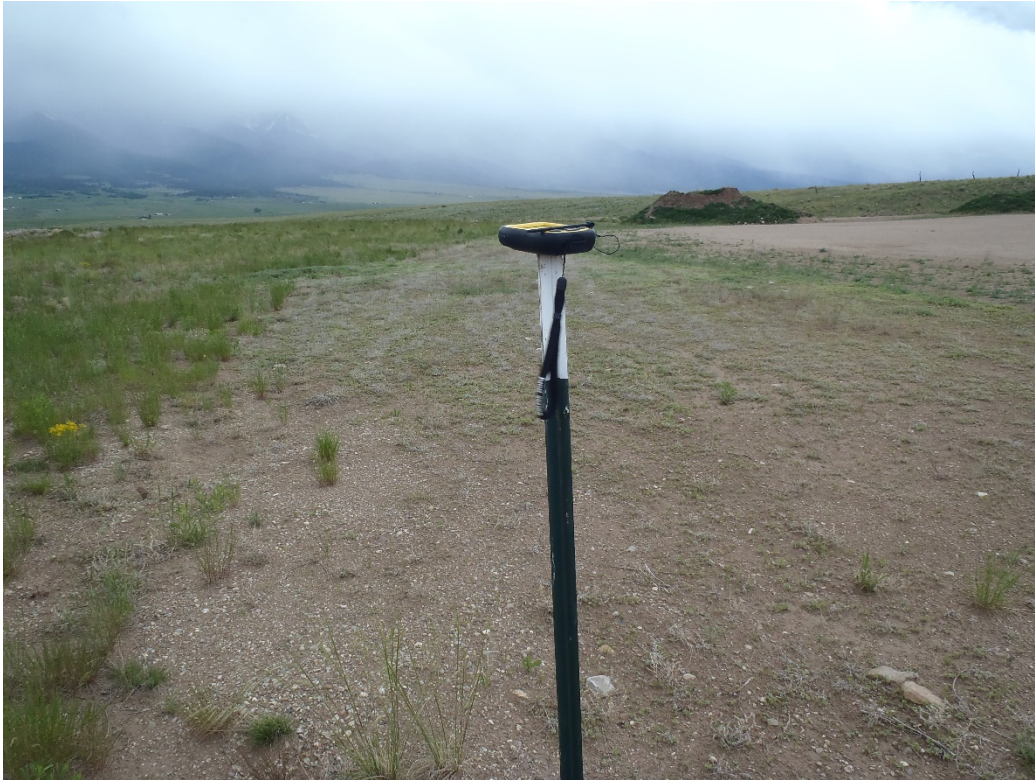
**Reclamation Success:** Some reclamation grading and seeding has been initiated (see **Photo 4**).

Photo 4. Reclamation grading & seeding (south side, looking west, note GPS unit on top of T-post)

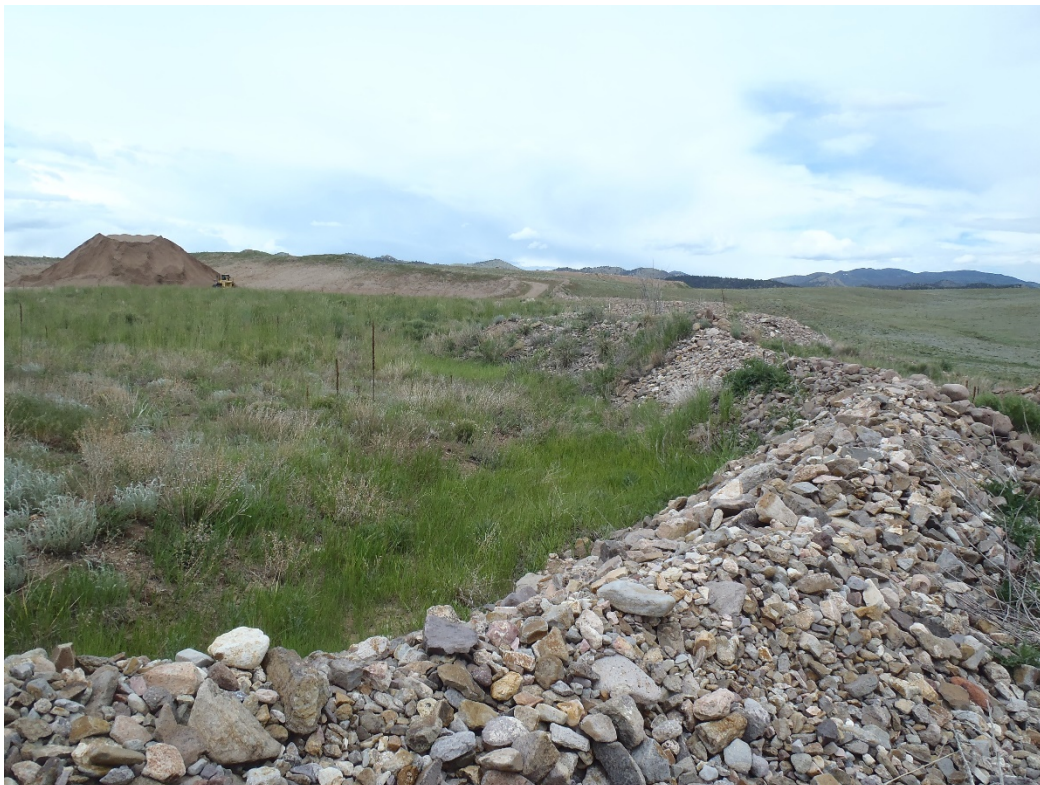
**Sediment Control:** No erosion problems were observed and no BMPs were needed at the time of the inspection. A rock check dam on the southwest corner of the site appears to be adequate in preventing sediment discharge from the low point in that corner (see **Photo 5**).

Photo 5. Rock check dam on the southwest corner of the site (looking east).

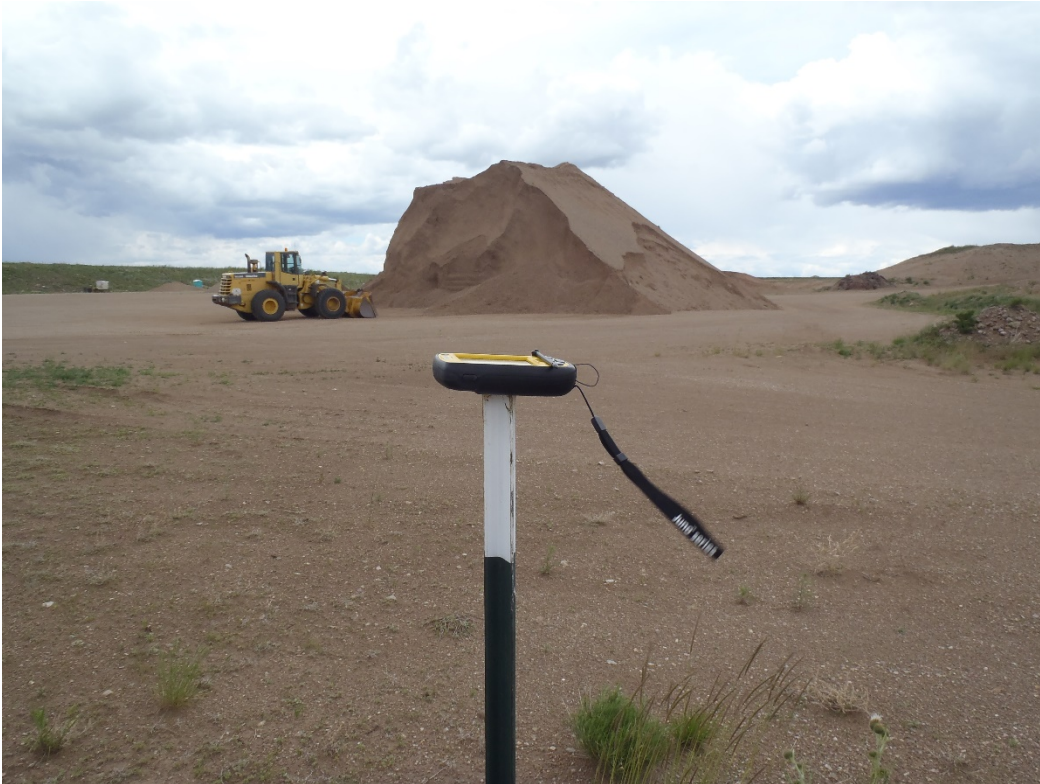
Photo 6. Loader and product stockpile (south side, looking north, note GPS unit on top of T-post).

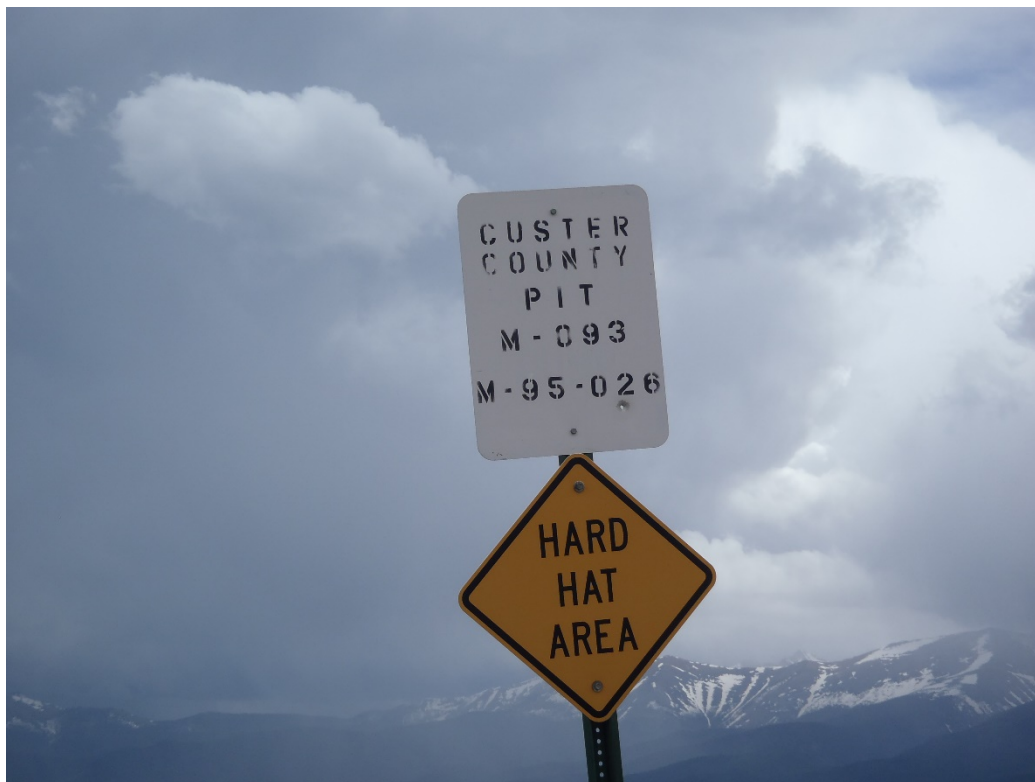
Photo 7. Permit sign at entrance (looking SW).

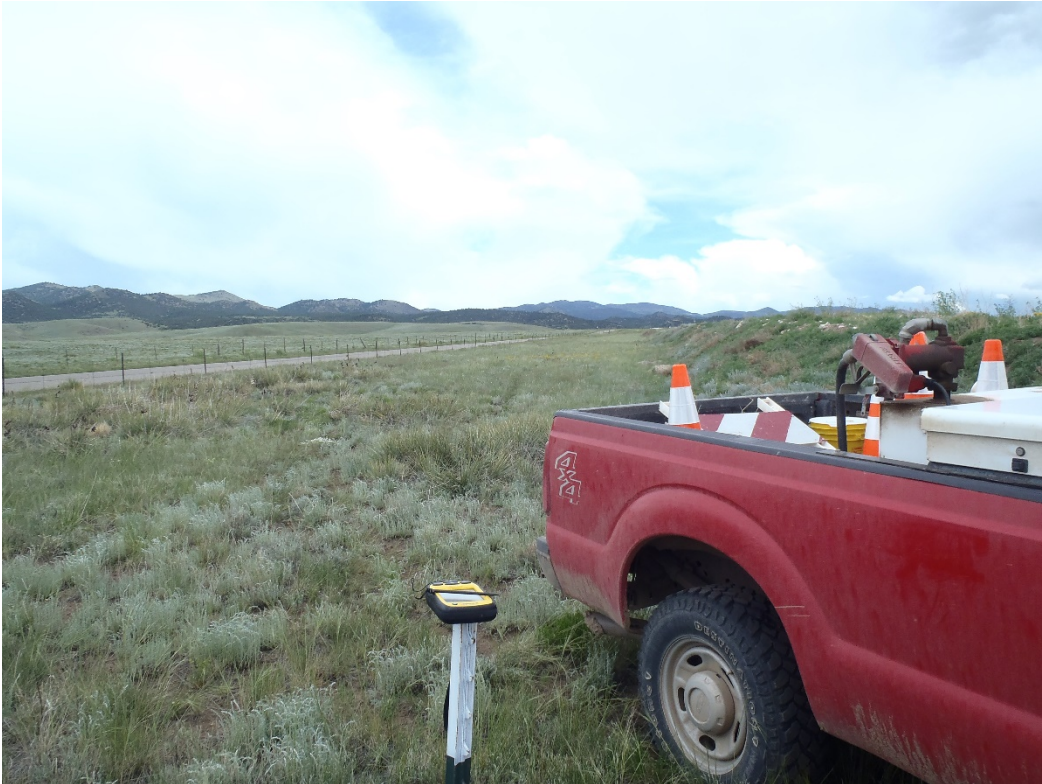
Topsoil: Topsoil stockpiles were observed on the pit floor and on the highwall crests (see **Photos 8 and 9**).

Photo 8. Topsoil stockpile on north end of pit (beyond pickup, looking east).

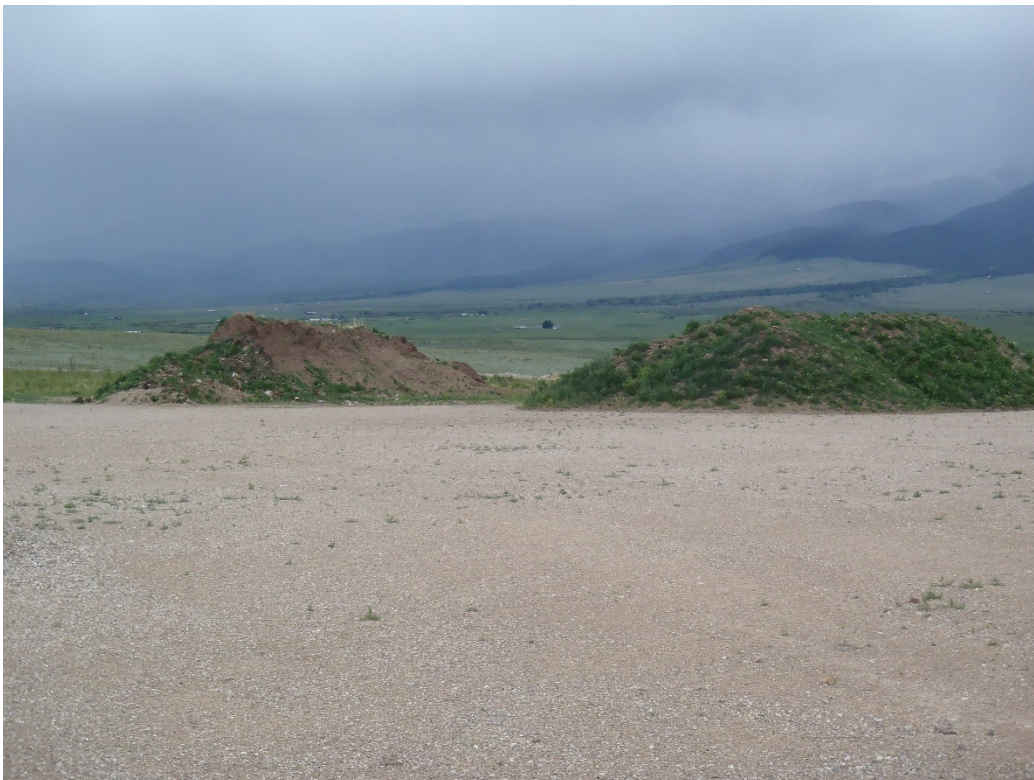
Photo 9. Topsoil stockpile (looking SW from pit floor).
