MINERALS PROGRAM INSPECTION REPORT
PHONE: (303) 866-3567

MINE NAME: Robinson Sons Gravel Pit No.1	MINE/PROSPECTING ID#: M-2008-076	MINERAL: Sand and Gravel	COUNTY: Las Animas
INSPECTION TYPE: Monitoring	INSPECTOR(S): Patrick Lennberg	INSP. DATE: October 22, 2019	INSP. TIME: 08:45
OPERATOR: Robinson Sons Inc.	OPERATOR REPRESENTATIVE: None	TYPE OF OPERATION: 112c - Construction Regular Operation	
REASON FOR INSPECTION: Priority	BOND CALCULATION TYPE: None	BOND AMOUNT: \$52,815.00	
DATE OF COMPLAINT: NA	POST INSP. CONTACTS: None	JOINT INSP. AGENCY: None	
WEATHER: Clear	INSPECTOR'S SIGNATURE:

MINERALS PROGRAM INSPECTION REPORT**PHONE: (303) 866-3567**

MINE NAME: Robinson Sons Gravel Pit No. 1	MINE/PROSPECTING ID#: M-2008-076	MINERAL: Sand and gravel and	COUNTY: Las Animas
INSPECTION TYPE: Monitoring	INSPECTOR(S): Jared L. Ebert	INSP. DATE: July 29, 2019	INSP. TIME: 12:00
OPERATOR: Robinson Sons Inc.	OPERATOR REPRESENTATIVE: Daniel Robinson	TYPE OF OPERATION: 112c - Construction Regular Operation

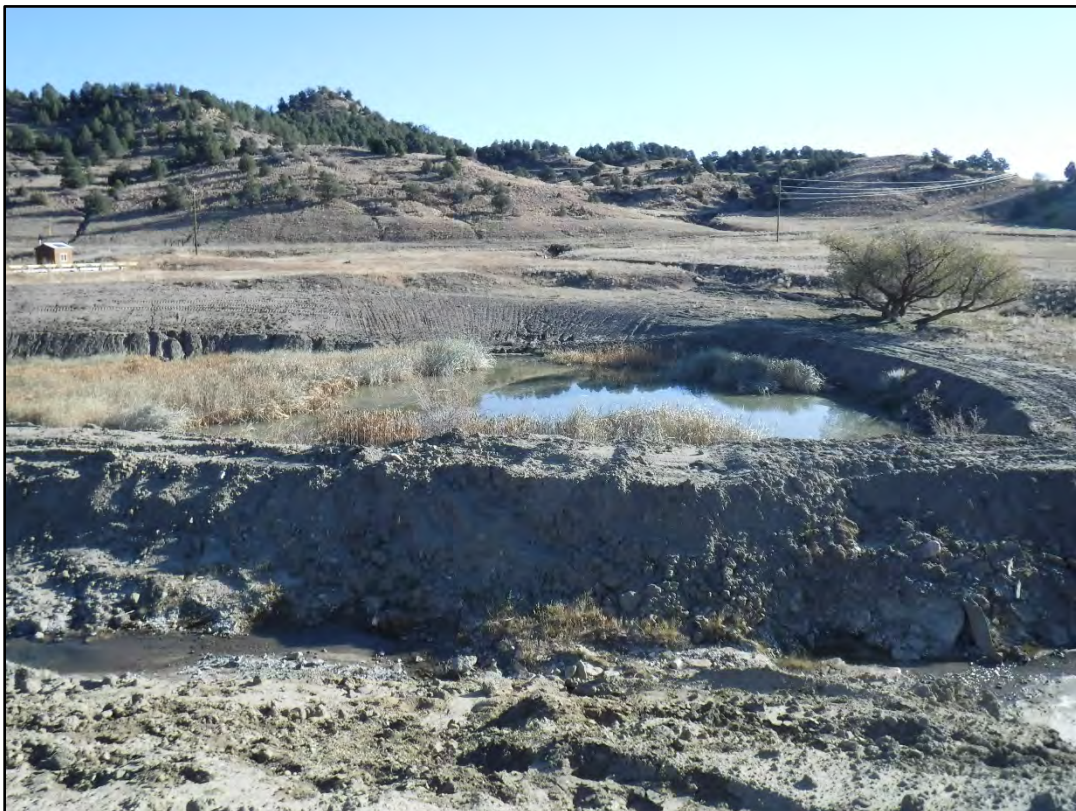
The two basins that are holding water, mentioned in the previous report, still contained water. In talking to Dan about these basins he stated that he was seeking approval and augmentation for these basins and was waiting to hear back from the city of Trinidad in the manner. He was expecting approval in the very near future.

Photo 2: One of the two ponds needing augmentation, this one is at the entrance to mine site

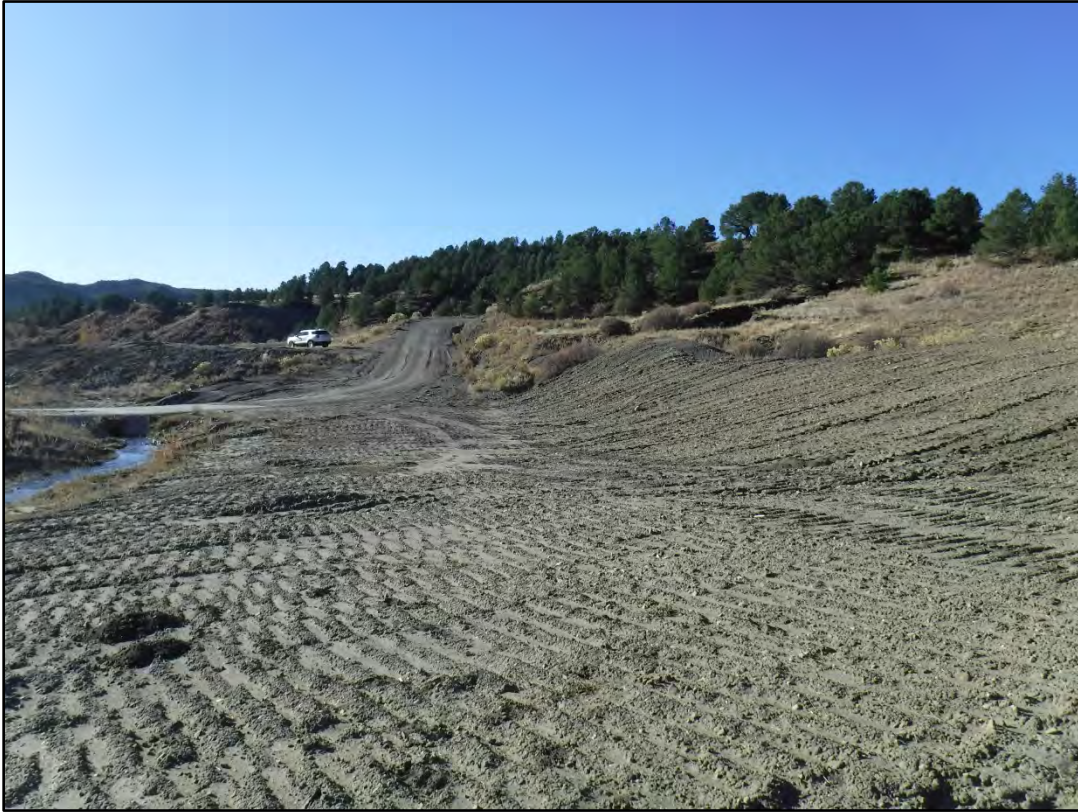
It does not appear that any of the previously reclaimed areas have been seeded.

Photo 3: Area near entrance to mine regraded but still needed seeding

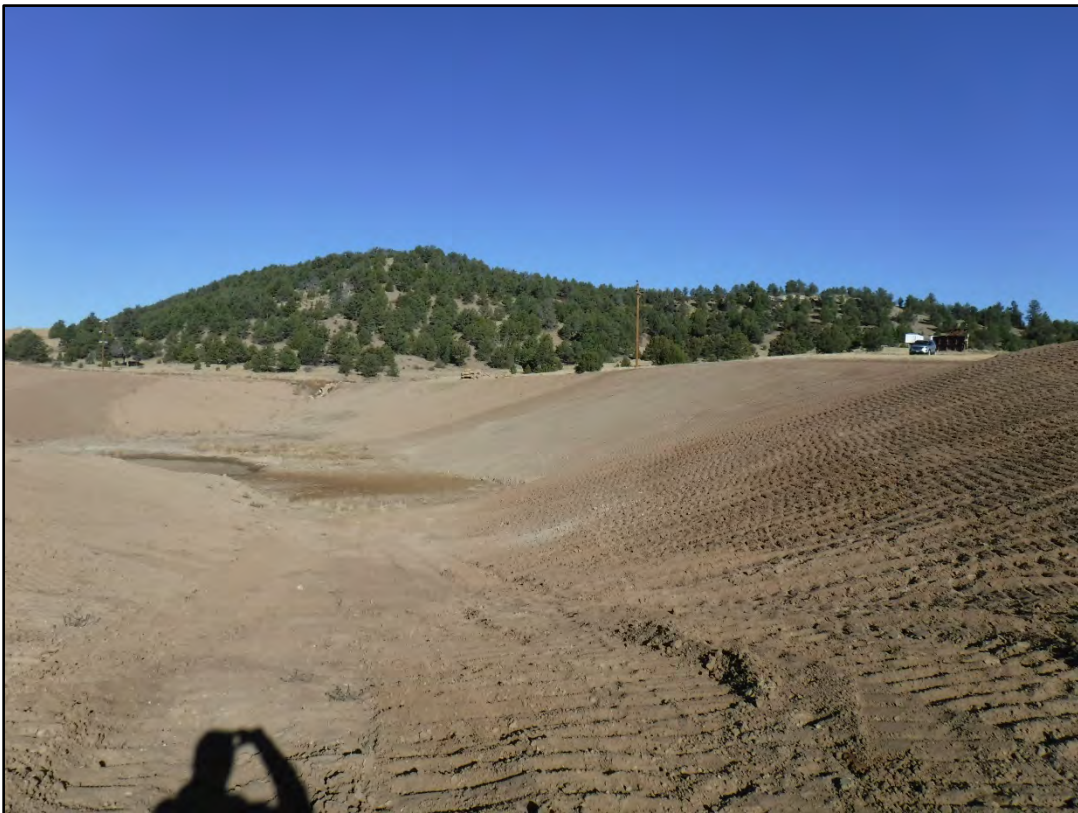
Photo 4: Basin in the eastern portion of Area 1, regraded slopes still require seeding

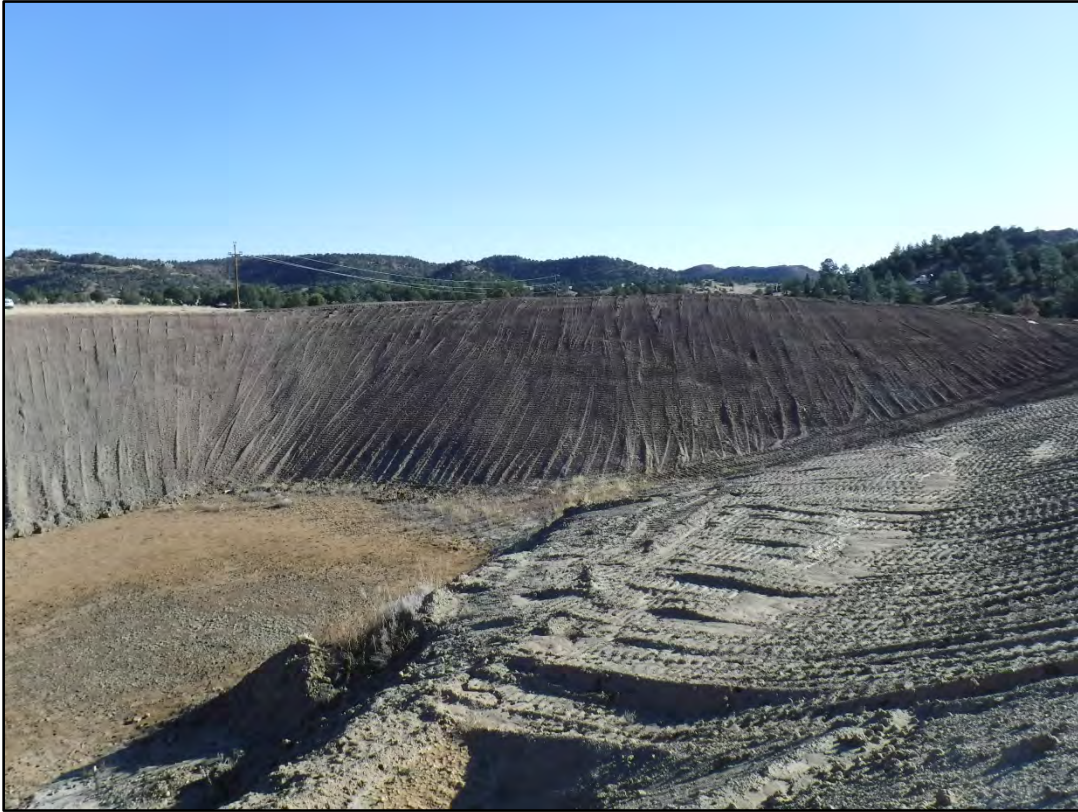
Photo 5: Outlet of basin in Area 1 still needs appropriate outlet unless otherwise allowed to detain water

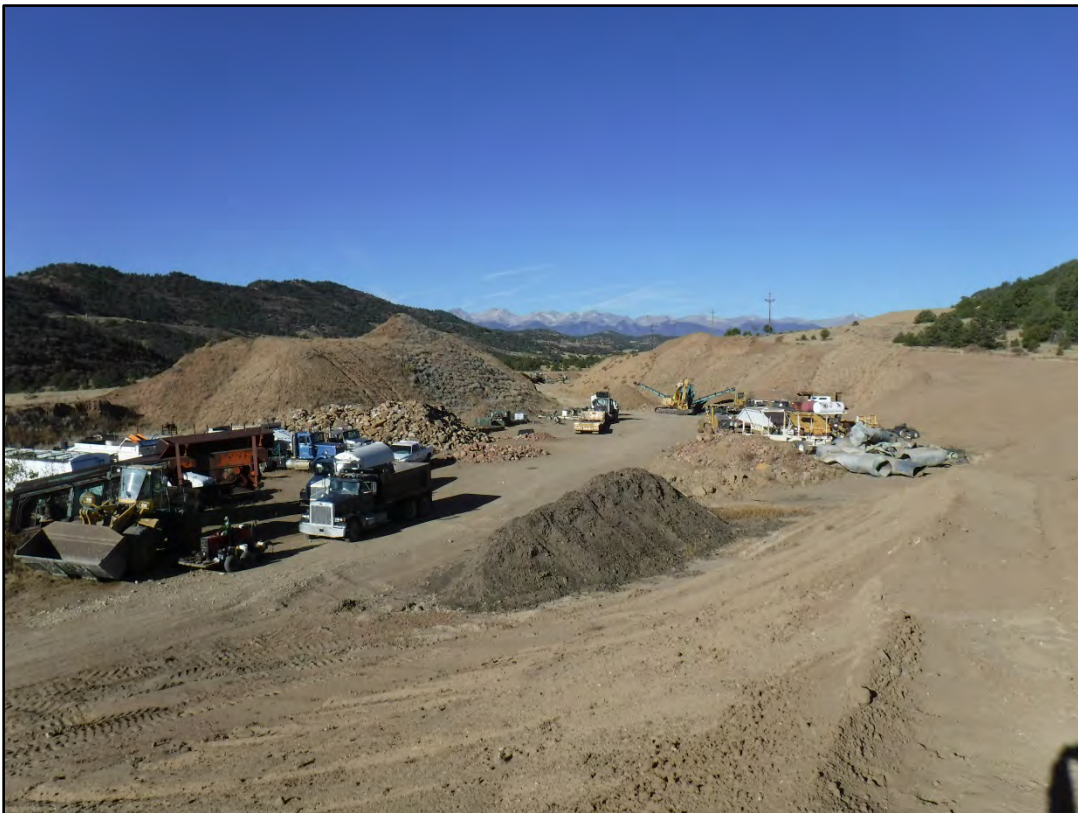
Photo 6: Large overburden stockpile center left of picture

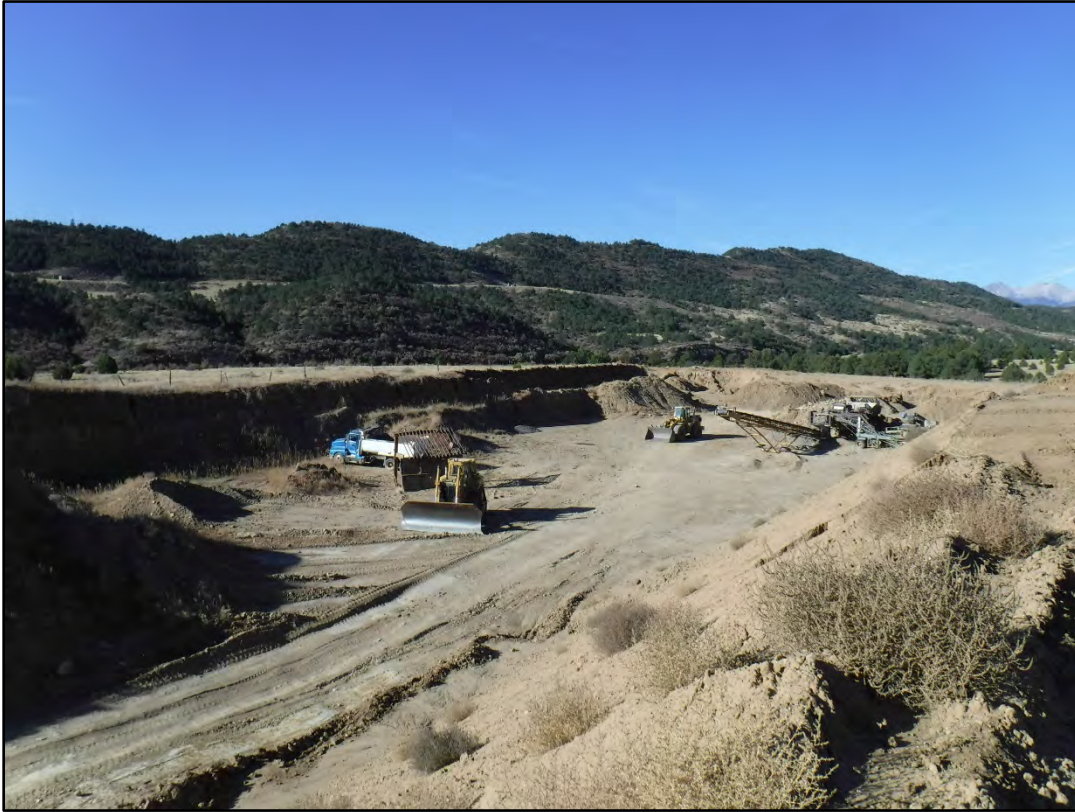
During the previous inspection it was noted that the large rectangular shaped pit, along the southern boundary of the permit area, was only 35% reclaimed. The excavation still appears to be in the condition. There are highwalls along the southern boundary that are 20 feet in height. The western and northern pit walls vary in angle but on average were set near the angle of repose. A large pile of overburden is adjacent to the southern highwall this pile is available for backfill and should be used to grade the highwalls to 3H:1V or shallower slope.

Photo 7: Near vertical highwall immediately west of overburden stockpile

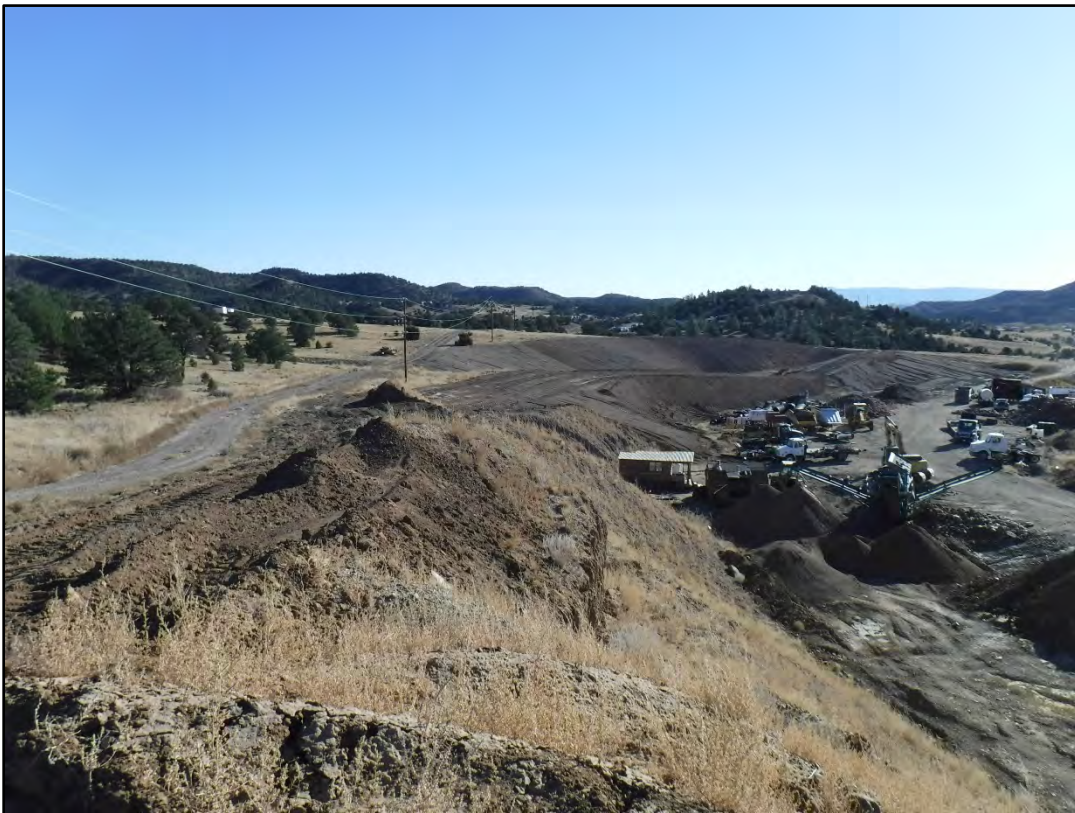
Photo 8: Looking east across the northern portion of Area 1

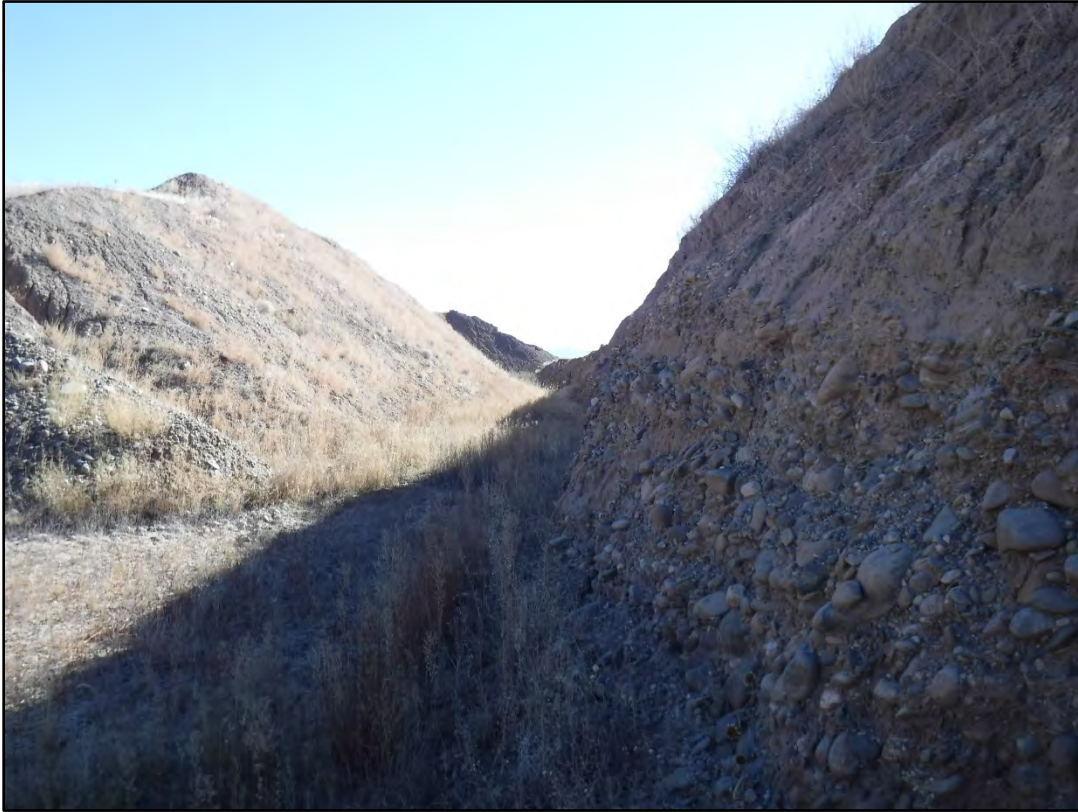
Photo 9: Looking east at the area between the highwall and the overburden stockpile

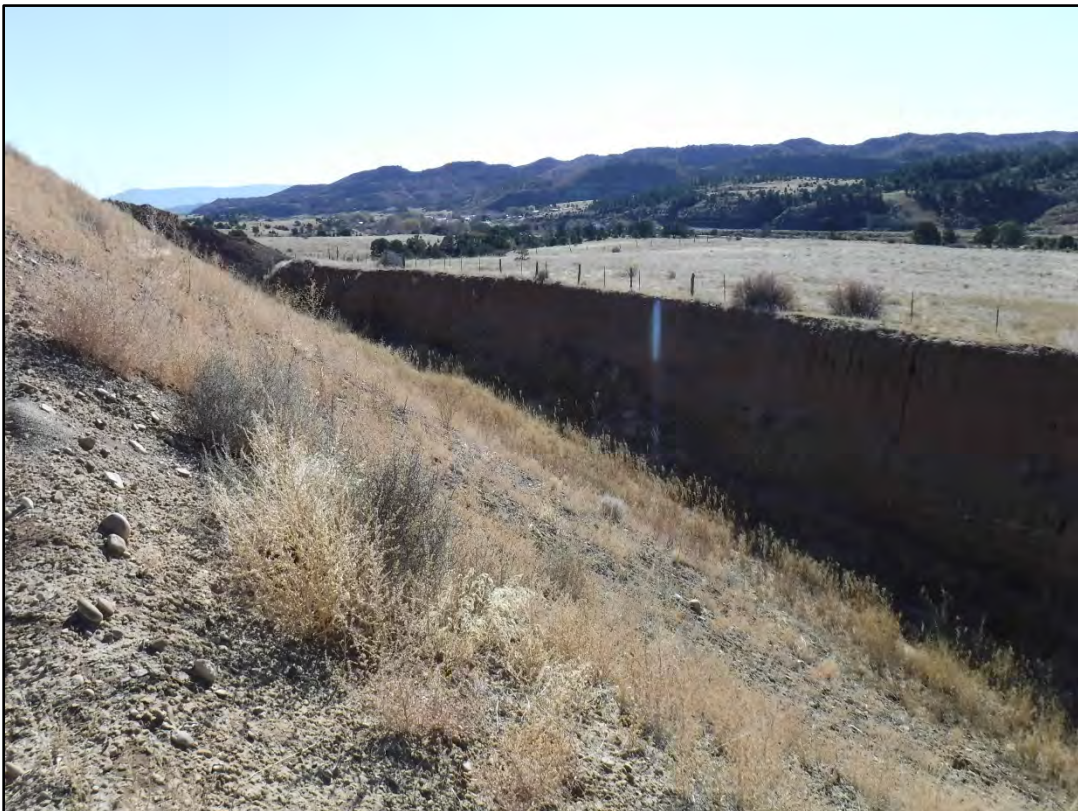
Photo 10: Looking south from the stockpile to the highwall that needs to re-graded to 3H:1V slope

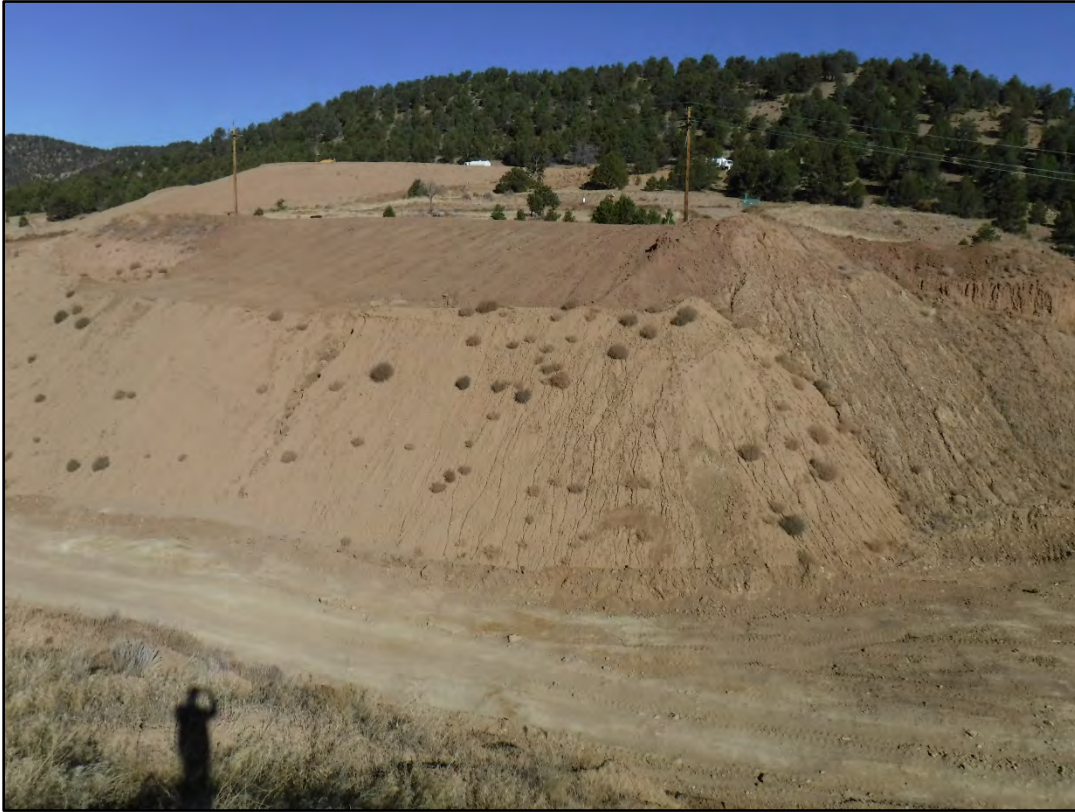
Photo 11: Looking north at the northern highwall along Area 1 that needs continued regrading

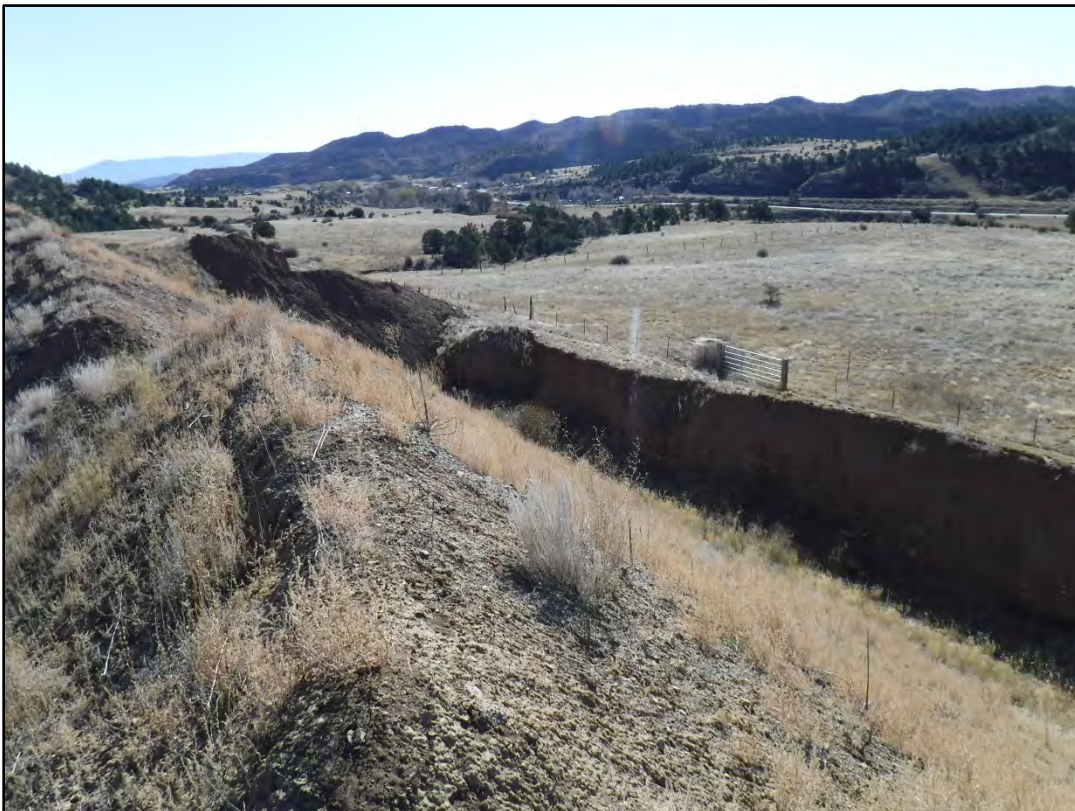
Photo 12: East end of overburden stockpile next to the highwall

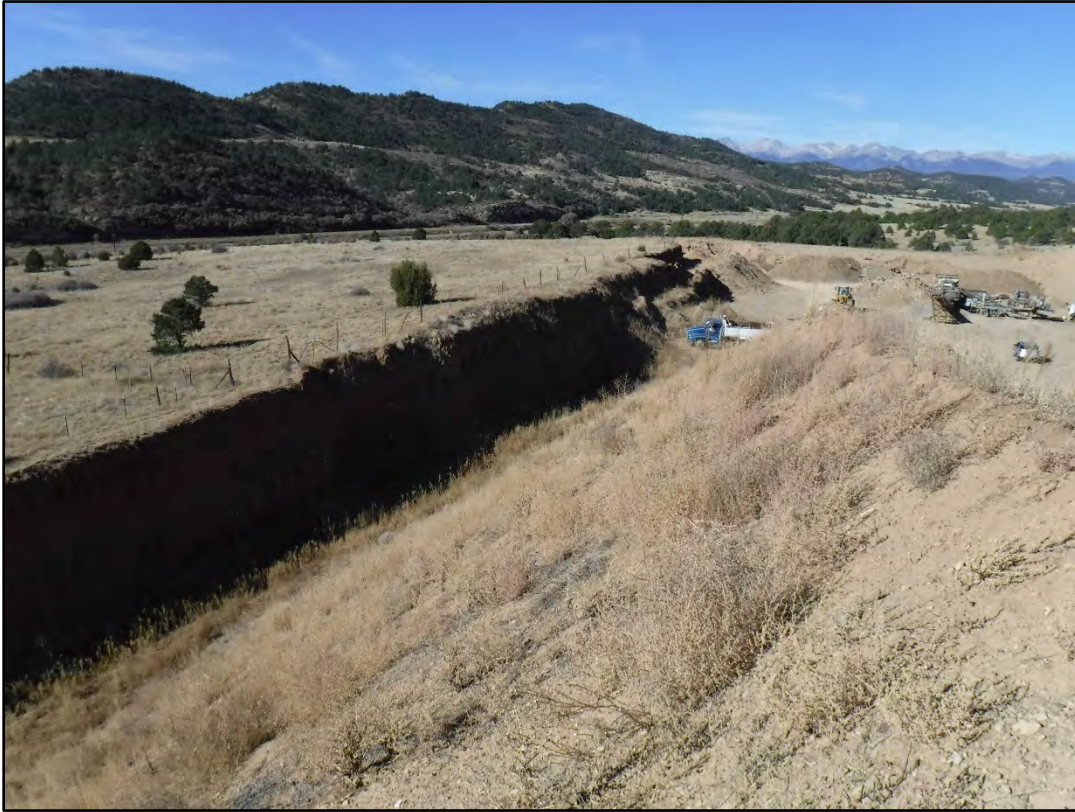
Photo 13: Looking west along the area between the highwall and stockpile

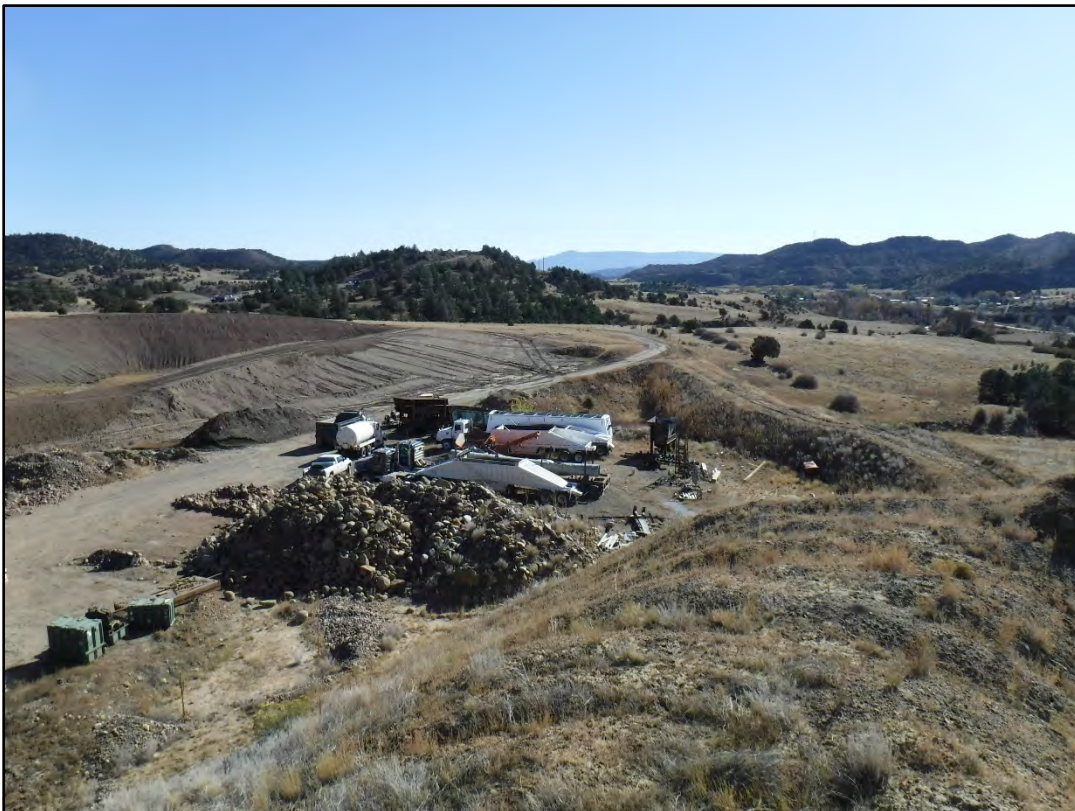
Photo 14: Looking east from the stockpile over the eastern portion of Area 1

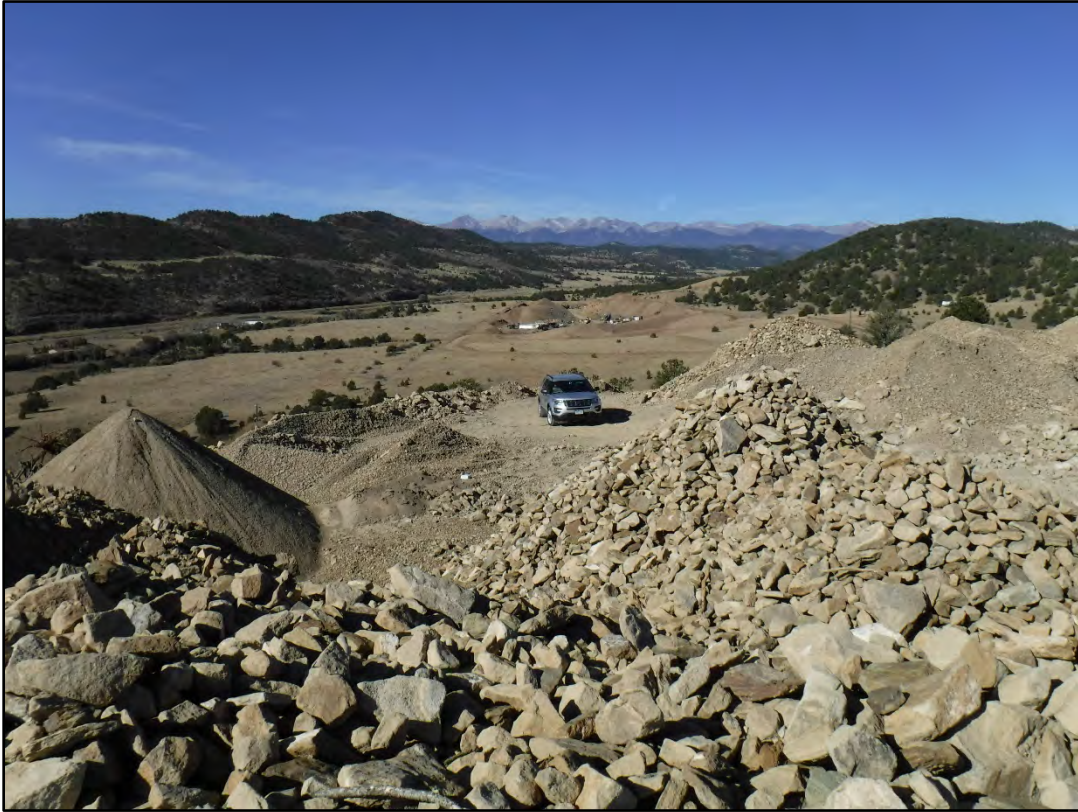
The last area that still needs to be reclaimed is an area on a hilltop towards the eastern end on the permit. Associated with this hilltop sandstone mining is a work area at the base on the access road to the top. This area still need to be reclaimed.

Photo 15: Looking west from Area 2 Sandstone mining area

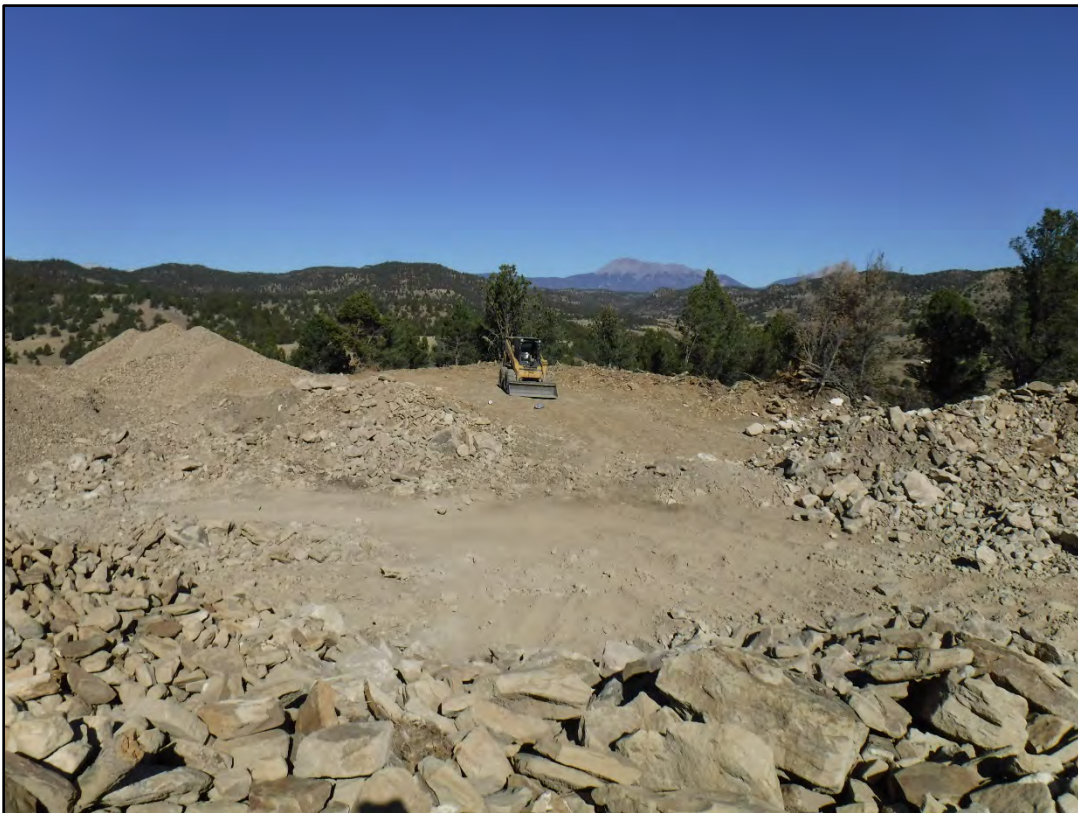
Photo 16: Looking north across Area 2

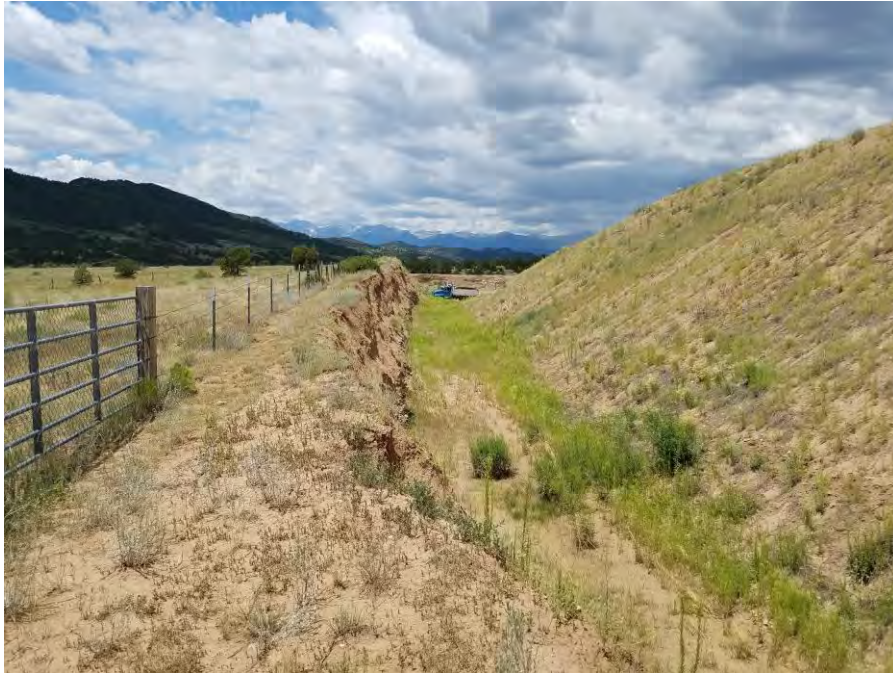
Figure 1. From the south central portion of the permit boundary looking west.

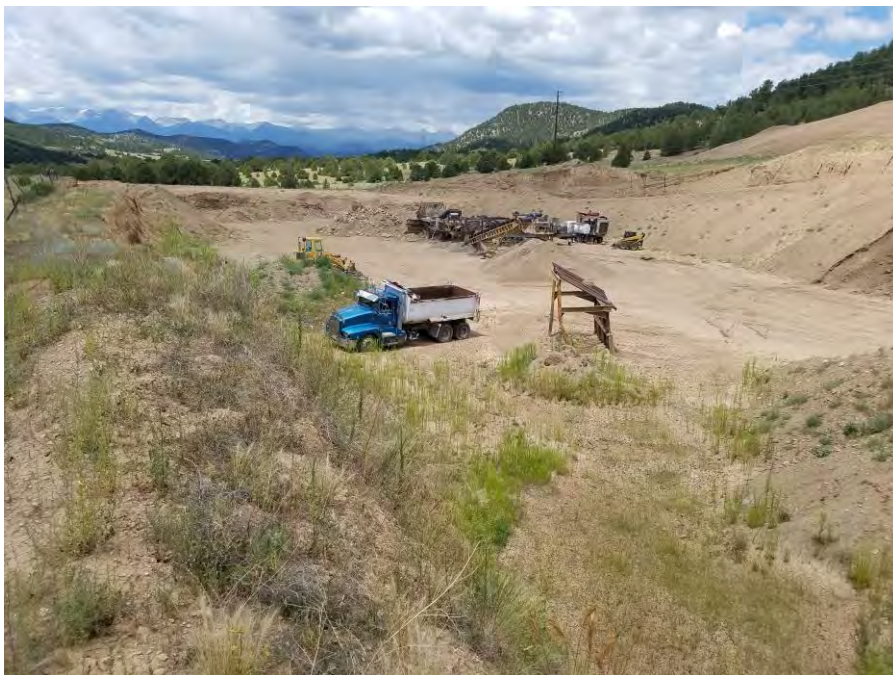
Area 1 consists of a large rectangular shaped pit excavation, a former overburden storage area and a partially regraded area. The pit appears to be on average 20 feet deep with near vertical highwalls along the southern permit boundary. The western and northern pit walls vary in angle but on average were set near the angle of repose. Robinson has graded the eastern quarter of the pit slopes to a 3H:1V angle or less. A small ephemeral drainage enters through a culvert that drains into the pit basin. A large stockpile of topsoil is located in the southeast corner of the Area 1 pit basin. This pile appears to be acting as an impoundment and does not allow the affected land to drain and standing water was observed in the base of the pit. The southern pit slopes were found to be near vertical in most places and there is no room for Robinson to cut and fill these slopes. However, a large pile of overburden is located at the base of this highwall and is available for backfill material. Northwest of the pit excavation is an area that appears to have been previously used for overburden storage. This area has been graded to nearly blend in with the surrounding hillside. However, the eastern portion of this area has steep near angle of repose side slopes. The Division estimates about 35% of the earthwork is completed in the Area 1 portion of the affected land.

Figure 2. From the south western end of the south boundary looking west by northwest into Area 1 pit.

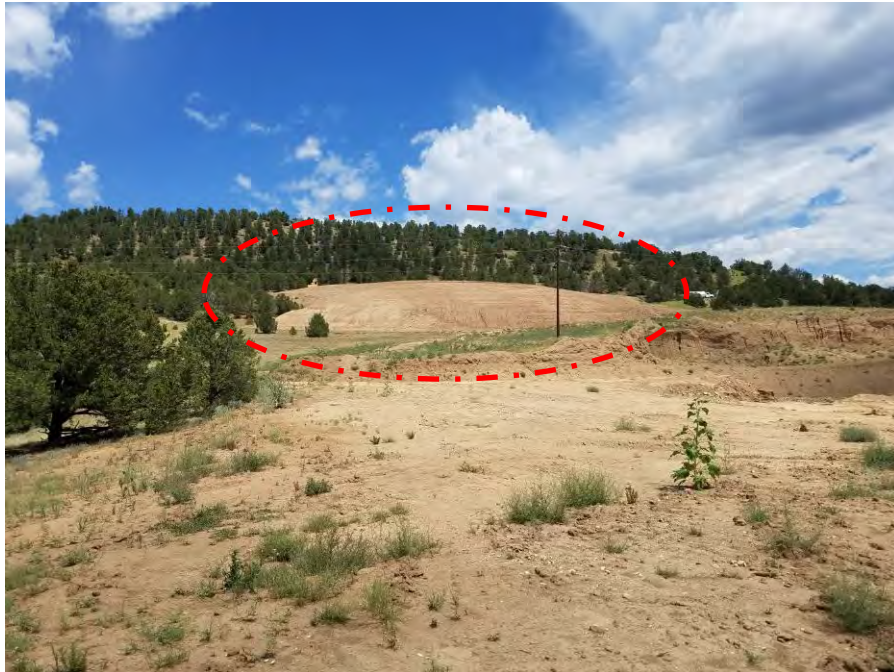
Figure 3. From the southwest corner of the Area 1 affected land looking north. The overburden storage area outlined in red.

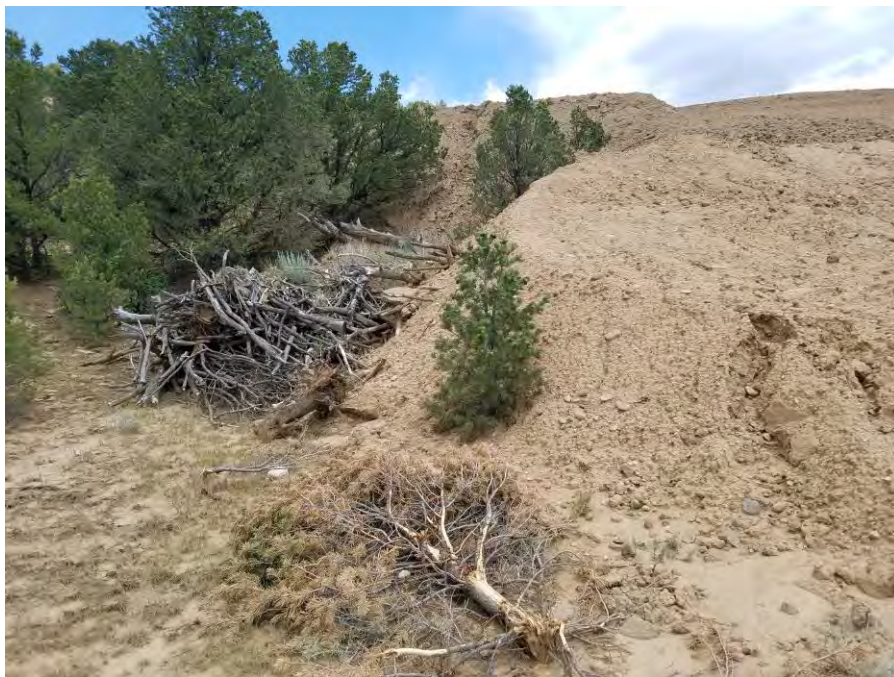
Figure 4. From the southwest end of the former overburden storage area looking north. Steep slope area that will need to be graded.

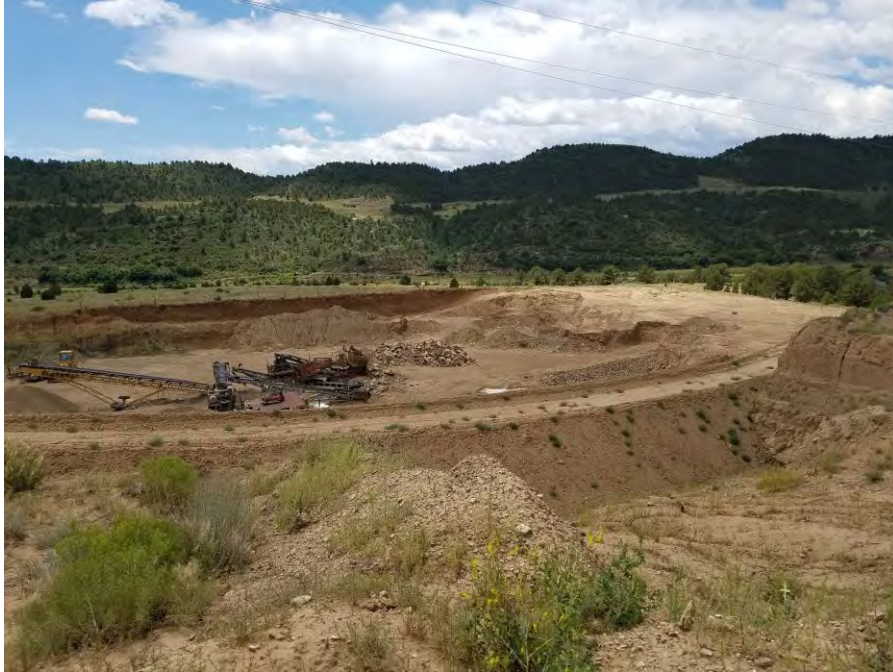
Figure 5. From the north side of the southwest portion of Area 1 looking south.

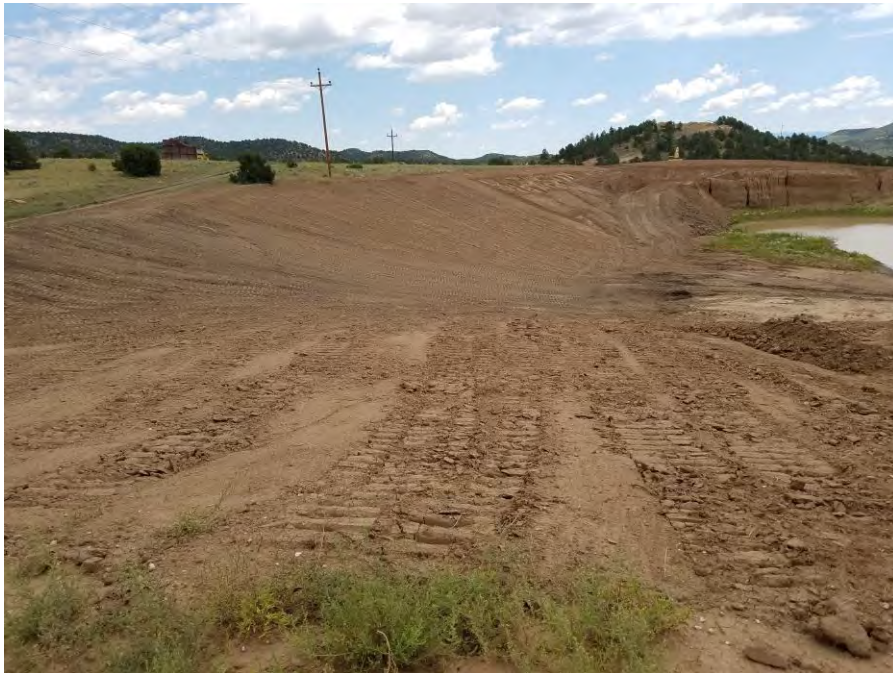
Figure 6. From the north central portion of Area 1 looking southeast at the graded portion of Area 1.

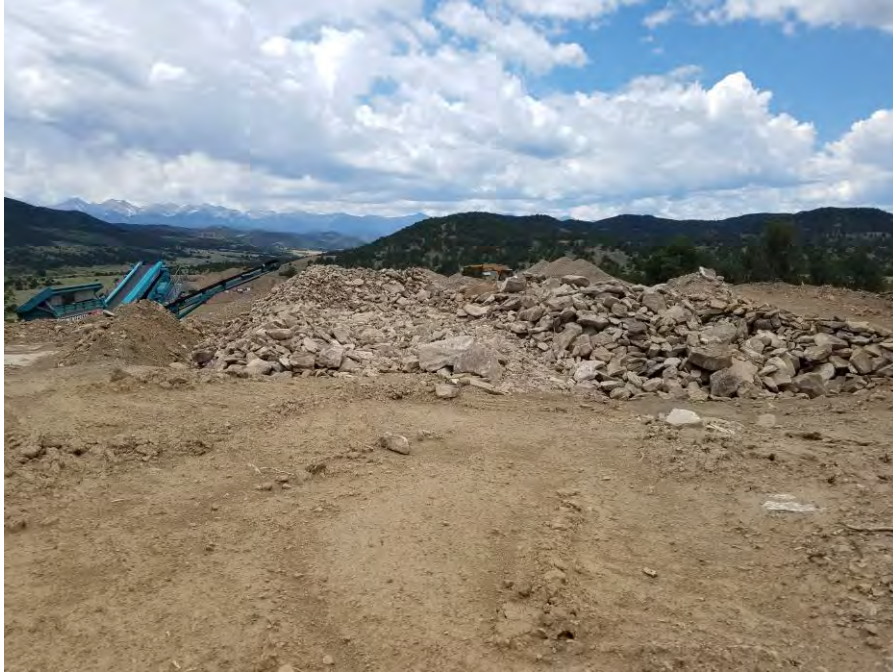
Area 2 consists of an access road, a lower work area and an upper area on top of the hill. Robinson has excavated and lowered the top of the hill in Area 2 and various stockpiles of product and a crusher are stored

Figure 7. Top area of Area 2.

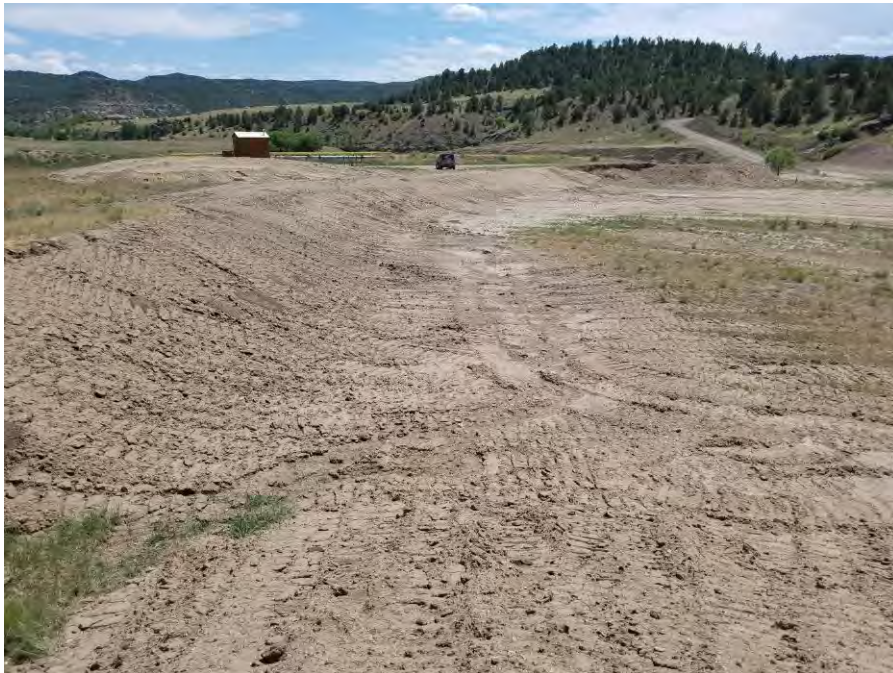
Figure 8. Reclamation Area Only parcel. North of the access road looking south from the east end.

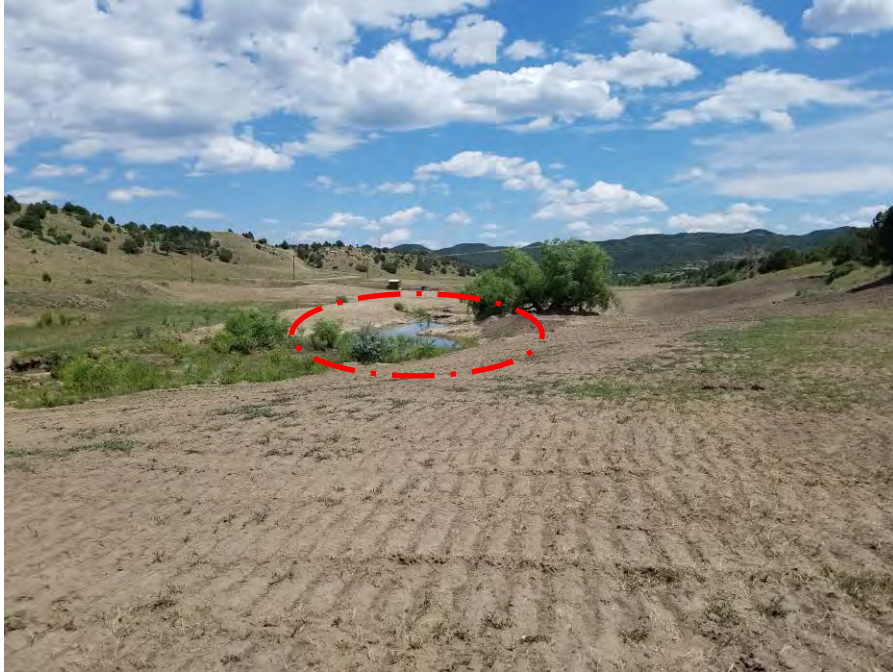
PROBLEM: The Division has no evidence that the operator has a valid well permit, substitute water supply plan, or approved water augmentation plan for the exposed groundwater and/or impounded surface water in the two pit basins located in the Reclamation Area Only parcel near the entrance to the site north and south of the access road. This is a problem related to section 34-32.5-116(4)(h) of the Colorado Revised Statutes and 3.1.6(1)(a) of the Construction Materials Rules and Regulations governing injury to existing water rights.

The two basins/impoundments discussed above are holding water. This issue is cited as a problem at the beginning of this report. Robinson must either submit documentation that they have approval from the Division of Water Resources for the impoundment of this water or backfill these basins so that water is no longer impounded.

Figure 9. From the north end of the Reclamation Area Only parcel looking south.
Northern water basin highlighted in red.

CORRECTIVE ACTIONS: The Operator shall demonstrate that the operation is in compliance with the Colorado Division of Water Resources (DWR), show evidence that the operator is taking measures to bring the site into compliance with the DWR, or backfill the pits to at least two feet above the water surface by the corrective action date specified.

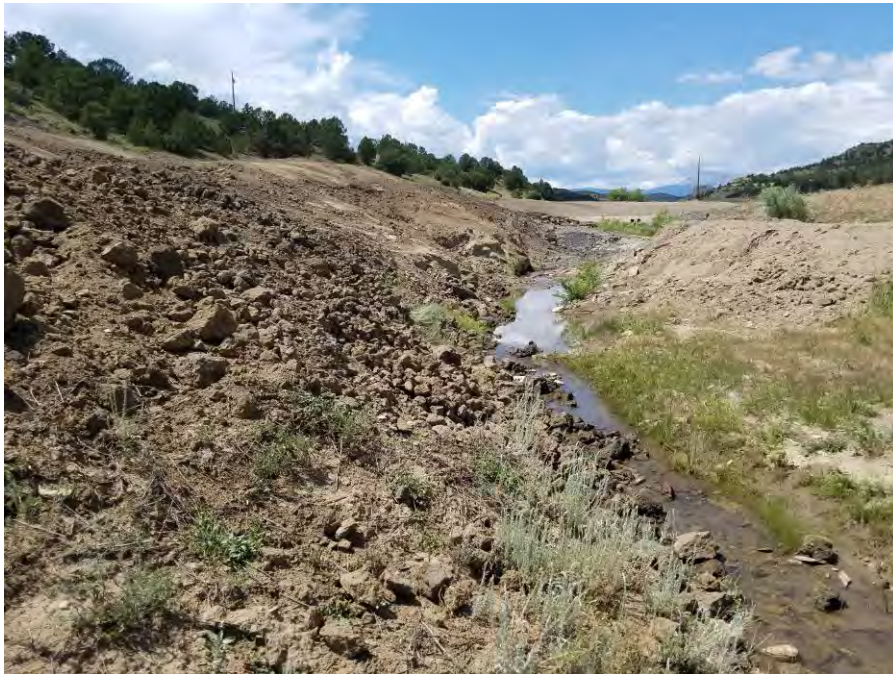
Figure 10. Re-established stream channel on the south side of the Reclamation Area only
parcel looking north.

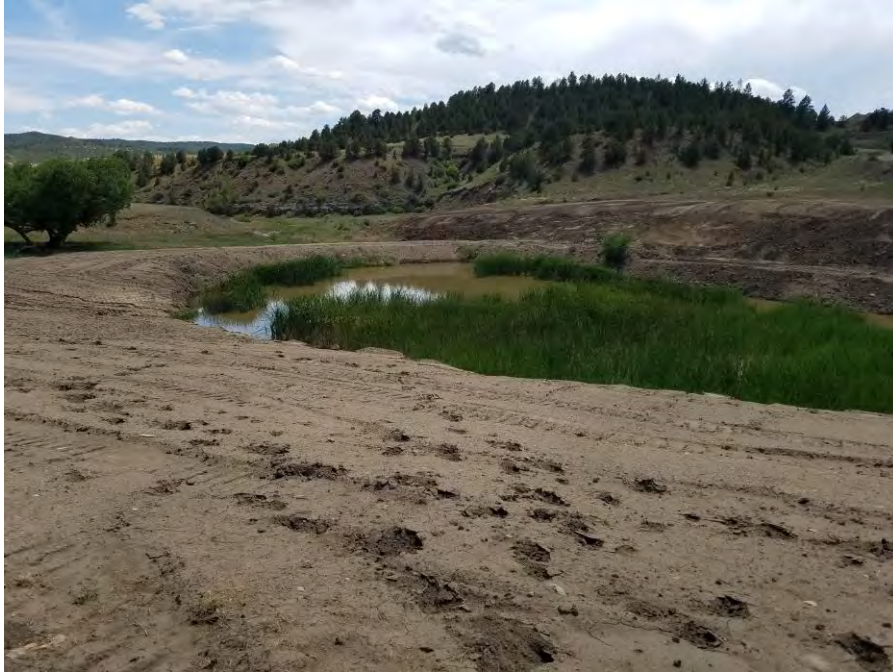
Figure 11. Pit basin on the south side of the access road from the east side looking west.
