MINERALS PROGRAM INSPECTION REPORT
PHONE: (303) 866-3567

MINE NAME: Cresson Project	MINE/PROSPECTING ID#: M-1980-244	MINERAL: Gold	COUNTY: Teller
INSPECTION TYPE: Monitoring	INSPECTOR(S): Patrick Lennberg and Brock Bowles	INSP. DATE: November 4, 2019	INSP. TIME: 09:30
OPERATOR: Cripple Creek & Victor Gold Mining Company	OPERATOR REPRESENTATIVE: Katie Blake	TYPE OF OPERATION: 112d-3 - Designated Mining Operation	
REASON FOR INSPECTION: Normal I&E Program	BOND CALCULATION TYPE: None	BOND AMOUNT: \$209,491,188.00	
DATE OF COMPLAINT: NA	POST INSP. CONTACTS: None	JOINT INSP. AGENCY: None	
WEATHER: Clear	INSPECTOR'S SIGNATURE:

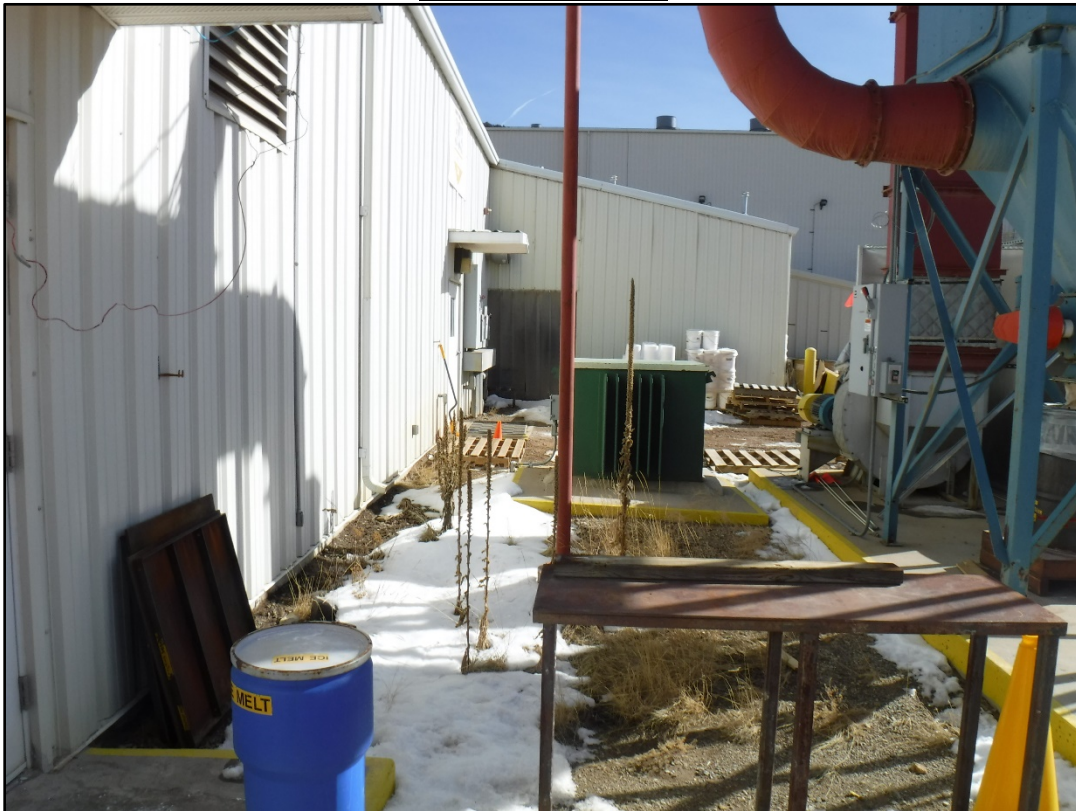
The Division walked the perimeter of the Assay Lab area, no problems were observed.

Photo 1: Assay Lab exterior looking east from main entrance

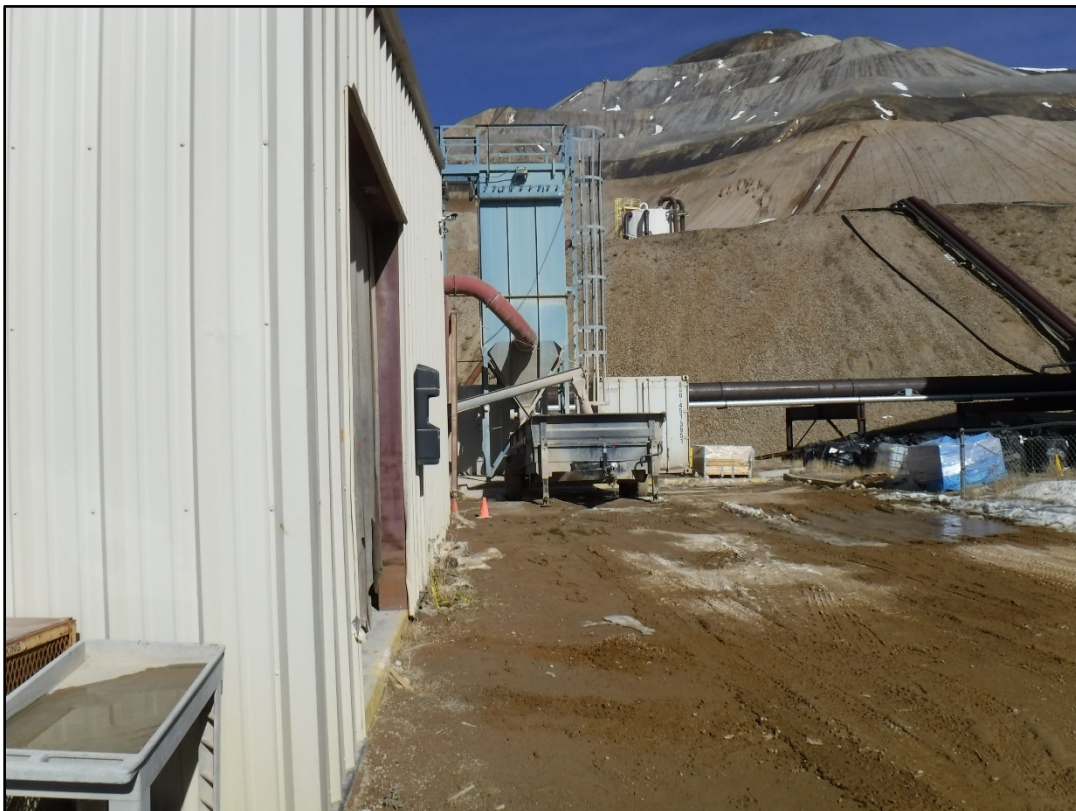
Photo 2: Assay lab east end of building

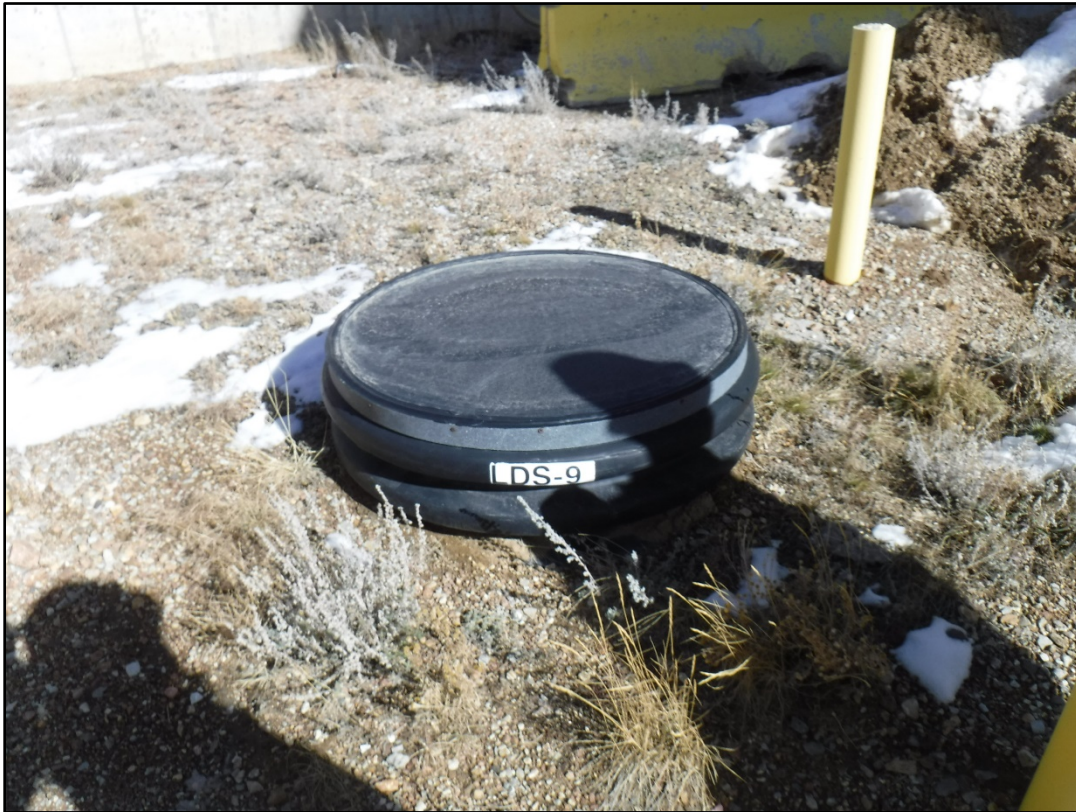
One of the 15 of the AGVLF Leak Detection System (LDS) sumps was inspected, AG-LDS-9. The sump was found to be dry. The operator must inspect all sumps weekly, and sample and characterize any water present. Any

Photo 3: Leak Detection System Sump, LDS-9 (dry)

water should be removed after sampling so it can be determined if water continues to enter the sump.

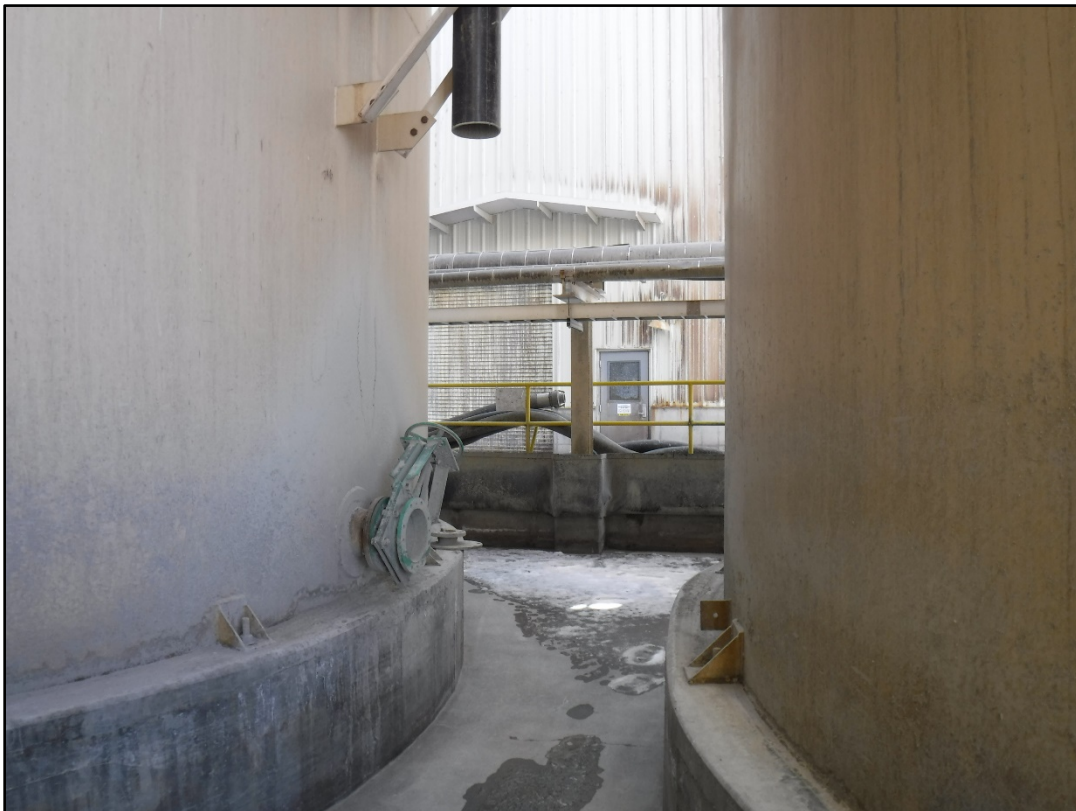
Photo 4: Secondary containment area of the Vat Leach area, note no sediment

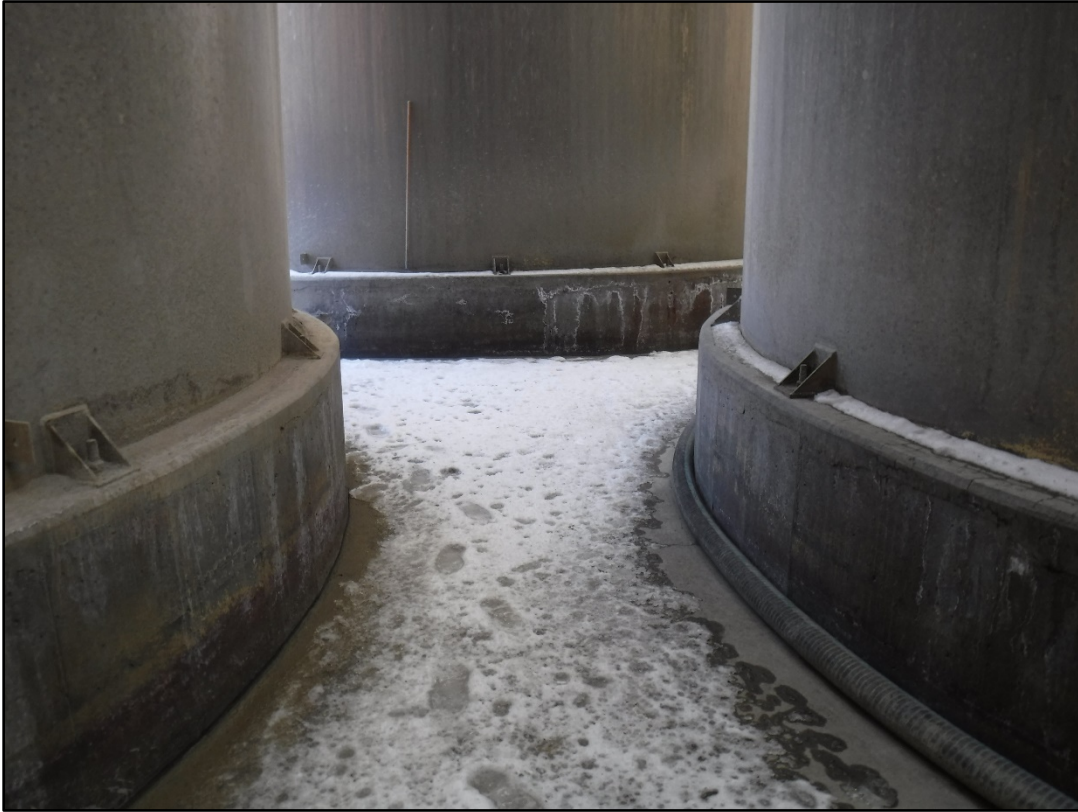
Photo 5: Secondary containment area of the Vat Leach area, note no sediment

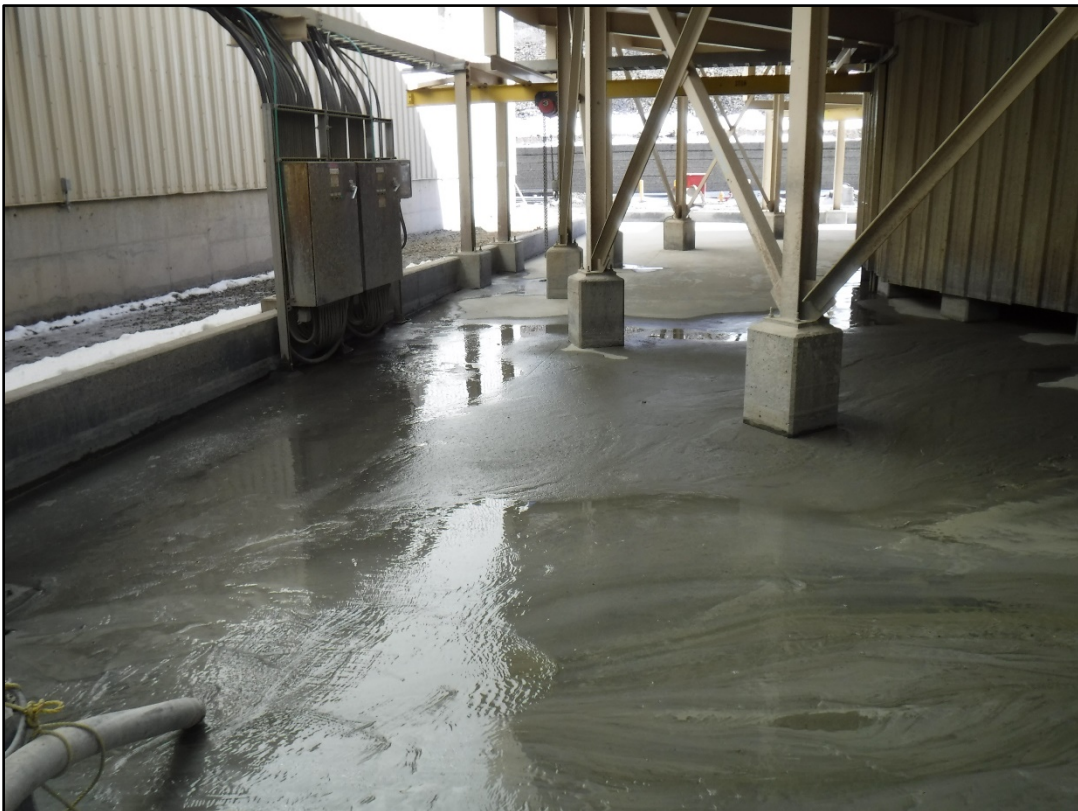
The Division performed a mill exterior walk-around inspection. The purpose was to perform a visual inspection for leaks, spills and secondary containment problems. Both the east and west sides of the mill exterior were inspected, as well as the area around the concentrate storage facility (Con Barn). No problems were observed. All the sediment that was in the Vat Leach area secondary containment on the west side of the Mill had been removed (as indicated via an email dated 9/30/2019).

Photo 6: Secondary containment area on the east side of the Mill

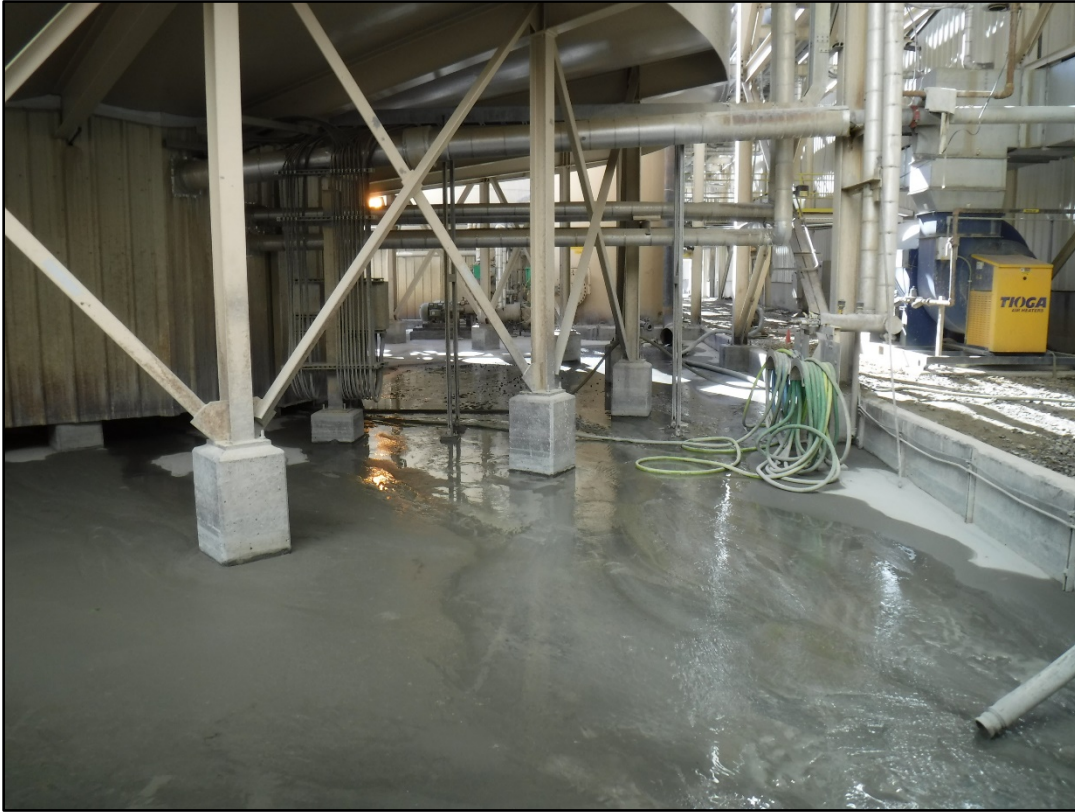
Photo 7: Secondary containment area on the east side of the Mill

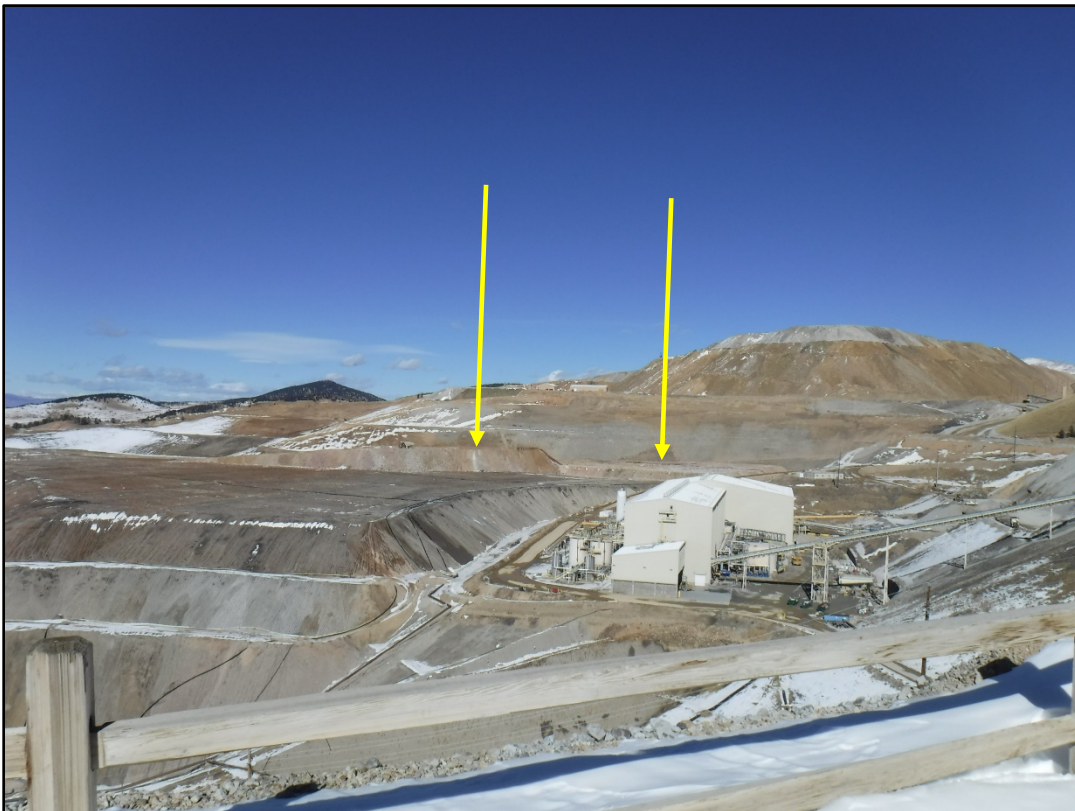
The operation is currently advancing the 9,950 foot lift with run of mine material mixed with cement material, approved through TR-111, which is dispensed directly into the truck beds from the relocated silo approved through TR-114. Run of mine material is ore material of sufficient quality that it can be leached without having to be crushed. Additionally, crushed material is being placed along the 9,850 foot lift. These two lifts are being built out northwest of the mill facility. The Division inspected active leaching surfaces on the SGVLF. The operation is required to minimize ponding of leaching solution to less than 3 feet by 3 feet in area. This is to prevent the ponds from being a wildlife attractant. Active leaching areas appeared to be well-rippled to minimize ponding. No ponding was observed.

Photo 8: VLF 2 overlook area, arrows indicate active dumping areas

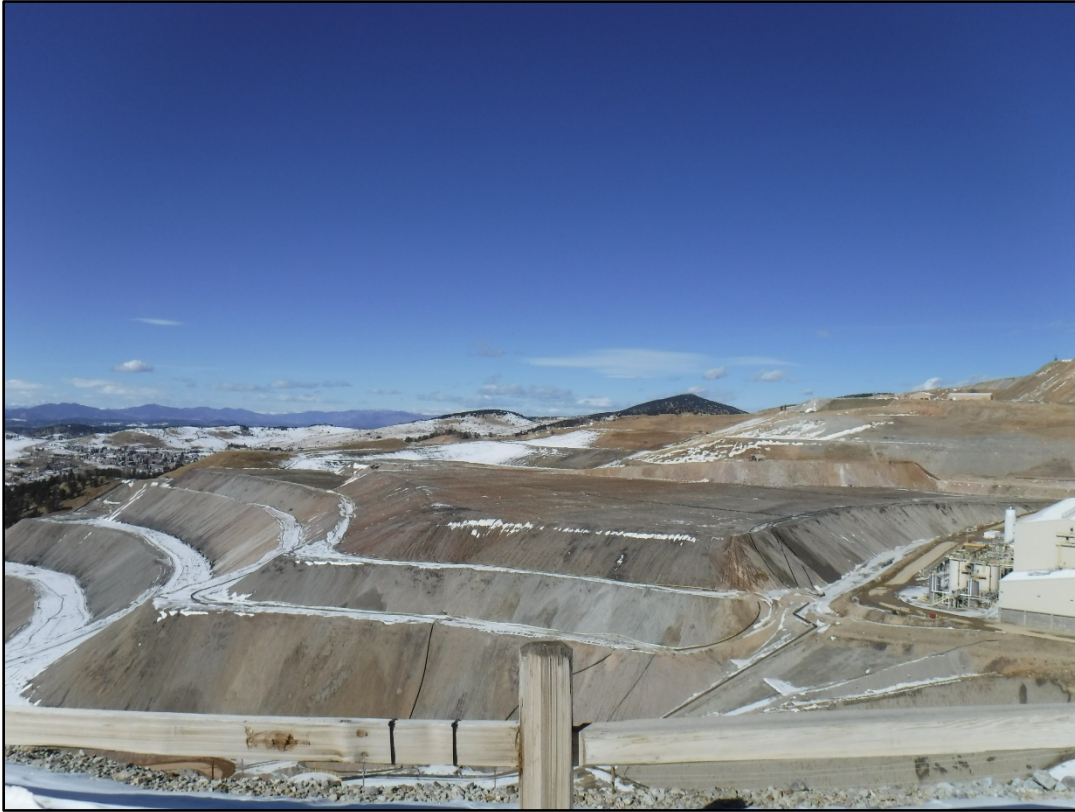
Photo 9: VLF 2 overlook area, no ponding visible at the time of inspection

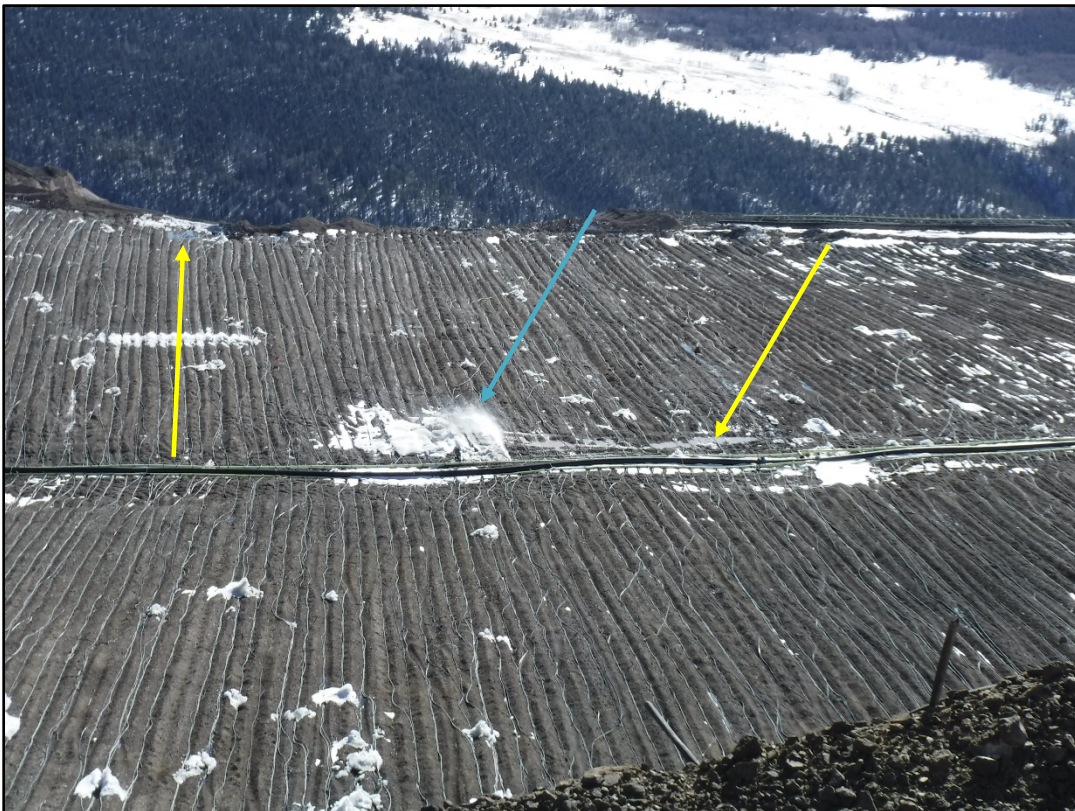
The current and maximum elevation of ore placement in the AGVLF is 10,400 feet (for Phase V). The Division inspected active leaching surfaces on the AGVLF. These surfaces were well saturated and ponding of leachate, greater than 3 feet by 3 feet, was observed. In addition, ponding of leachate was observed on the lower 10,200 foot level, although not as common as was observed on the upper level. The snow storm last week, the reason for rescheduling this inspection, resulted in several inches of snow accumulation. The weekend after the storm and prior to the inspection the temperatures rose substantially resulting melting of most all of the snow that fell. It is believed that the majority of the ponded water is a result of the quick snow melt. Prior to writing this inspection report the Operator stated that they were in the process of ripping the surface material to promote infiltration. The inspectors did note that a crew had arrived at the 10,400 foot level to begin addressing the ponding issues.

Photo 10: AGVLF 10,200' level, ponding water indicated by yellow arrows and spraying water indicated by blue arrow

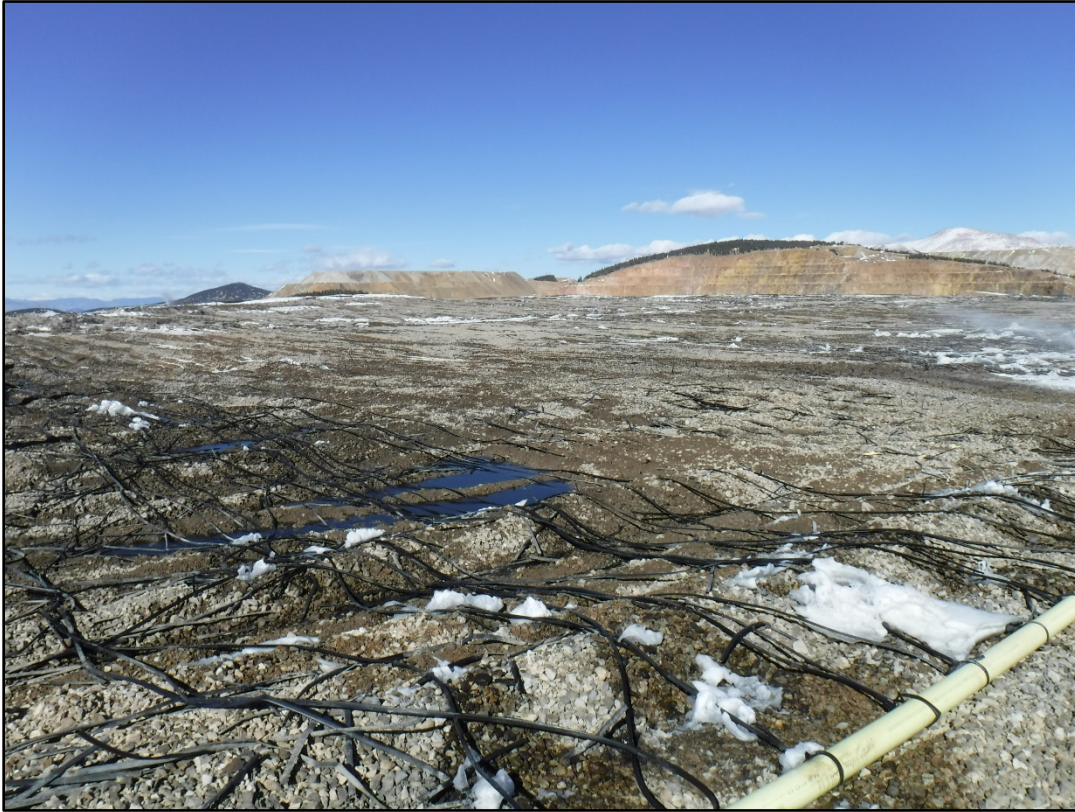
Photo 11: AGVLF 10,400' level, typical conditions

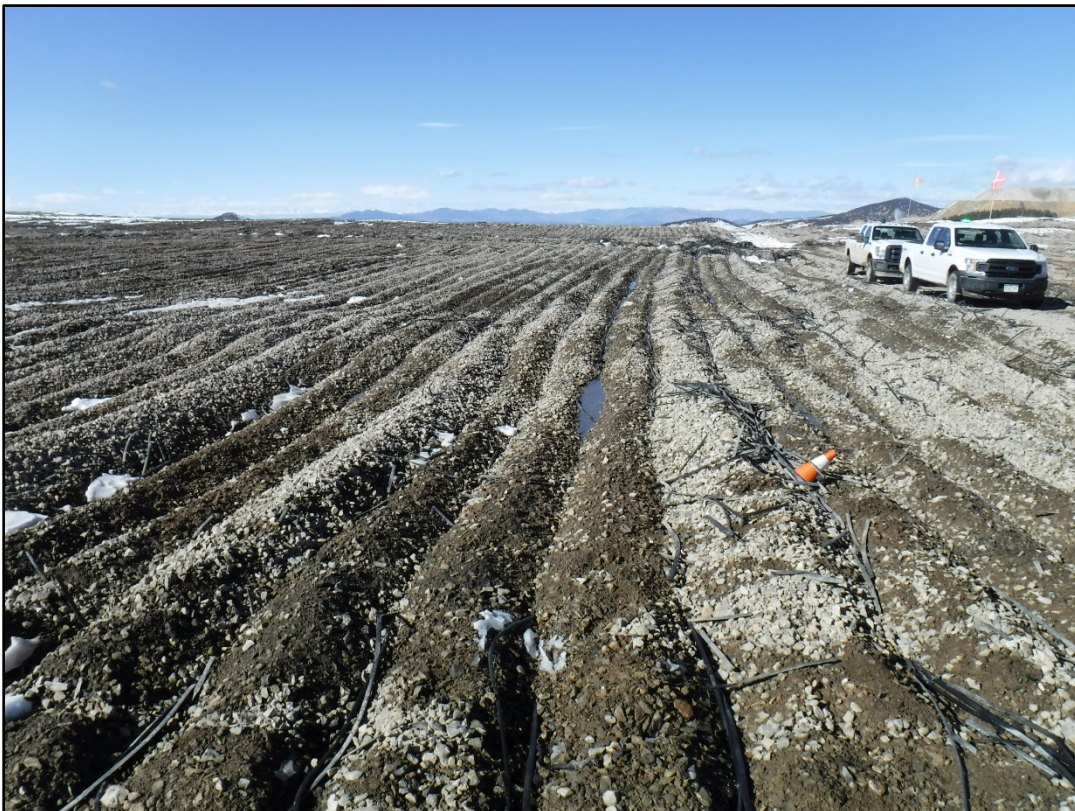
Photo 12: AGVLF 10,400' level, typical conditions

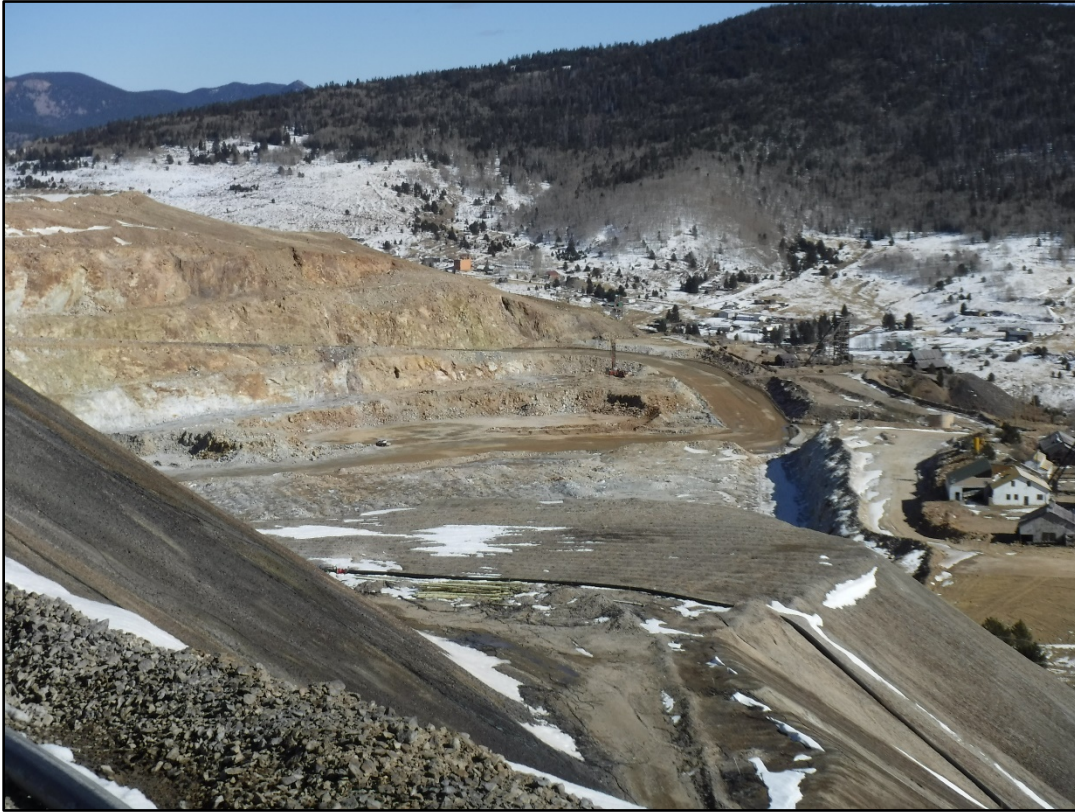
Photo 13: A view of the South Cresson Pit from AGVLF 10,400' level

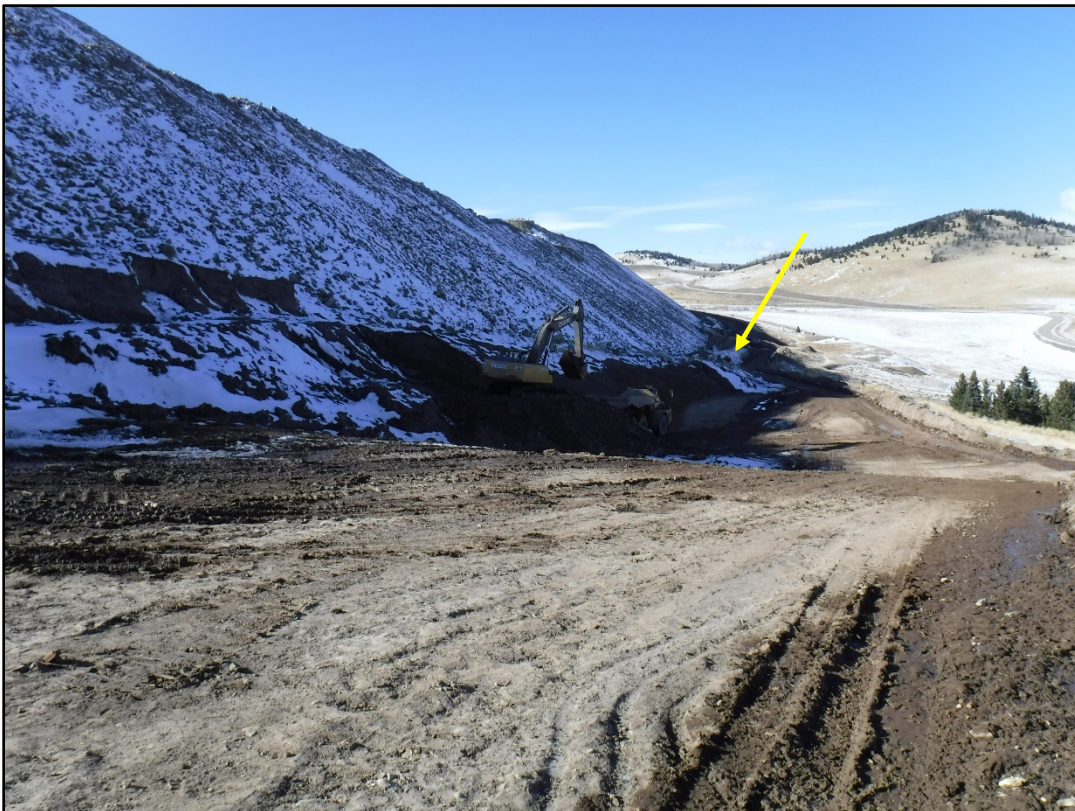
The Division inspected the seep area located at the eastern toe of the ECOSA. The Operator at the time of the inspection had employed a subcontractor, Conley Construction of Cripple Creek, to excavate clay material to be stockpiled for Phase 3 liner construction (Amendment 13) and potential reclamation efforts. The excavation began near where the ECOSA seep water is collected and pumped out when needed and continued up the road to the south. The material is being removed to depths up to 30 feet in 10 foot benches. The clay is being hauled to the clay stockpile area where there is a clay processing plant.

Photo 14: ECOSA clay excavation looking north, arrow indicates location of seep collection pump

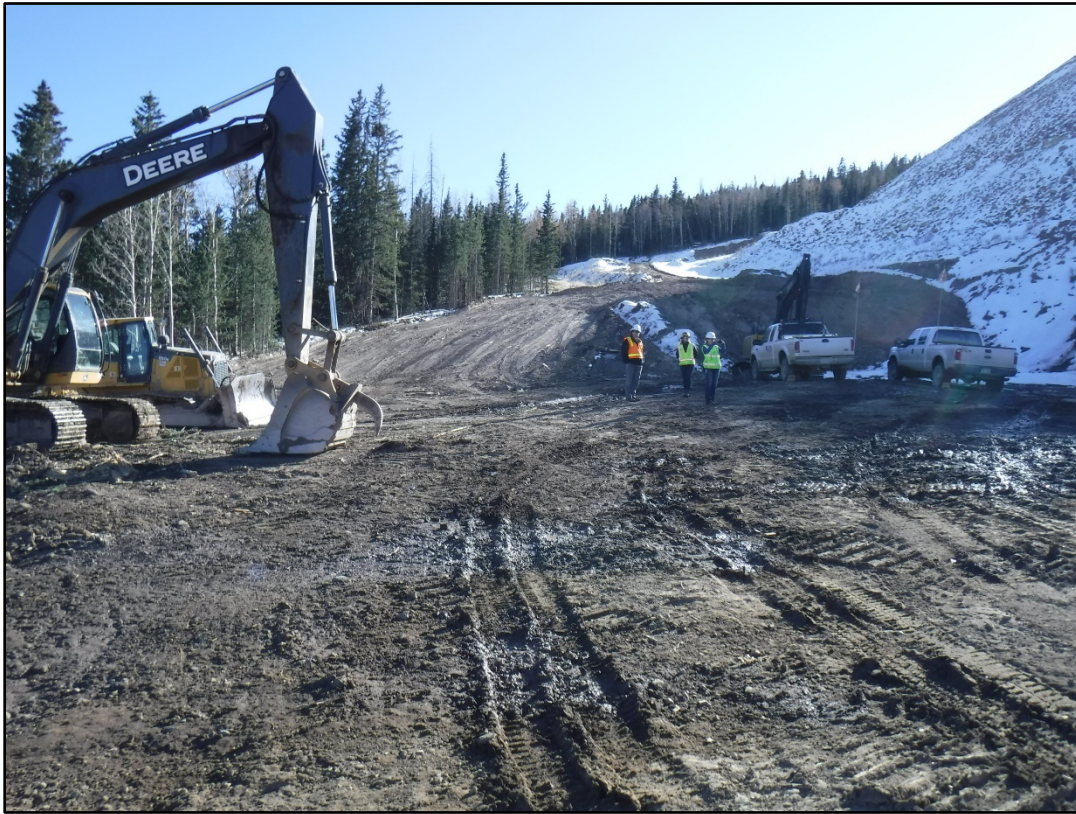
Photo 15: ECOSA clay excavation area looking south

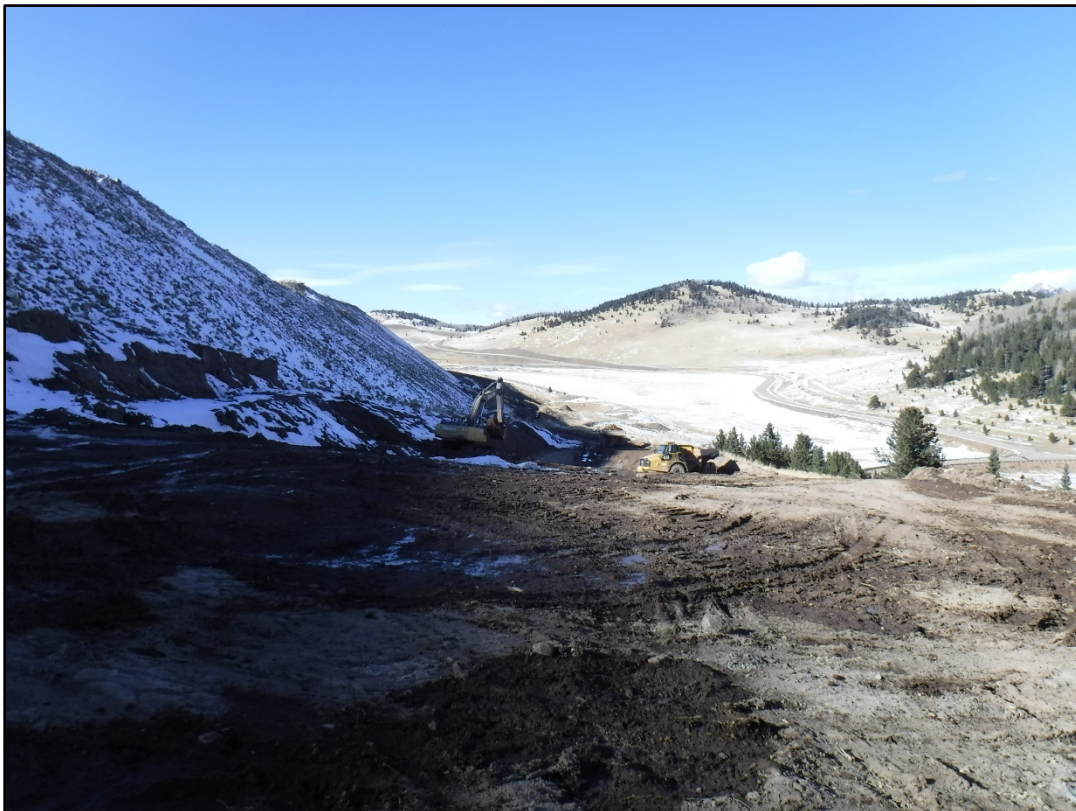
Photo 16: ECOSA clay excavation area looking north
